Recall Circular

Code: **26E5/R5**

Subject: **1999-2005 Passat & Passat Wagon (5th Generation)**

Install Underbody Heat Shield(s); Inspect/Replace

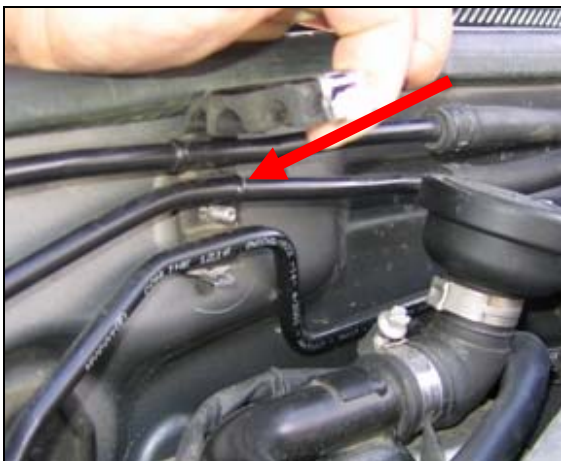
- ⇐ Check center fuel line -arrow- for signs of cracking or fuel leaks
 - If fuel line shows visible leaks or cracks, **proceed to Section D**
 - If no cracking or fuel leaks are found, close brackets and continue

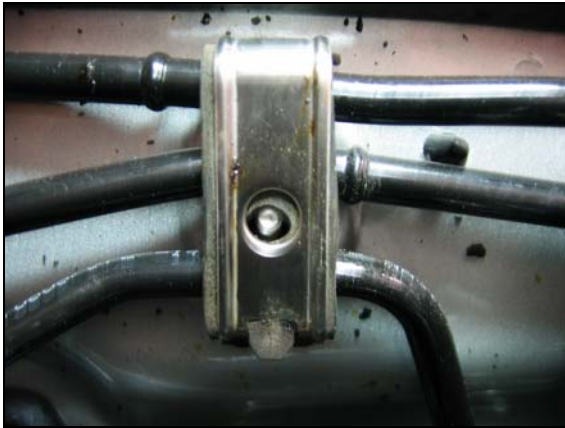
- ⇐ Inspect center fuel line to ensure flare joint is positioned to the right and outside of bracket
 - If flare joint is visible outside of bracket approximately 1mm to the right, **work is complete**
 - If flare joint is not visible outside of bracket approximately 1mm to the right, **proceed to Section C**

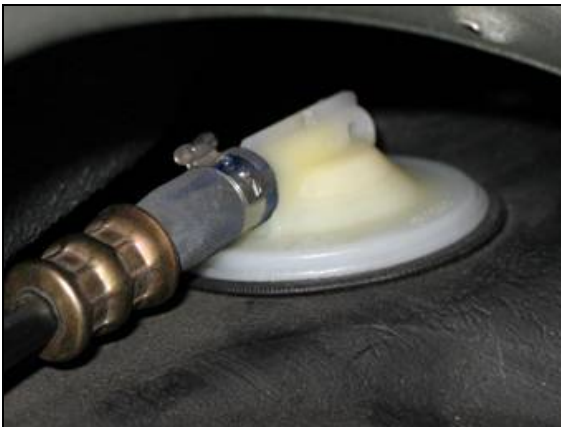
- Visually check fuel tank ventilation valve and surrounding area for fuel leak
 - If fuel leak is found go to **Section G**
 - If no fuel leak is found, continue with procedure

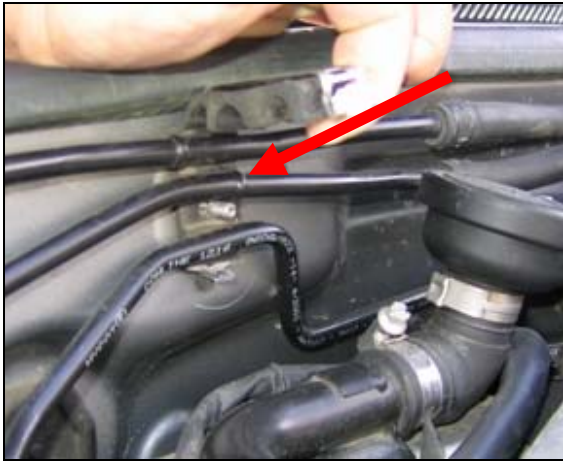
- ⇐ Check center fuel line -arrow- for signs of cracking or fuel leaks
 - If fuel line shows visible leaks or cracks, **proceed to Section D**
 - If no cracking or fuel leaks are found, close brackets and continue

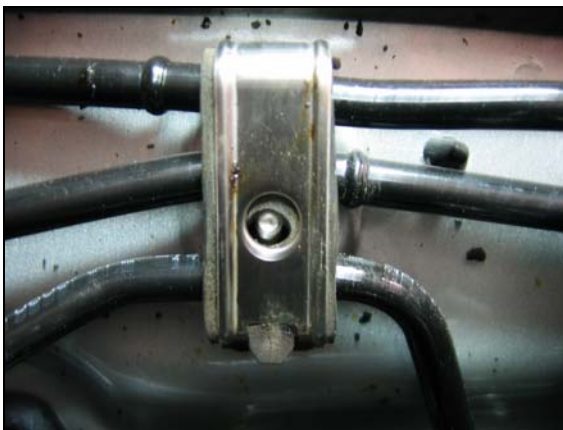
- ⇐ Inspect center fuel line to ensure flare joint is positioned to the right and outside of bracket
 - If flare joint is visible outside of bracket approximately 1mm to the right, **work is complete**
 - If flare joint is not visible outside of bracket approximately 1mm to the right, **proceed to Section C**

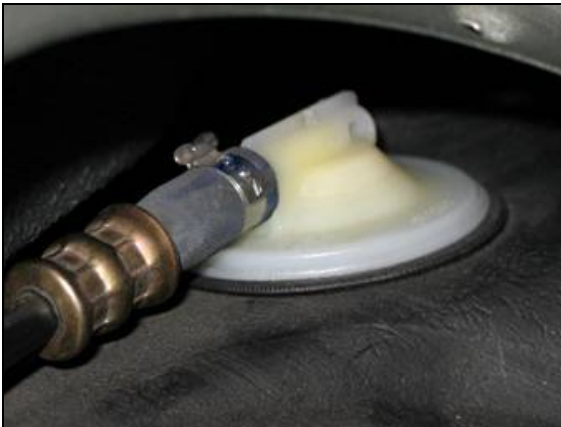
- Visually check fuel tank ventilation valve and surrounding area for fuel leak
 - If fuel leak is found go to **Section G**
 - If no fuel leak is found, continue with procedure

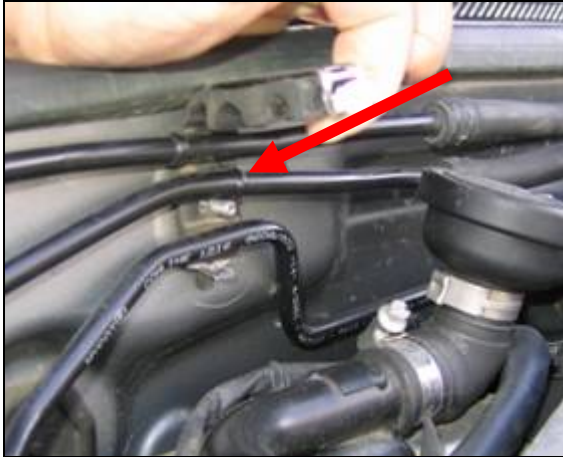
- ⇐ Check center fuel line -arrow- for signs of cracking or fuel leaks
 - If fuel line shows visible leaks or cracks, **proceed to Section D**
 - If no cracking or fuel leaks are found, close brackets and continue

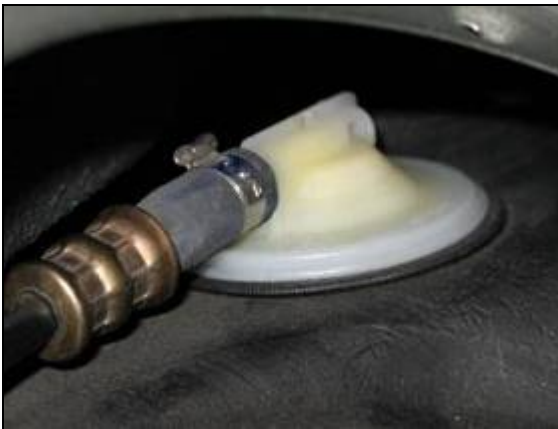
- Visually check fuel tank ventilation valve and surrounding area for fuel leak
 - If fuel leak is found go to **Section G**
 - If no fuel leak is found, continue with procedure
