PE10-027

VW

EXHIBIT TO
REQUEST 8, DATA

9752 – Engine Wiring Loom - PASSAT/Audi A4 - MJ01-03 VWOA / AOA

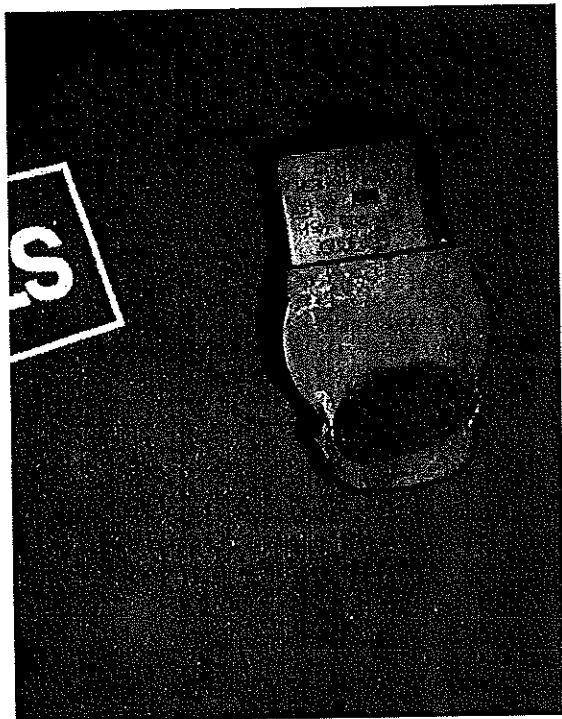
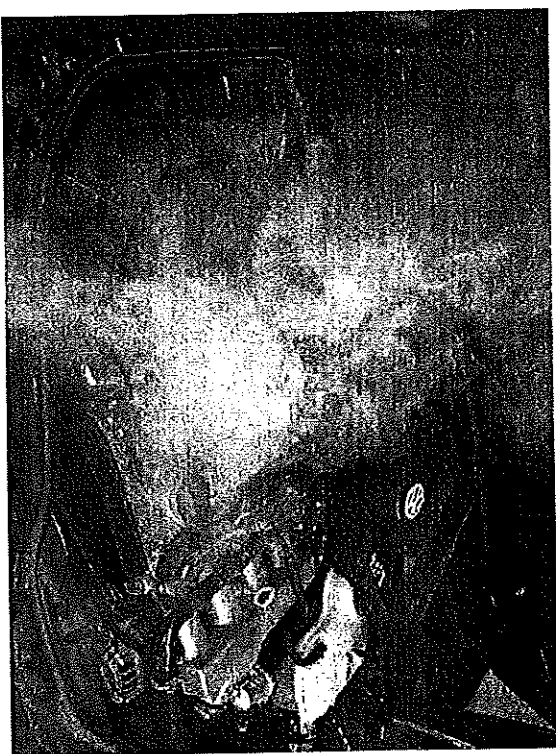
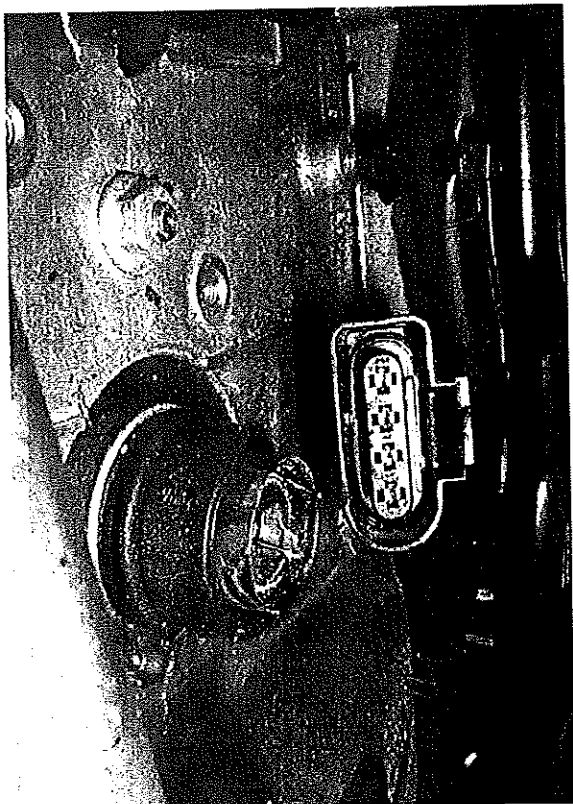
3/11/03- Technician cold started vehicle and drove into shop with the engine missing and the MIL flashing. Opened hood and removed engine cover. Coil #4 suddenly started glowing red at the head of the coil. Sparks immediately started shooting from the hole (above the chip) and continued for 40 seconds. Sparks stopped, tech removed connector and when attempting to remove the coil, the coil head came apart.

Harness connectors to coil packs appear to have moisture marks on the face of the connector. Seacoast will remove harness and send to A.H.. New J coils were installed and the vehicle was tested at cold start and warm idling. Data logs from Fluke meter are saved as : Seacoast-cold start X and Seacoast-coldstart-day2-2-X.

See attached pictures for coil failure.

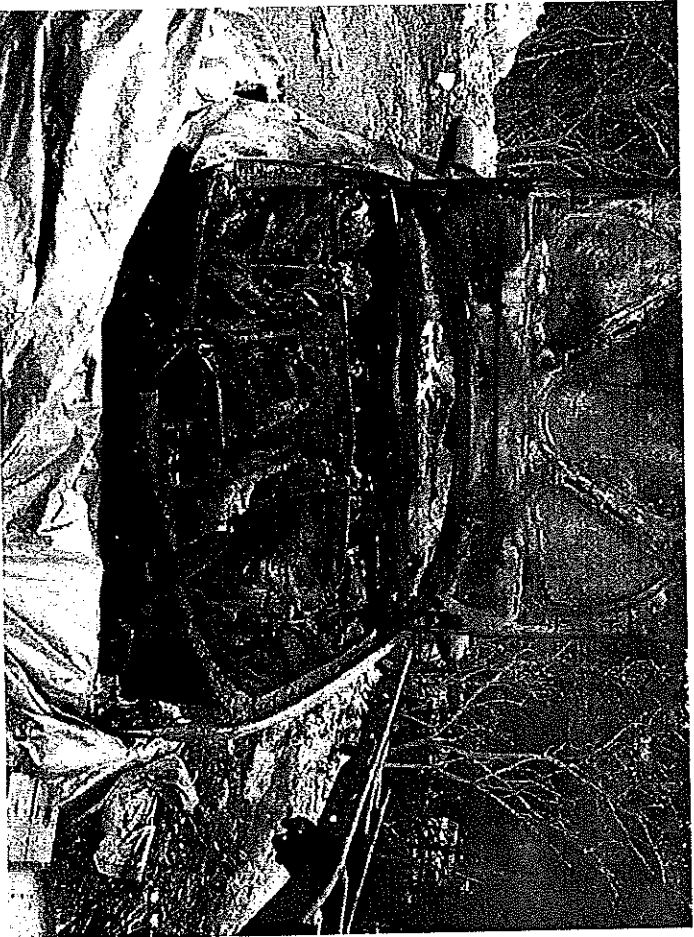
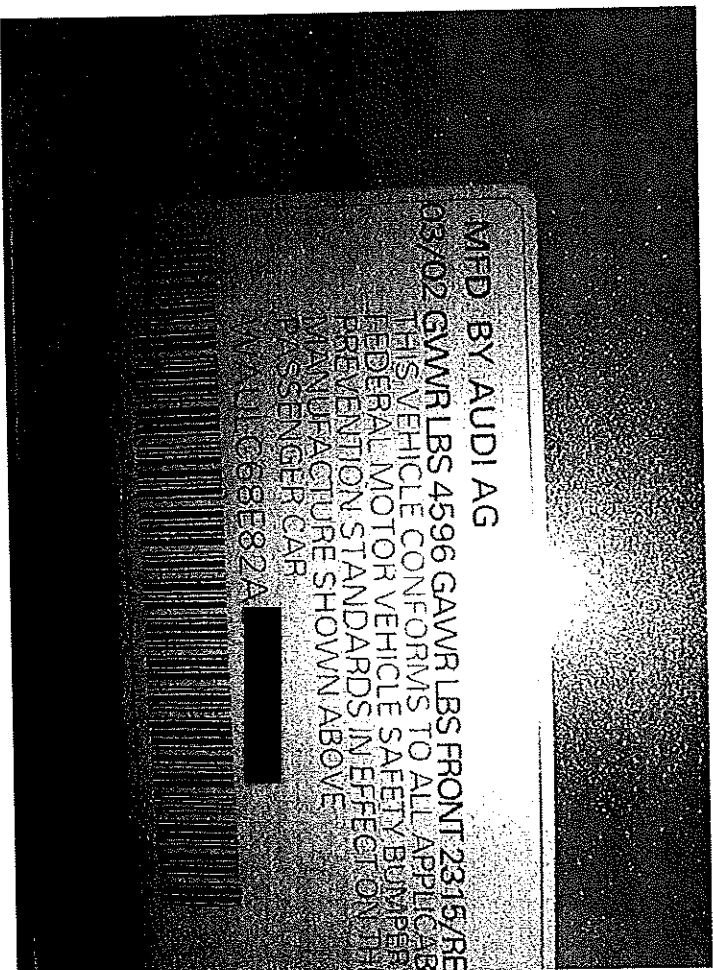
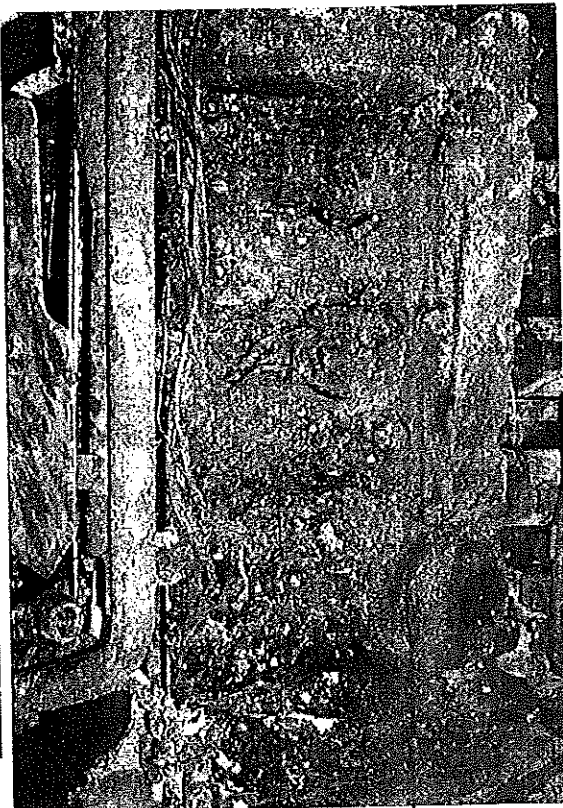
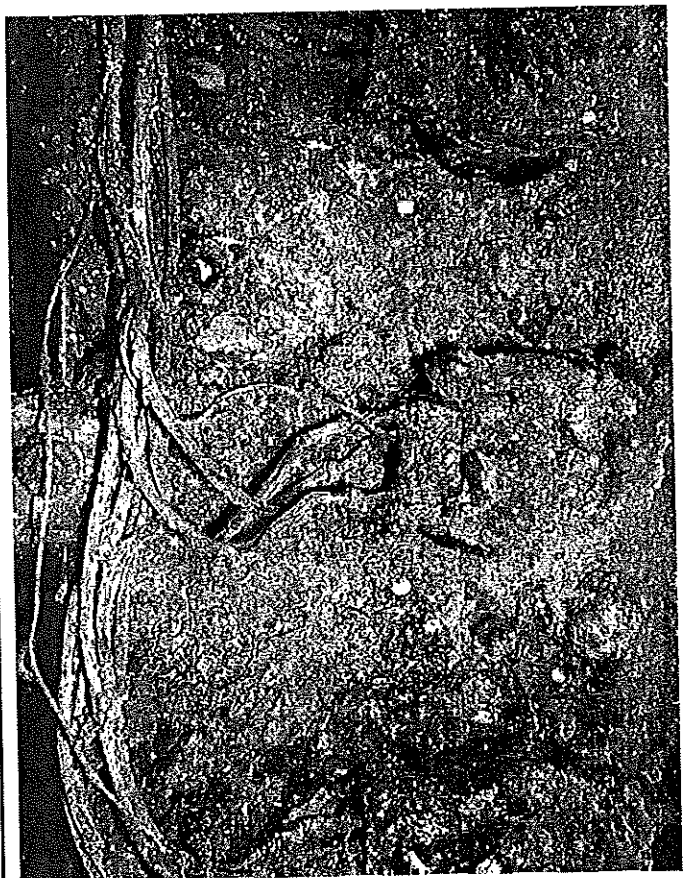
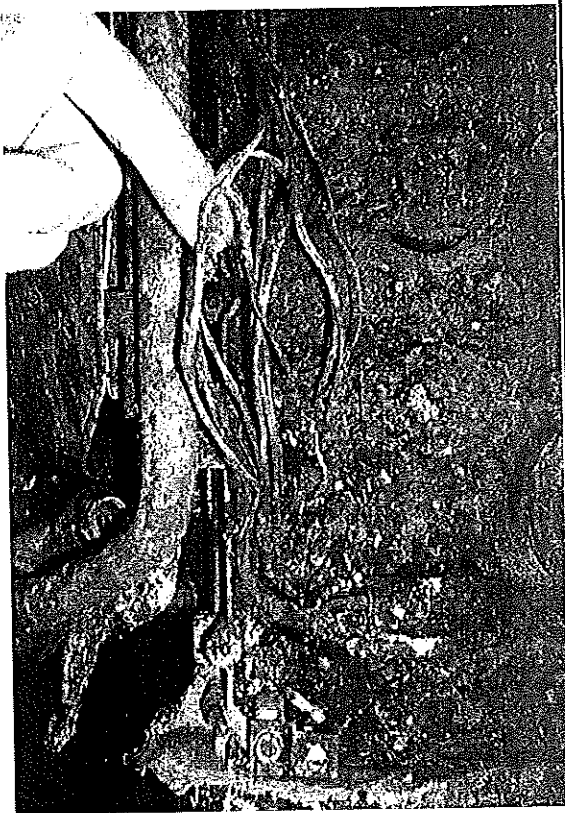
Inspection reveals that the #1 coil may have failed (see pictures- head of coil appears to have separated from the main body-A typical failure mode when the secondary windings fail) and caused a RK. Pat (SM) was unable to come up with the customer statements on the case and will contact me when the dealer locates the files. They will also inspect the wiring harness on TTs and contact me when any issues are found.

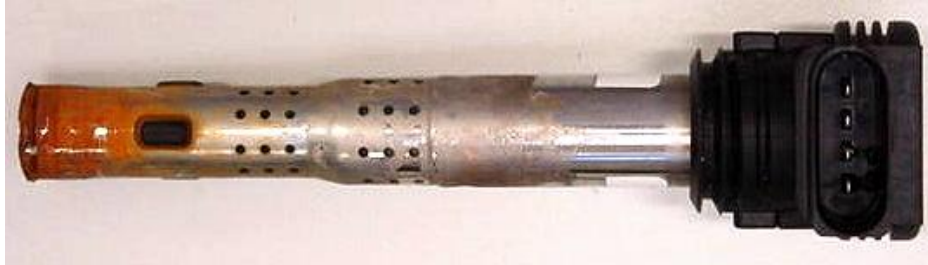
Photo 1

The coil appear damaged in the connector area, photo 1.

In the surface of the long shield there is a unknown material, we suppose that this material coming from the motor plug well.

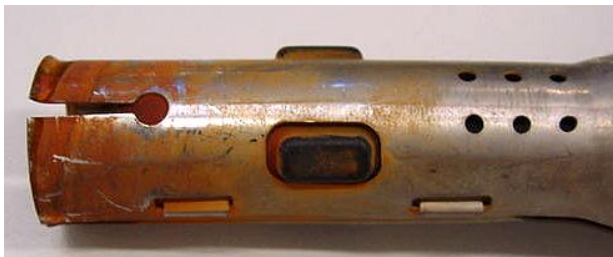
Photo 2

Photo 2,3, shows the unknown material on the surface of the long shield.

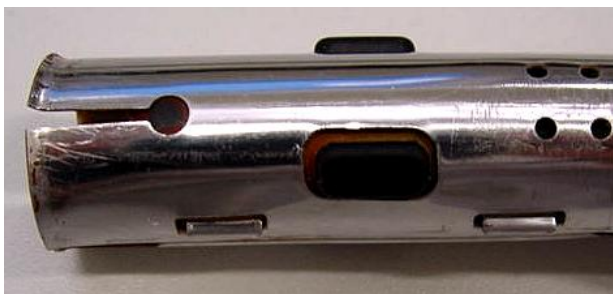
Photo 4

Photo 3, 4, show the long shield clean, after the removing of the unknown material.

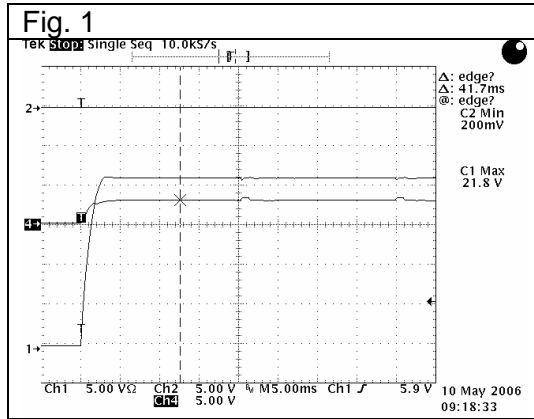
The pencil coil was electrically verified in Eldor in the follow condition $V_{batt} = 14V @ IP=0A$;
 Freq.= 50Hz; $IP = 15A$; Load $1M//25pF$.
 The coil don't work, fig. 1.

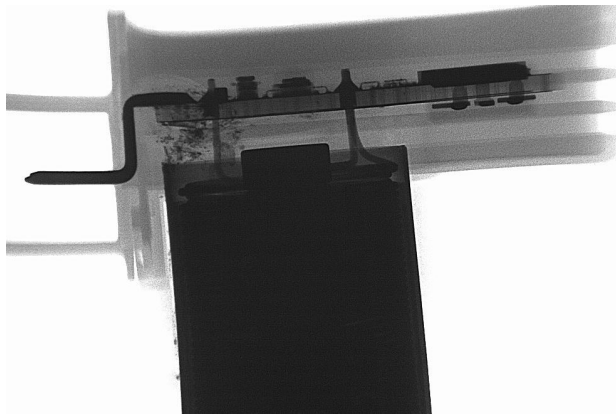
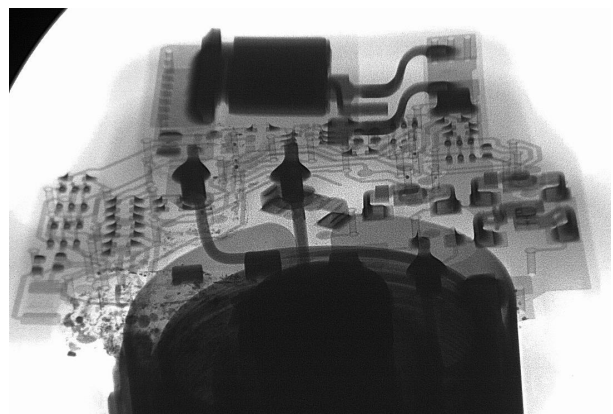
Photo 7

The X-ray, show the pencil very damaged, photo 6.

Is present some soldering material due to the high temperature reach by the pcb in pin1 area, photo 7.

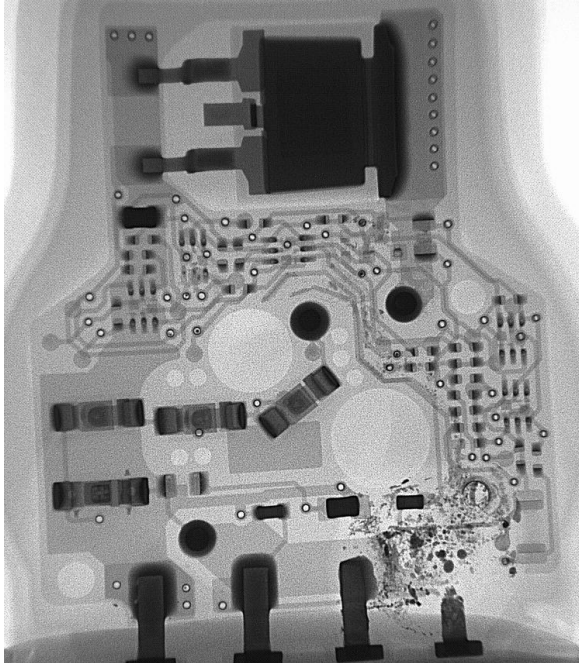
Photo 8

The X-ray, show the damaged area on the electronic, photo 8.
Photo 9, show the burn area on the bottom side of the pcb.

Probably humidity penetration on the PCB that has determined the burning of the electronic.

Change of the head rubber in order to guarantee a better sealing between the plug well and the ambient area in all tolerances condition -> in wk 04/06.

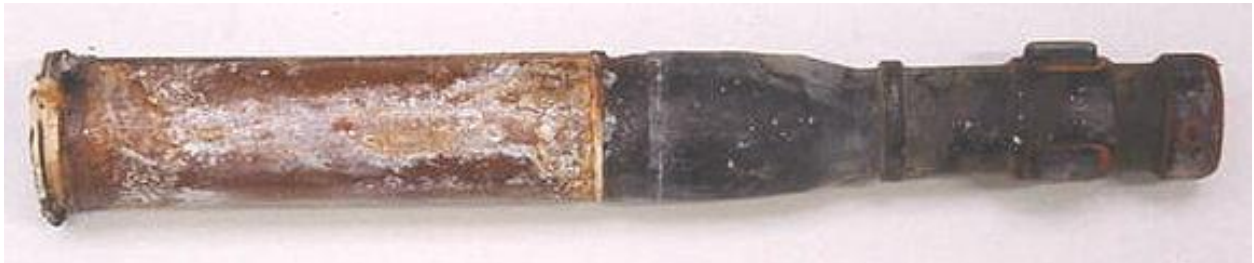
Photo 10

The long shield was extract from the pencil for to check the primary windings : the plastic tape results very damaged, but not contact point are observed between the primary wire and the shield, photo 10.

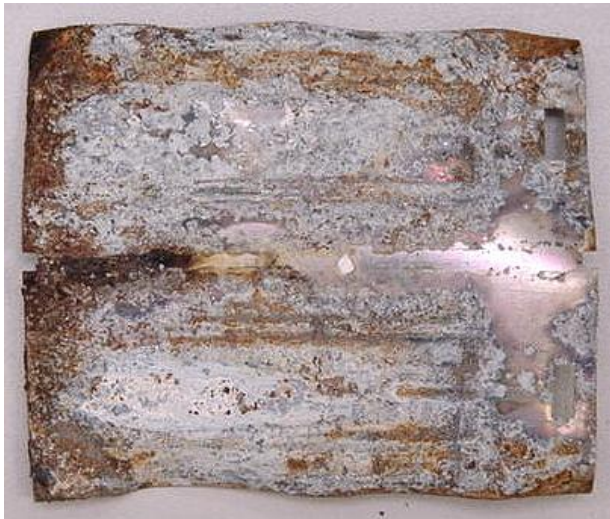
Photo 11

On the external surface of the shield it was observed the oxidation, see photo 11.
On the internal surface of the shield it was observed the oxidation, photo 12.
No contact point were observed in the surface of the shield.

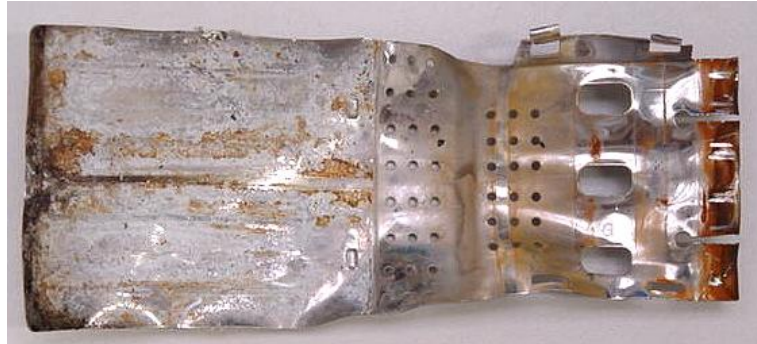
Photo 13

On the internal long shield there is the oxidation residual coming from the internal shield, see photo 13.

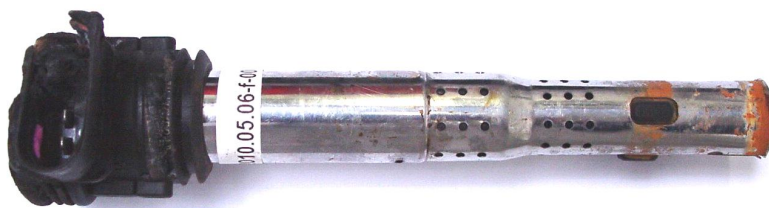
Photo 1

The coil received is too much burnt on the head side, photo 1, 2.
Pins 1 and 2, on the connector LV, are missing;
The external surface of the shield with oxidation signs, photo 3.

The level of damaging of the pcb is too high for perform the analysis but with very probability the defect is due to humidity penetration on the pcb that has determined the burning of the pcb.

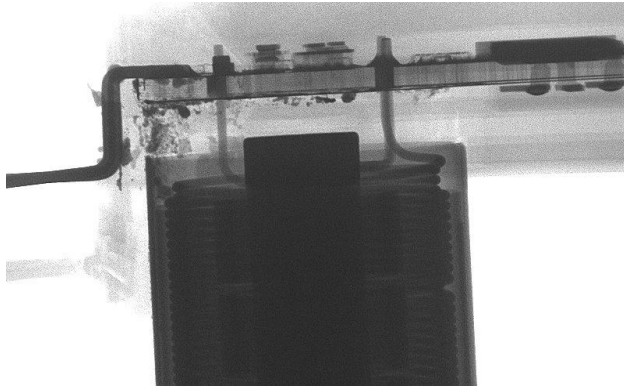
Photo 4

The X-ray, show the pencil coil very damaged on the pcb, photo 4, 5.

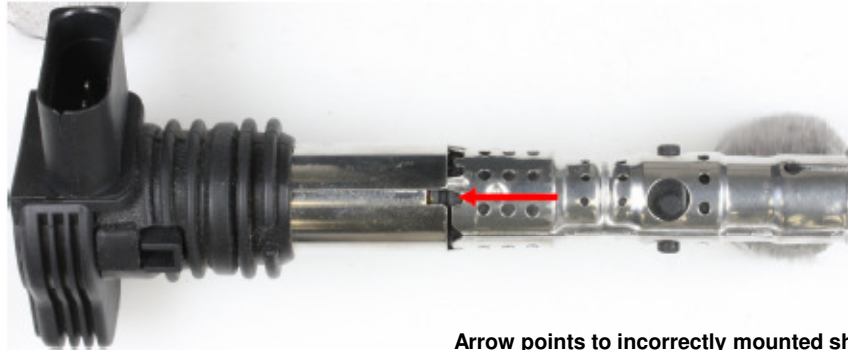
Aftermarket Part
Ref.: 11-Z-09-09730

Arrow points to incorrectly mounted shell
