Action	Document	Start Date:	End Date:	Subject/Objective:	Responsible:	Summary:
Action 09-01	09-01_PQA2004470102.pdf	11/19/2004	11/19/2004	Failure analysis of overheated pencil coils	Sub-Supplier Fairchild (Pulse's supplier for IGBT)	IGBT overheated due to current related overstress
Action 09-02	09-02_MPV05-009.pdf (German Original) 09-02_MPV05-009_EN.pdf (English Translation)	9/1/2004	3/4/2005	Failure analysis of 8 failed pencil coils	Supplier Pulse	Coils were damaged by external influences; electrical overstress resulting from missing ground connection caused IGBT to overheat
Action 09-03	09-03_0001924068.pdf (German Original) 09-03_0001924068_EN.pdf (English Translation)	11/25/2004	3/23/2005	Component analysis of ignition coil	Audi AG	Exact analysis not possible because of damage degree
Action 09-04	09-04_11-Z-05-2207.pdf (German Original) 09-04_11-Z-05-2207_EN.pdf (English Translation)	4/14/2005	4/15/2005	Failure analysis of overheated pencil coils	Volkswagen Laboratory	IGBT latch-up, impaired capacitor soldering

Action 09-05	09-05_MPV05-018.pdf (German Original) 09-05_MPV05-018_EN.pdf (English Translation)	9/1/2004	4/25/2005	Failure analysis of overheated pencil coils	Supplier

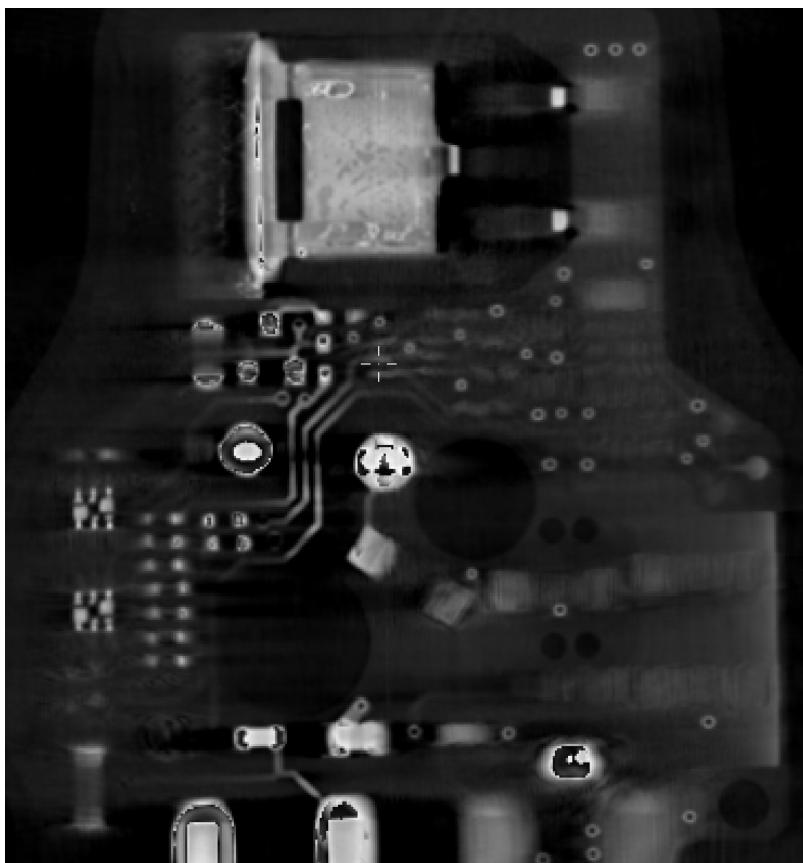
- The IGBT has failed.
- A ceramic condenser shows irregularities in the area of the solder post.

Image 1:CT cross section, ignition coil, vehicle ID.3VWSF71K55M603138 Jetta USA, failed IGBT

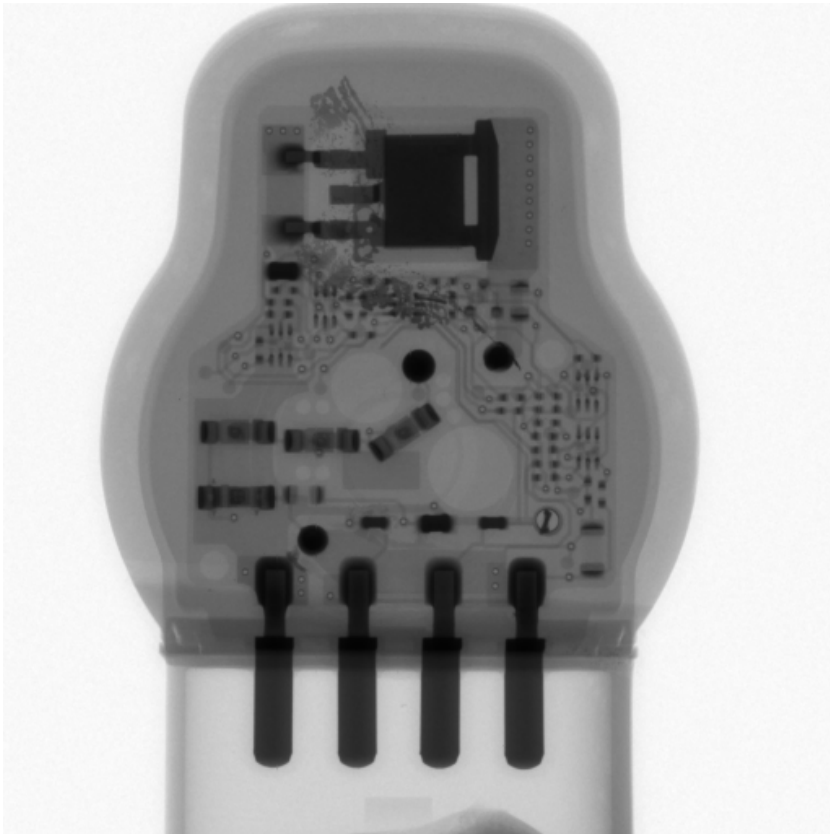
Image 2: Radioscopy image, ignition coil, vehicle ID.3VWSF71K55M603138 Jetta USA

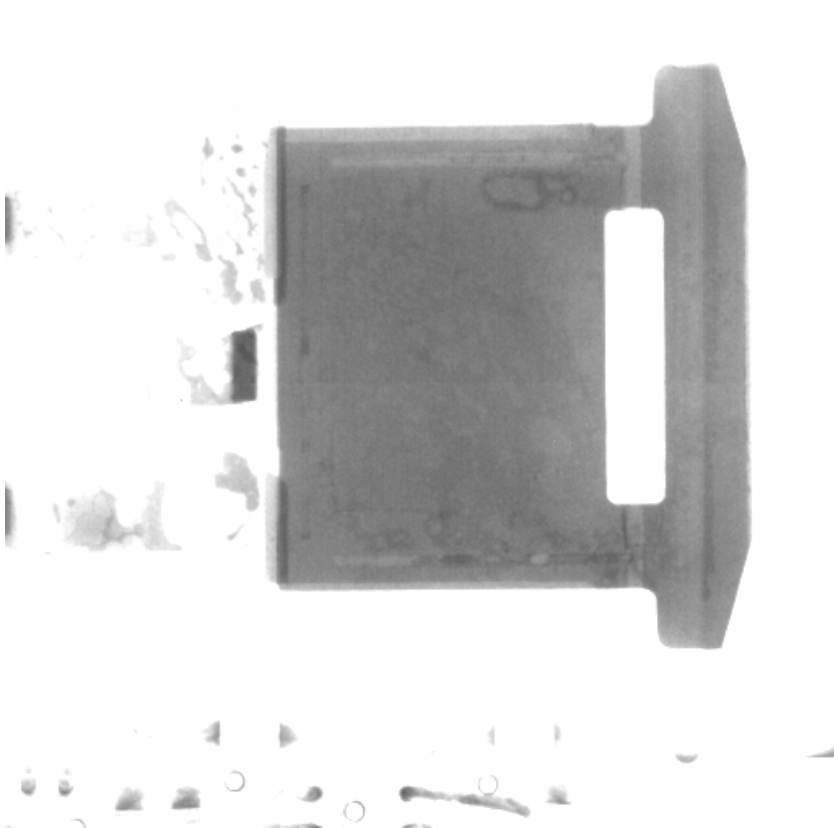
Image 6: Radioscopy image, ignition coil, vehicle ID.3VWSF71K55M603138 Jetta USA, failed IGBT

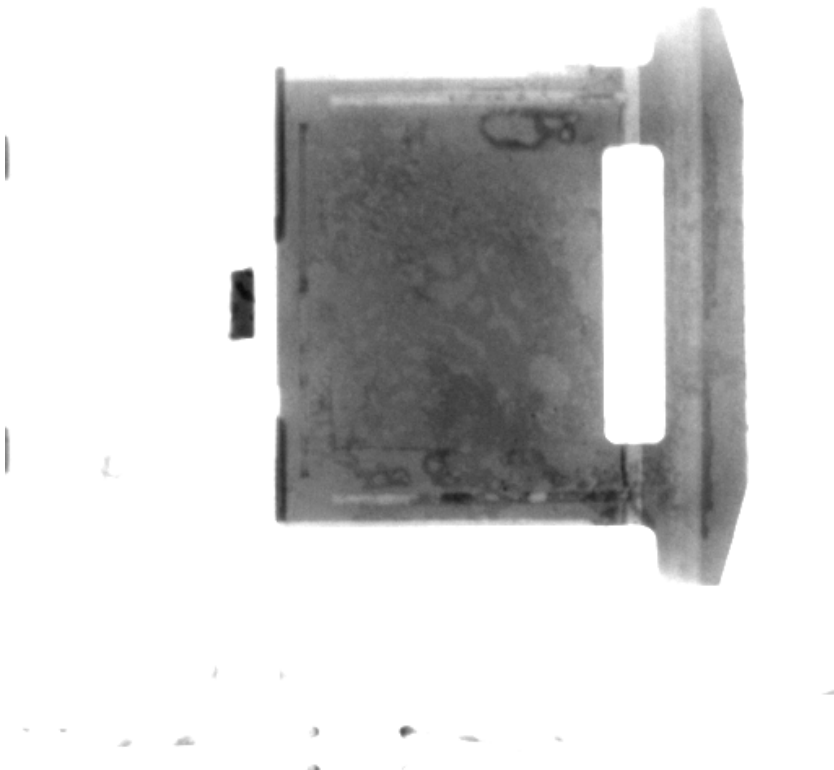
Image 7: Radioscopy image, ignition coil, vehicle ID.3VWSF71K55M603138 Jetta USA, failed IGBT

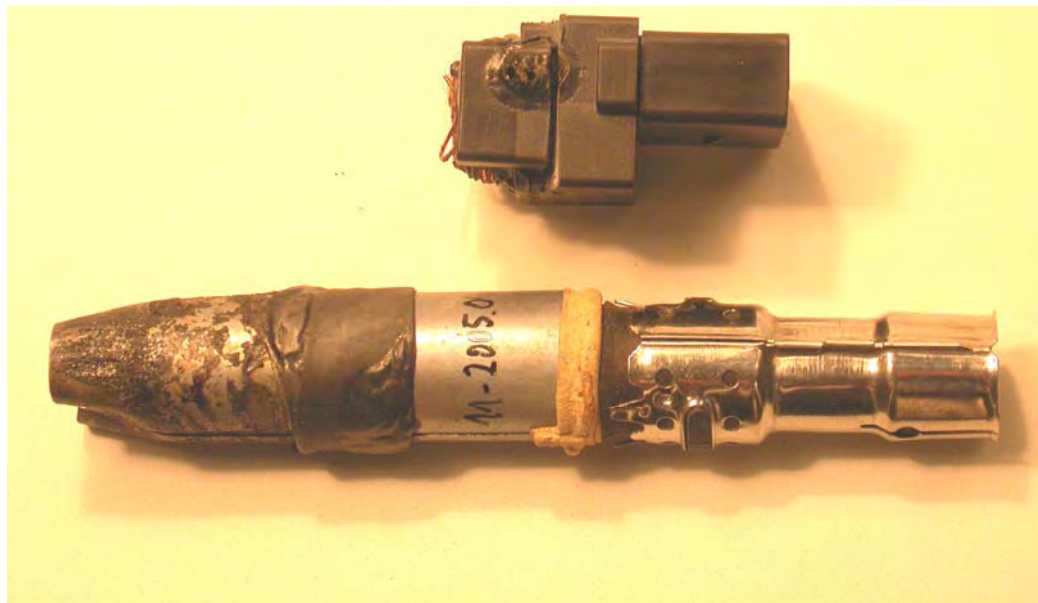
Image 1: coil view

- Part number: 022 905 100A L2 B1F5 6 11/04 Bremi
- Vehicle no.: WVGBC77L44D071365
- the material from the primary coil body was plastically deformed by a temperature adjustment (image 1).
- the IGBT is damaged. After it was ripped out, it was ascertained that the IGBT body is very strongly braised (image 5).

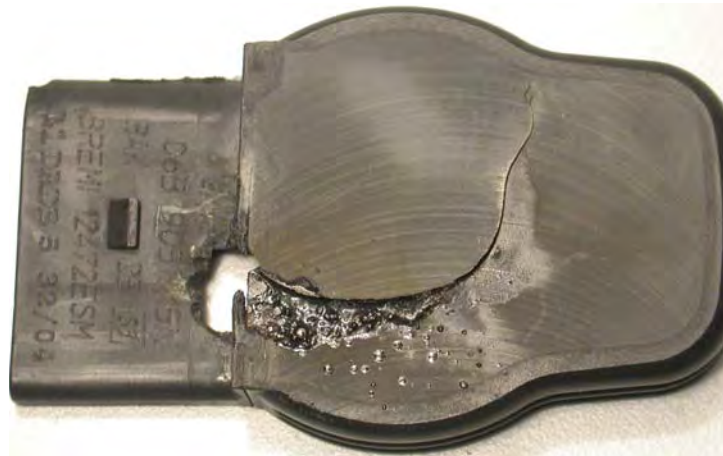
Image 18: control electronics view

- Part number: 06B 905 115N L1 DADB 5 32/04 Bremi
- Vehicle no.: WVVAD63B75E056942
- The sealing compound above the control board is cracked and is very dirty in the area of the Pin 1 plug (image 17).

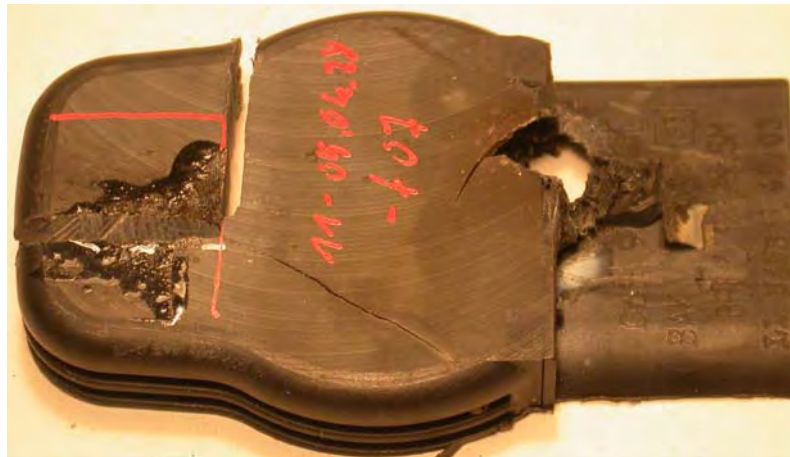
Image 21: control electronics view

- Part number 06B 905 115L L1 N45B 5 49/03 Bremi
- Vehicle no.: WVWPD63B94P199954
- The sealing compound above the control board is cracked and is very dirty in the area of Pin 1.
- after it was ripped out and aligned it was established that the IGBT is OK.

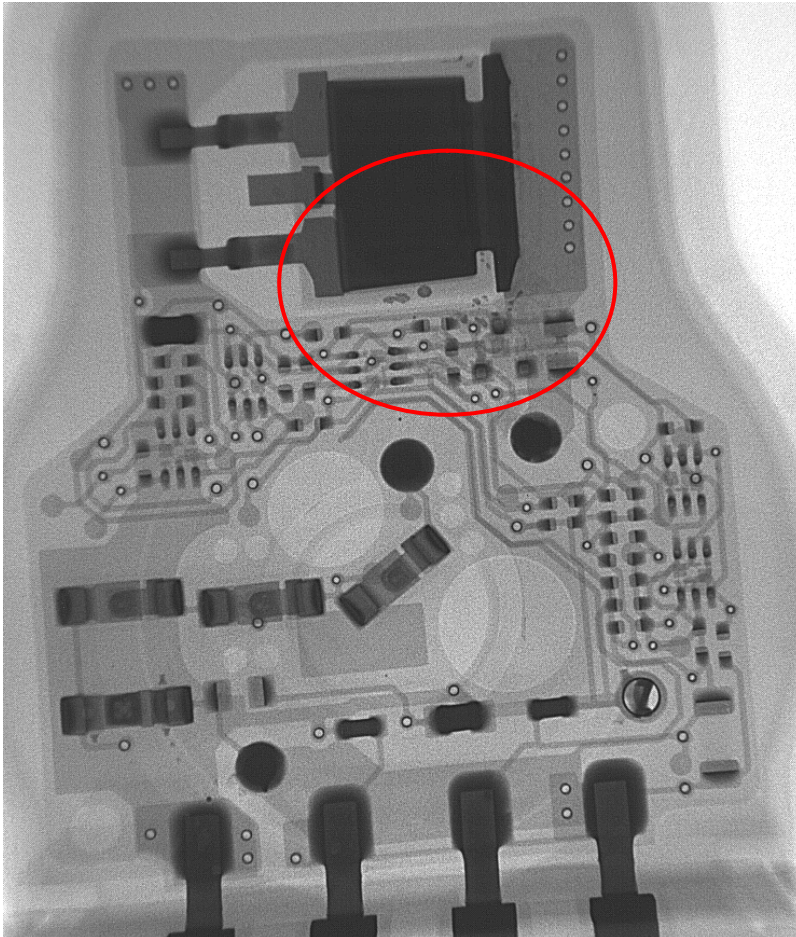
Photo 3

The X-ray, show the damaged area near lgbt (photo 2) and the crack in plastic over the lgbt (photo 3).

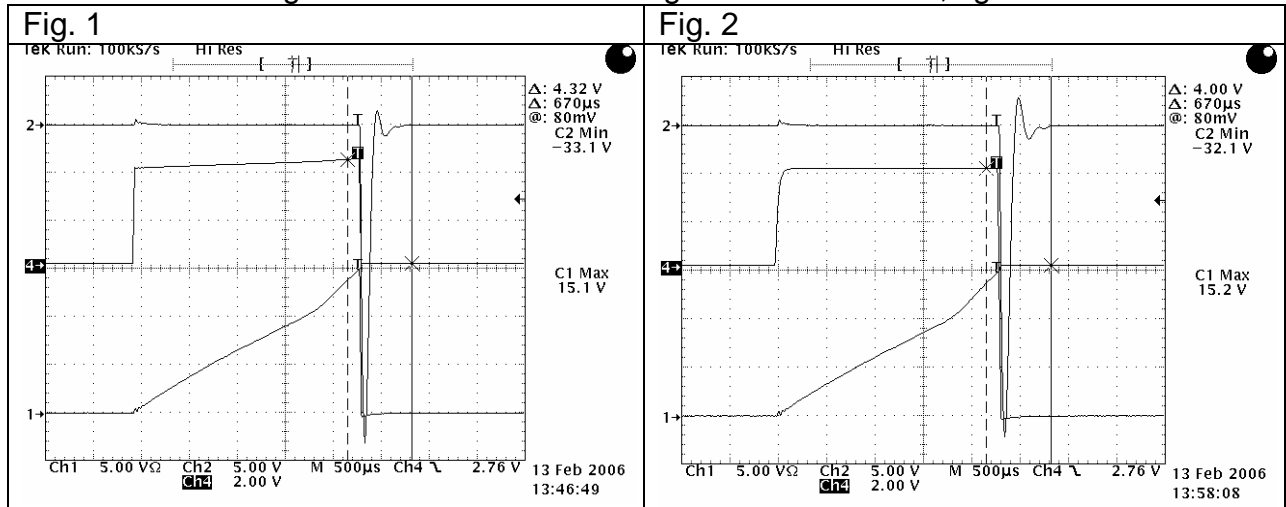
The lgbt was extract from the pencil and checked it in a sure good electronic: Ok, fig. 1.
So also the windings were tested with a sure good electronic: Ok, fig. 2.

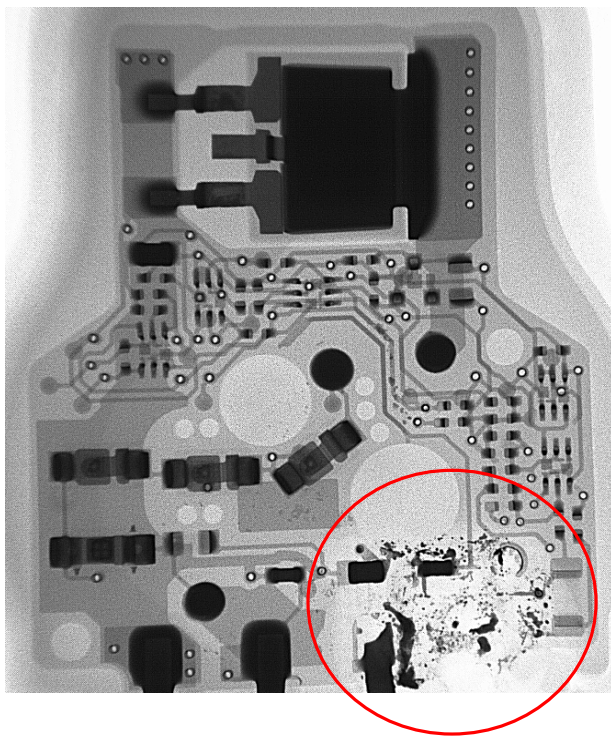
Photo 8

The X-ray, show the burned area on the electronic and the soldering residual, photo 8.
Photo 9, show the pcb burned.

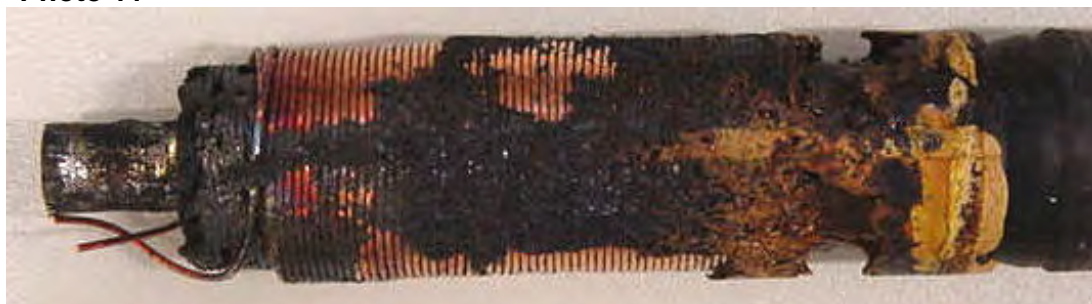
Photo 11

The primary windings appear very damaged, the primary plastic is melted for the excessive heating due to the high temperature reached by the primary wire, photo 11.

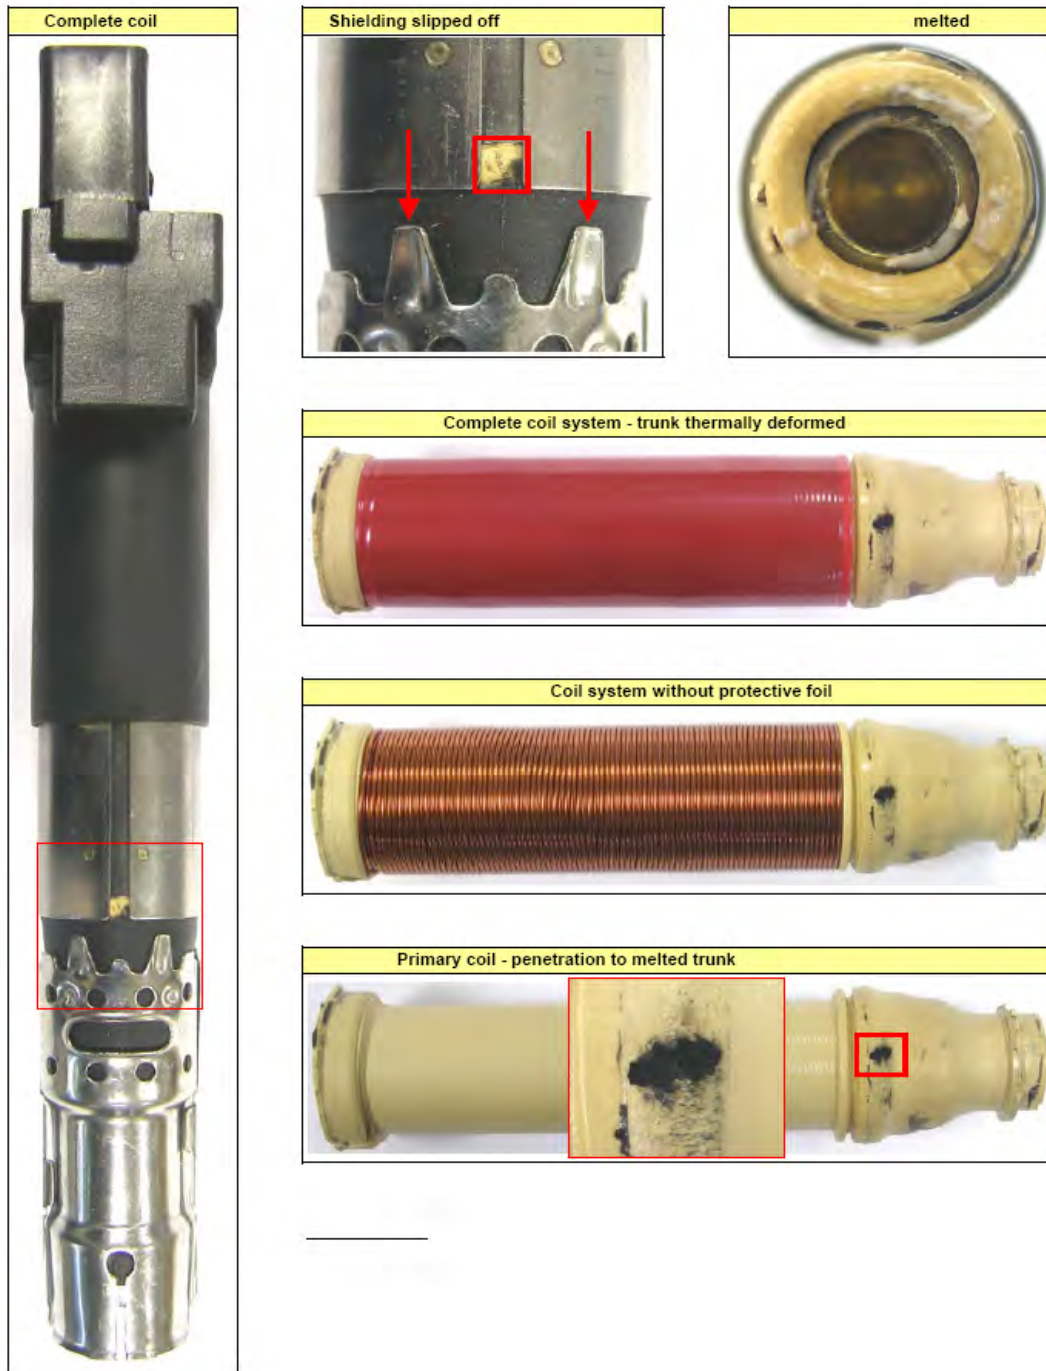
The trunk of the primary ignition coil is penetrated. The cause could be an overheating (on engine side) which caused the melting of the trunk and the loss of insulation. This could have been started by a faulty or wrongly fitted spark plug, a spark-over between the coil and the SAE connection of the spark plug is also possible (see MPA07-047).

- A lengthening of the ignition coil in the area of the shielding and an overheating of the trunk could be recognised straight away.
- After removing the shielding and the protective hose it becomes clear that the trunk is deformed and melted in the area of the connection.
- The overheating (at engine end, spark plug missing, spark-over between coil and spark or similar) and the resulting melting led to a pressure knock on the end plate.

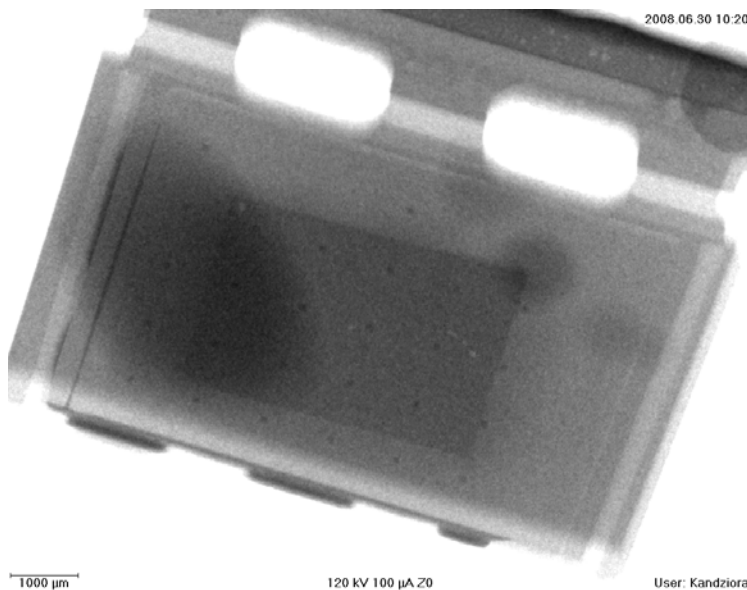
<p>Volkswagen AG Konzern-Qualitätssicherung Zentrallabor K-GQL-1/2, 1437/1</p> <p>11-Z-05-4271_1Abschlußbericht</p> <p>Bildablage:</p>		<p>Eingang Auftrag 12.09.2005 Eingang Teile EA / WA Zeichnungs-Nr. .06B.905.115.L Zeichnungs-Datum Baumusterpflichtig Nein Berichts-Datum 19.09.2005</p> <p>Note Bemusterung - Aufwand Stunden:</p>
<p>Stabzündspulen aus Kunden-Fzg. Audi A4 1,8T USA</p>		<p>Seite 1 von 1</p>

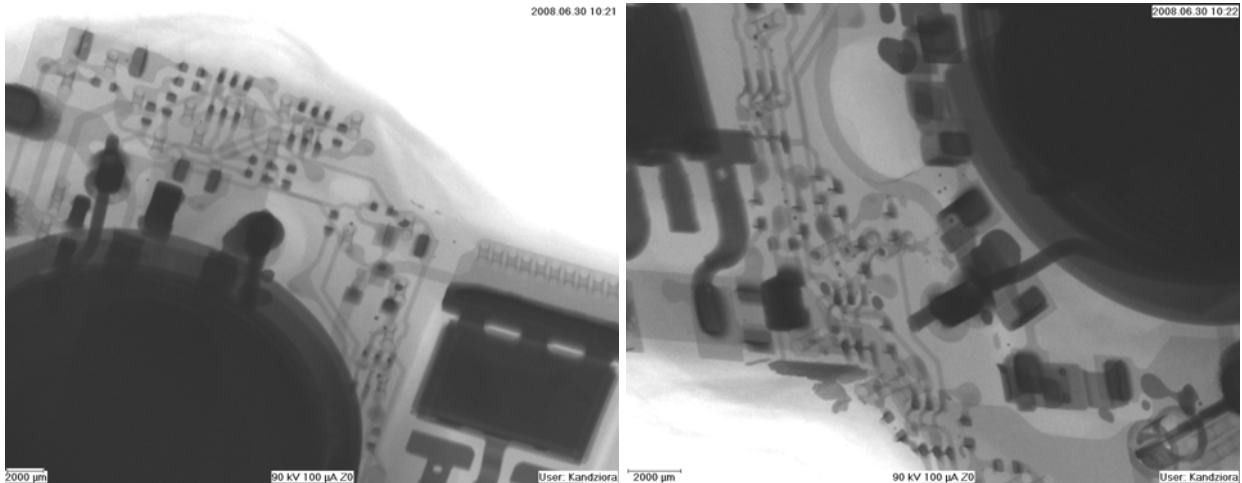
Zur Analyse erhielten wir zwei Stabzündspulen die einen Belag aufwiesen und drei Prozeßmaterialien zum Vergleich.

2 Zusammenfassung / 3 Einzelergebnisse

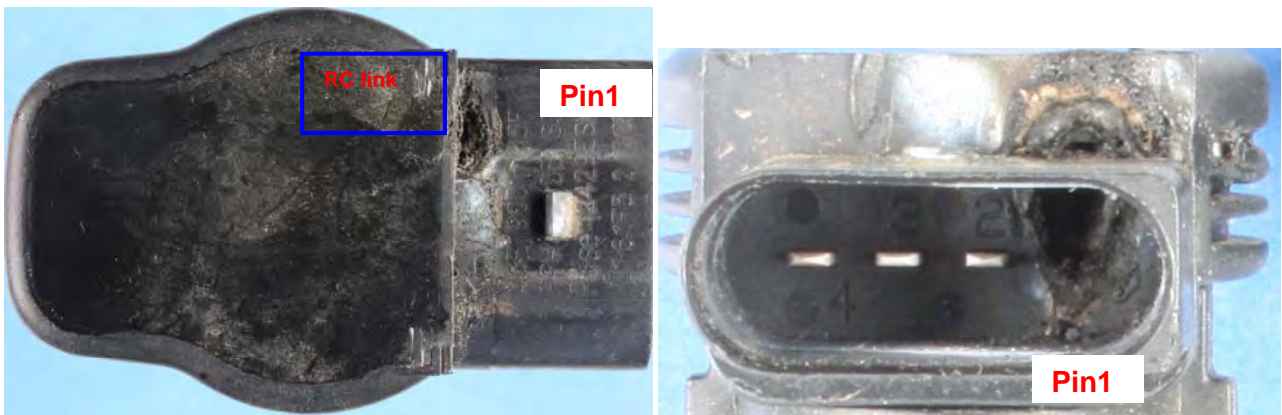
Image 5: 11-z-10-02246_2, damage to the coil head in the area of the RC link

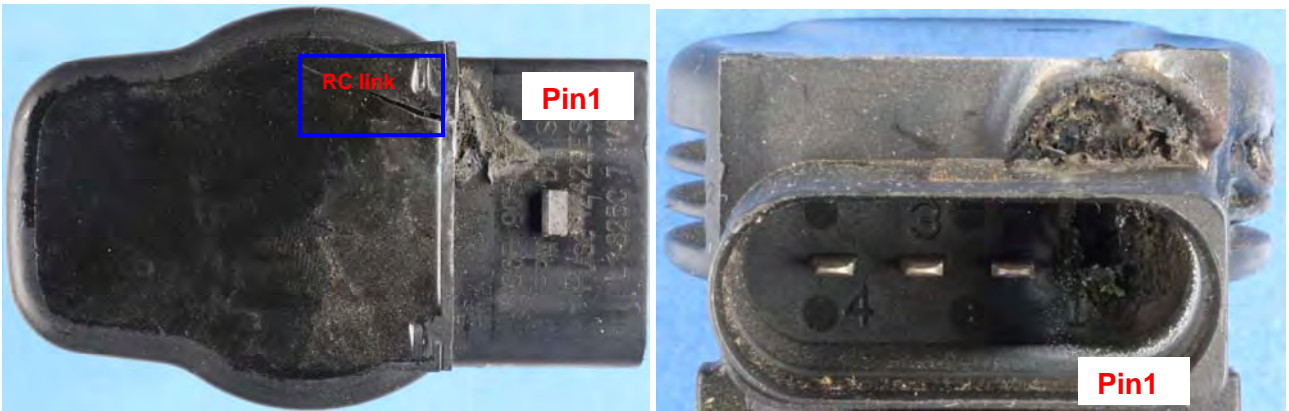
Image 8: 11-z-10-02246_7, damage to the coil head in the area of the RC link

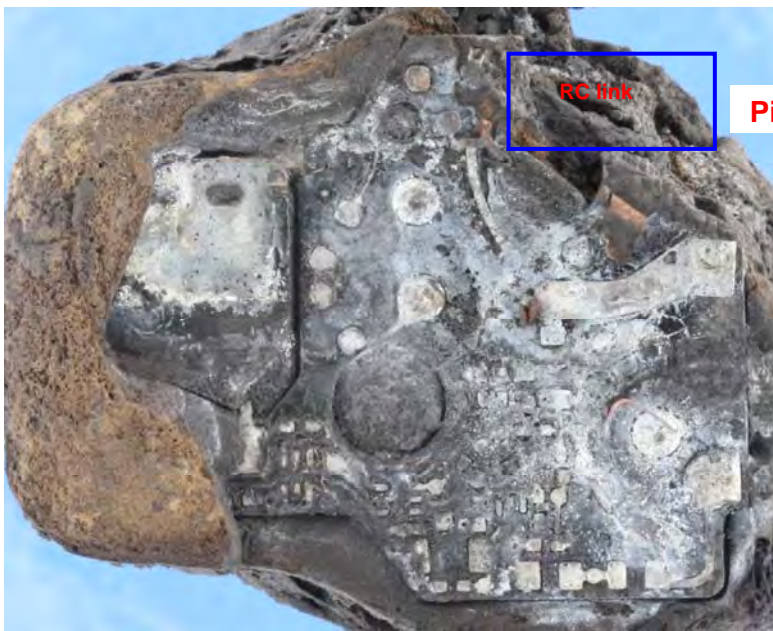
Image 11: 11-z-10-02246_10, damage to the coil head in the area of the RC link

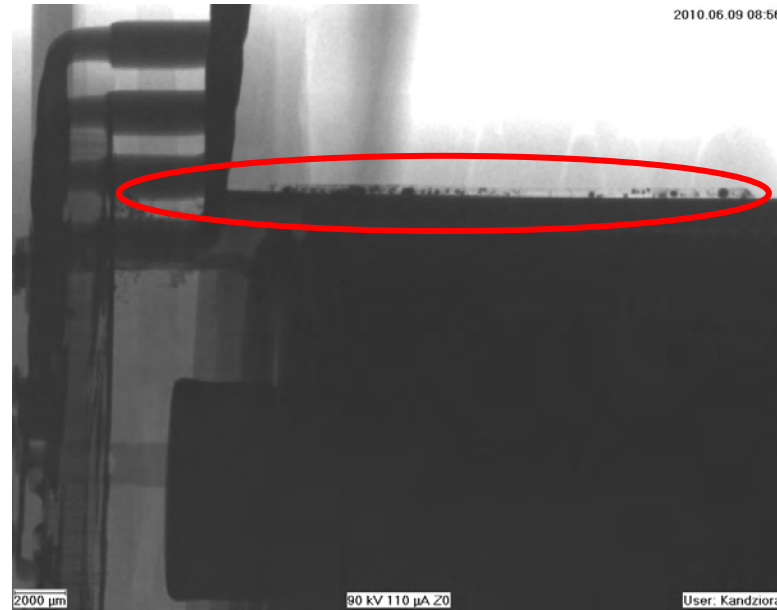
Lot von der Klemme 15 geschmolzen und leitende Verbindung zum Rückschlussblech aufgebaut, im Folge dessen entstand Kurzschluss (14V und Masse)

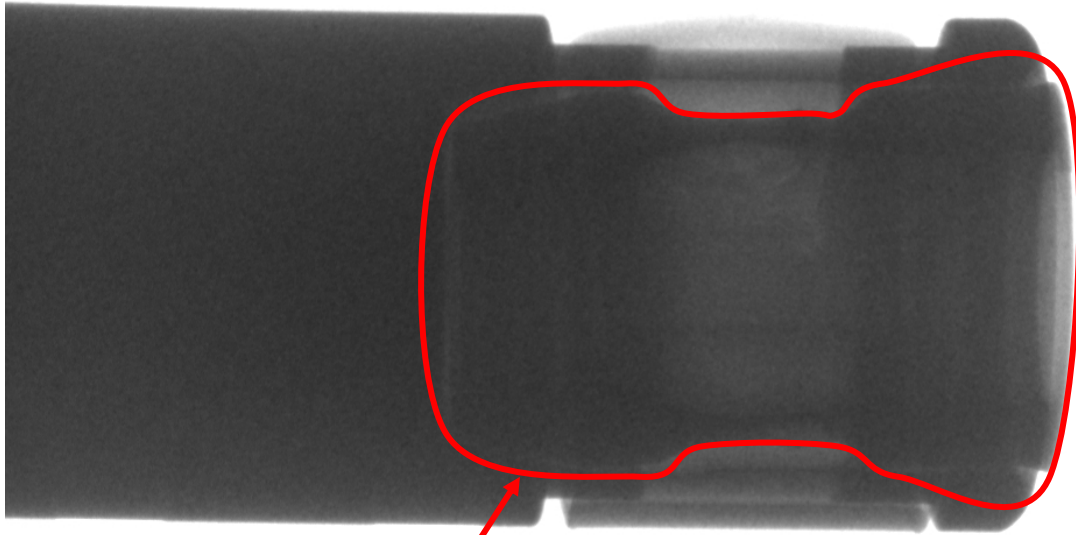
SAE-Stecker der Kerze ist im SAE-Adapter der Spule stecken geblieben
