PE10-037

Q6 Labor Op and Problem  
Codes

| Theme | Low beam doesn't work<QAH2946><br>(Lighting SW) |

# Analysis results (Comparison of US FIT and Japanese FIT)

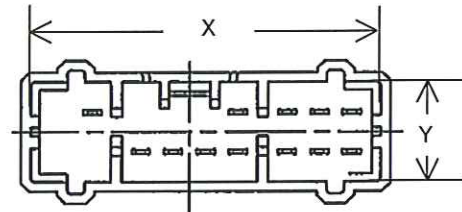
- 1) 外観確認結果
- ・ライティングSW外観に傷、打痕等の異常なし。
  - ・ケース等の表面に油分の付着が確認できる。
  - ・カブラ内部、Lo端子に変色が確認できる。
  - ・カブラ内部、Lo端子周辺に付着物が確認できる。
  - ・端子外観より返却された現品はメッキ対策品である。
  - ・カブラ内寸、Lo端子板厚確認 (単位:mm)

- ・カブラ内寸、端子板厚共に規格を満足しており問題無し。

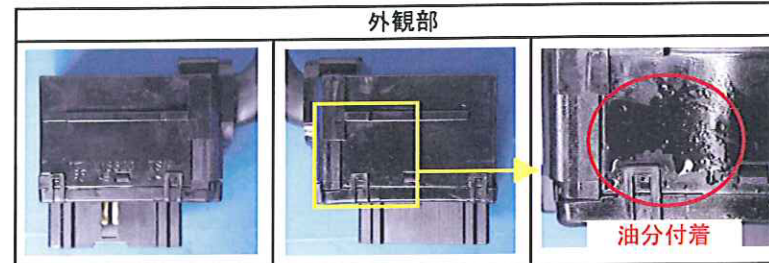
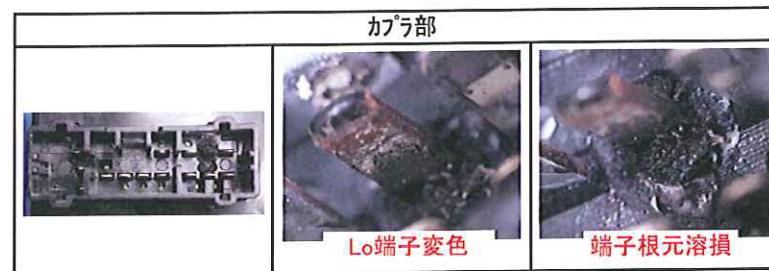
- ・各回路の導通確認(Lo回路は端子間を除く)を行ったところ、導通不良等の異常は見られなかった。

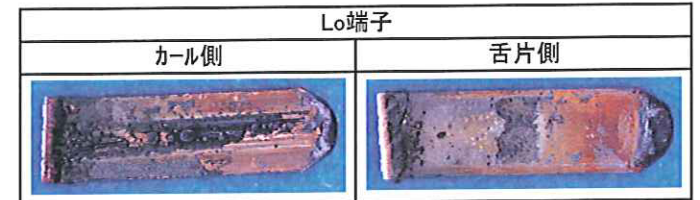
## 2) 分解確認結果

- ・Lo端子を切断し、この外観を確認したところ、カール側・舌片共に、端子全体が変色していることが確認できる。また、接触部及びその周辺に樹脂が付着していることも確認できる。

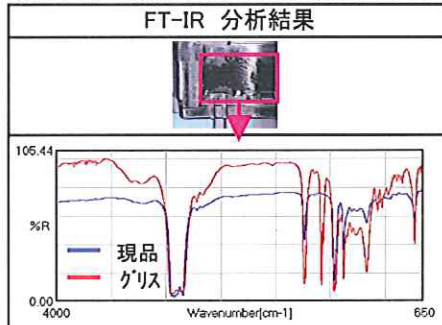
## 1) FT-IR分析結果

| 分析箇所 | 分析結果 |
|---|---|
| ケース側面付着物 | SW使用グリス |

特に異質な成分は検出されていません。

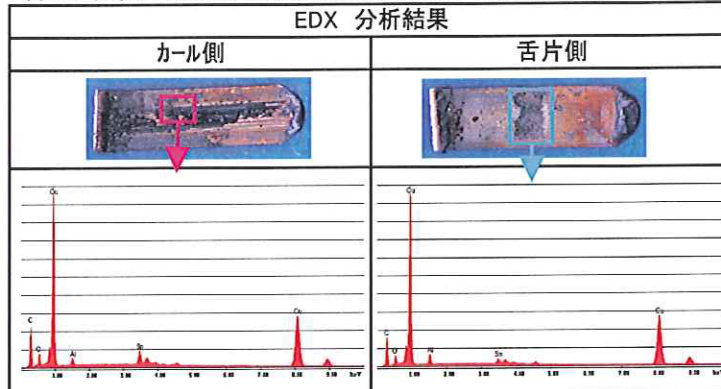
## 2) EDX分析結果

以上の確認結果より、返却されたSWの内部回路に異常な箇所は確認されませんでした。  
ただし、Lo端子の溶損が確認できましたが、本SWにおいて発熱・溶損に至る要因は確認されませんでした。  
なお、発熱に至った要因として、何らかの接触不良が考えられますがその原因については相手側端子の詳細確認が必要と判断致します。

| 分析箇所 | 分析結果 |
|---|---|
| Lo端子 | SW端子成分の銅(Cu)、錫(Sn)が検出された。<br>上記成分の他には、SW樹脂成分の炭素(C)、酸素(O)、アルミニウム(Al)が検出された。 |

今回の事象に至らしめる様な成分は検出されていません。

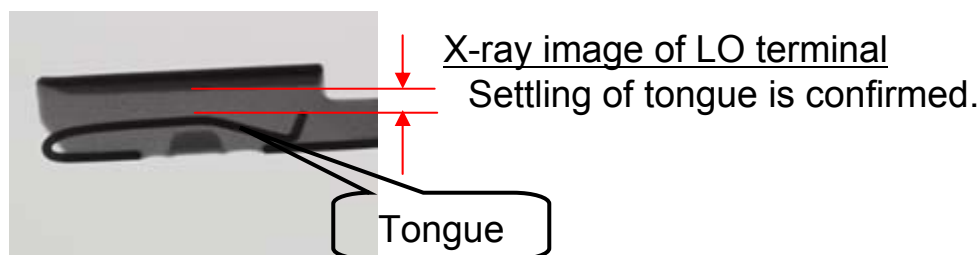
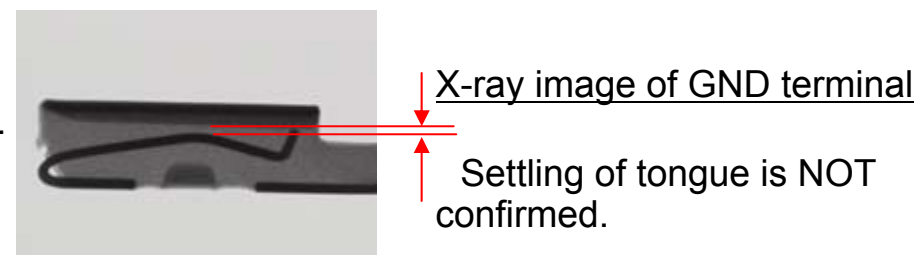
## Analysis results by X-ray (Harness side)

Heat discoloration is found on the returned lighting switches on LO circuit terminal and resin is melted at the root.

**It is similar to a symptom occurred on FIT in Japan market.**

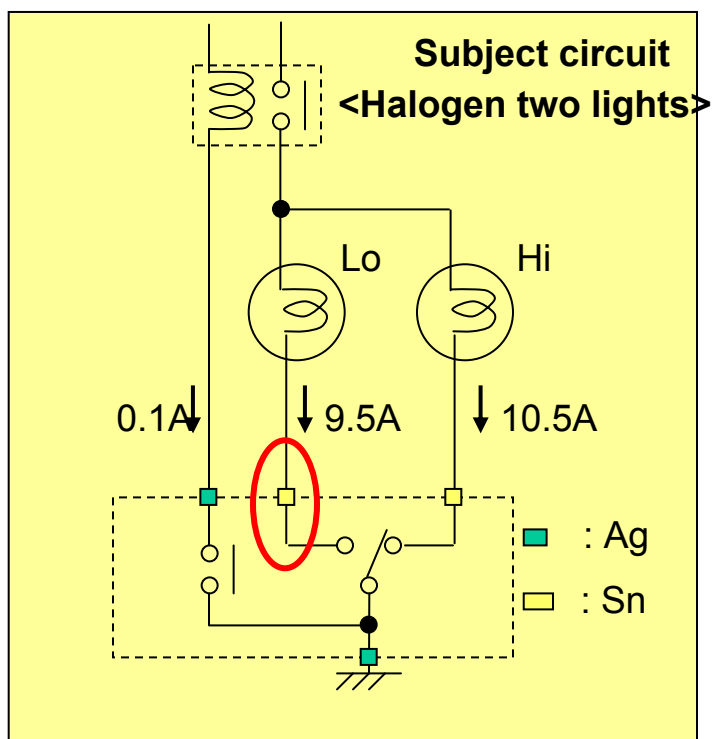
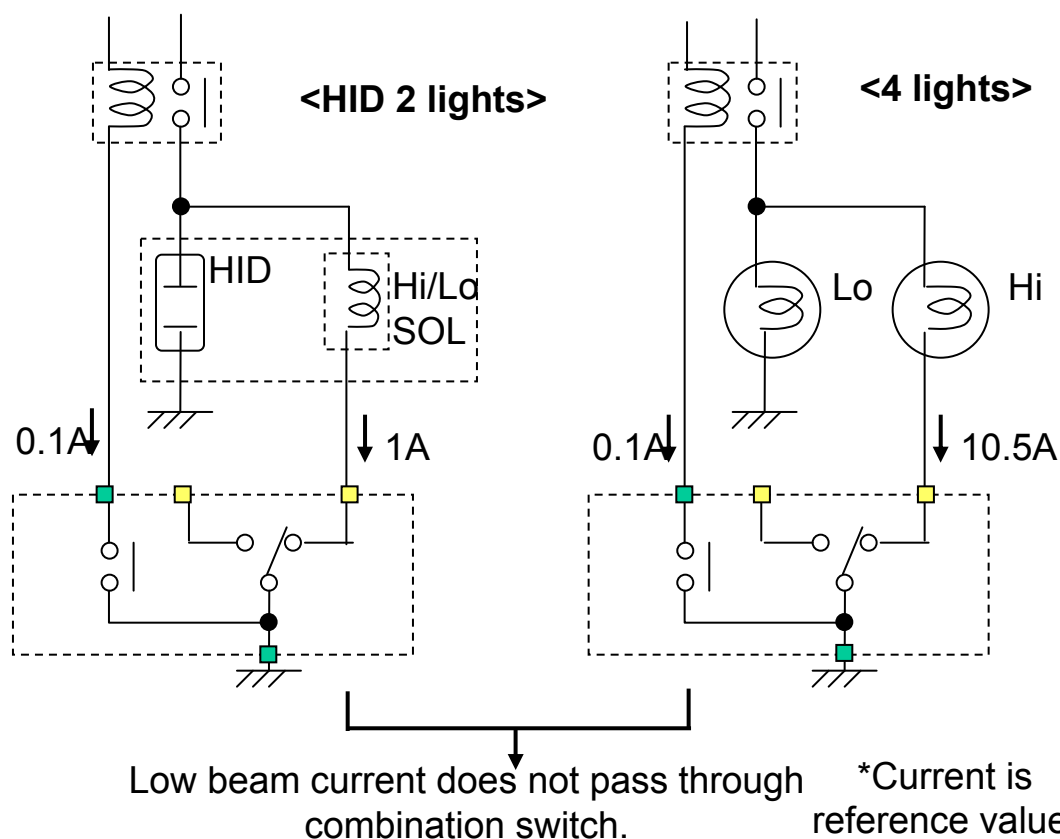
Low beam current passes through combination switch.

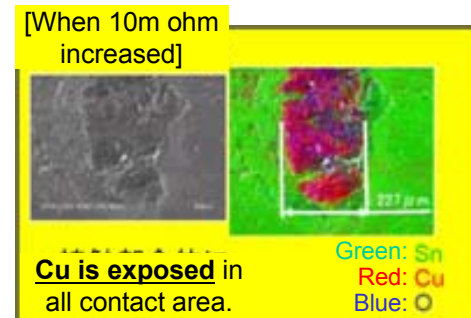
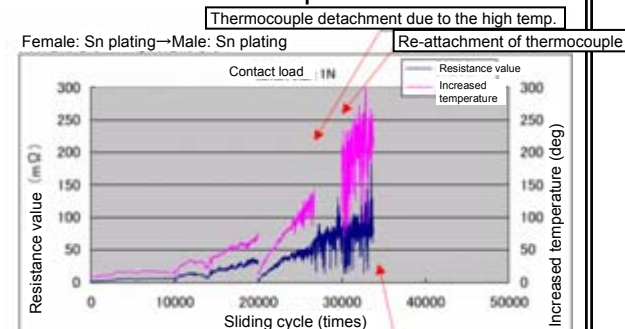
### <Surface observation>

- ◆ No abnormalities confirmed when contact pressure is within mass production control value (8N or more).
- ◆ GND (Ag-Sn) spec. has advantage so Ag plating is a factor to improve toughness of GND terminal. (Cu-Sn, Sn-Sn: 6N, Ag-Sn: 4N)
- ◆ Increased resistance is caused by exposed base material, copper.
- ◆ If contact load is high, resistance is stabilized from "oxide film is torn" that is a known effect and from "terminal sliding is reduced and plating wear is unlikely to be advanced" from the results of this time.  **$\Rightarrow$ It revealed that reduced contact load causes plating to wear, leading to heating and melt.**

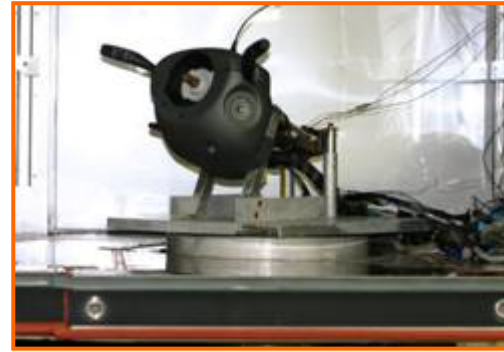
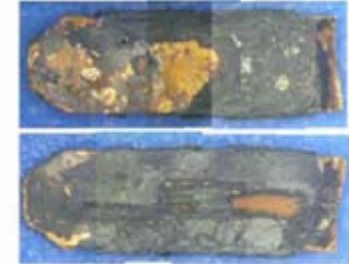
Melted terminal

The same appearance to market failed part

- ◆ No abnormalities confirmed at contact pressure within mass production control value.
- ◆ Lowered contact pressure to 1.5N and added a mode that promotes oxidation as acceleration factor then the symptom was recreated under equivalent condition to on car.
- ◆ Evaluated by replacing GND terminal only with that of NG contact pressure but a little voltage drop only could be confirmed and it did not lead to melt. (Test cycle was conducted twice as much as normal.)
- ◆ Evaluated with sample by replacing plating material then melt was recreated on Ag plated Lo terminal.

**⇒ It was clarified that the symptom occurred on LO terminal only.**

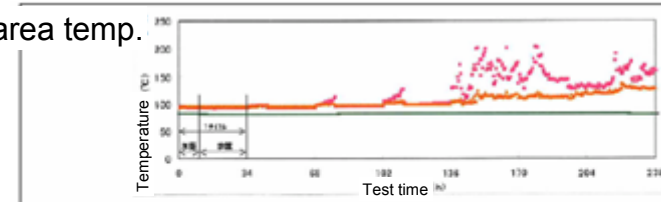
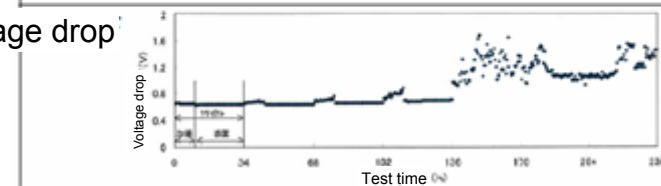
Terminal area temp.

Voltage drop

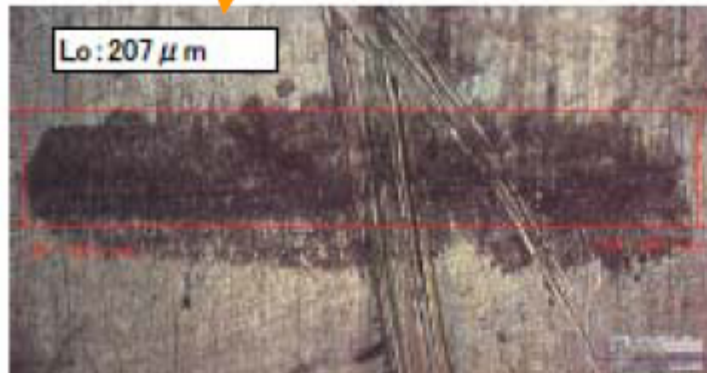
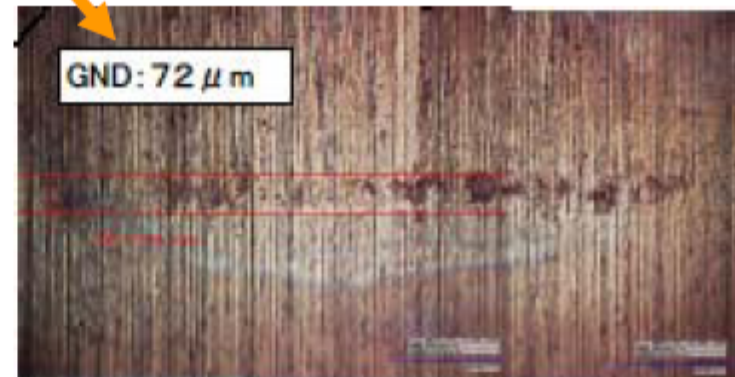
Wear amount measurement results on male terminal surface

Market return parts indicate that terminals on the upper stage couplers are worn heavily

Small amount of wear = > Plating wear is not advanced and melt is unlikely to be led.

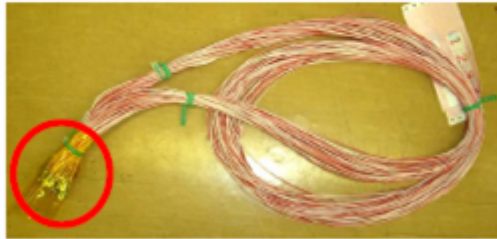
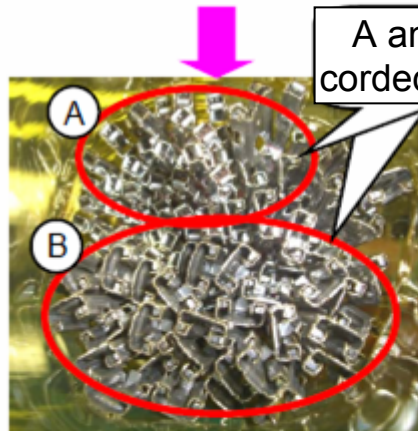
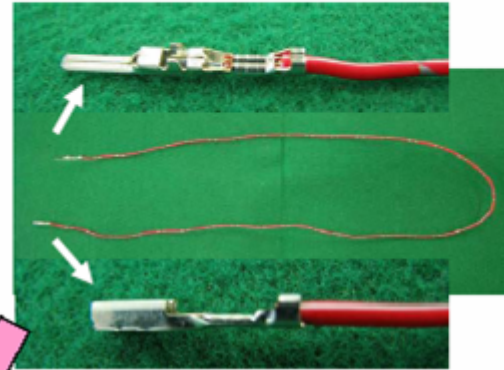
Work in process of FIT Lo circuit

◆ Corded condition of work in process has a factor causing terminal deformation and improvement was instructed.

A and B are  
corded together.

Male terminal gets in female terminal  
and tongue may be deformed.

Terminals should be corded separately without fail.

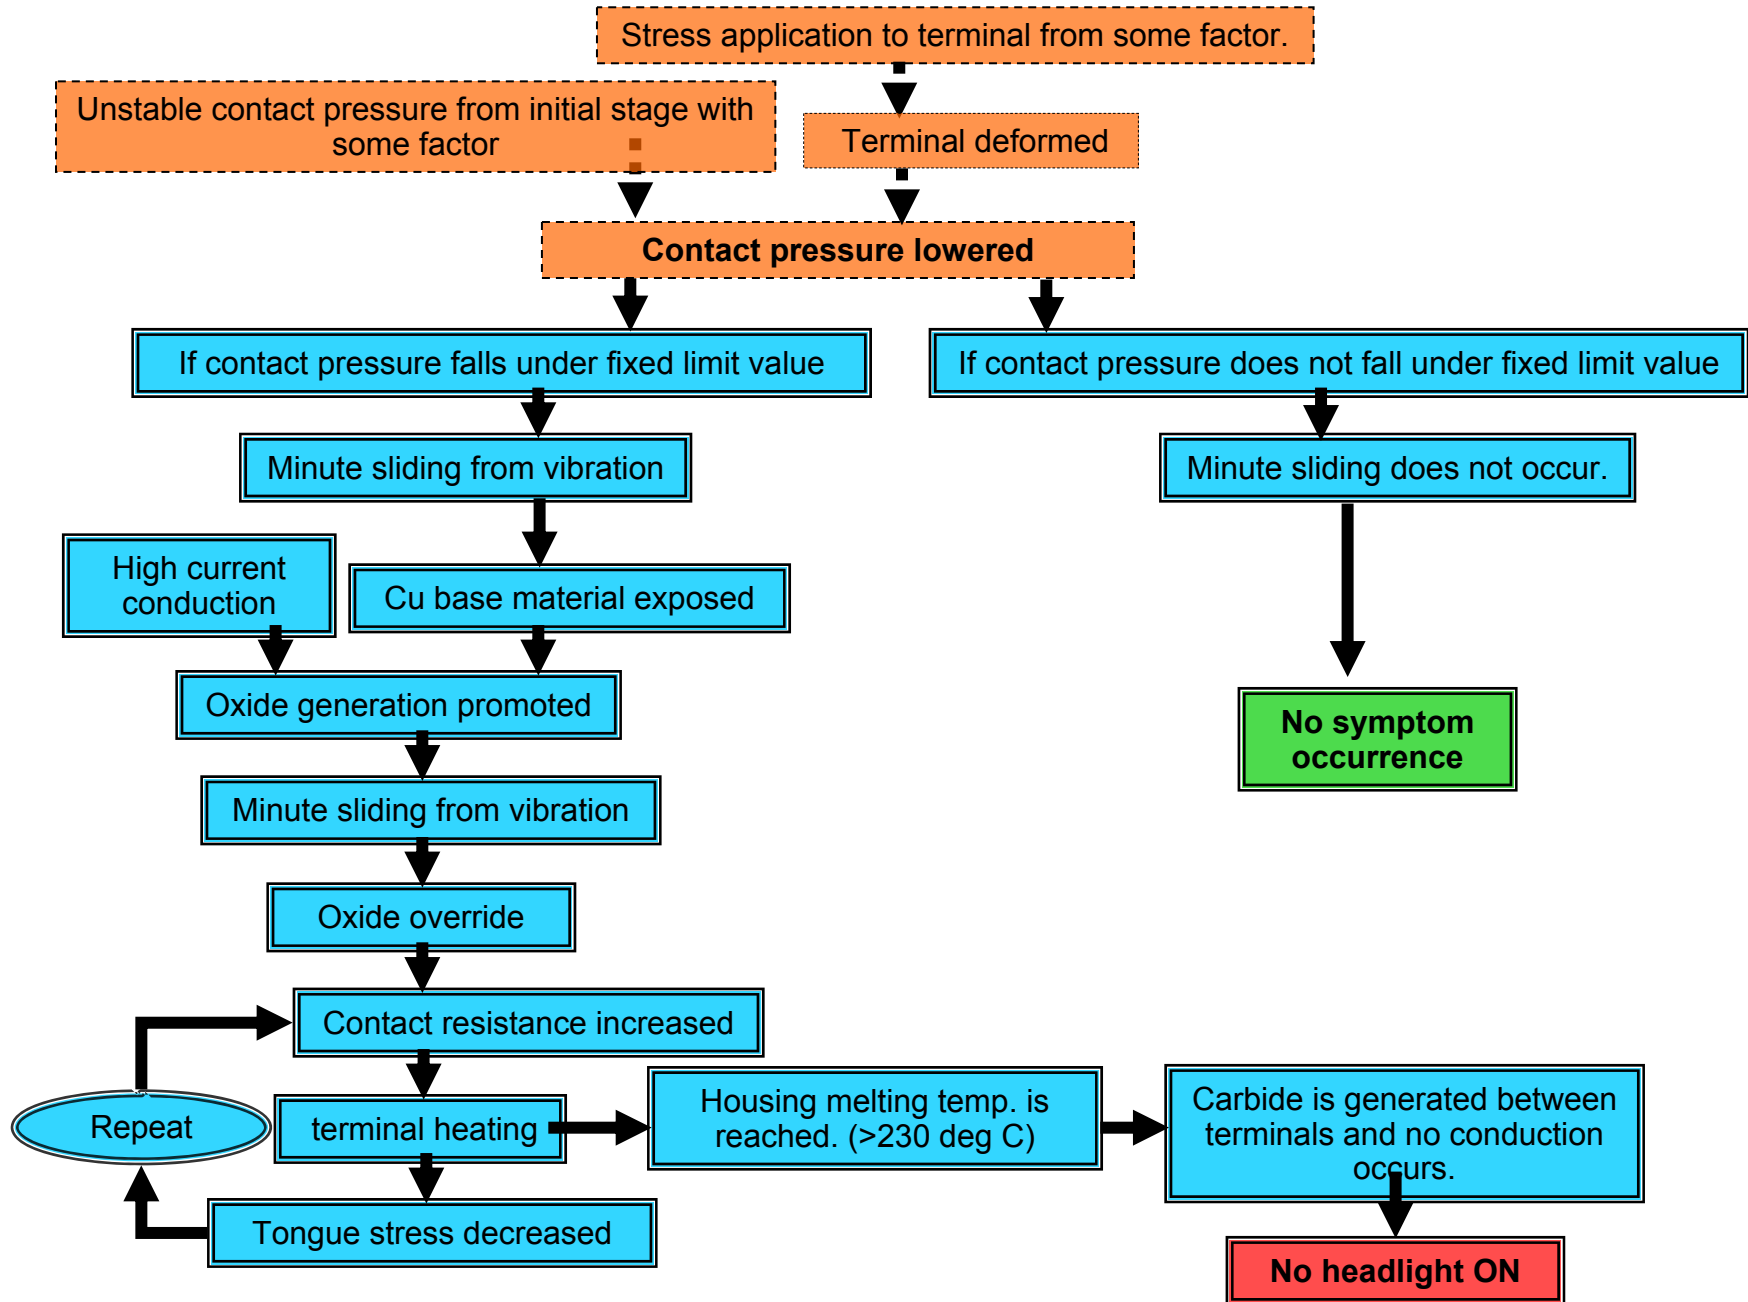
# Presumed occurrence mechanism

**Lowered contact pressure on terminal is considered to be the main factor but failure leading to the factor is not found in harness and vehicle manufacturing processes.**

**The reason why it occurs on Lo terminal only instead of Hi or GND terminals, is considered that Lo terminal is in a location minute sliding is likely to occur and use frequency of low beam is higher than low beam.**

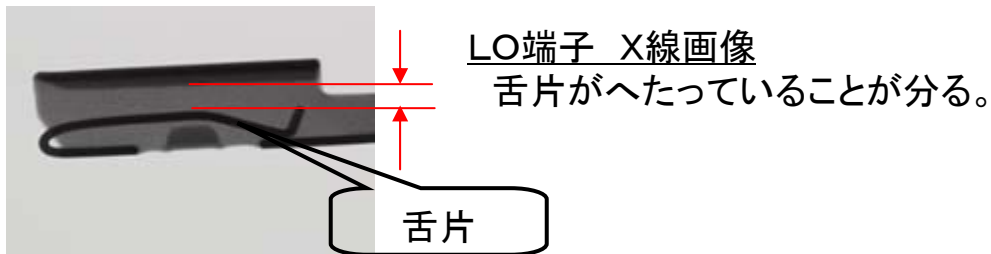
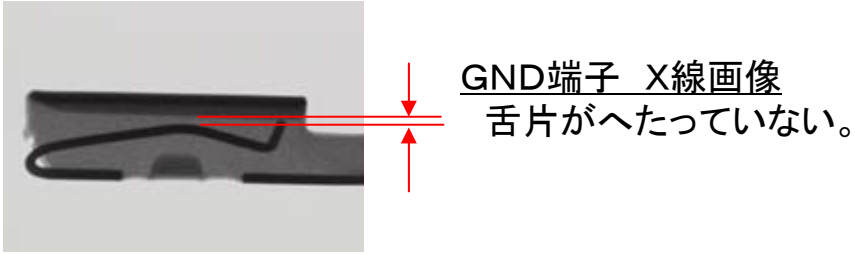
X線解析結果(ハーネス側)

返却現品のライティングスイッチLO回路端子が熱変色 根元樹脂が溶損している

**日本市場FITで発生した事象と同様である**

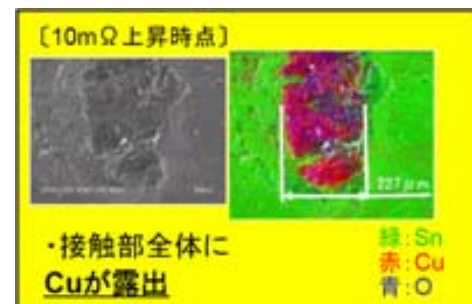
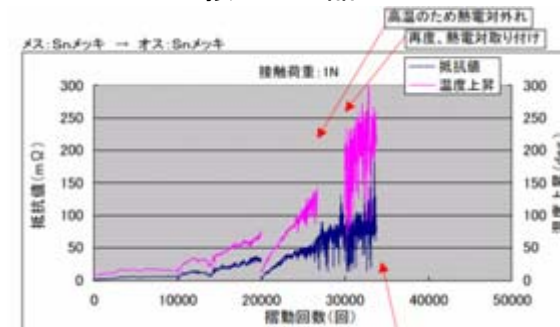
### <表面観察>

- ◆ 接触圧 量産管理値内(8N以上)では異常が認められない。
- ◆ GND(Ag-Sn)の仕様に優位性が見られることから、AgメッキがGND端子のタフネスアップの一つの要因である。(Cu-Sn、Sn-Sn:6N、Ag-Sn:4N)
- ◆ 抵抗値上昇の原因は、母材である銅の露出である。
- ◆ 接触荷重が高いと  
従来より確認されていた効果「酸化膜を破る」ことと  
今回の結果より「端子の摺動が抑えられ、メッキの磨耗が進みにくい」ことで、抵抗値は安定する。

⇒接触荷重の低下がメッキの磨耗を招き、発熱・溶損に至ることがわかった。

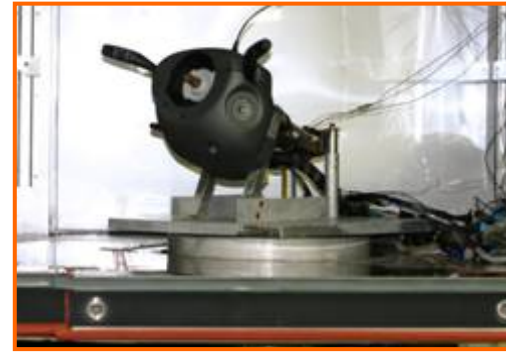
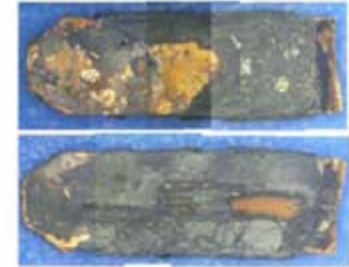
### 溶損端子

市場不具合品と同じ顔つき

- ◆接触圧、量産管理値内では異常が認められない。
- ◆接触圧1.5Nまで落とし、酸化を促進させるモードを加速要因として入れると、実車振動相当で事象再現した。
- ◆GND端子のみ接圧NG品を組み込み評価したが、若干の電圧降下が確認出来たのみで、溶損には至らなかった。(通常の倍のサイクル数実施)
- ◆メッキ材質を入れ替えたサンプルで評価したが、AgメッキのLo端子で溶損が再現。

⇒Lo端子にのみ発生する事象であるということが明確になった。

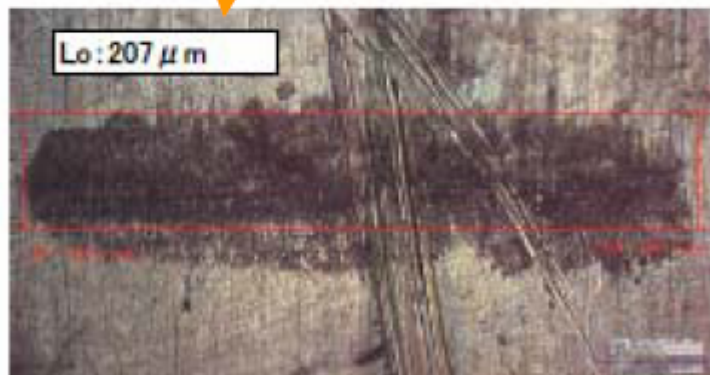
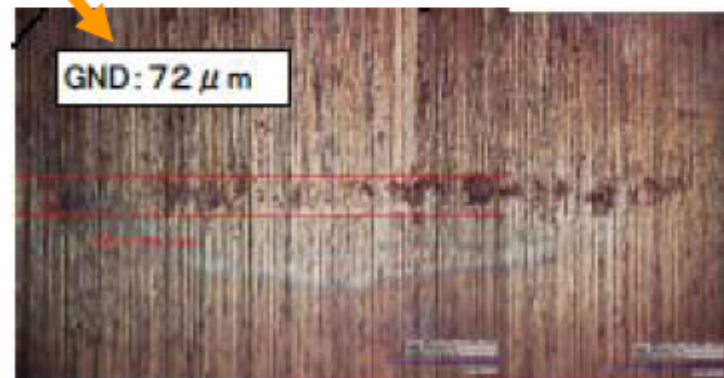
Fit 健康車 GD1-2000904 39,949km走行 オス端子表面摩耗量測定結果

市場回収品を見ると、カプラー上段にL/Oされる端子の摩耗量が大きい傾向がある。

摩耗量が小さい⇒メッキの摩耗が進まない為、溶損に至りにくい。

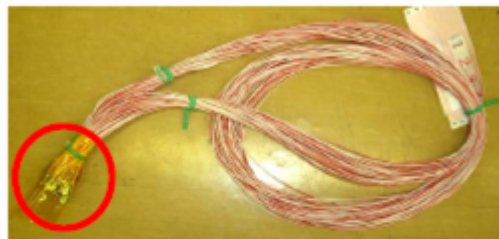
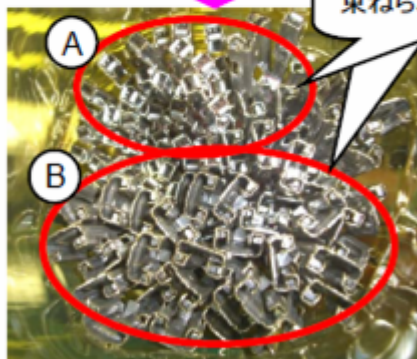
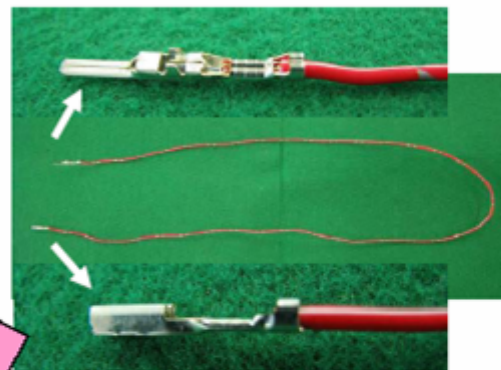
### FIT Lo回路の切圧品

## ◆ 切圧品の結束状態に端子変形を起こす要因があり、改善を指示

AとBがまとまって束ねられている。

オス端子がメス端子に入り込み舌片を変形させる恐れがある

端子は、必ず別々に束ねること
