PE10-045

DUCATI

# Leakage

## PE 10-045 - IR on Monster Old

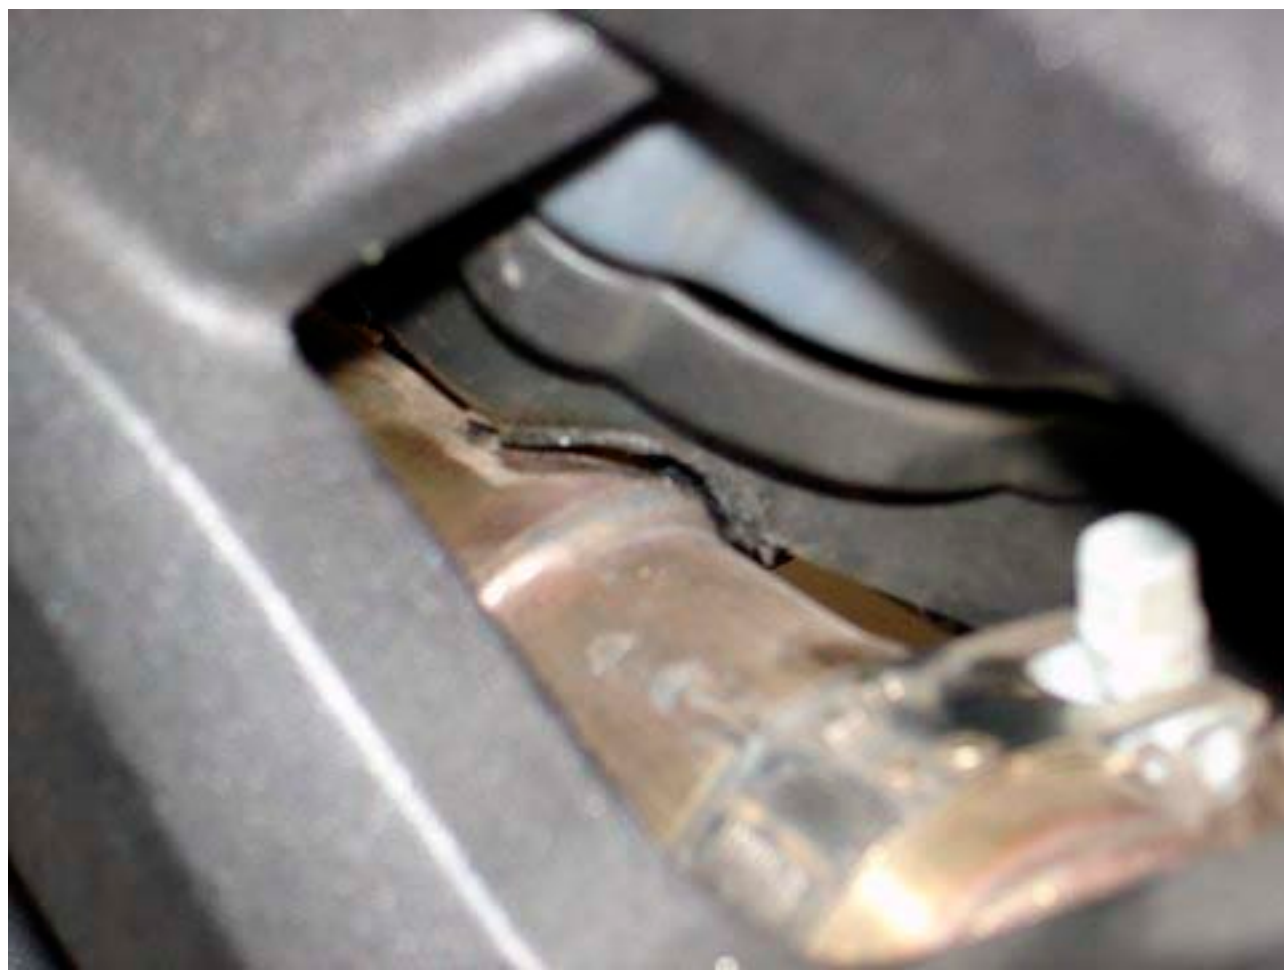
| It would appear that the heat from the exhaust has softened the plastic of the tank and the weight of fuel in it has caused it to bend so the pump flange cover contacted the exhaust. No fuel leakage at this time but I feel this is imminent. | | | | | | | | | |

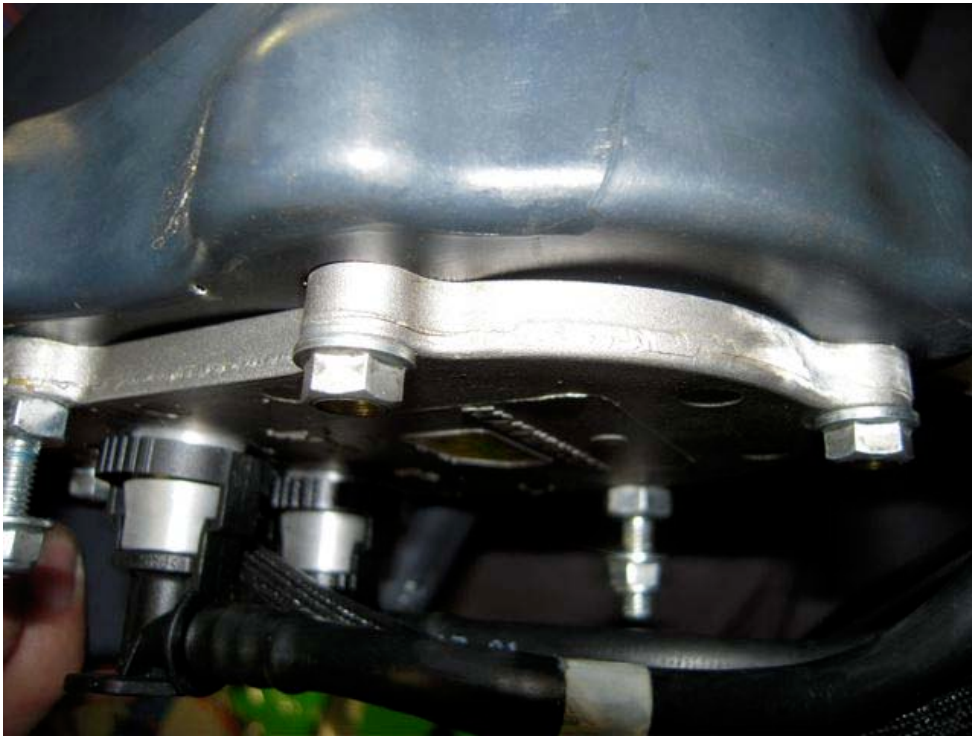
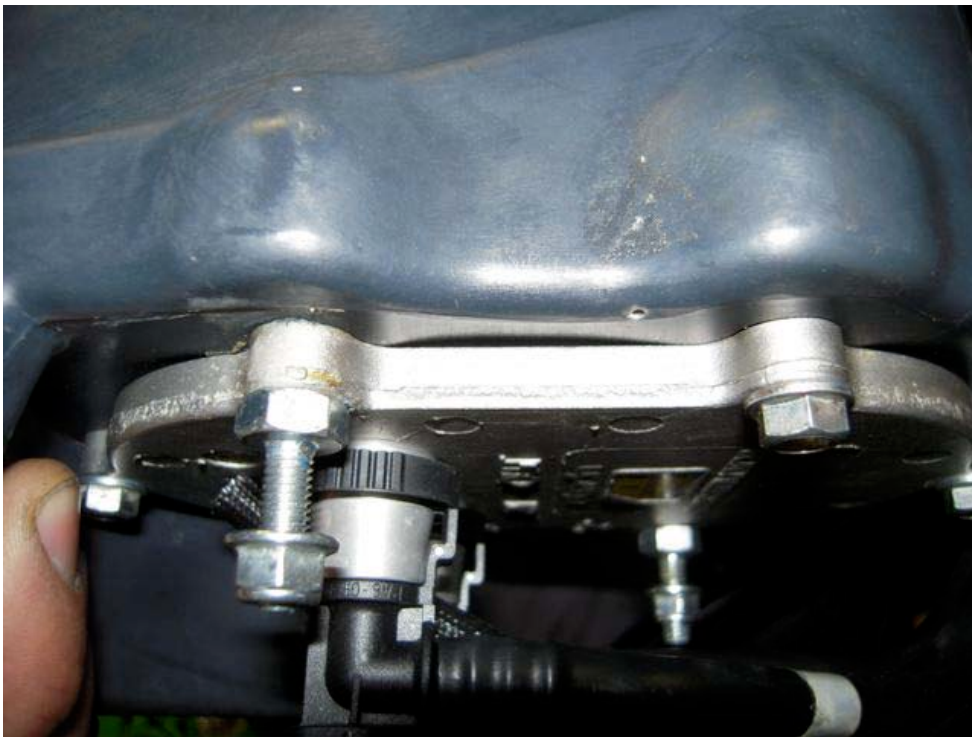
| Severe distortion of tank @ pump flange. Dealer already removed pump to attempt repair as customer was waiting. Have ordered new tank. RCL 901 open-will perform during this visit to dealer. | | | | | | | | | |

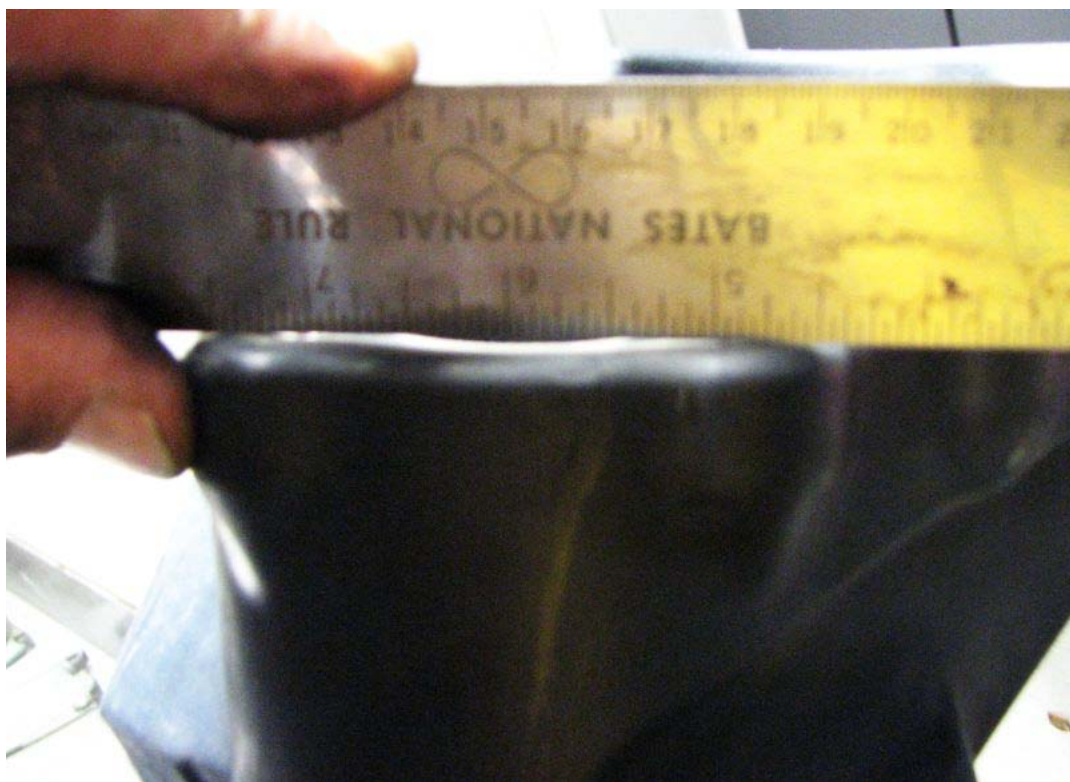
| Extreme distortion of fuel tank around pump flange. Significant leak on to exhaust. Started leaking while motorcycle parked in the sun. | | | | | | | |

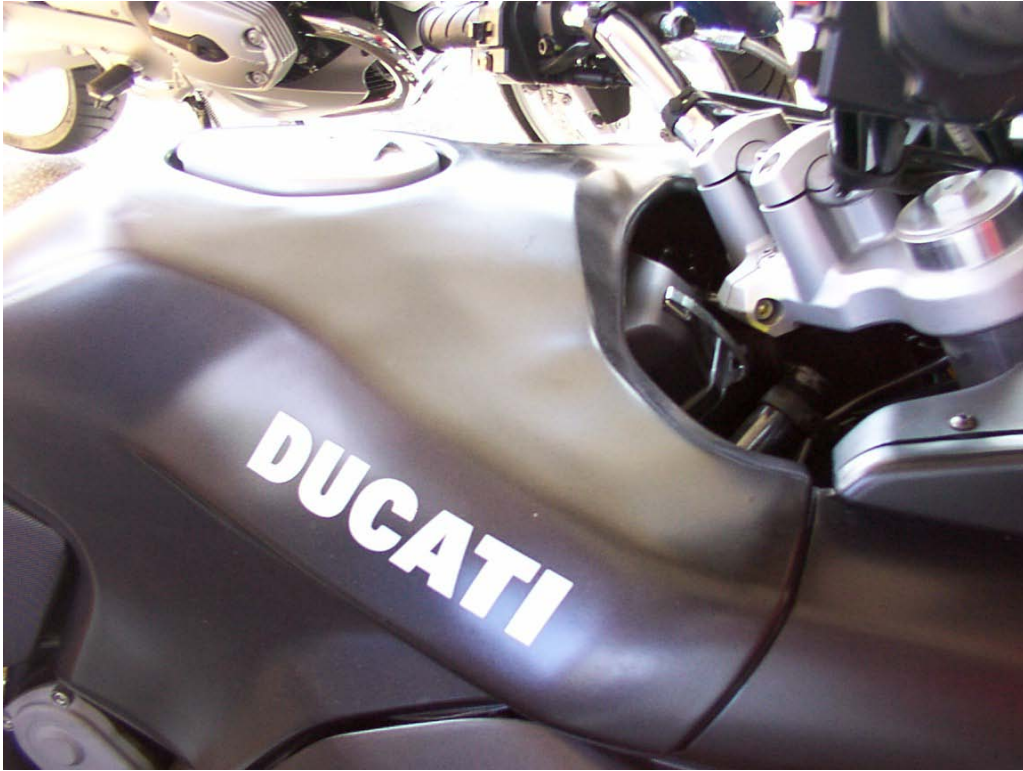
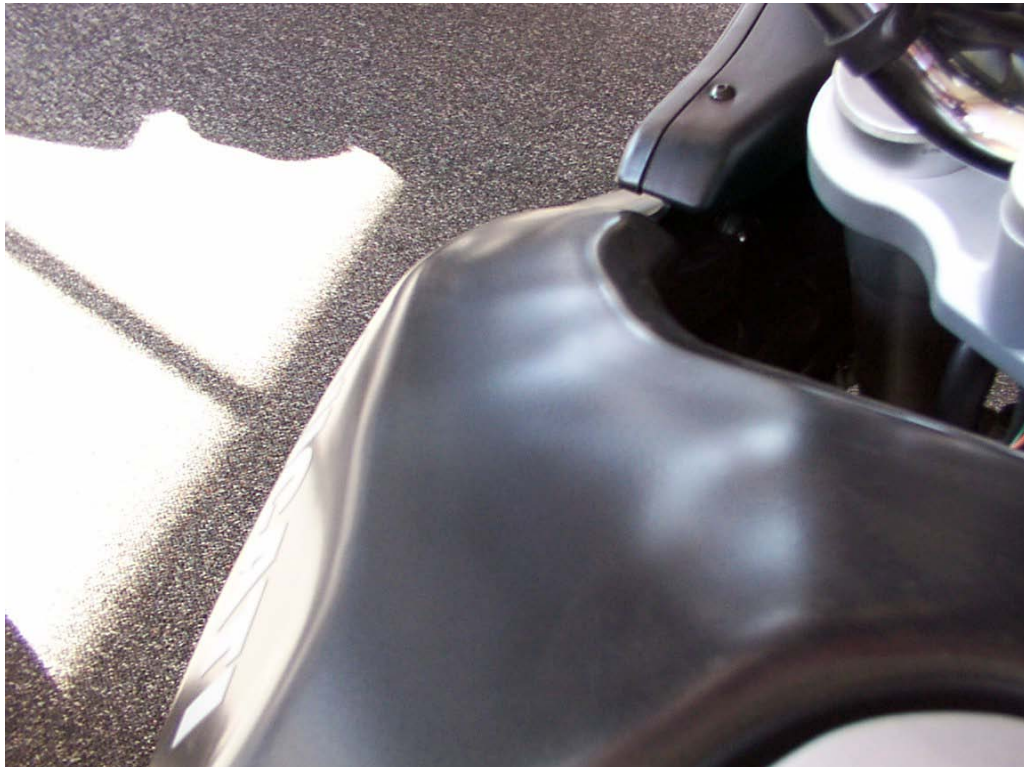
Deformation of the fuel tank plastic. See attached pictures. Authorization approved for dealer to replace tank.

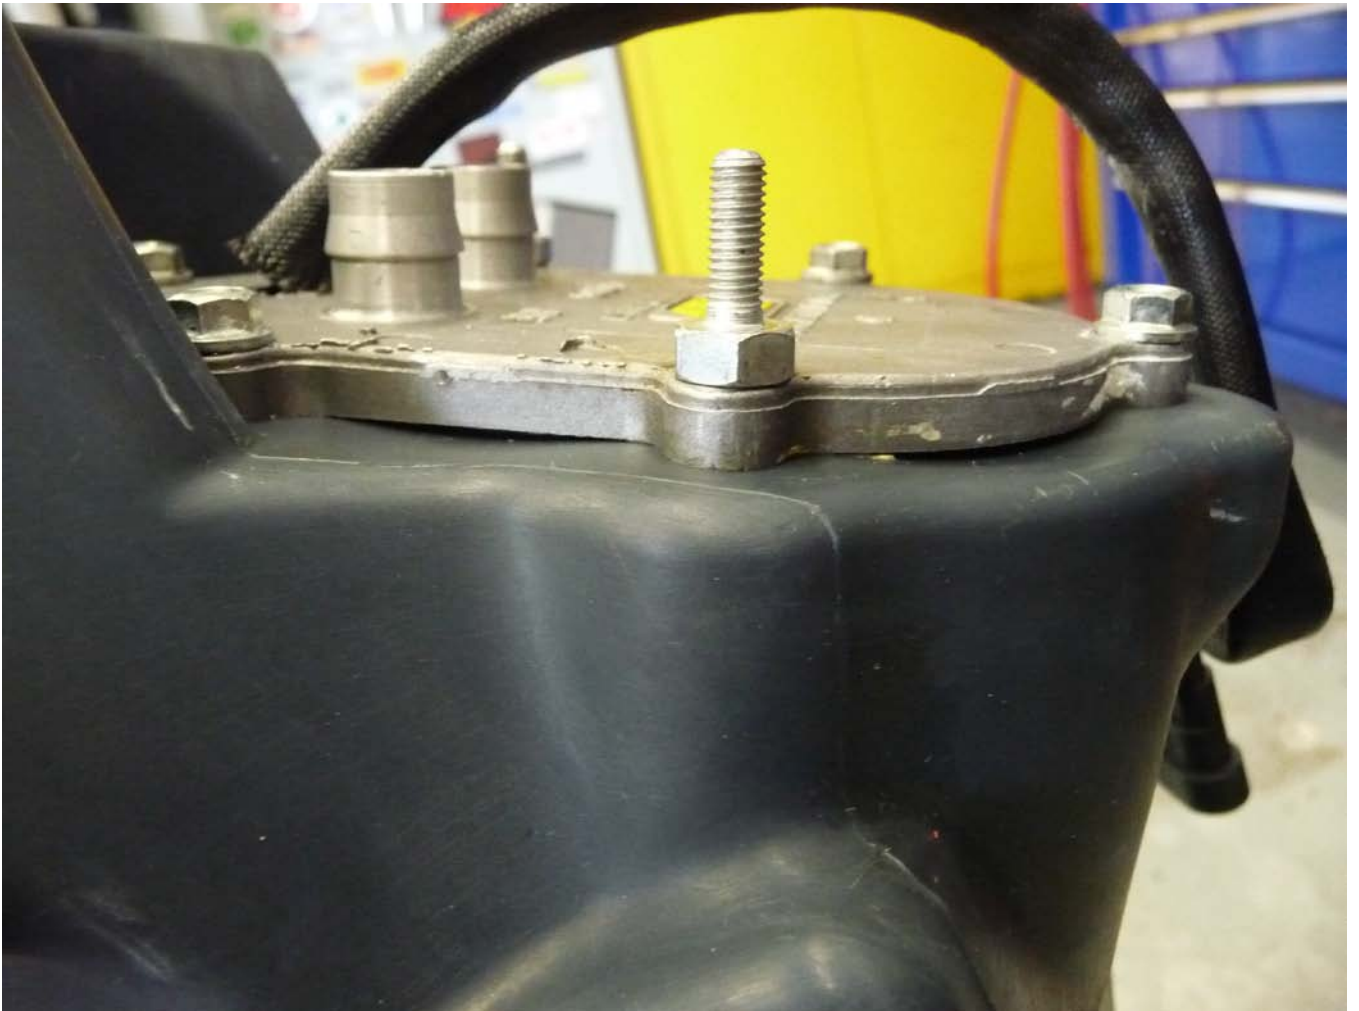
Customer brought motorcycle to dealership because of an apparent gas leak. Upon inspection the technician found the likely source to be a significant deformation of the tank at the fuel pump mounting flange (see attached photo).

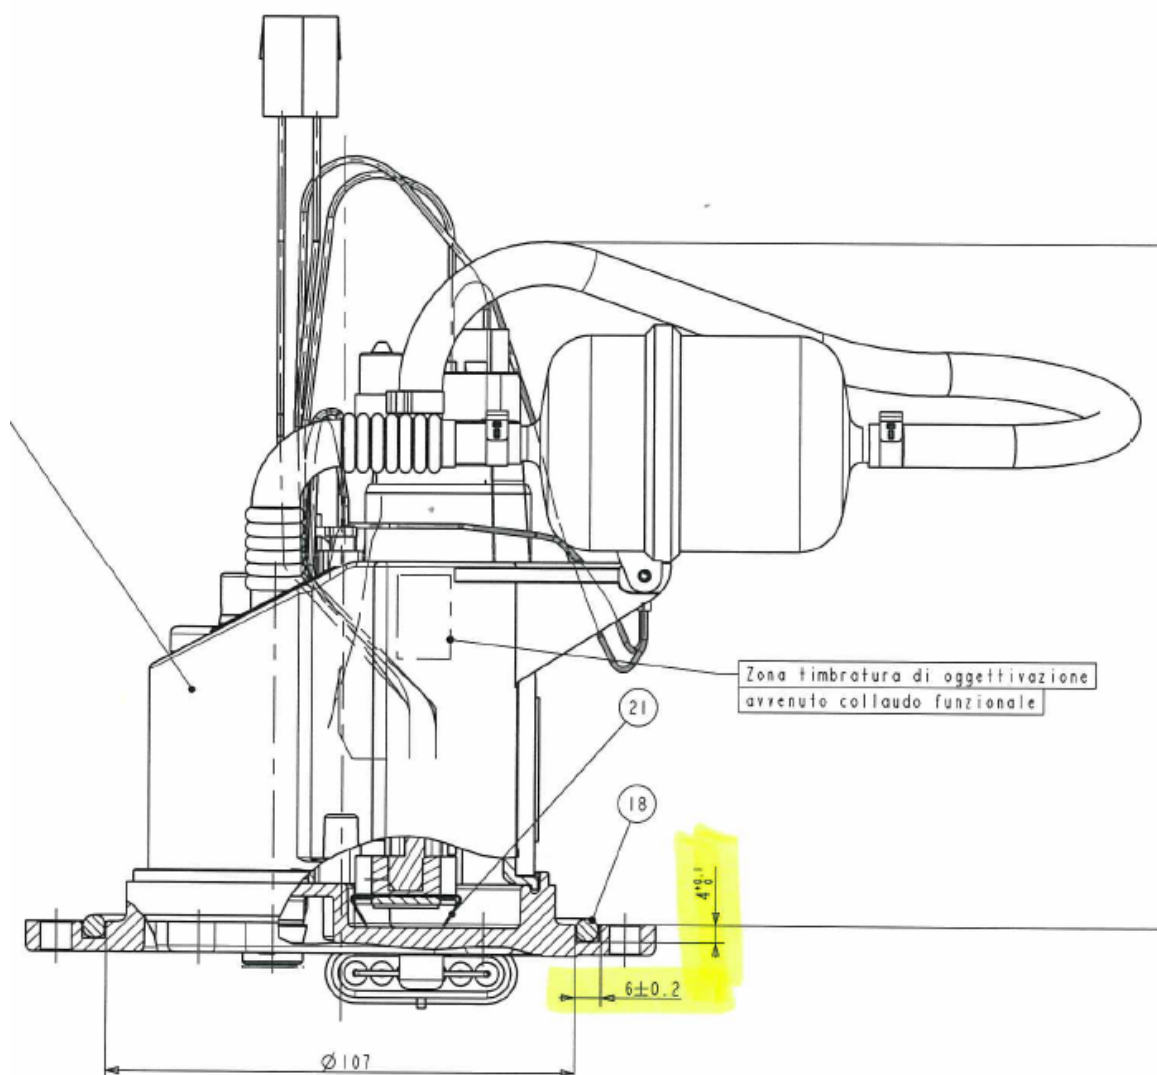
Extract of 2D drawing of fuel pump assembly:

The O-Ring housing dimensions and compression were then analyzed in order to identify an alternative gasket that would fit.

It was found a commercially available gasket that will fit in the same housing of the O-ring and could be most effective with respect to leakage; it is an X-ring 107,32 x 5,34 FKM 70.45-02. Compared to the O-Ring, the four-lipped sealing geometry of the X-Ring offers the following advantages that are important in our application:

- it provides more sealing surfaces than standard O-Ring thanks to its multi-lobed design
- the lip shape requires less squeeze to maintain an effective seal
- can be used in all O-Ring installation grooves

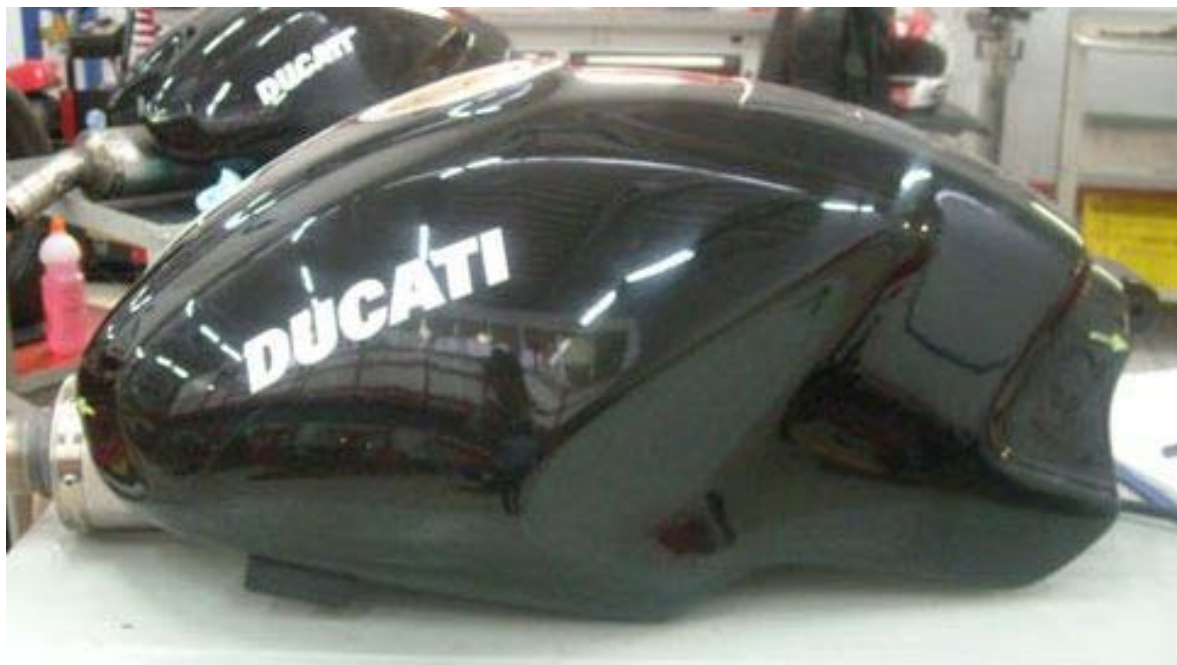
Fuel tank subject of current investigation was originally fitted on Monster S2R 800 VIN 105183, and replaced by Dealer Corsa MotorSports at 4.211 miles, because of "deformation and leakage".

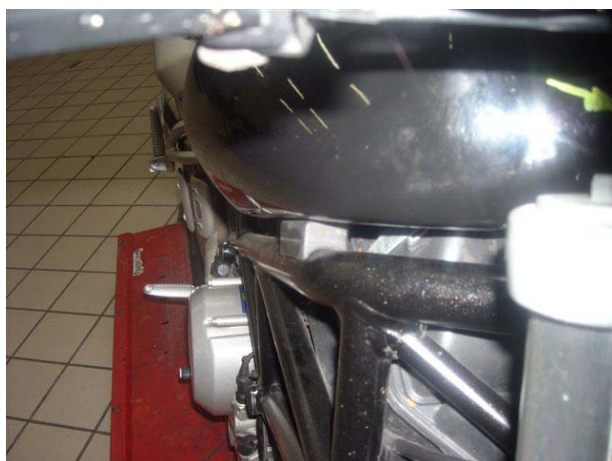
front right support

**Result : the fuel tank fits perfectly the reference bike without any functional and/or aesthetic drawback**

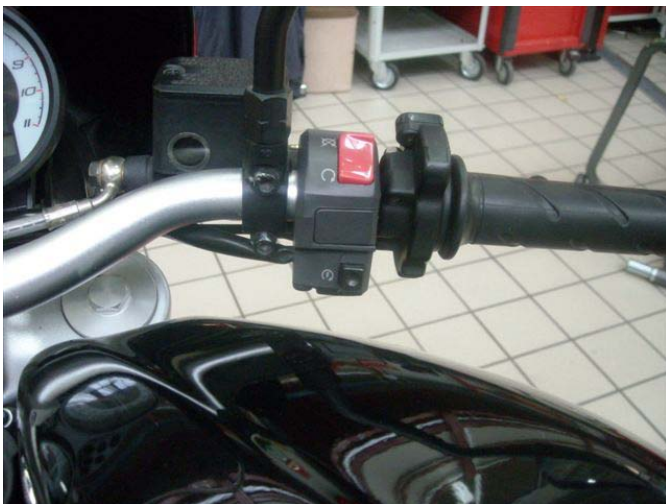
distance between handlebar and tank at right side full steering

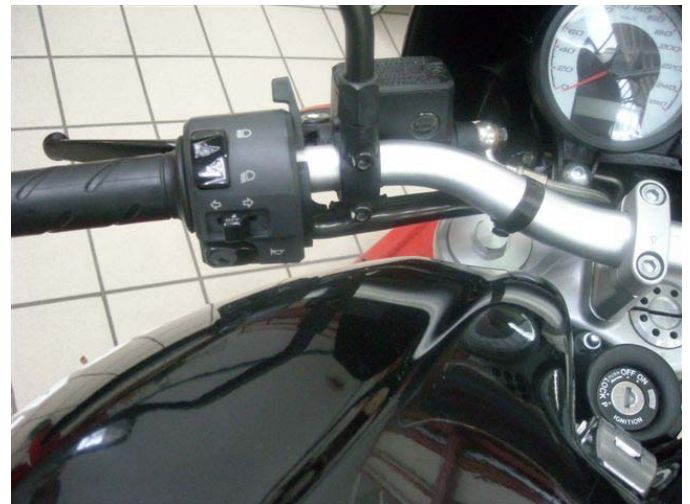
distance between handlebar and tank at left side full steering

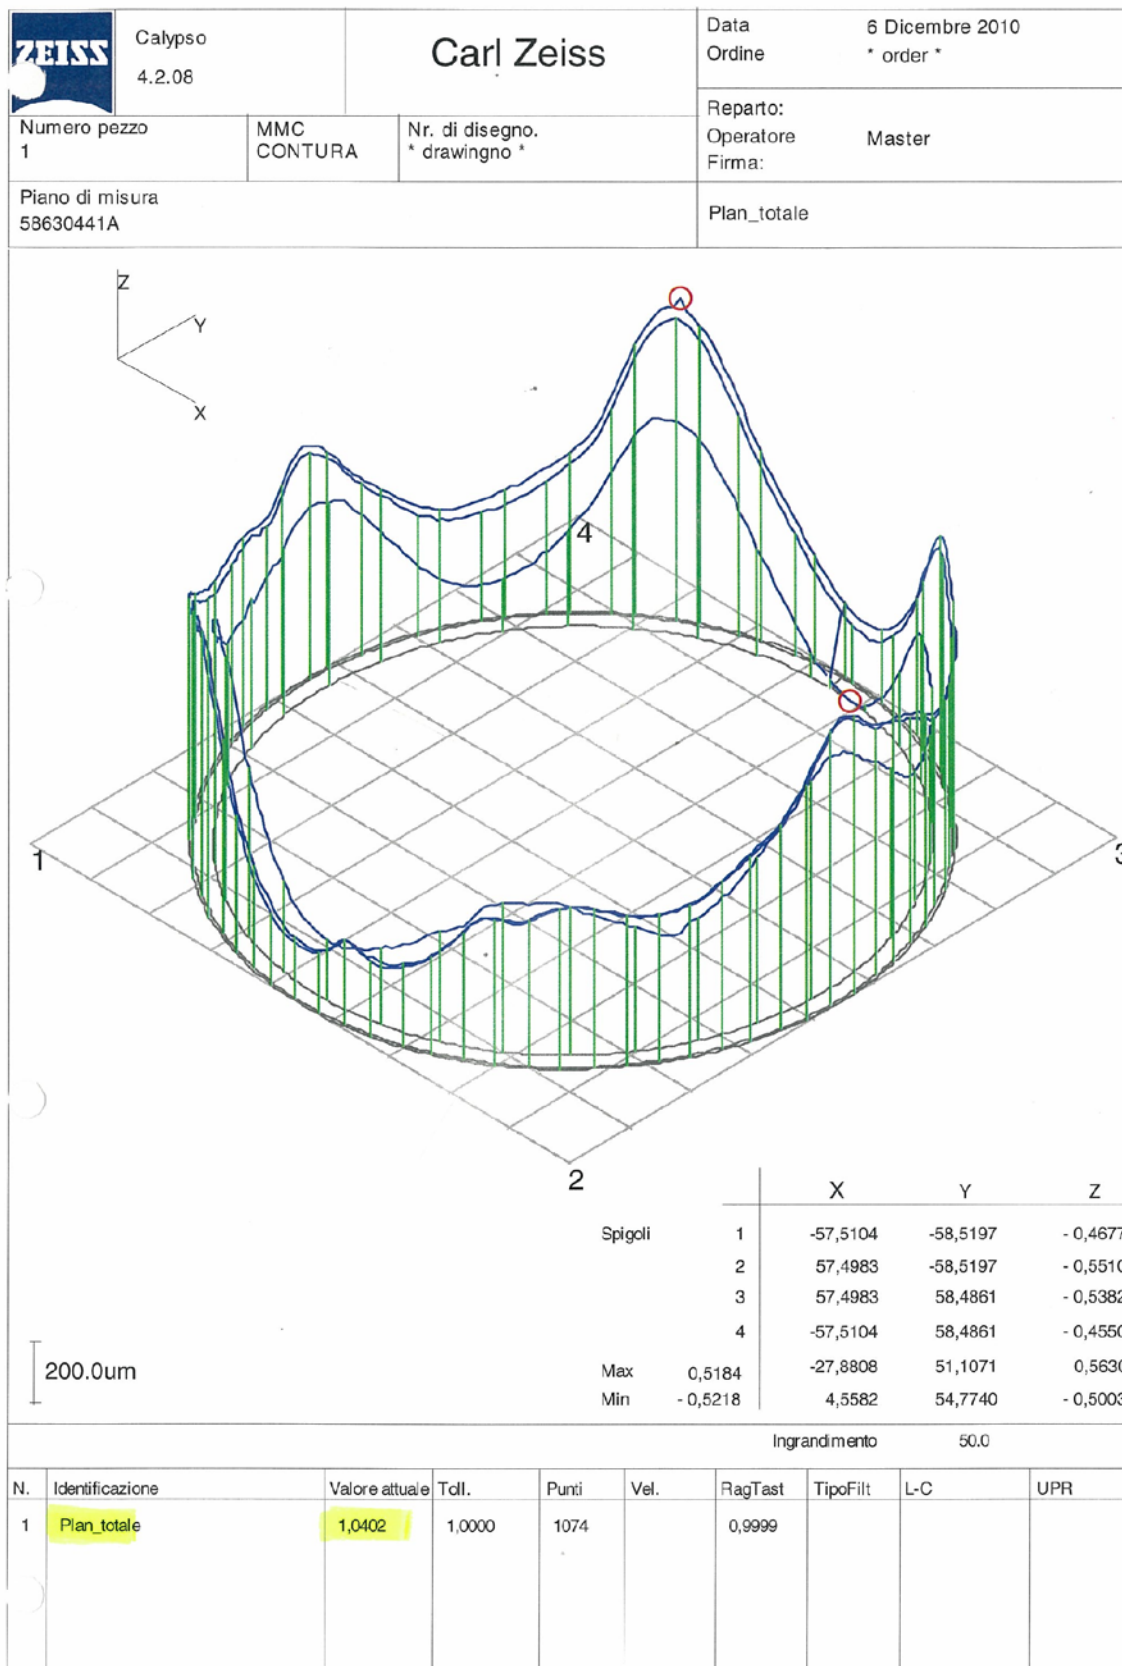
Replaced fuel tank flatness in the "working area" of the sealing = 1,042 mm

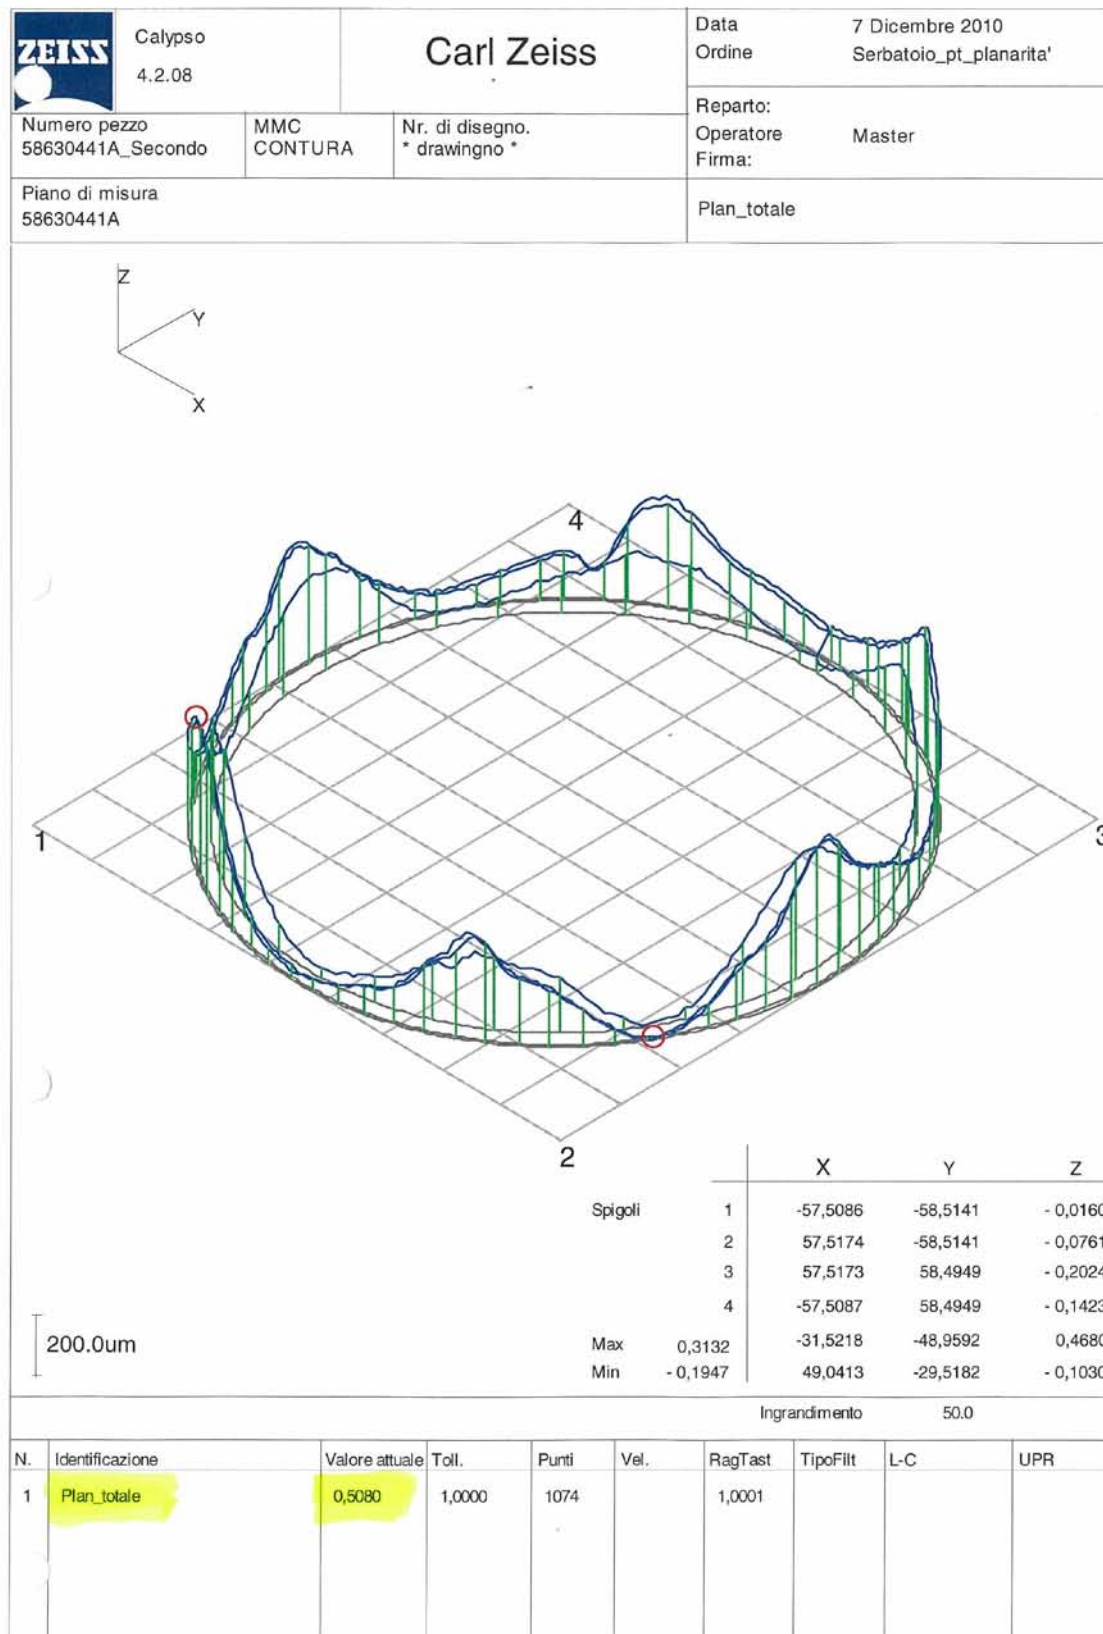
Reference fuel tank flatness in the "working area" of the sealing = 0,51 mm
