Quality Assurance - Early Warning Report

TQCN DOC#: EVRG101821C	RTS#: 13412-1	RTS Disposition: Forward	TMS QA Dept: QA-Powertrain	Assigned PE: STEGERT	Distribution Date: 1/24/02
Report Source: FPE	Primary Model: ES 300	Model Year: 2002	Production Date: 10-2001	Miles: 1105	VIN: (CONFIRM 17 DIGITS) JTHBF30G420 [REDACTED]
Condition Title: SURGE ON ACCELERATION - A/F SENSOR FAILURE				Author: MATT HENNESSEY	Dealer Code: 64204

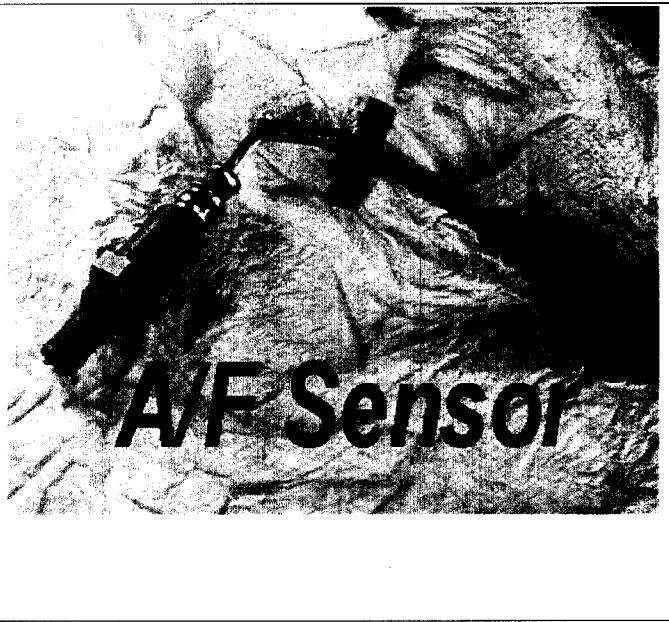
Short Term Fuel Trim, AF B1 S1, ranged from -16% to +16%; rapidly fluctuating. A/F sensor defective.

Picture of defective A/F sensor

Technician replaced A/F sensor B1 S1 to correct condition.

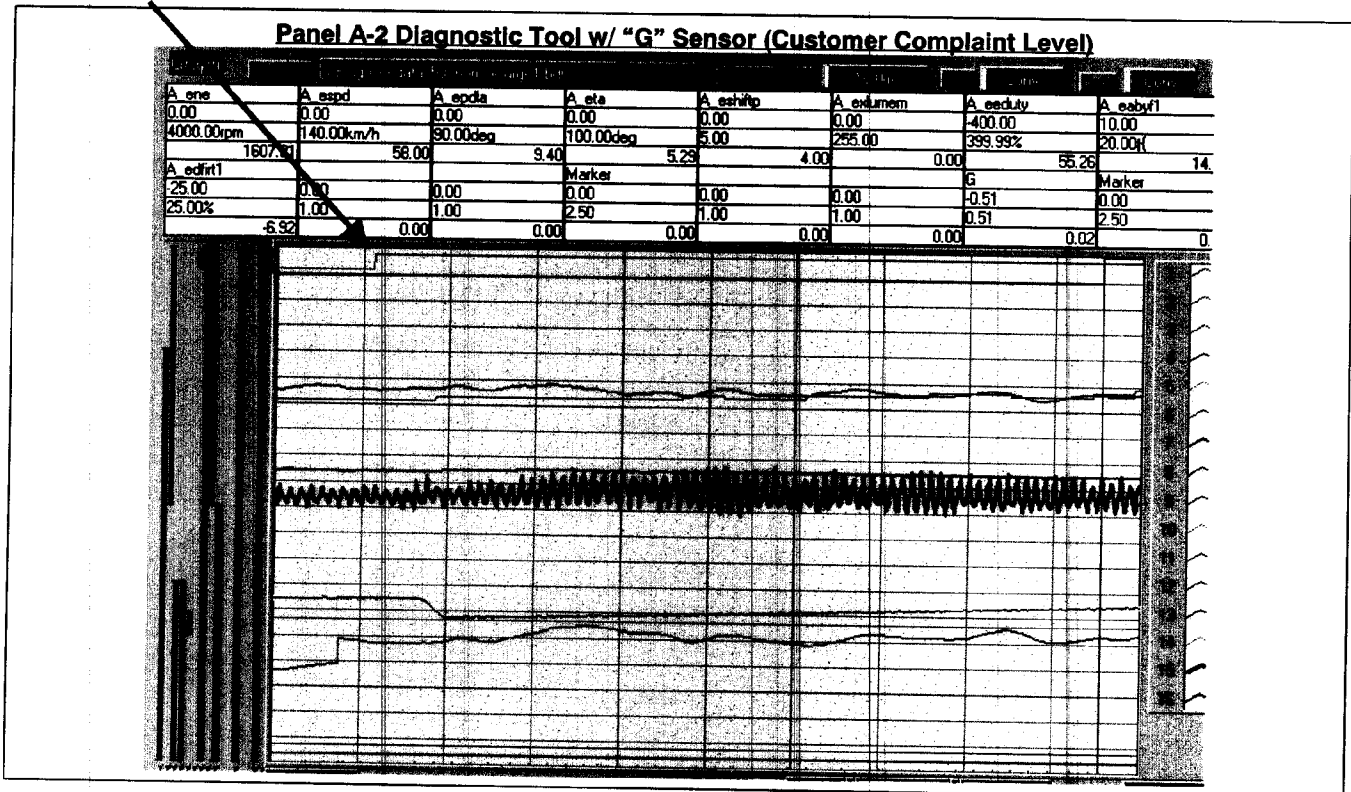
All vehicles tested, both customer complaint **and** new dealer in-stock units, exhibited the "surging" condition between 38 ~ 42 mi/h, transmission in 4th gear, L/U "ON" (Lock-Up). Throttle input was 13 ~ 15% with the vehicle maintaining a steady cruise. It was agreed by both TTC and TMS engineers that the "surging" condition experienced on the customer and dealer vehicles was equal to the TMS Internal Fleet Vehicle previously evaluated by TTC, TMS and TMC. Using Vehicle No. 2 described in Chart 1, TTC and TMS engineers installed a Panel A-2 diagnostic tool including the installation of a "G" sensor on the front passenger seat mounting rail. This allowed for the precise measurement of the longitudinal forces that were experienced during the "surging" condition. Measurements were taken during the "surging" condition with L/U coming on at 38 mi/h. The measured frequency was 8hz with the "G" sensor reading a 0.1G force **during** the "surging" condition. The Panel A-2 screen is shown below with the RED line indicating the "G" sensor signal and the GREEN line indicating L/U operation. (L/U "ON" is at this point)

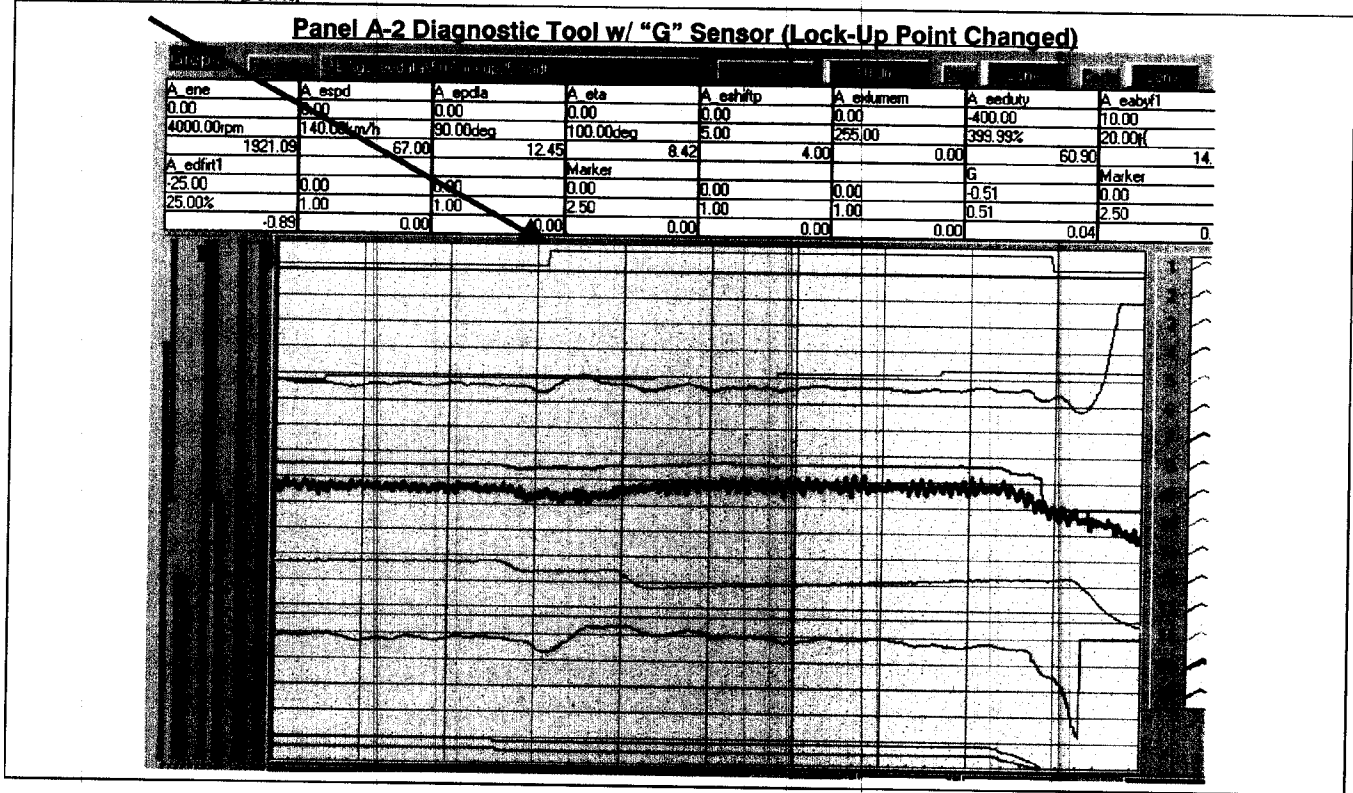
The second test involved changing the shift schedule to move the point at which L/U (Lock-Up) would occur. The L/U point was changed from 38 mi/h to 44 mi/h to evaluate what effect it would have on the "surging" condition. Vehicle No. 2 was then driven and measurements taken. The Panel A-2 diagnostic tool showed that the "G" sensor detected the same 8hz amplitude but the G force had been significantly reduced from 0.1G to 0.04G during the "surging" condition. The Panel A-2 screen is shown below with the RED line indicating the "G" sensor signal and the GREEN line for L/U. (L/U "ON" is at this point)

NOTE: Both TMS / TTC engineers and the GST Regional FTS and FPE agreed that the "surging" condition was eliminated after the change to the shift schedule L/U point.

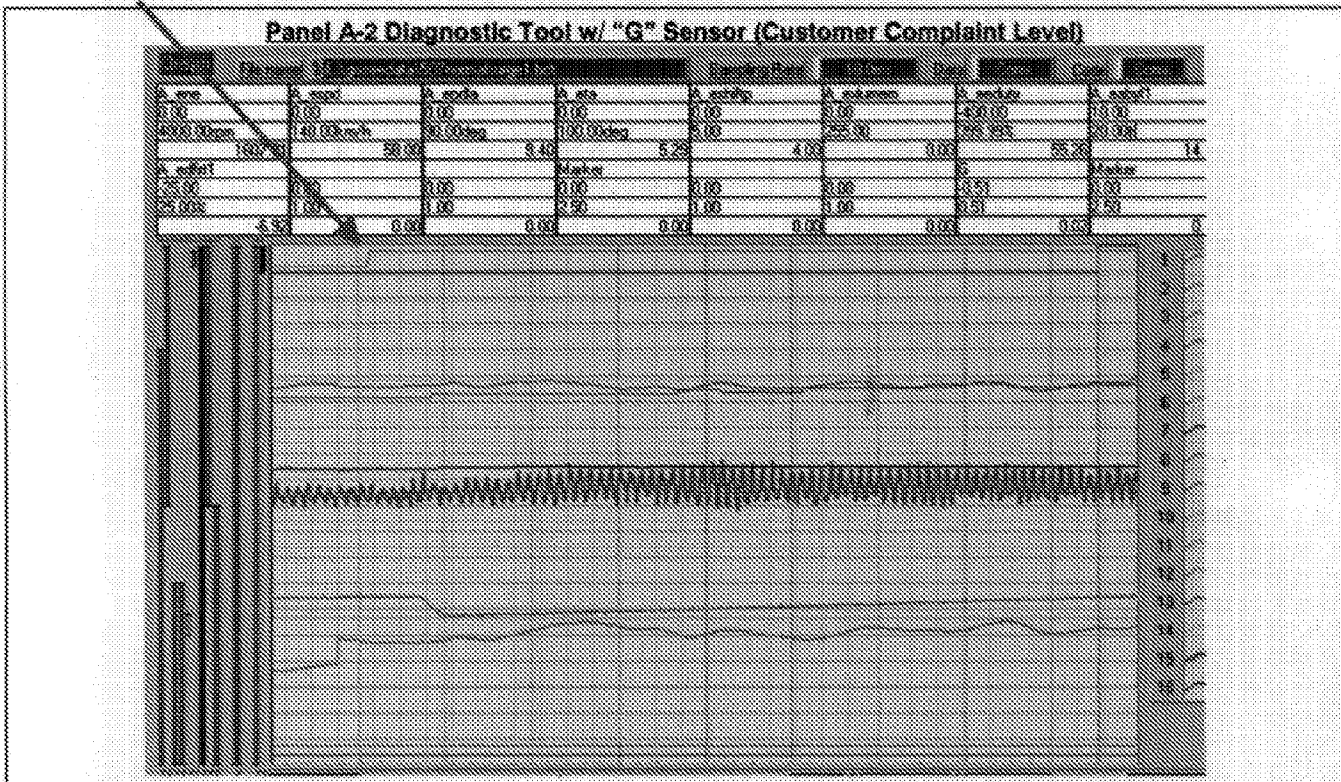
All vehicles tested, both customer complaint and new dealer in-stock units, exhibited the "surging" condition between 38 ~ 42 mi/h, transmission in 4th gear, L/U "ON" (Lock-Up). Throttle input was 13 ~ 15% with the vehicle maintaining a steady cruise. It was agreed by both TTC and TMS engineers that the "surging" condition experienced on the customer and dealer vehicles was equal to the TMS Internal Fleet Vehicle previously evaluated by TTC, TMS and TMC. Using Vehicle No. 2 described in Chart 1, TTC and TMS engineers installed a Panel A-2 diagnostic tool including the installation of a "G" sensor on the front passenger seat mounting rail. This allowed for the precise measurement of the longitudinal forces that were experienced during the "surging" condition. Measurements were taken during the "surging" condition with L/U coming on at 38 mi/h. The measured frequency was 8hz with the "G" sensor reading a 0.1G force during the "surging" condition. The Panel A-2 screen is shown below with the RED line indicating the "G" sensor signal and the GREEN line indicating L/U operation. (L/U "ON" is at this point)

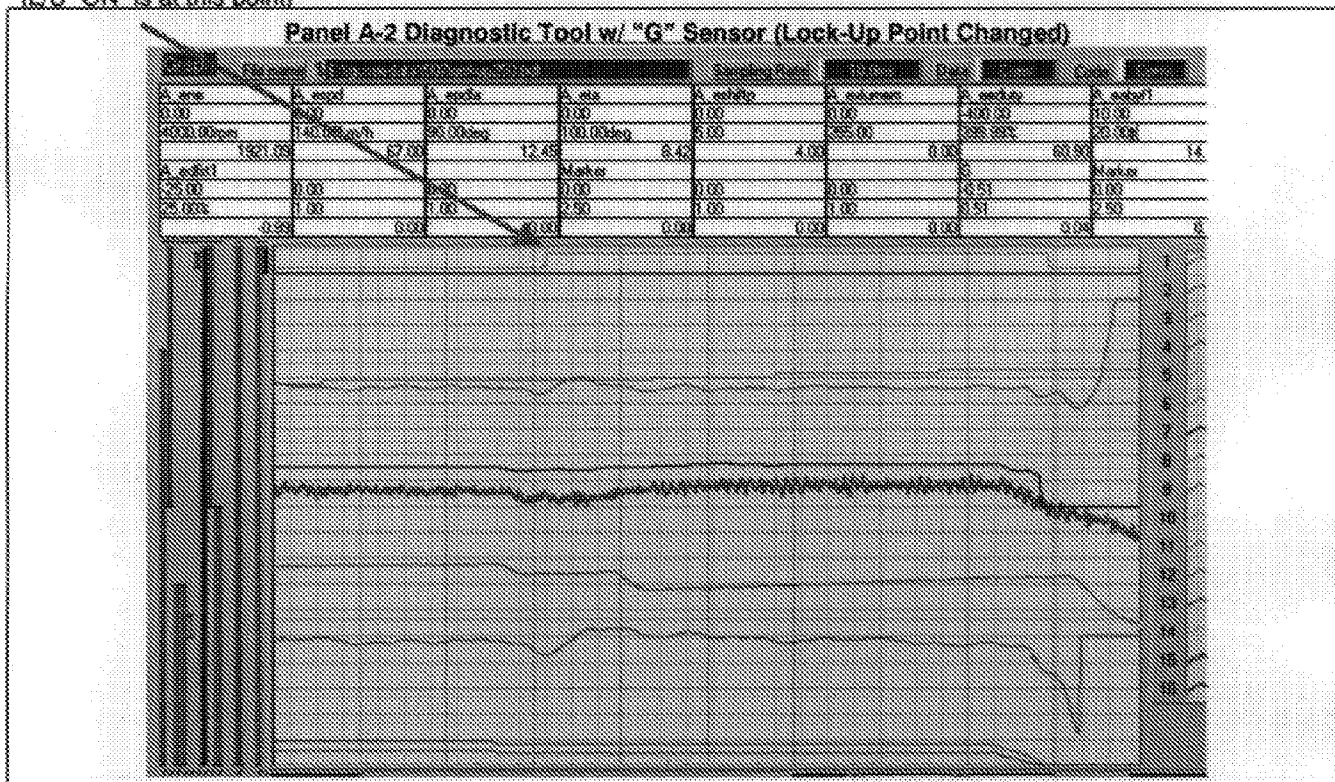
The second test involved changing the shift schedule to move the point at which L/U (Lock-Up) would occur. The L/U point was changed from 38 mi/h to 44 mi/h to evaluate what effect it would have on the "surging" condition. Vehicle No. 2 was then driven and measurements taken. The Panel A-2 diagnostic tool showed that the "G" sensor detected the same 8hz amplitude but the G force had been significantly reduced from 0.1G to 0.04G during the "surging" condition. The Panel A-2 screen is shown below with the RED line indicating the "G" sensor signal and the GREEN line for L/U. (L/U "ON" is at this point)

NOTE: Both TMS / TTC engineers and the GST Regional FTS and FPE agreed that the "surging" condition was eliminated after the change to the shift schedule L/U point.

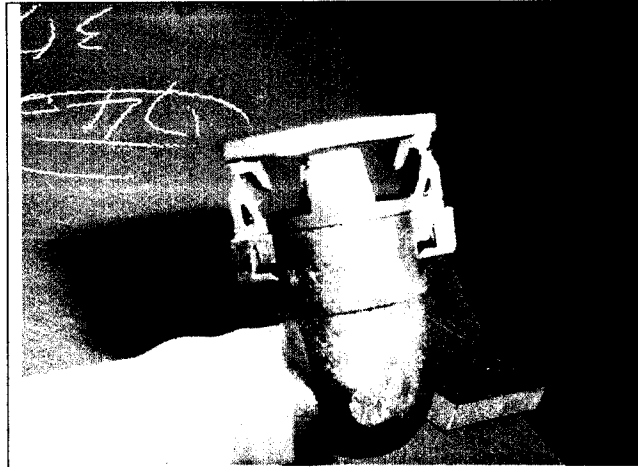
Photo C
Vapor Hose Connector (No Trouble)

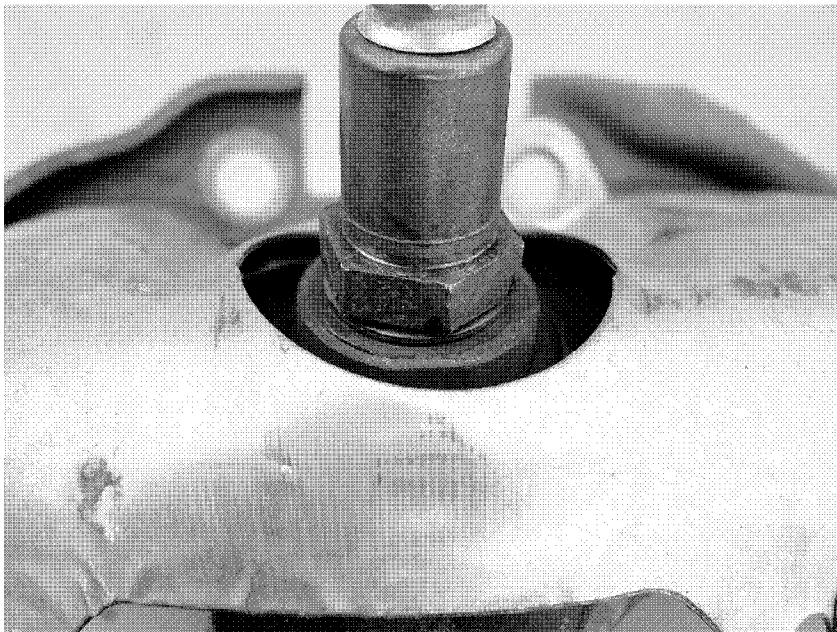
Seized Bank 1 Sensor 1 A/F Sensor causing an engine surge. The Sensor is seized in the Bank 1 Manifold.

The A/F Sensor and Bank 1 Exhaust Manifold (due to a seized Bank 1 Sensor 1 A/F Sensor) were replaced which restored normal A/F Sensor output and proper engine operation.

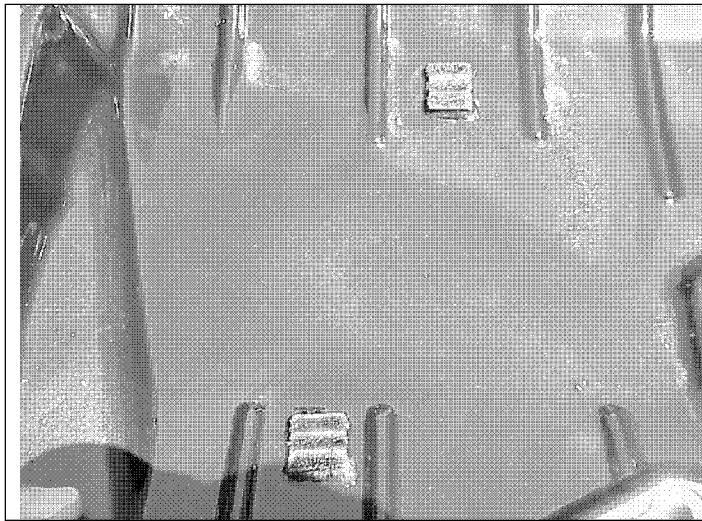
Close-up view of U151E Transaxle Oil Pan showing excessive Clutch material and metal debris deposited on floor of Pan.

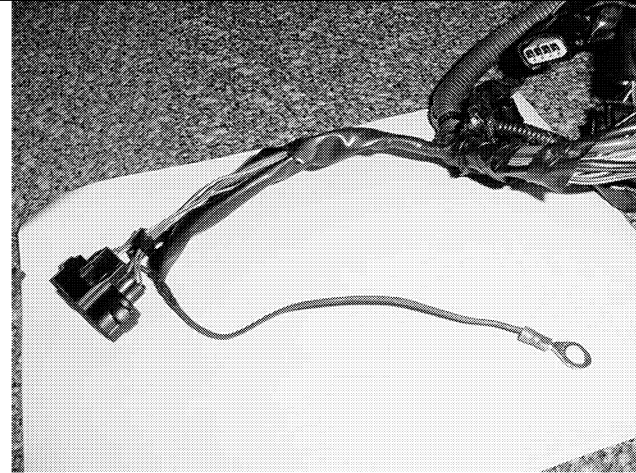
Test wire added from throttle body to engine ground.

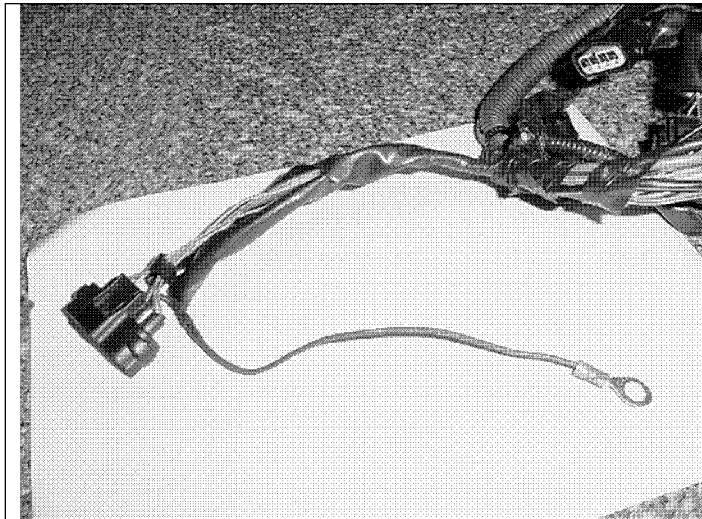
Test wire added from throttle body to engine ground.

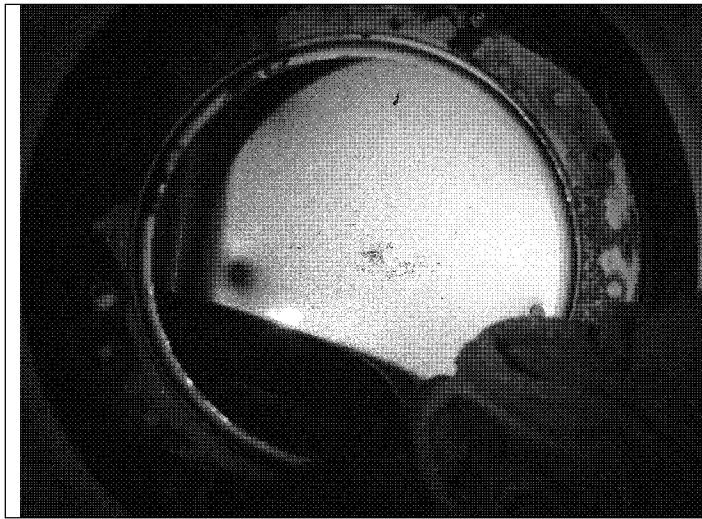
Close-up photo of fuel tank showing a small accumulation of dirt/debris on floor of tank immediately below fuel pump assembly.

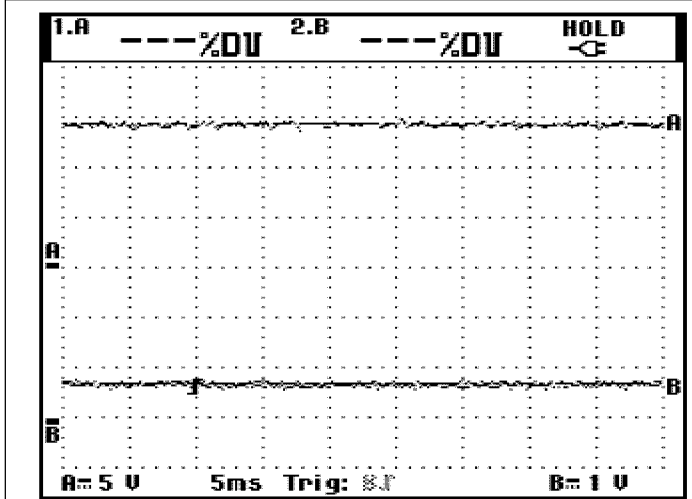
JTJHA31U 940046786 - NOT idle after
harness replacement.
Ch A = M+ Ch B = VTA

Once the relationship between the spikes on VTA and the M+ was found, bypassed VTA and VTA2 wires with external jumper wires. Condition still present. Swapped wiring harness from known good unit and condition was corrected.

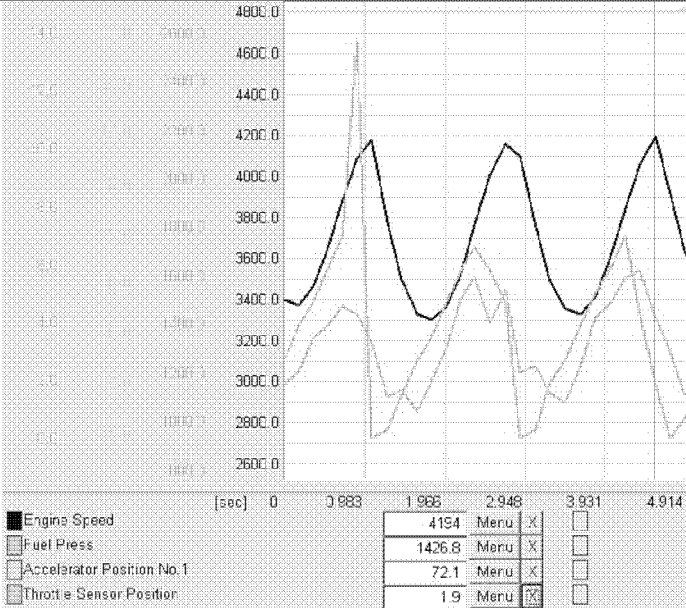
This is a screen capture out of the snapshot (Data 4). It shown the throttle position decreasing with the accelerator position holding steady (completely depressed). Shortly after the throttle position decreases engine speed follows.

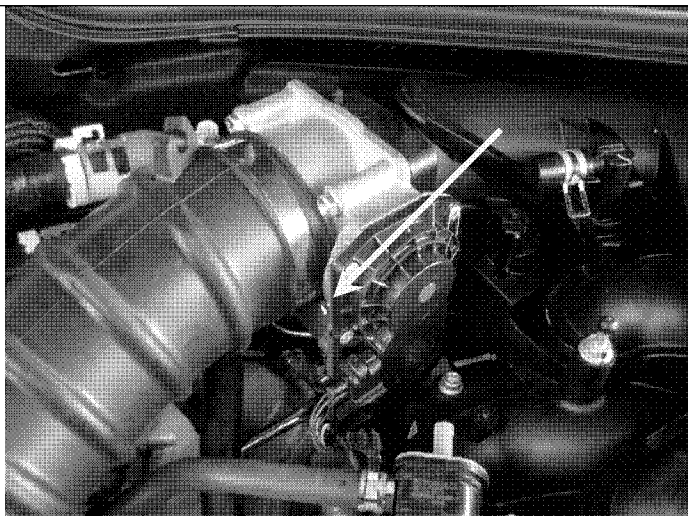
Throttle body concern

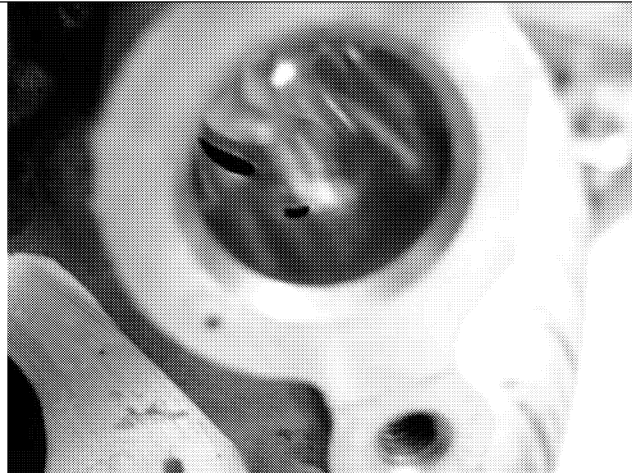
Incorrect OCV oil supply port machining in problem cylinder head.

- Technician replaced cylinder head assembly.

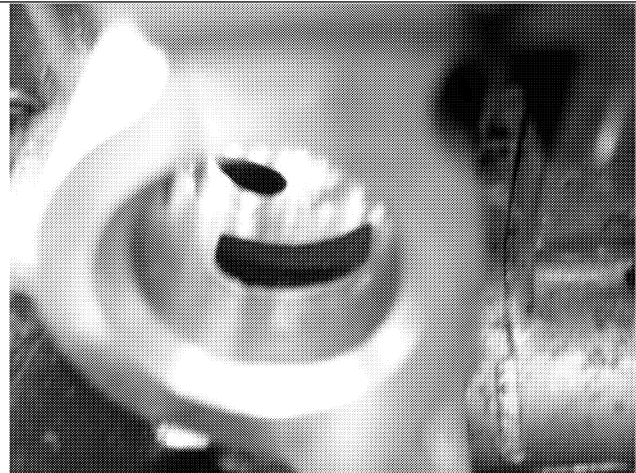
Replacement cylinder head with a considerable larger oil supply port
