NVS-213dsy
PE04-021

This letter is to inform you that the Office of Defects Investigation (ODI) of the National Highway Traffic Safety Administration (NHTSA) has opened a Preliminary Evaluation (PE04-021) to investigate allegations that the electronic throttle control system fails to properly control engine speed in model year (MY) 2002 and 2003 Toyota Camry, Camry Solara and Lexus ES300 model vehicles manufactured by Toyota Motor Corporation, and to request certain information.

Subject: AMENDMENT TO PETITION FOR DEFECT INVESTIGATION OF ALL 2002-2005 TOYOTA AND LEXUS VEHICLES CONCERNING VEHICLE SPEED CONTROL (VSC), ELECTRONIC THROTTLE, AND UNCONTROLLABLE ACCELERATION PROBLEMS, ATTACHMENTS NOT IMAGED FWD TO NVS-200

Denial of Motor Vehicle Defect Petition

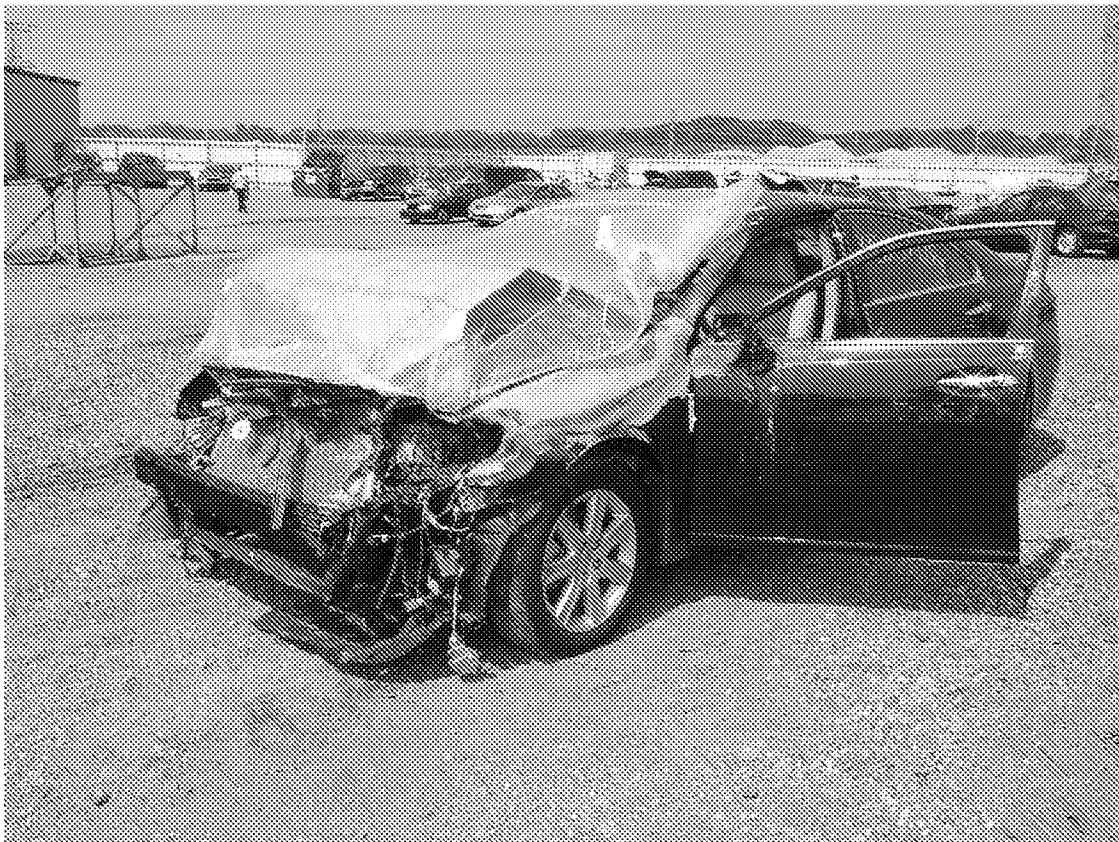
Photo 2: Front oblique view of vehicle showing collision and fire damage

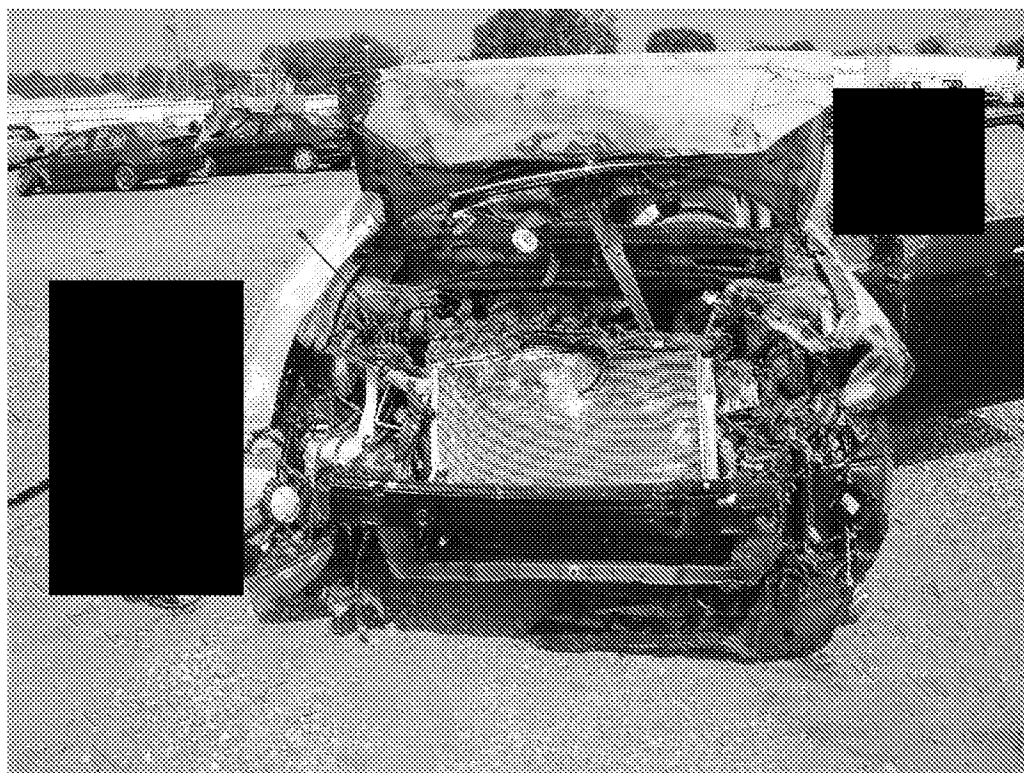
Photo 4: Front view, hood open, fire damage in engine compartment (redacted)

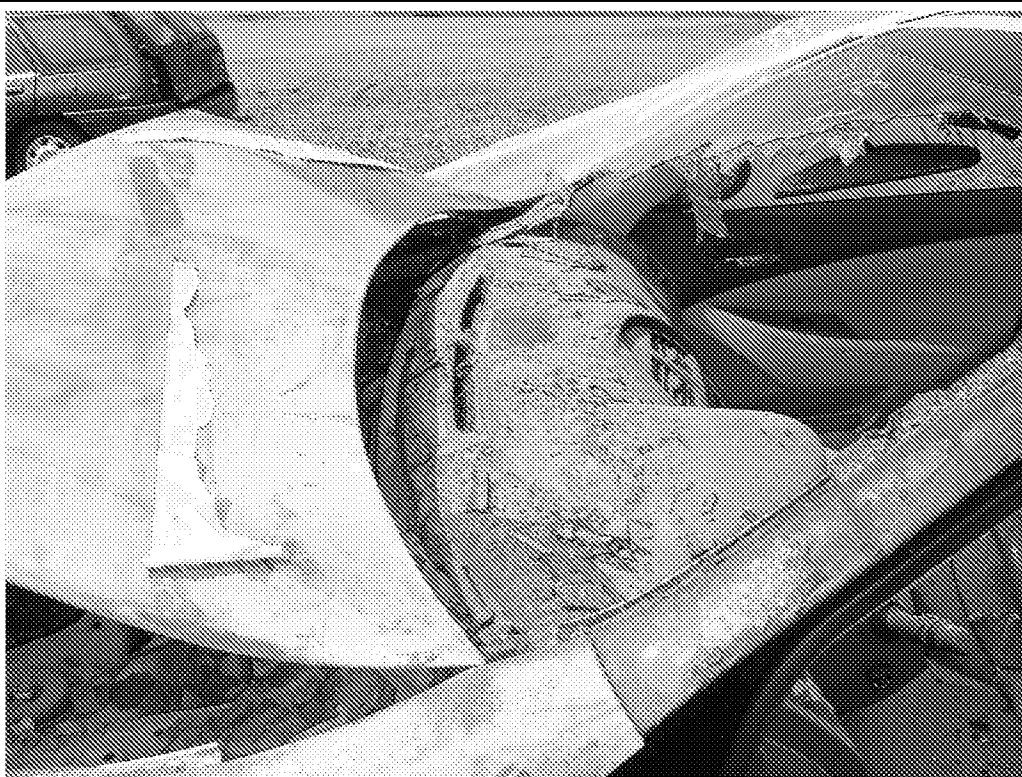
Photo 5: Fire damage to front windshield and dash panel

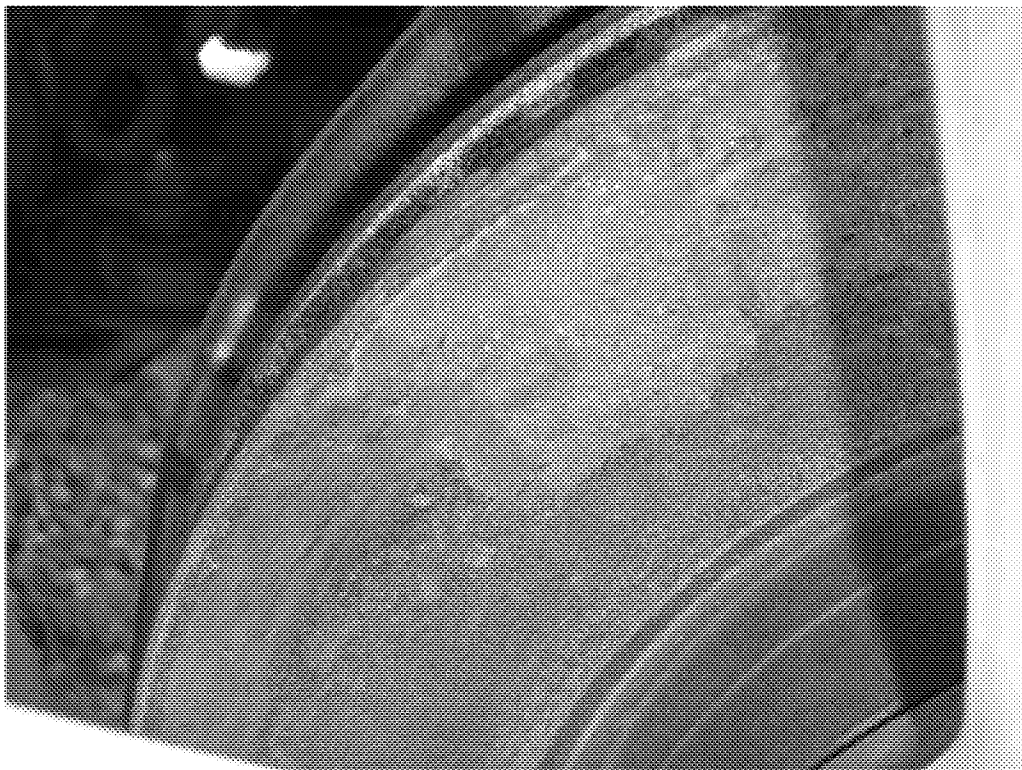
Photo 6: RHF rotor surface as viewed through the wheel aperture

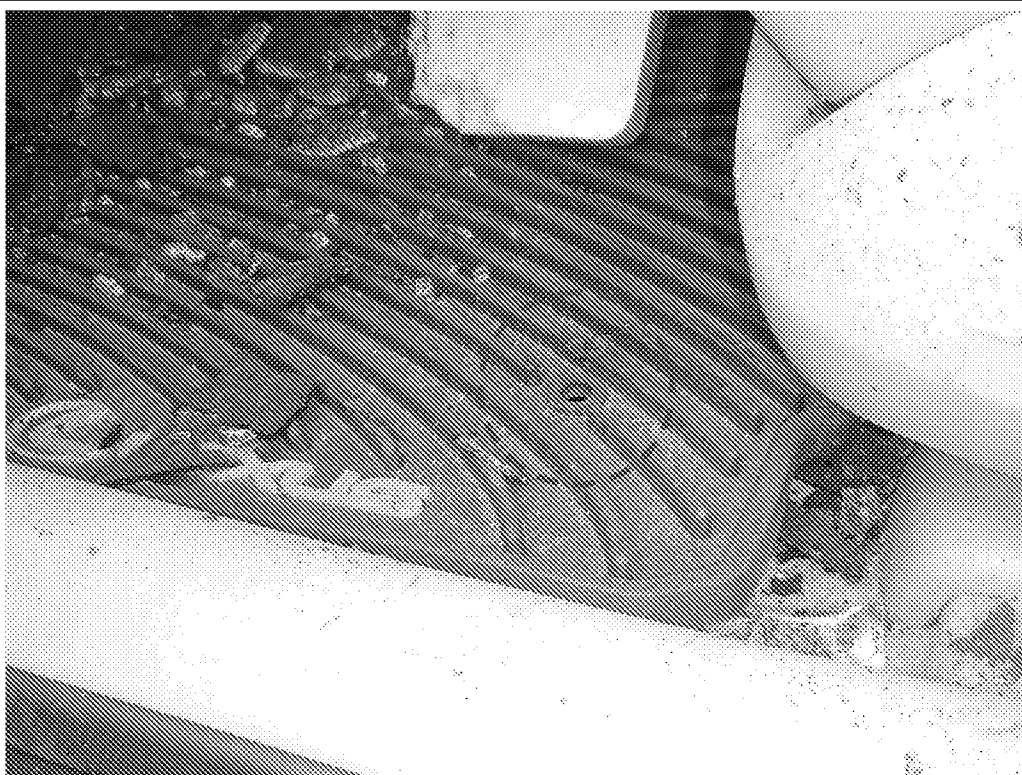
Photo 12: Drivers outboard mat retention hole without retaining hook engaged

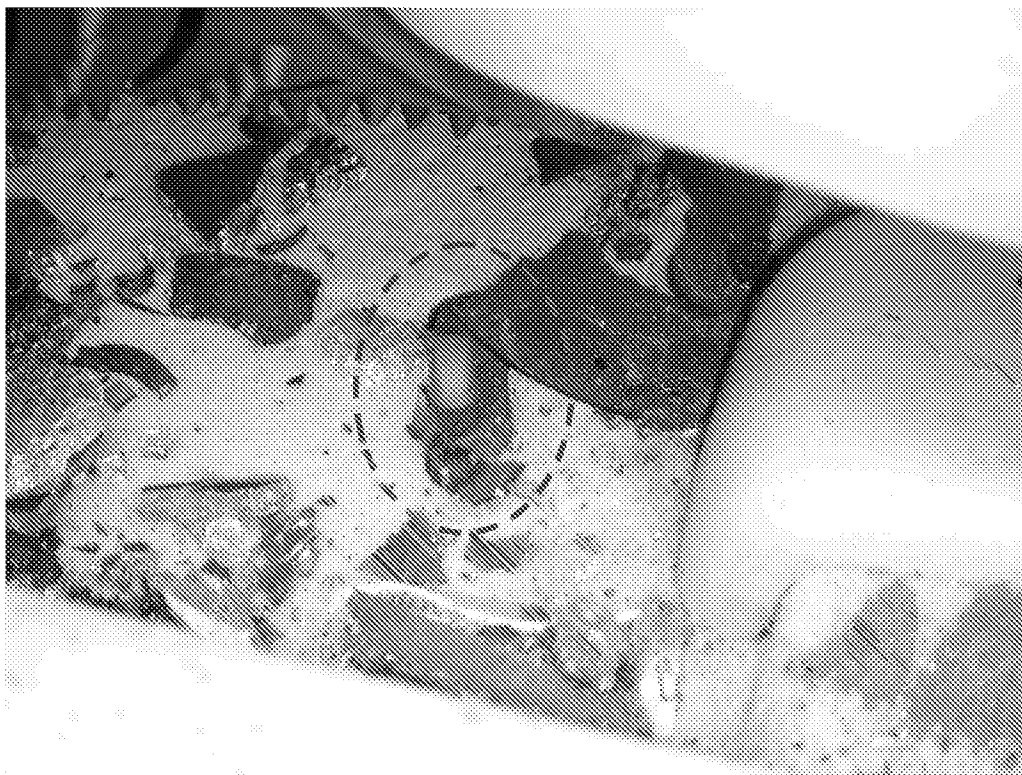
Photo 14: Driver outboard hook engaged in flooring, carpet mat not installed

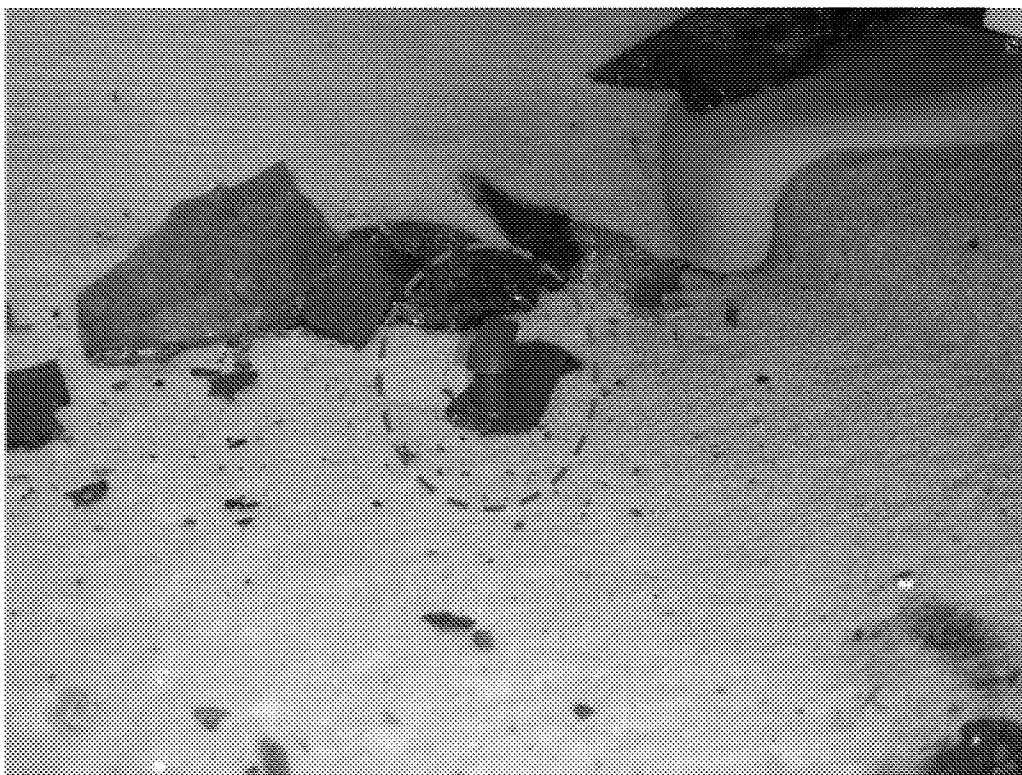
Photo 16: Driver inboard mat retention hook engaged in floor material
