#05-02-32-002D: Power Steering Inoperative/Steering Wheel Hard to Turn, PWR STR Message Displayed on DIC After Jump Starting Vehicle (Replace Fuse and Instruct Owner How to Jump Start Vehicle) - (May 29, 2009)

Subject: Power Steering Inoperative/Steering Wheel Hard to Turn, "PWR STR" Message Displayed on Driver Information Center (DIC) After Jump Starting Vehicle (Replace Fuse and Instruct Owner How to Jump Start Vehicle)

Models: 2006-2009 Chevrolet HHR
2003-2007 Saturn ION

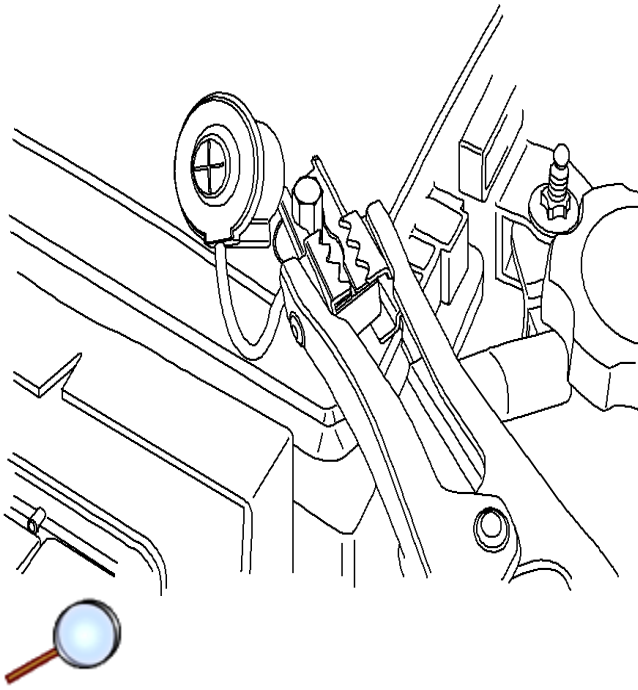
Saturn ION

4. Open the hoods and locate the positive (+) and negative (-) terminal locations on each vehicle. You will not need to access your battery for jump starting. Your vehicle has a remote positive (+) jump starting terminal. The *remote positive (+) terminal* is located on the *engine compartment fuse block*, under a red cap. Do not remove the black fuse box cover.

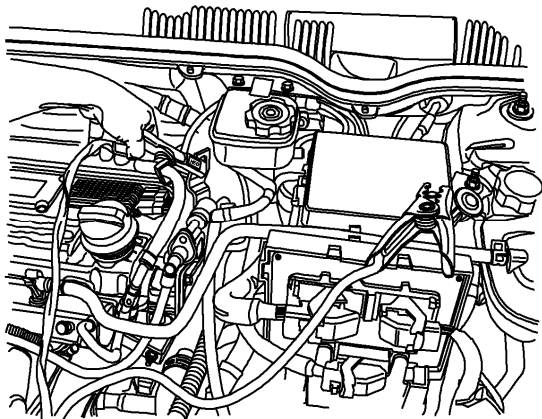
- For 2003 and 2004 model year IONs, attach the black negative (-) cable to the *engine lift*

hook of the dead battery vehicle, about 18 inches (45 cm) away from the remote positive (+) terminal, but not near engine parts that move.

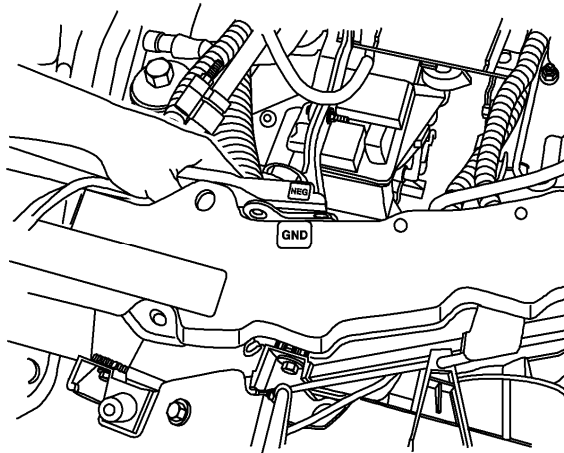
- For 2005 and 2006 model year IONs, attach the black negative (-) cable to the *remote negative terminal*. The remote terminal is located under the GND (-) sticker on the driver side of the radiator support bar (near hood prop rod).

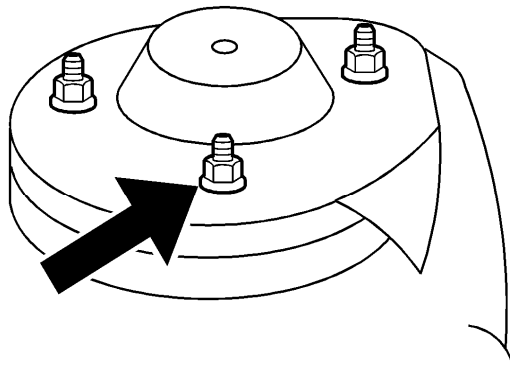
- For 2006 HHRs, attach the black negative (-) cable to the *remote negative terminal*. The remote terminal is located on the driver's side shock tower and is marked with a GND (-) sticker.
