Reference: NVS-212am; PE10-022

Attached is Chrysler Group LLC's ("Chrysler") response to the referenced inquiry. In performing the analysis and reaching conclusions, and by providing the information contained herein, Chrysler is not waiving its claim to attorney work product and attorney-client privileged communications.

The rate of reported headlamp malfunction appears to have been higher than normal during the early life cycle of the subject vehicles, but it has clearly trended downward to normal warranty rates and there is no evidence to suggest that this trend will reverse. Also, the lack of harmful events being reported supports the conclusion that there is no demonstrative risk to motor vehicle safety for the remaining subject vehicles still in service. As a result, Chrysler believes this investigation should be closed.

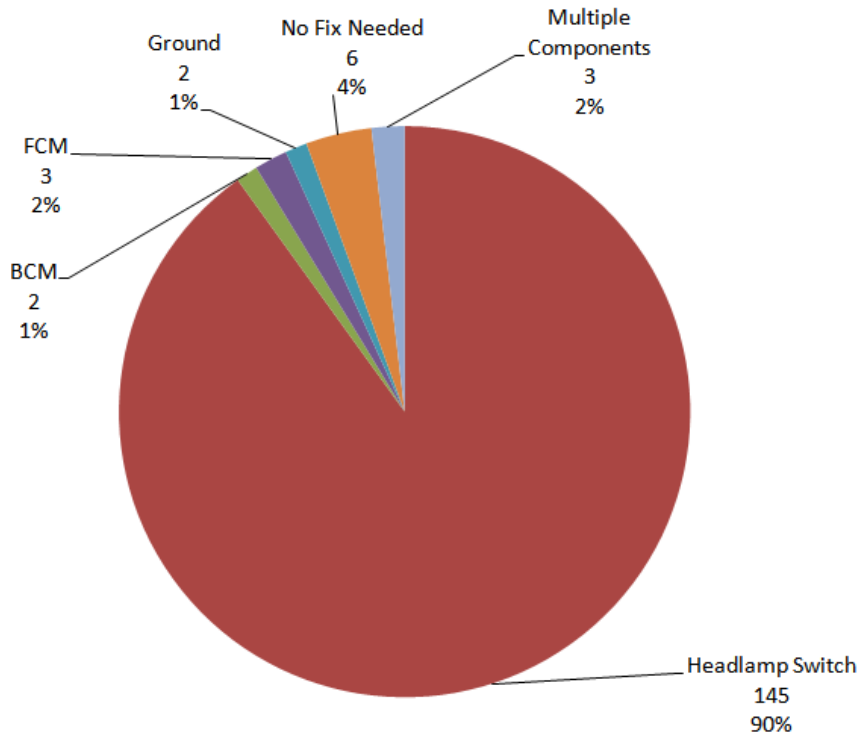
**PE10-022 Repair Study of QNA (Field) Reports**

Field Report Study Results: Chrysler completed a study of the repairs conducted for the field reports for which a repair was listed. Out of the 861 reports, repairs were listed for 161 of them. Of these 161, Chrysler assessed what repair action was taken by the field personnel. A summary of the results is shown below.

Field Report Study Summary: A significant majority of the repairs were to replace the headlamp switch (approximately 90%). Chrysler is still reviewing the repair records of these 161 vehicles to ensure that the repair was effective and that there are no repeat repairs for the same complaint.

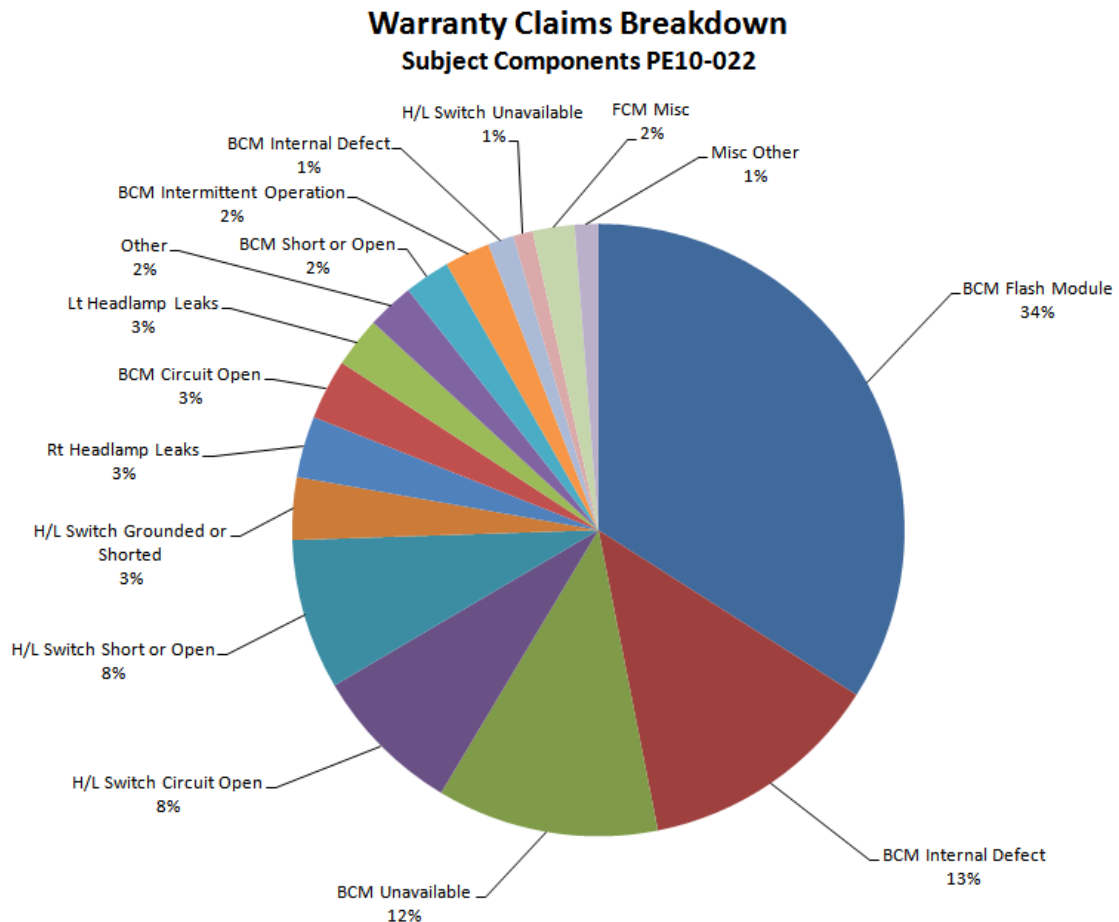
Analysis of Subject Component Warranty Claims Results: The study results are shown below.

Analysis of Subject Component Warranty Claims Summary: Over half of the warranty claims are related to the BCM (flash or software update or unit replacement) and another 19% or so due to the headlamp switch. It is important to note, however, that the BCM controls many other functions aside from front exterior lighting and there is no way to extract only the complaints related to the alleged condition as many of the warranty claims do not have narratives. Thus, Chrysler has not drawn any conclusions from this data.

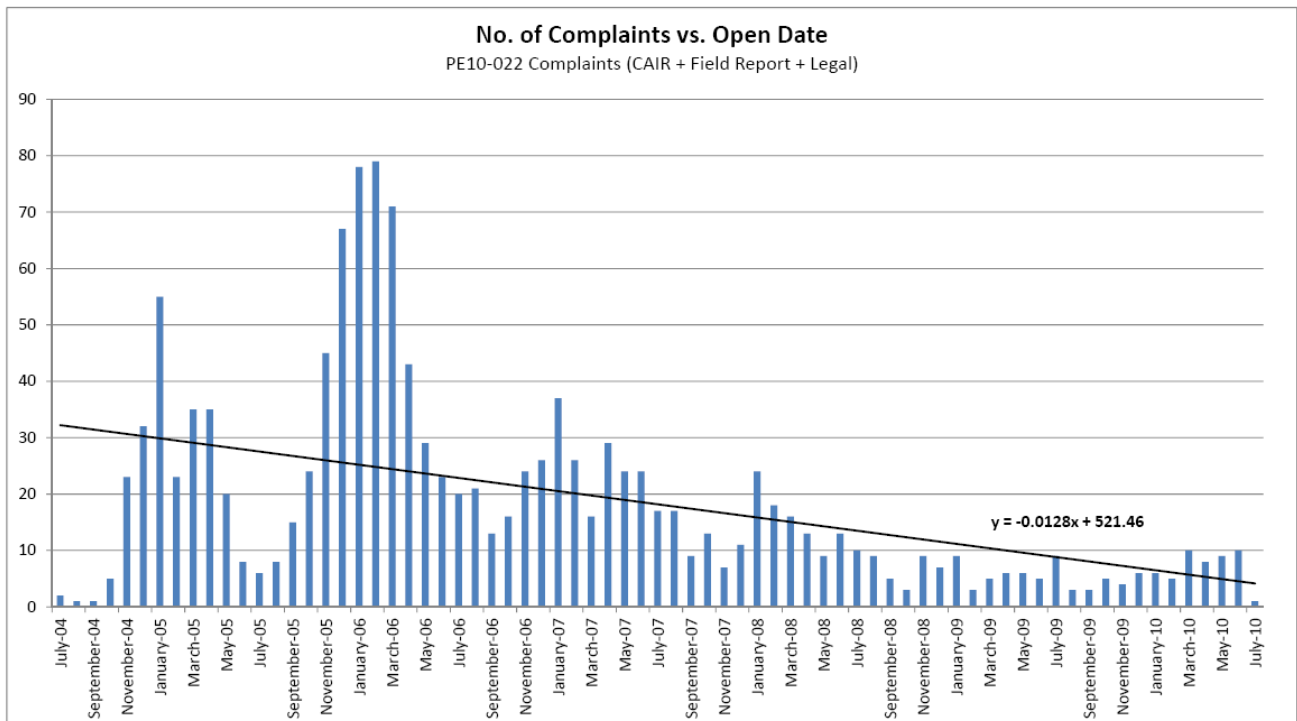
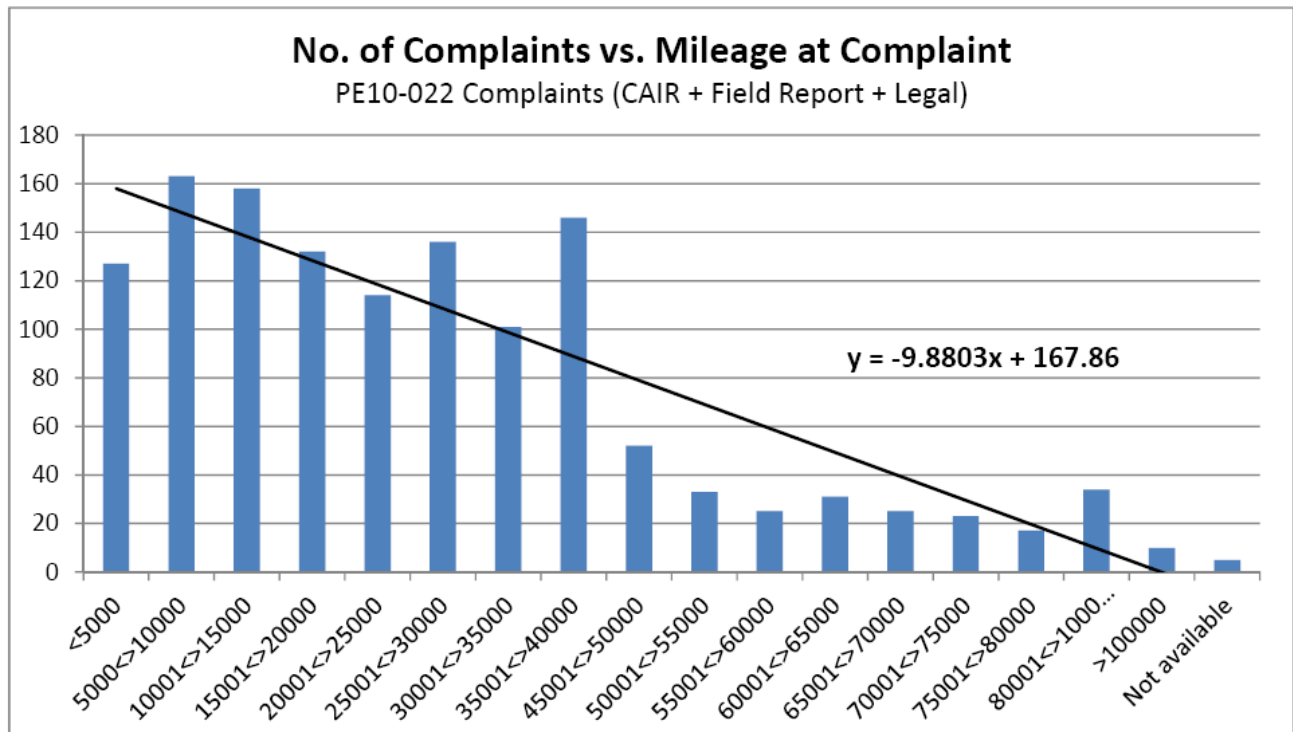
3. The headlamp switch is thought to be a significant contributor to headlamp complaints. The headlamp switch was initially supplied by Delphi during the first two months of the 2005 MY production with very low warranty rates (see headlamp MOPMIS charts in Enclosure 8C). Thereafter, TRW supplied the 2005 MY headlamp switches that used a different design and process and the warranty rates for the headlamp switch increased significantly. As noted in Enclosure 8G, the increase in the headlamp switch warranty claims may be attributed to debris contamination during assembly of the switch by TRW. This document indicates that manufacturing process changes were implemented by TRW. The warranty claim rate subsequently began to significantly decrease (see headlamp MOPMIS charts in Enclosure 8C).

Additionally, there are two noteworthy trends in the field data. First, the subject vehicles with the auto-headlamp option have a lower warranty complaint rate when compared to vehicles without this option (see headlamp MOPMIS charts in Enclosure 8C). This suggests the auto-headlamp option is less susceptible to experiencing the alleged condition. Second, and most importantly, there is a significant, decreasing trend for headlamp malfunction complaints received by Chrysler. The charts below of complaints (taken from Enclosure 8B) show a clear downward trend in the number of reported headlamp malfunctions over time and with increasing vehicle mileage. It is important to note that the majority of complaints were made while the vehicles were still under warranty. It also appears that the subject vehicles that were once at risk for a headlamp malfunction have already been repaired.
