Subject: PE10-034 NVS-213hkb: Engine Stall and/or Loss of Motive Power;
TDI Clean Diesel Engine

Please find attached Volkswagen's response to your letter dated September 14, 2010 requesting information concerning engine stalling and/or loss of motive power, on certain 2009-2010 MY Volkswagen Jetta, 2010 MY Volkswagen Golf and 2010 MY Audi A3 vehicles equipped with the TDI Clean Diesel engine.

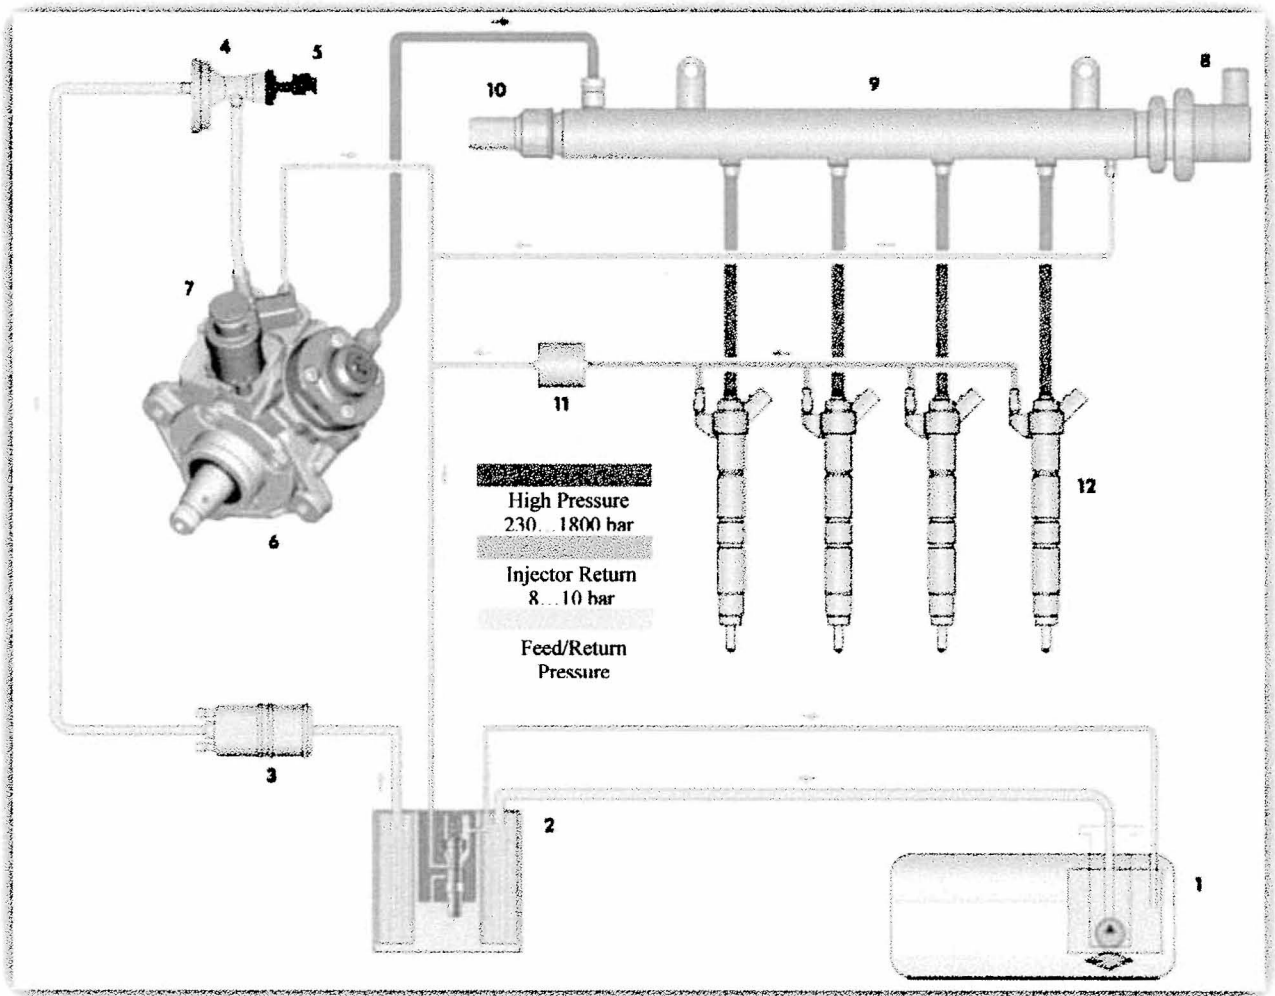
Image 1 – Fuel System Schematic

Image 1 displays the schematic of Volkswagen’s TDI Clean Diesel “common rail” system. (Please note that “fuel” always refers to diesel fuel unless otherwise stated.)

The in-tank fuel pump¹ delivers the diesel fuel from the fuel tank to the fuel filter², located within the engine compartment. A secondary “in-line” fuel pump³ provides additional pressure to the feed line. The fuel passes a fuel temperature sensor⁵ and enters the HPFP⁶ through a strainer⁴. The HPFP increases the fuel pressure up to 1,800 bar / 26,107 psi and feeds the fuel to the “common rail.”⁹ The actual pressure inside the common rail is controlled by a pressure sensor¹⁰ and a regulation valve⁸, depending on engine operating load and fuel demand requirements. The engine control unit operates the fuel injectors¹² and provides for multiple injections (when necessary) during one combustion cycle. Excess fuel is returned via return lines to the fuel filter. The pressure retention valve¹¹ in the return line provides a reference pressure for each injector during operation and prevents the injectors from running dry (fuel being drained from the line) when the engine is off. Inside the fuel filter², a temperature valve determines whether fuel is redirected to either the HPFP or to the fuel tank, dependent on operating and ambient temperatures.

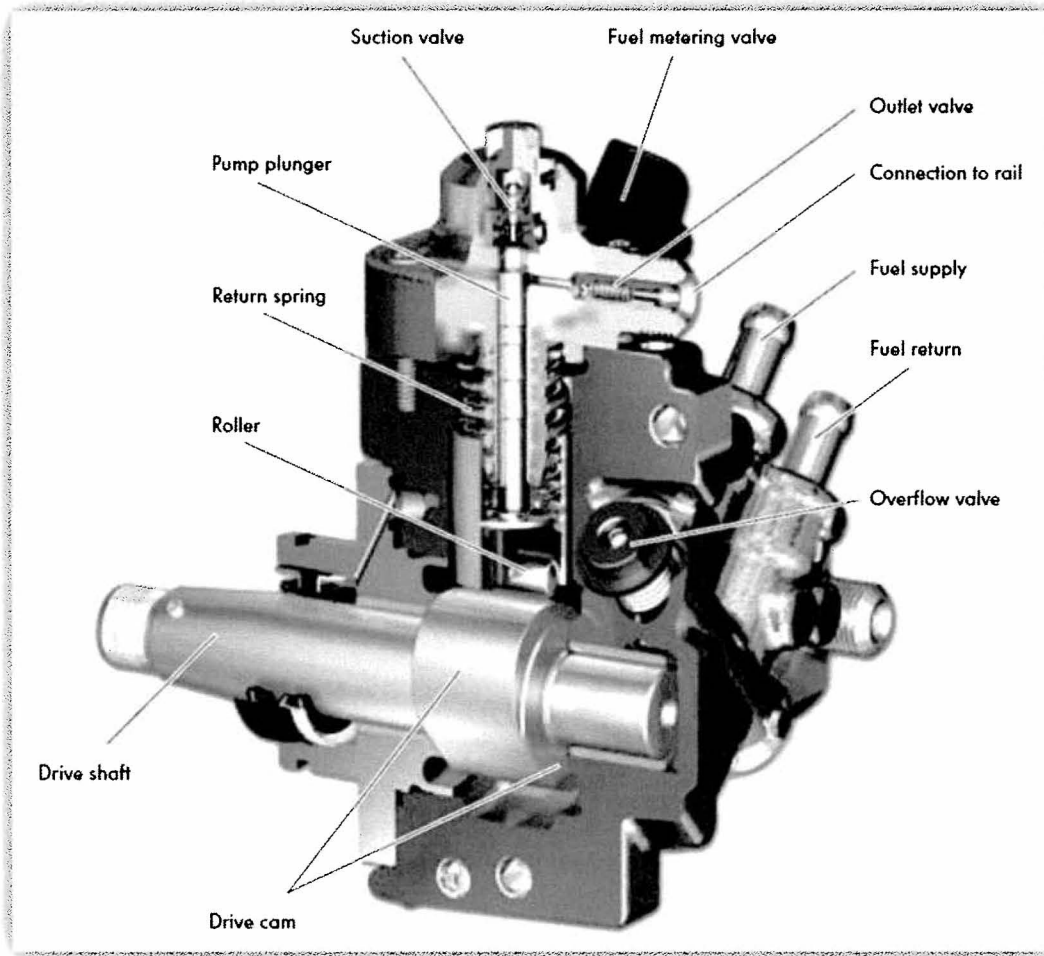
Image 2 – High Pressure Fuel Pump – Cut-away Model

Image 2 shows a cut-away model of the HPFP and displays the internal components. The basic design of the HPFP is a radial piston pump.

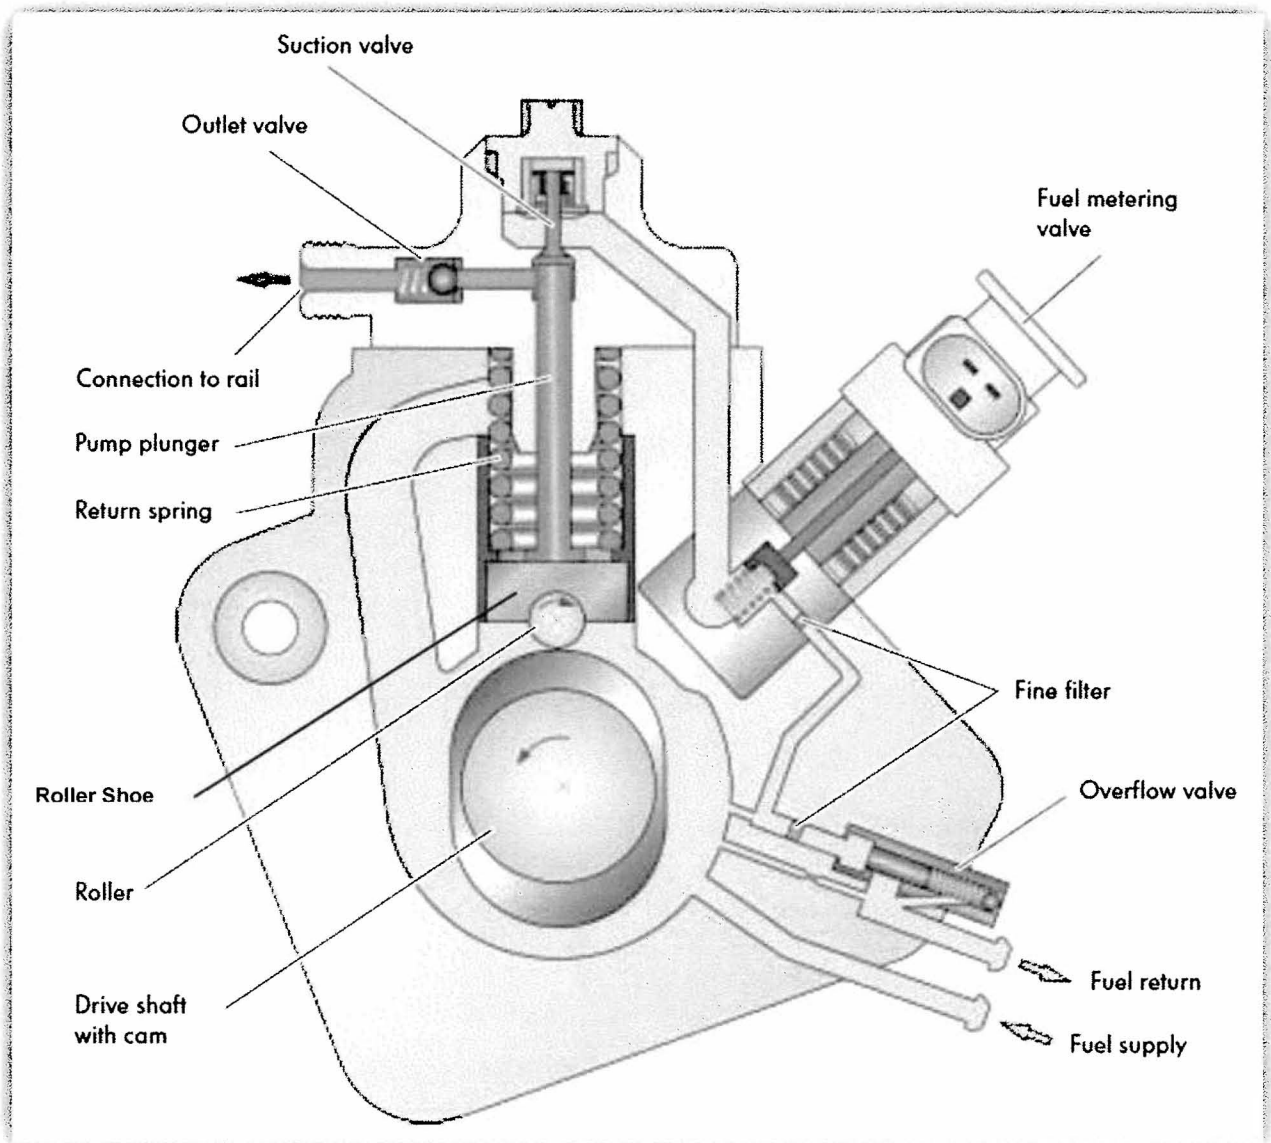
Image 3 – High Pressure Fuel Pump - Schematic

Image 3 displays the operation of the HPFP.

The pump is driven by a dual lobe camshaft. The camshaft is in constant contact with a roller, which is retained in position by a spring loaded roller shoe. The roller shoe provides the contact point between the roller and pump plunger. One revolution of the camshaft provides two actuations of the pump plunger.

Well-lubricated operation of this shoe/roller/cam contact is vital to the pump's mechanism and, as discussed later, an area directly impacted by gasoline contamination in the diesel fuel supply.

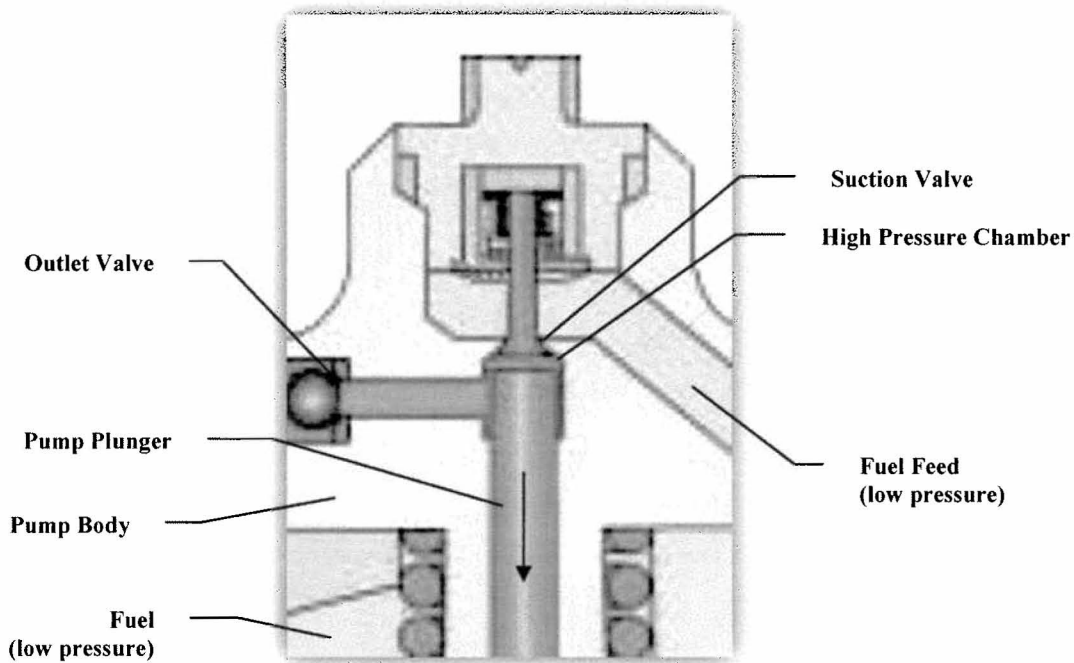
Image 4 – High Pressure Fuel Pump – High Pressure Chamber Detail

Image 4 displays the high pressure chamber of the HPFP in detail. As the plunger moves down (in the direction of the arrow), the suction valve opens and draws fuel into the high pressure chamber. As the camshaft lobe drives the plunger up, the suction valve closes, raising the pressure of the fuel within the high pressure chamber. The outlet valve then opens, feeding the high pressure fuel to the “common rail.”
