RE: NVS-213kmb, PE10-035

161,946 MY 2011 Hyundai Sonata vehicles have been manufactured through October 8, 2010.

If the connection between the steering wheel and steering gear separates, the driver would lose the ability to steer the front wheels, which may increase the risk of a vehicle crash. Hyundai submitted a Part 573 defect information report to NHTSA on September 21, 2010 stating its decision to conduct a recall to inspect the subject vehicles for the alleged defect and to make repairs when necessary and is presently conducting recall 10V-426.

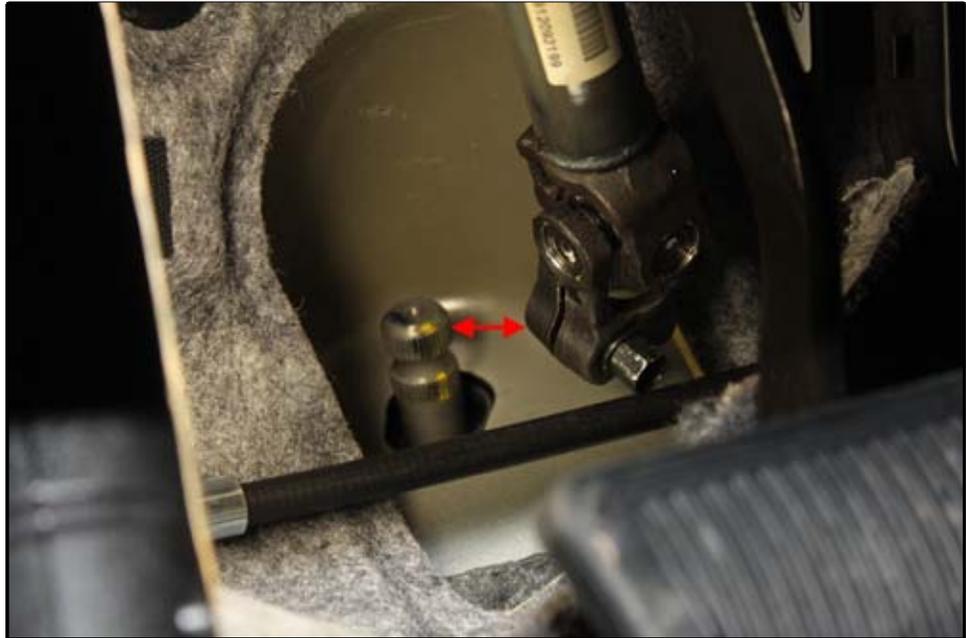
- When vehicle arrived at dealer the technician found the intermediate shaft detached from the steering rack shaft as shown here

Install the intermediate shaft onto the steering rack shaft in the correct location and torque mounting/pinch bolt

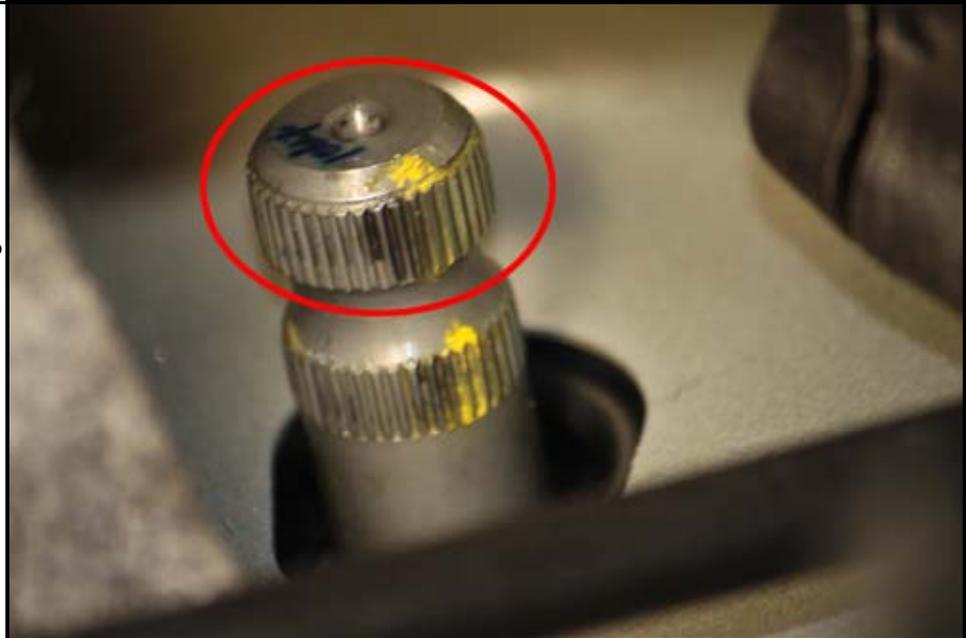
- The intermediate shaft was on installed on the top splines shown here and the mounting bolt was tightened above the shaft it was never slid down to the groove shown here

- NOTE: The pinch/mounting bolt was tight when the vehicle arrived at the dealer

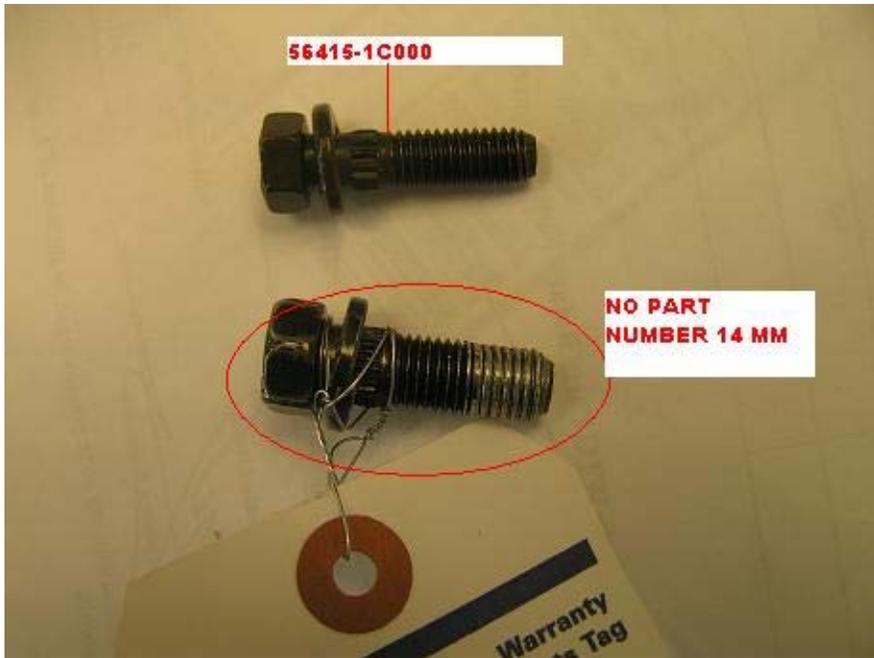
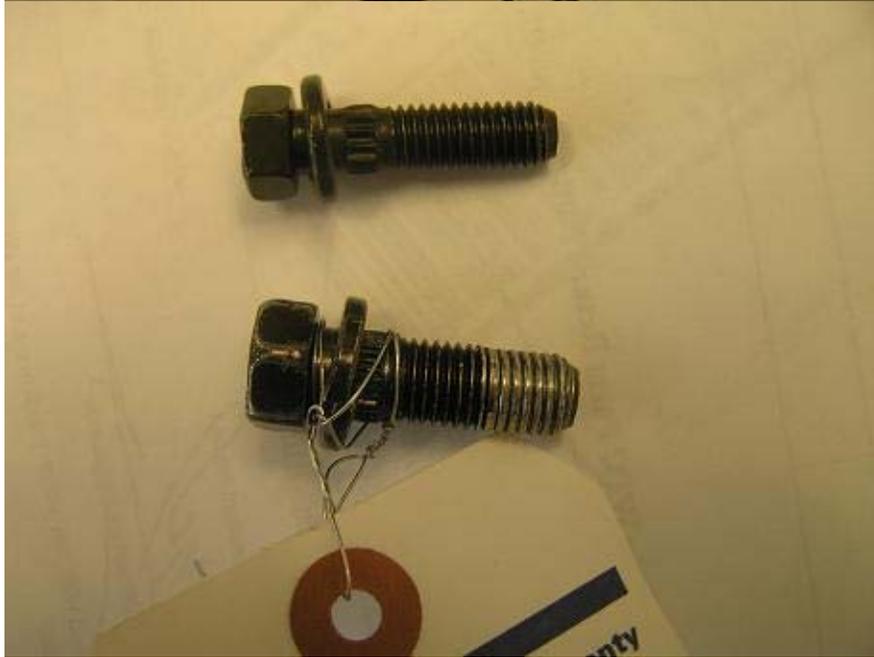
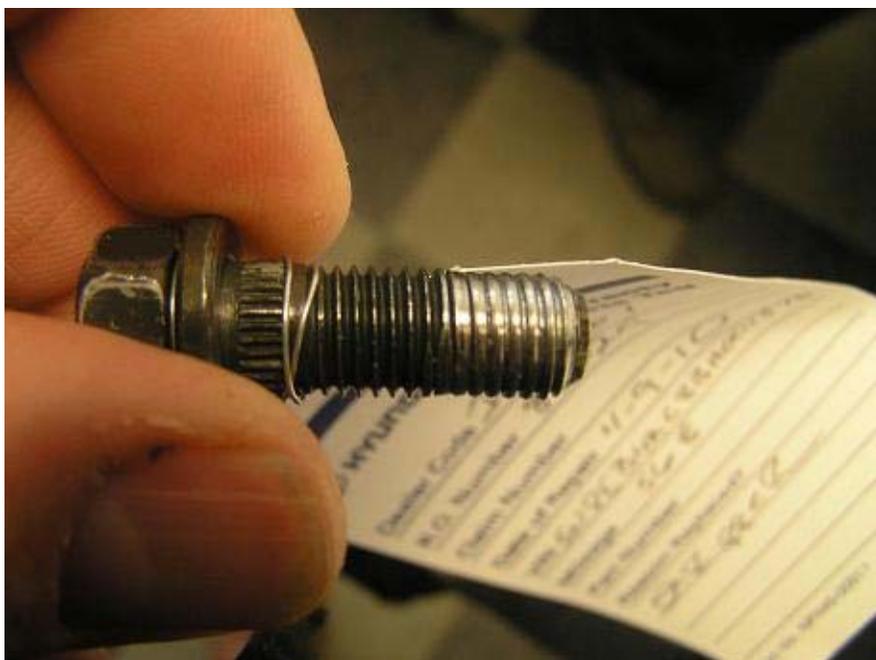
Customer states when moving steering wheel, a rattle noise is coming from under the dash. Tech found upper intermediate shaft U-Joint bolt stripped, not tight

dealer will replace intermediate steering shaft and pinch bolt (part taken from like vehicle at central region

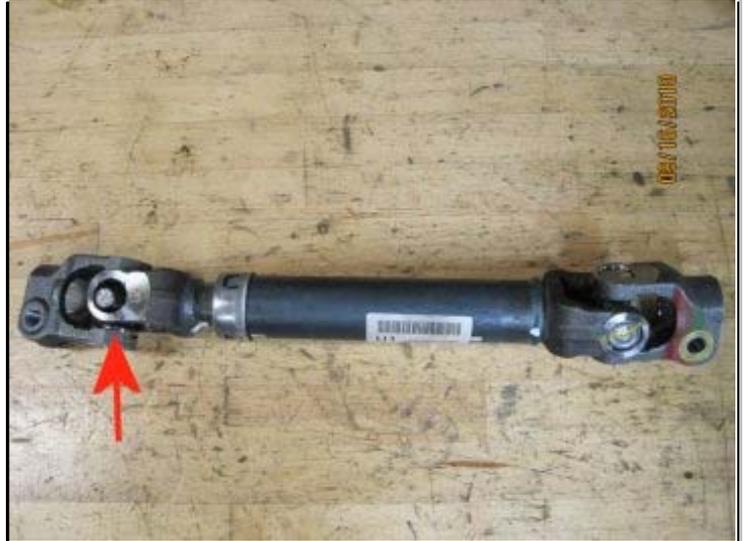
One of the steering shaft joint caps was missing.

- Picture shows steering shaft.

Replace steering shaft.

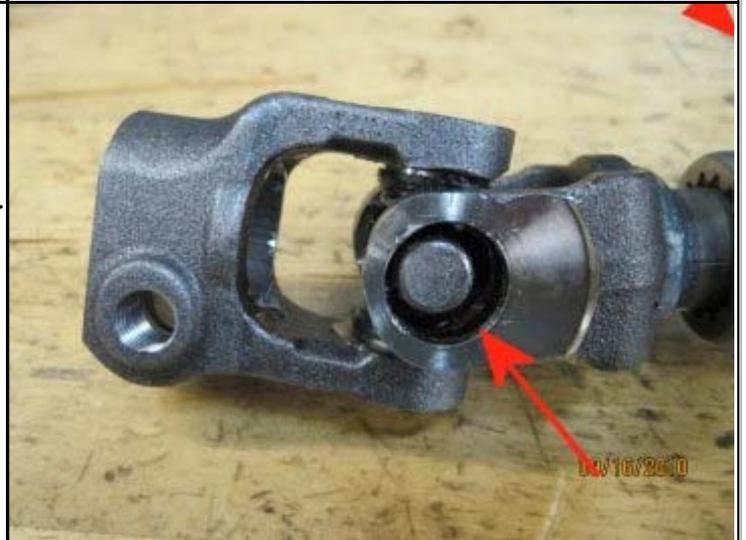
- Picture shows steering joint and missing cap.

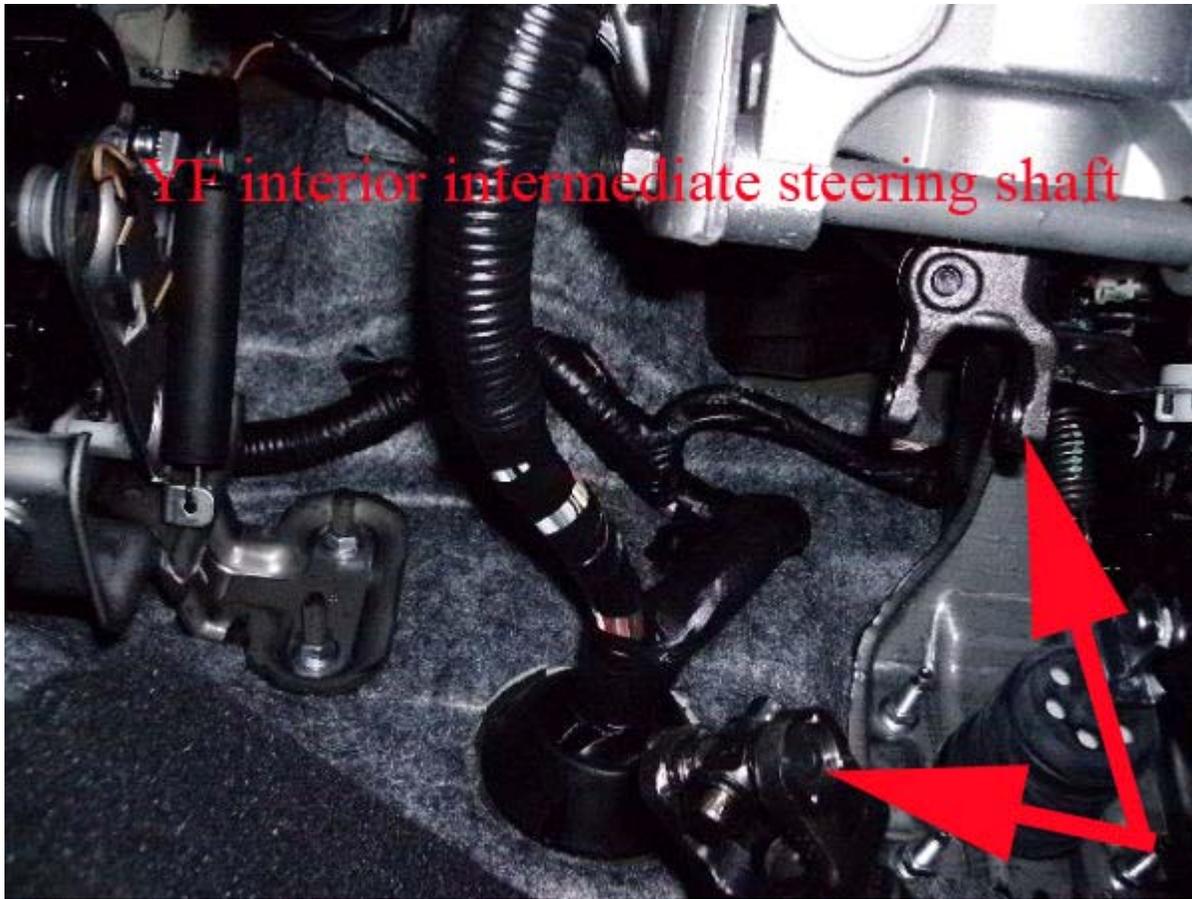
Customer stated steering is loose

Dealer to replace steering shaft assembly

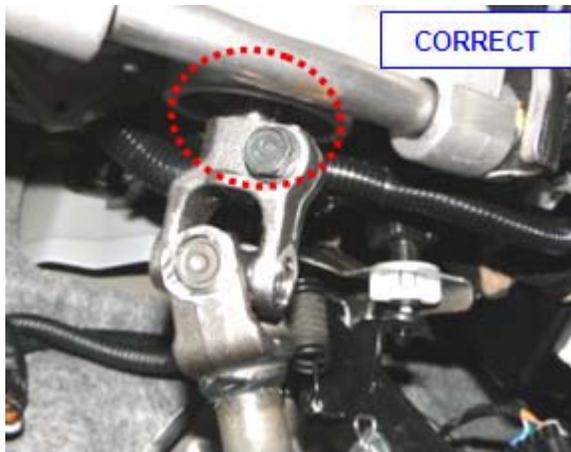
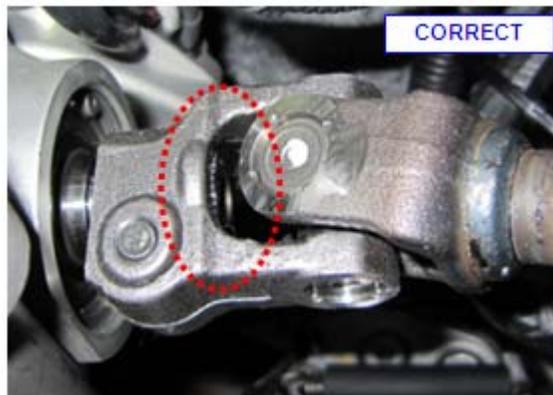
2. Visually check that the steering column and the U joint are properly connected as shown in the picture on the right.

NOTE: Look to verify that the end of the steering shaft protrudes about 1/8" into the void of the U-joint (see image). It is not seated properly if it does not protrude slightly.

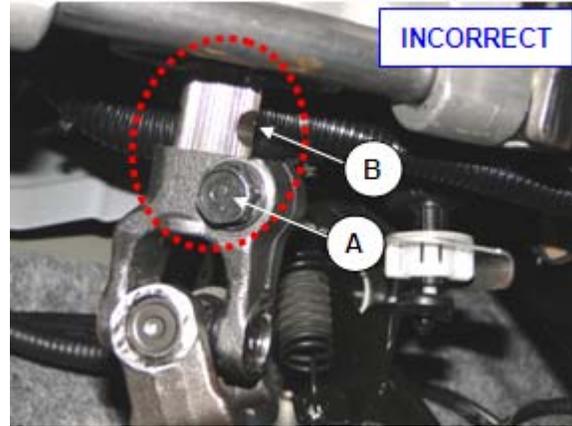
3. If the steering column and the U joint are improperly connected as shown in the picture on the right, re-connect the U joint to the steering column according to the steps below. If properly connected, go to step 8.

NOTE: The steering column-to-U joint bolt (A) must be fastened through the groove (B) in the end of the steering column.

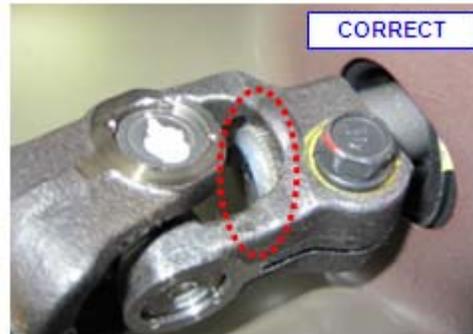
3. Visually check that the steering pinion splined shaft and the U joint are properly connected as shown in the picture on the right.

NOTE: Look to verify that the end of the splined shaft protrudes about 1/4" into the void of the U-joint (see image). It is not seated properly if it does not protrude slightly.

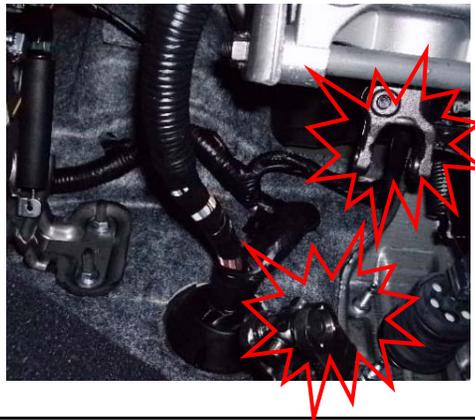
- Dealer technician found intermediate shaft had separated from the base of the steering column.
- This condition completely disables the ability to steer.
