Re: **PE10-042**  
**NVS- 214phk**

On behalf of Mack Trucks, Inc., I am responding to the questions raised in your letter dated January 19, 2011.

DSR...Fifth Wheel Angle Hardware Issue

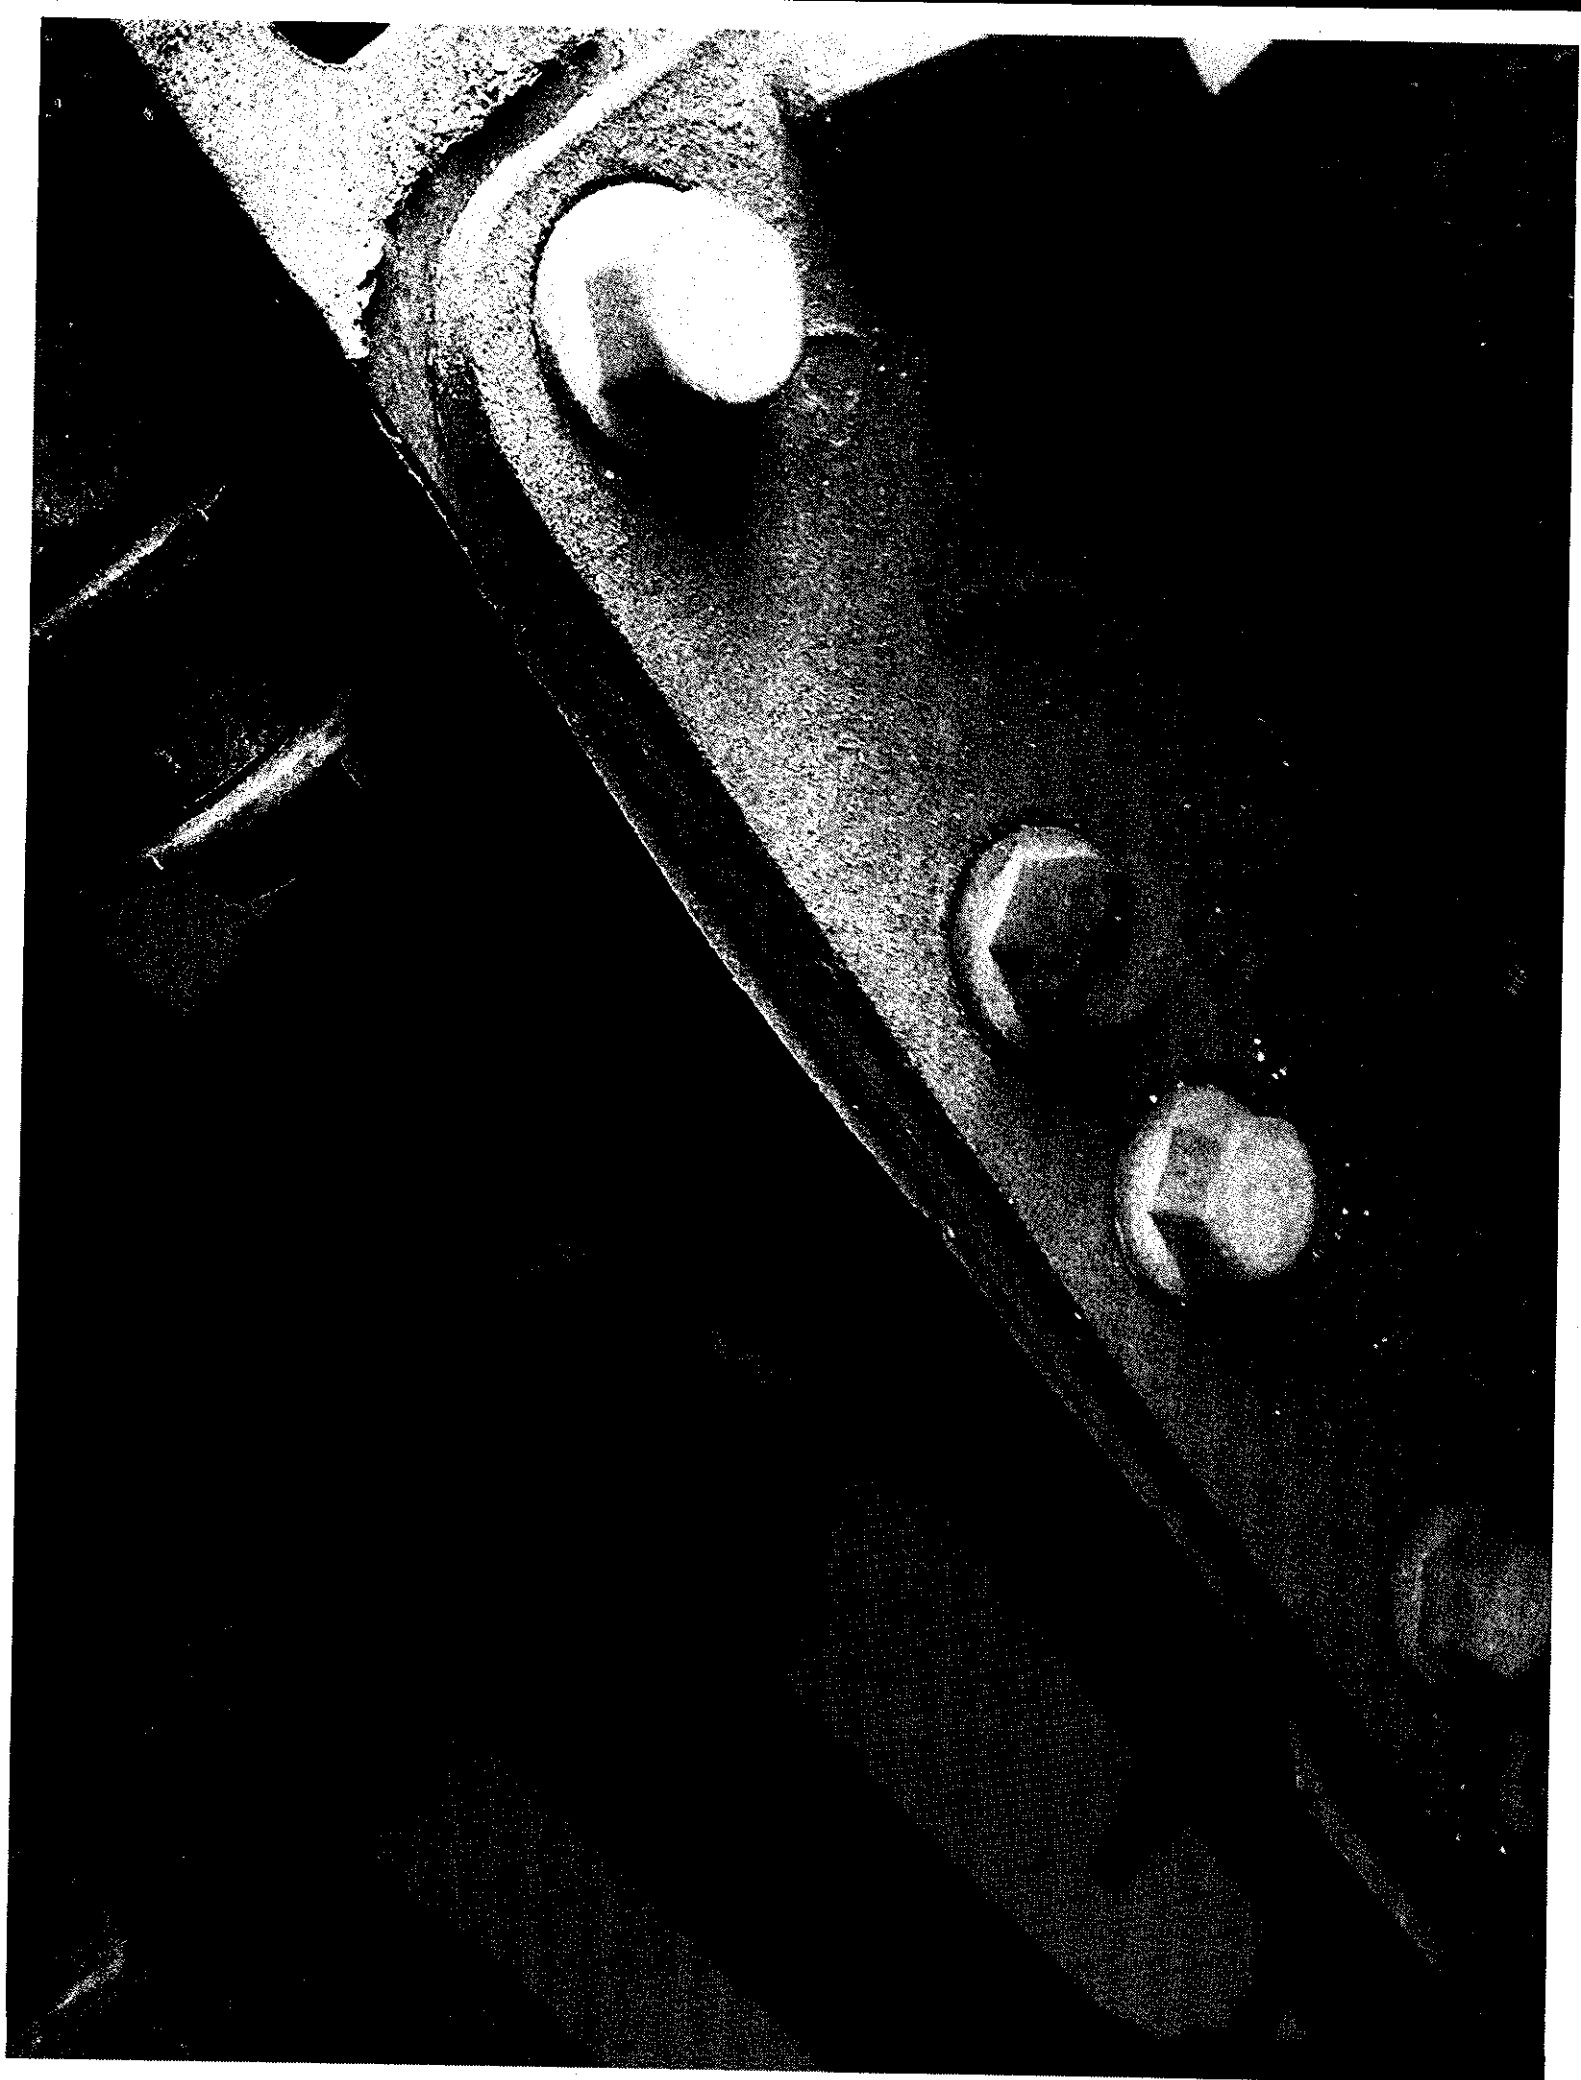
Found all 5th wheel mounting bolts loose. Also looks like fifth wheel flange to frame huck bolts at the front of the fifth wheel are loose. See attached pictures. Technician started replacing loose fifth wheel bolts with bolts per VIN, [REDACTED]. Technician noticed that the mounting bolt when ran all of the way down bottomed out on top of a huck bolt. Checked and looked at another similar spec'd unit on the yard for service and found it too also had the mounting bolts sitting on top of the huck bolts. (CXU613,010948.)  
Went to customers local terminal and found one unit there with loose mounting bolts also. (CXU613,012155.)

See attached pics of the mounting bolts sitting on the huck bolts. There is a pic of the other unit on the yard with the original bolts still and one where we replaced the loose bolts (27AM66) and this is when we noticed the bolt stopping when it hit the huck bolt.

| Created | Created By | Activity Type | Description |
|---|---|---|---|
| 2010-09-24 11:18:35 | RONALD DUNCAN | Web Response | Thanks for the report. Please replace fifth wheel hardware with part # 25189745 flange screw(12ea) and 25093559 nut(12ea) on all units that you currently have at your location. |

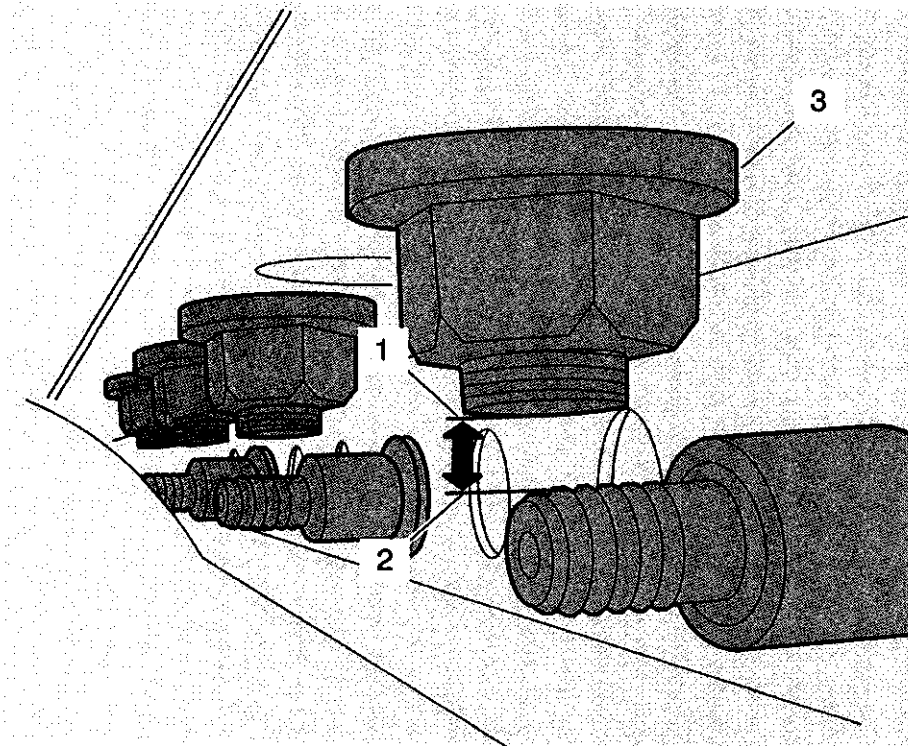
W9062981

Field reports suggest there may be an issue with the fifth wheel mounting hardware on certain CXU and CHU model vehicles. Reports indicate some of the fifth wheel mounting hardware may be contacting the Huck bolts that are used to mount the fifth wheel mounting brackets to the frame. This condition is limited to vehicles having a 266 mm (10.47in). frame rail height. The procedure below describes how to address this issue. Please note; if this issue is found, all fifth wheel mounting hardware must be replaced.

**Note:** Torque is 320 Nm  $\pm$  50 Nm (236 ft-lb  $\pm$  37 ft-lb).

Ensure the distance between 1 and 2 is a minimum of 0.5 mm (0.2 in).

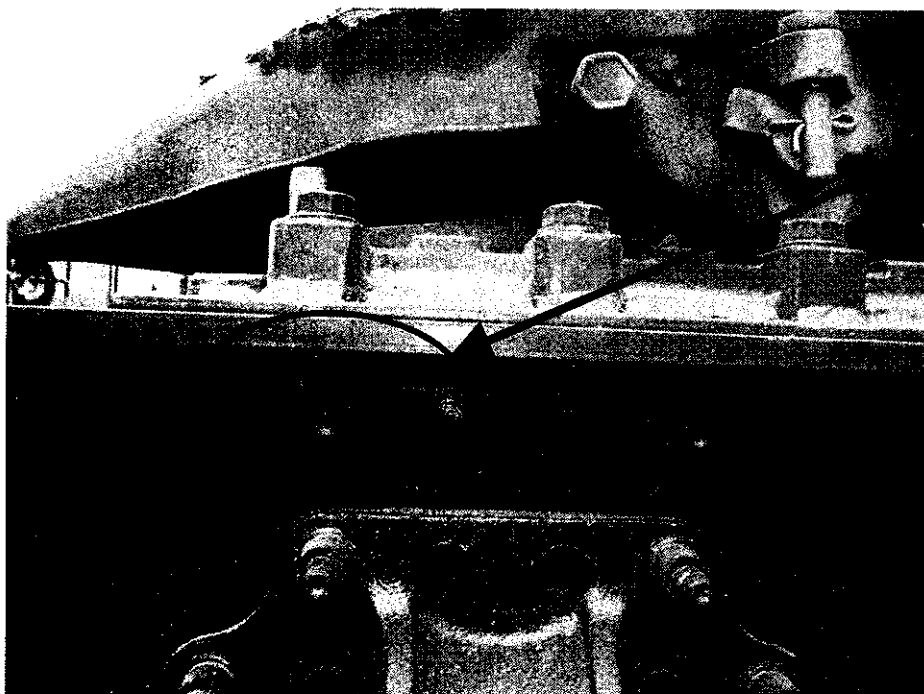
Any contact between these mounting bolts may cause bolted joint failures in the field.

Bolt  
interference.

The 5<sup>th</sup> wheel mounting bolts must be inspected at the factory on all tractors to ensure that there is no such contact.

Minimum clearance between bolts must be 0.5mm. [2]
