**National Highway
Traffic Safety
Administration**

Subject: FINAL REPORT: PE10-038 "BMW Mini Cooper Electric
Power Steering"

Date: 4/11/2011

**Memorandum Report
PE10-038
BMW Mini Cooper Electric Power Steering**

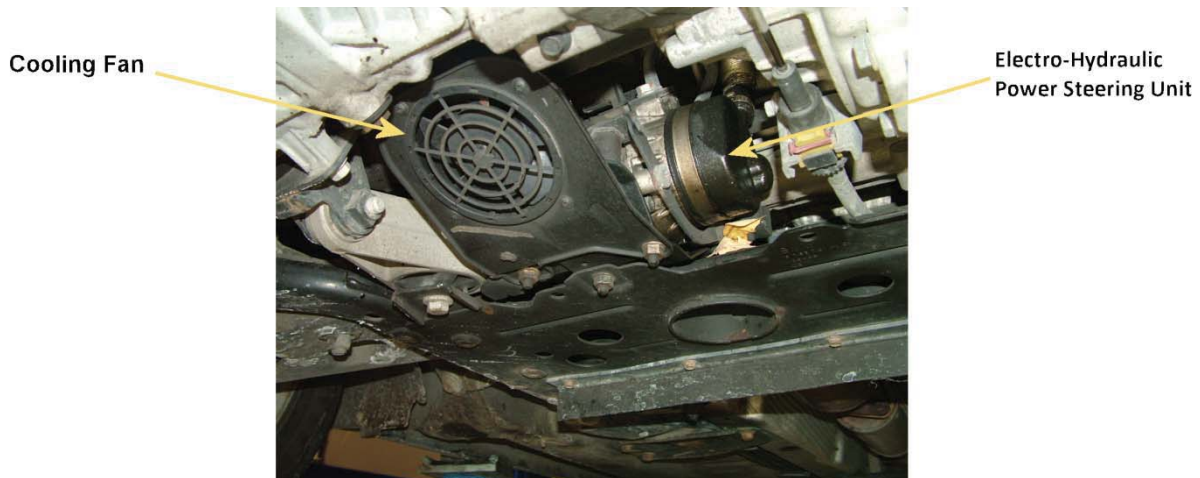
**Figure 1
Power Steering Unit and Cooling Fan Mounted in Vehicle**

Subject vehicles for this program are equipped with an electro-hydraulic power steering system (EHPS). Rather than having a conventional hydraulic power steering pump that is driven by a belt from the vehicle's engine, this system utilizes an electric motor to drive the hydraulic power steering pump. The motor, pump, and an electronic control unit, (ECU) that controls the operation of the electric motor, are all in one unit that is mounted low in the engine compartment, between the engine and the firewall. A small cooling fan is utilized to draw air from underneath the vehicle and blow it across the EHPS unit to help cool it. Figure 1 shows the EHPS unit and the cooling fan mounted in the vehicle.

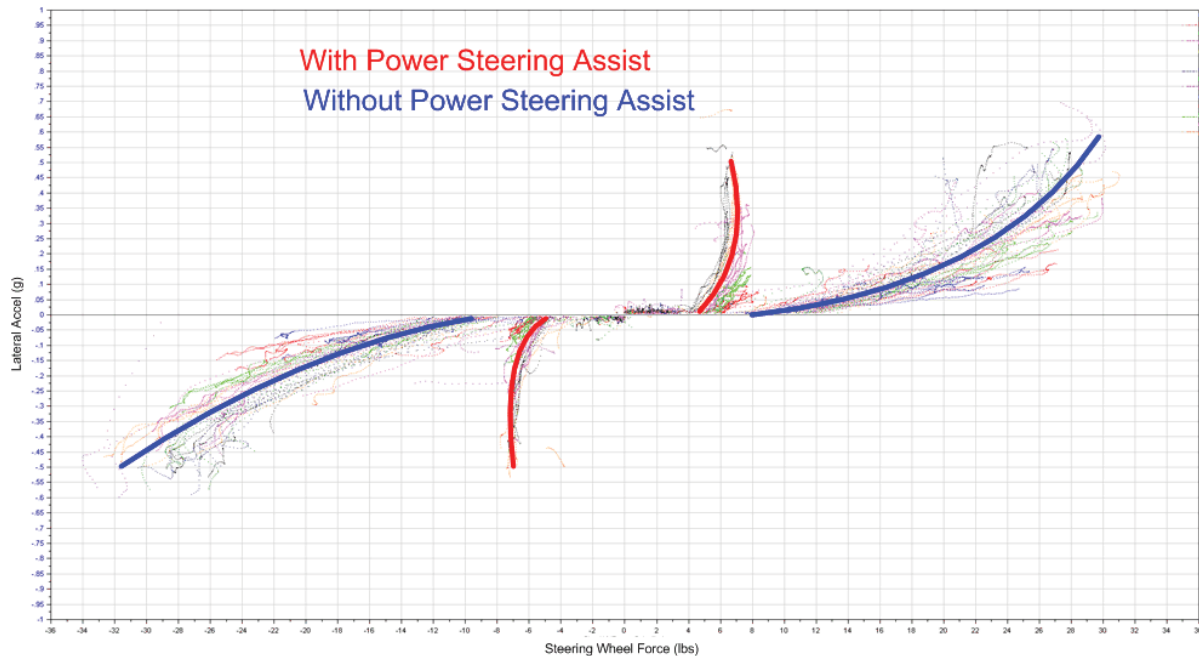
Figure 3
Lateral Acceleration vs. Assisted and Unassisted Steering Effort

Figure 3 shows the lateral acceleration vs. steering wheel force data for all testing and highlights the difference in required force between assisted and non-assisted steering effort. The blue line represents average unassisted steering effort while the red line represents average assisted steering effort.

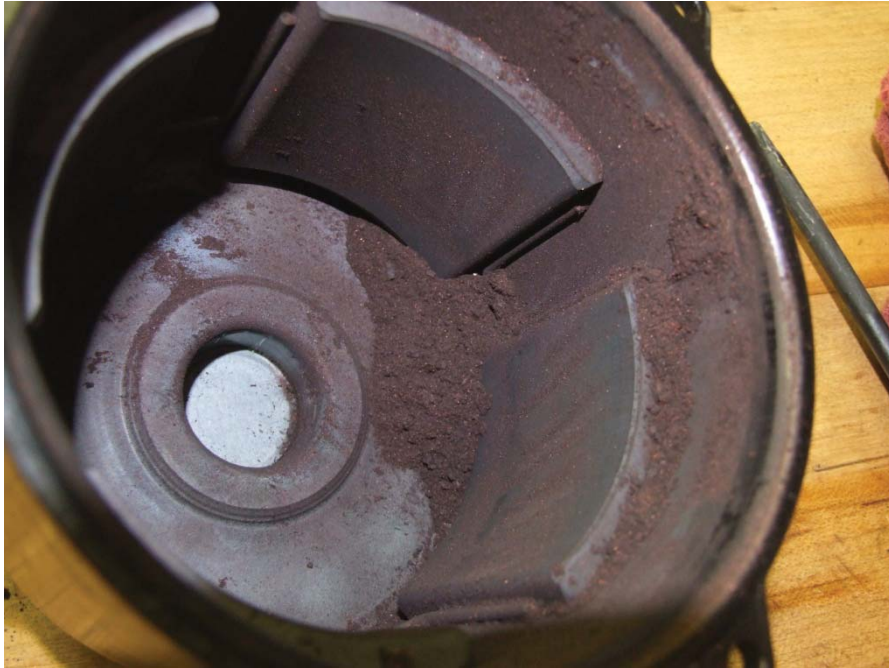
Figure 4
Dust in Motor after Disassembly

- 1) Disassembly of the EHPS motor showed that a significant amount of fine, black powder and dust were present in the motor. This material was found in the motor can, within the armature windings, and on the brush plate. Because there was no visible corrosion anywhere inside the motor, it was thought that the powder/dust was likely carbon brush material since it was electrically conductive.

Figure 4 shows a portion of the dust and powder found within the motor after disassembly. Figure 5 shows the armature and electrical connections. Figure 6 shows the brush plate and additional dust from inside the motor. Figure 7 shows the condition of the armature and the commutator.
