# Memorandum

Subject: Test Request: Evaluation of Driver Air bag  
Inadvertent Deployment Date: JAN 25 2010

From: Kathleen C. DeMeter, Director  
Office of Defects Investigation Reply to: NVS-212pco  
Attn of: EA10-001

**BACKGROUND:** ODI is conducting an Engineering Analysis (EA10-001) on Ford F-150 vehicles. The alleged defect is defined as driver side frontal air bag inadvertent deployment (ABID). This non-crash air bag deployment condition is due to a chafed wire resulting in a short-to-ground condition during initial engine start-up/restraint system diagnostic testing. Attachment 1 illustrates the source and location of the chafed/cut clockspring jumper wire. The air bag light (ABL) may illuminate (intermittently or constant ON) prior to this event. MY2004-2006 (to Jan 23, 2006) Ford F-150 vehicles are affected by this condition. Since these vehicles are now out-of-warranty, many owners may be operating their vehicles with the ABL illuminated or had experienced an inadvertent driver air bag deployment and have not repaired their vehicles.

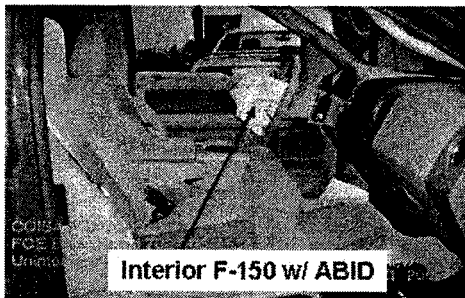
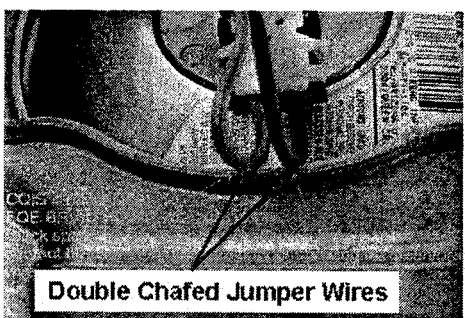
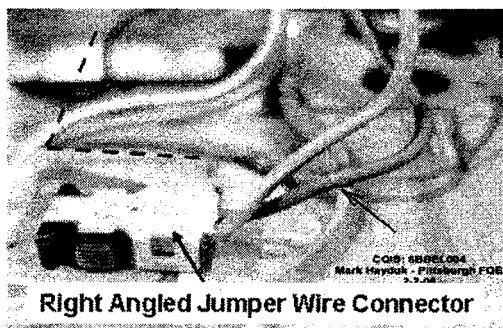
Attachment 1 Location of Chafed Wire after Air Bag/Horn Assembly Removal

# Clockspring Wire Chafed/Cut Condition
