#### 01 10 11 June 8, 2010 2023624

#### MIL ON, No Start or Rough Running (DTC P0087 - Rail Fuel Pressure Too Low)

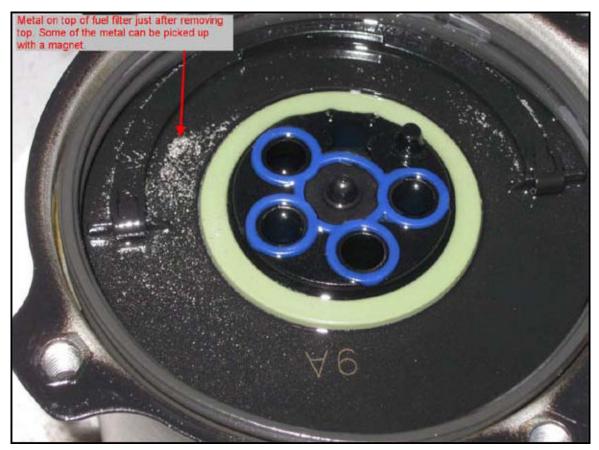
Figure 1. Example of metal shavings and debris in fuel filter housing

• Inspect the fuel filter housing. If there is any indication of fuel contamination, metal shavings/debris (figure 1), or rust inside the fuel filter housing (figure 2), call the Technical Assistance Center (TAC) and open a ticket before attempting any repair.

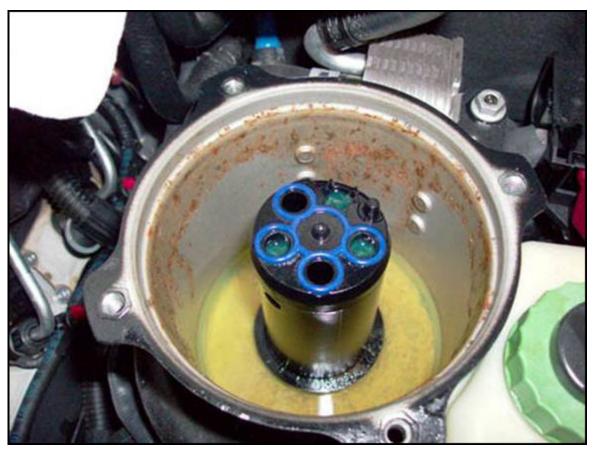
Figure 2. Example of rust in fuel system.

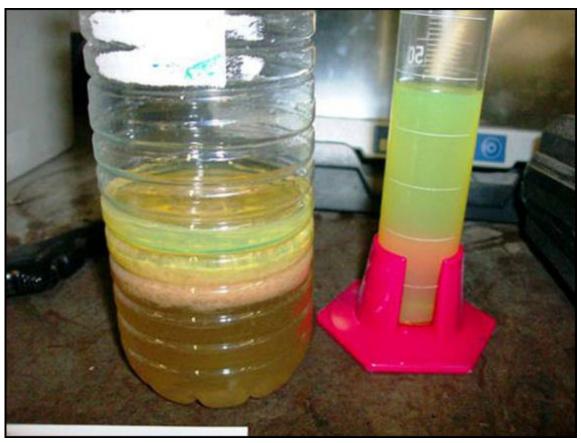
Figure 3. Fuel in the left container is contaminated.

• Take a sample of fuel from the filter housing and place it in a clear container (figure 3). Wait for the fuel to settle and take notice of any separation of fluids or debris/sludge within the fuel.

If there is any evidence of fuel contamination, request that the customer produce any possible record of their last fuel purchase.
