# ODI RESUME

**Investigation:** EA 11-007  
**Prompted by:** VOQ 10357608 & 10357609  
**Date Opened:** 05/27/2011  
**Investigator:** Tom Bowman  
**Approver:** Frank Borris  
**Subject:** Wheel Separations (Broken Studs)  
**Date Closed:** 07/16/2012  
**Reviewer:** Bruce York-B

**Closing Report – EA11-007  
(Formerly PE10-040)**

**Risk of Wheel Separation Due to Wheel Mounting Stud Fractures  
Caused by Diminished Clamp in Model Year 2009, 2010, and 2011  
DRV (formerly DoubleTree RV) Recreational Vehicles**

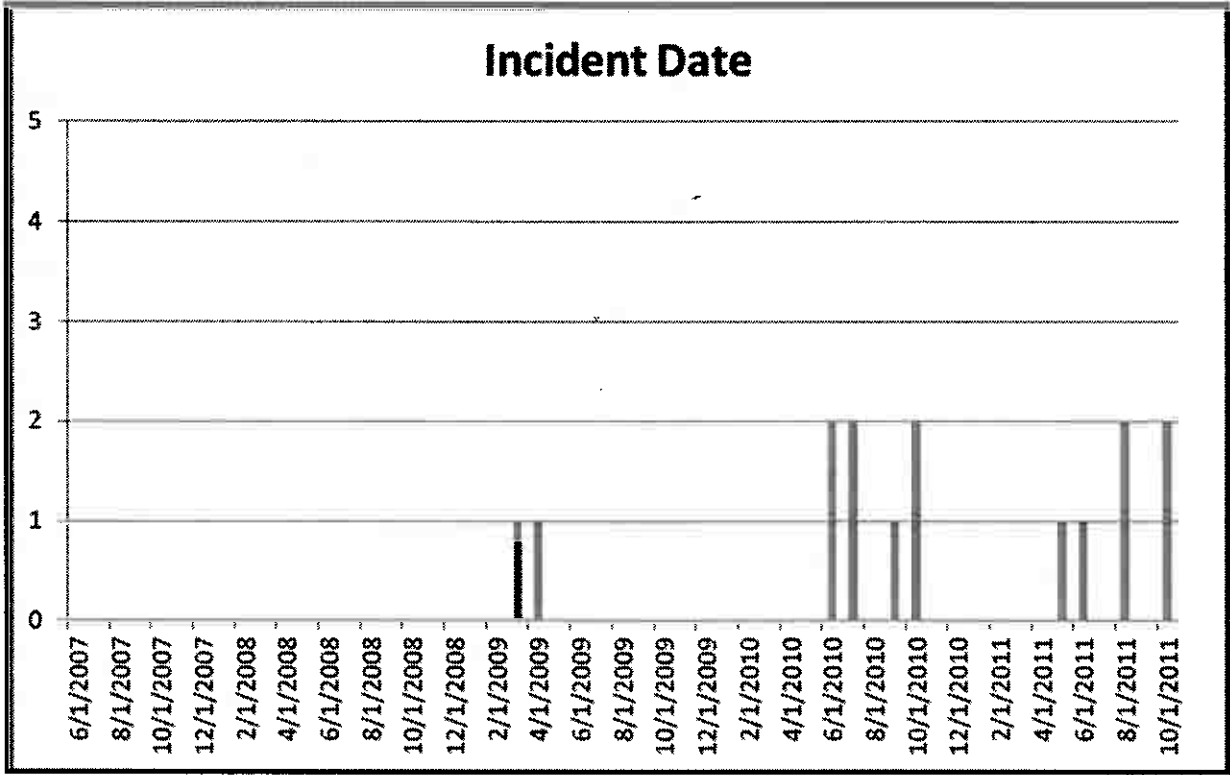
Chart 1 (below) depicts the known partial or complete separation by incident date.

The incident data depicted consists of (a) the five incidents identified at the initiation of PE10-040 in October 2010; (b) incidents numbered 11 and 13 which had occurred prior to October, 2010, but had not been reported to DRV / ODI until after these owners became aware of DRV's investigation activity through the DRV advisory letters prompting the affected owners to report their earlier-occurring incidents; and (c) incidents that occurred during the investigation.

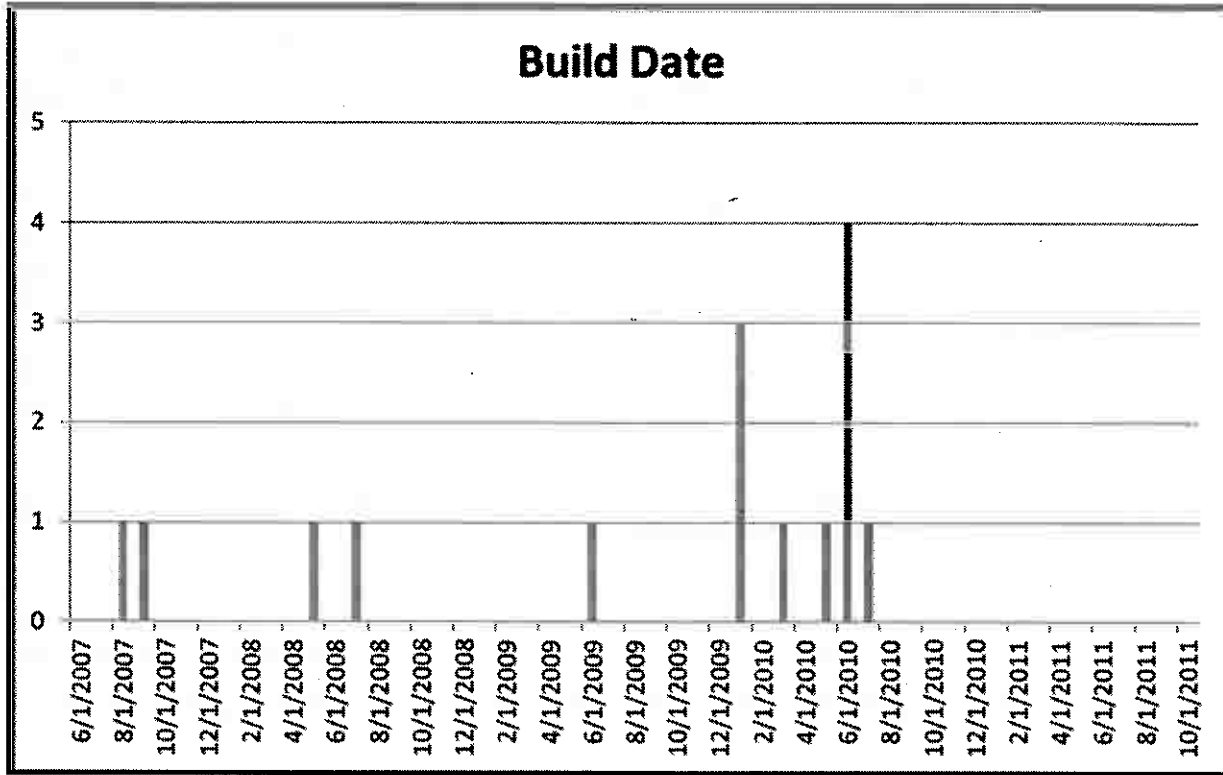
Chart 2 (below) depicts the known partial or complete wheel separations by vehicle build date.

As can be seen in Chart 2 above, there have been no reported complaints pertaining to vehicles manufactured after October, 2010, the general time period that corresponds to the initiation of PE10-040 and in the approximate time period of the paint removal procedure (January 2011) summarized in Section 7, "Product Changes" above.

The absence of post-October 2010 complaints supports the suspicion that excess paint in the hub and wheel clamp face has been a pertinent contributor to wheel clamp loss and subsequent wheel separation incidents.

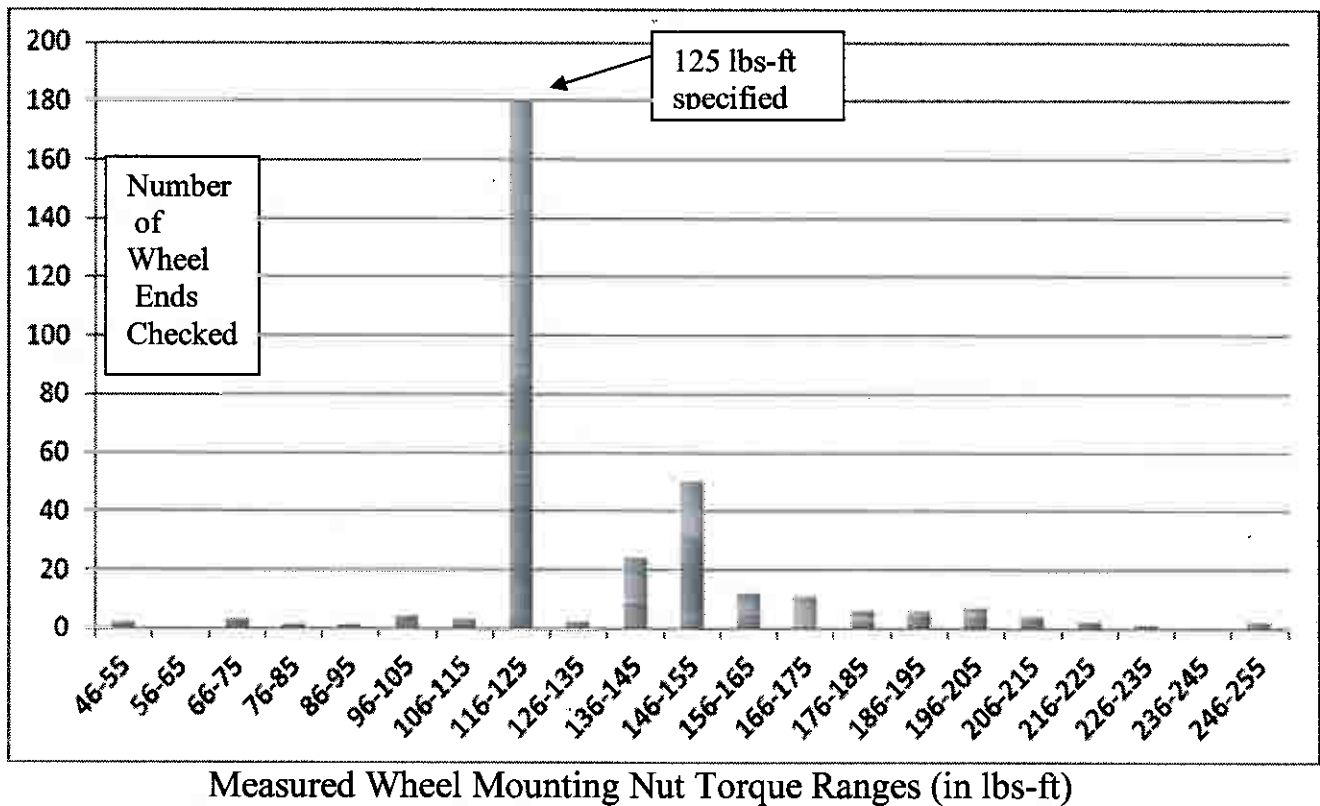
Summary of In-service Wheel Nut Torque Audit - 10 Vehicles Equipped with 16" Wheels (9/16" stud)

13 wheel end nuts (4%) were measured at less than 115 lb-ft.

125 wheel end nuts (39%) were measured at more than 135 lb-ft.

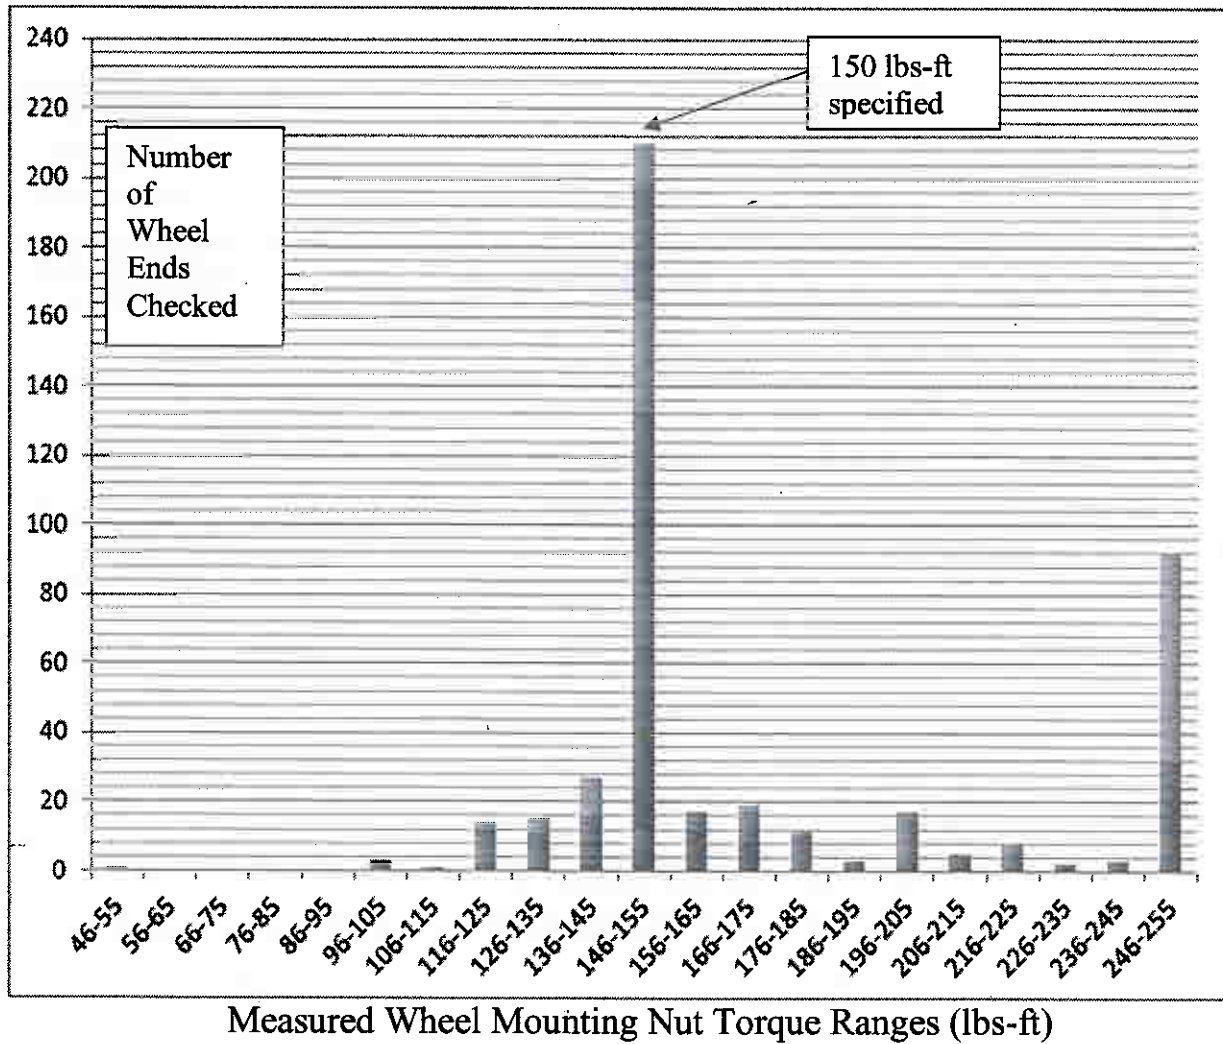
Summary of In-service Wheel Nut Torque Audit – 14 Vehicles Equipped with 17-1/2" Wheels (5/8" stud)

33 wheel end nuts (7%) were measured at less than 135 lb-ft.

161 wheel end nuts (36%) were measured at more than 165 lb-ft.
