## ENGINEERING ANALYSIS CLOSING REPORT

**SUBJECT:** High-pressure fuel pump (HPFP) failure resulting in engine stall while driving.

**EA No.:** EA11-003

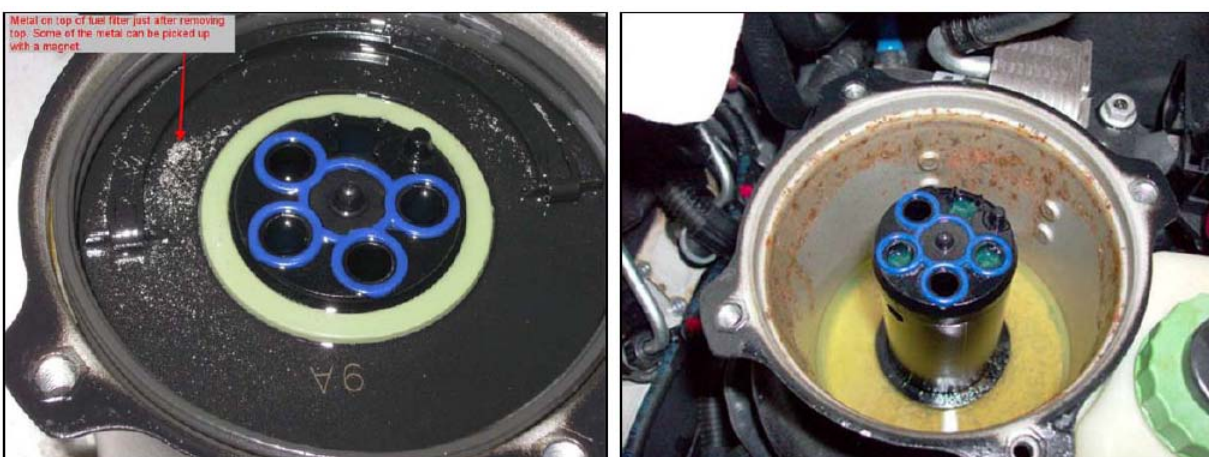
The bulletins listed multiple symptoms associated with contaminated or incorrect fuel, including malfunction indicator lamp (MIL) illumination, diagnostic trouble code P0087 (Rail fuel pressure too low), excess “rattling” noise from the engine (“diesel clatter”), no start or hard starting, loss of power while driving, and rust or metal debris found in the fuel system (Figure 4).

Figure 4. Examples of metal debris (left) and rust (right) in fuel filter housing inspection provided in Volkswagen and Audi service bulletins.

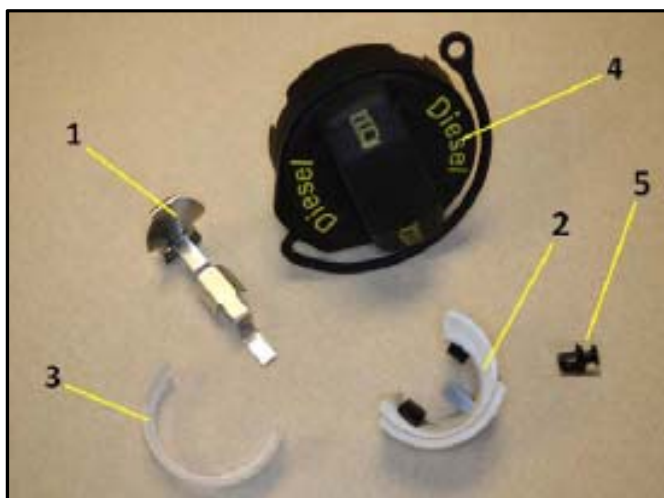
Figure 6a. Service Action Campaign kit: 1–Spring loaded flap insert, 2–Fuel filler lockout mechanism, 3–Plastic retaining ring, 4–Replacement fuel cap with tether, and 5–Mounting pin for fuel cap tether.

**Misfuel Guard campaign.** About 10 months later, on May 21, 2013, Volkswagen launched Service Action Campaigns 20T8 (Volkswagen Jetta and Golf) and 20U3 (Audi A3) to contact owners and provide free installation of misfuel guard devices in the filler necks of subject vehicles with the 2.0L engines (Figures 6a and 6b). The vehicles with 3.0L engines were not included in the campaign because the Audi Q7 vehicles already had misfuel protection devices in the original vehicle design and the filler neck of the Volkswagen Touareg vehicles would not accommodate the addition of a misfuel guard device.

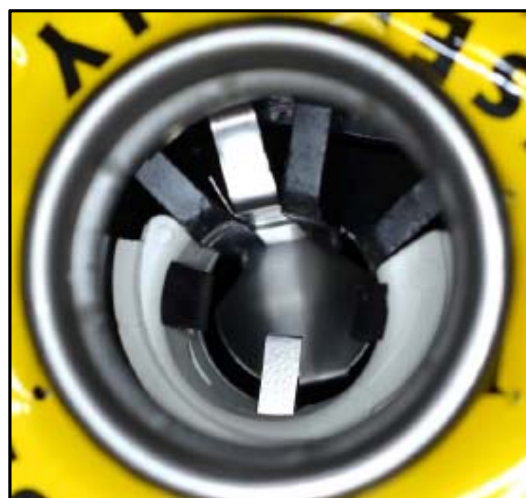
Figure 6b. Campaign kit installed in filler neck.

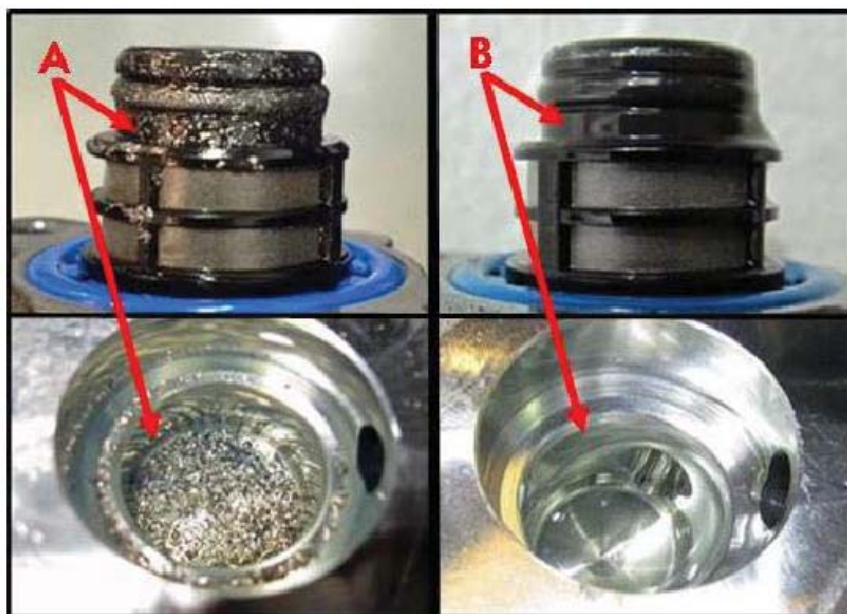
**Metering valve inspection bulletins.** In an effort to reduce unnecessary pump replacements, in March 2014 Volkswagen issued Technical Service Bulletins 2036656 (Volkswagen) and 2036668 (Audi) to change the requirements for replacing the HPFP when diagnosing driveability or engine stall complaints involving symptoms of MIL “on,” rough running, no start or fuel rail pressure diagnostic trouble codes (DTC P0087 – Fuel Rail/System Pressure- Too Low, DTC P0088 – Fuel Rail/System Pressure – Too High, or DTC P0191 – Fuel Rail Pressure Sensor “A” Circuit Range/Performance).. The bulletin eliminates the requirement to replace the pump following removal of the N290 metering valve to inspect for metal particles/debris if the inspection results are negative (Figure 7).

**Figure 7. Fuel metering valve and valve bore with metal particles (A); and without metal particles (B).**

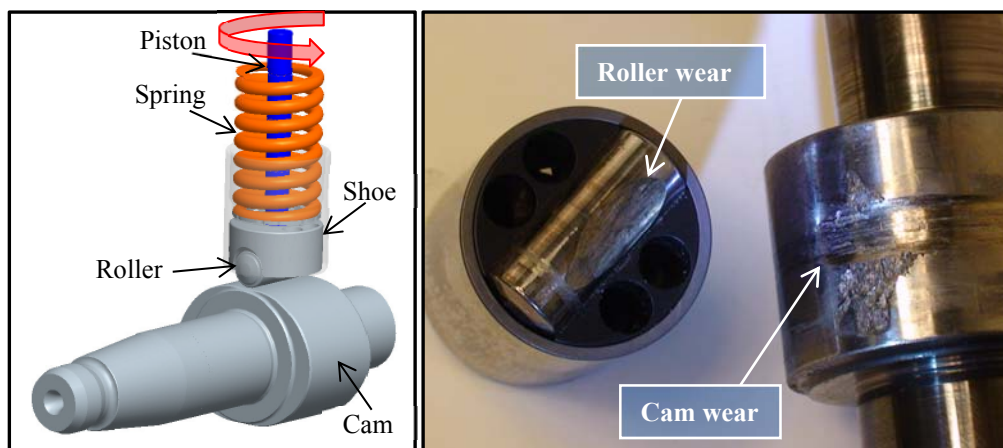
According to Volkswagen, drivetrain wear results in gradual reductions in fuel pressure due to decreased pump plunger displacement. In addition, as wear progresses metal is abraded from drivetrain surfaces forming small flakes that are circulated throughout the fuel system. Particles caught in the metering unit strainer cause a pressure drop, which results in a fault code and warning light. Volkswagen states that the rate of wear "depends on the properties of fuel being used as well as pump load conditions." Several of the pump failures in parts returned to ODI, or documented during inspections by Bosch or by some consumers, displayed failures caused by rollers rotating 90 degrees relative to the cam, resulting in a distinct abrasive wear pattern in the center of the cam. Figure 8 shows the Bosch self-stabilizing design and drivetrain damage resulting from roller rotation in an ODI complaint vehicle that reported experiencing a sudden decrease in engine power resulting in speed dropping from 70 mph to 50 mph, as the vehicle entered limp mode less than a minute after the engine light and then glow plug lamp illuminated (VOQ 10354434).

**Figure 8. Bosch self-stabilizing roller (left). Roller and cam damage resulting from rotation of the roller; MY 2009 Jetta, RP0 pump, 06/08 vehicle build (right).**

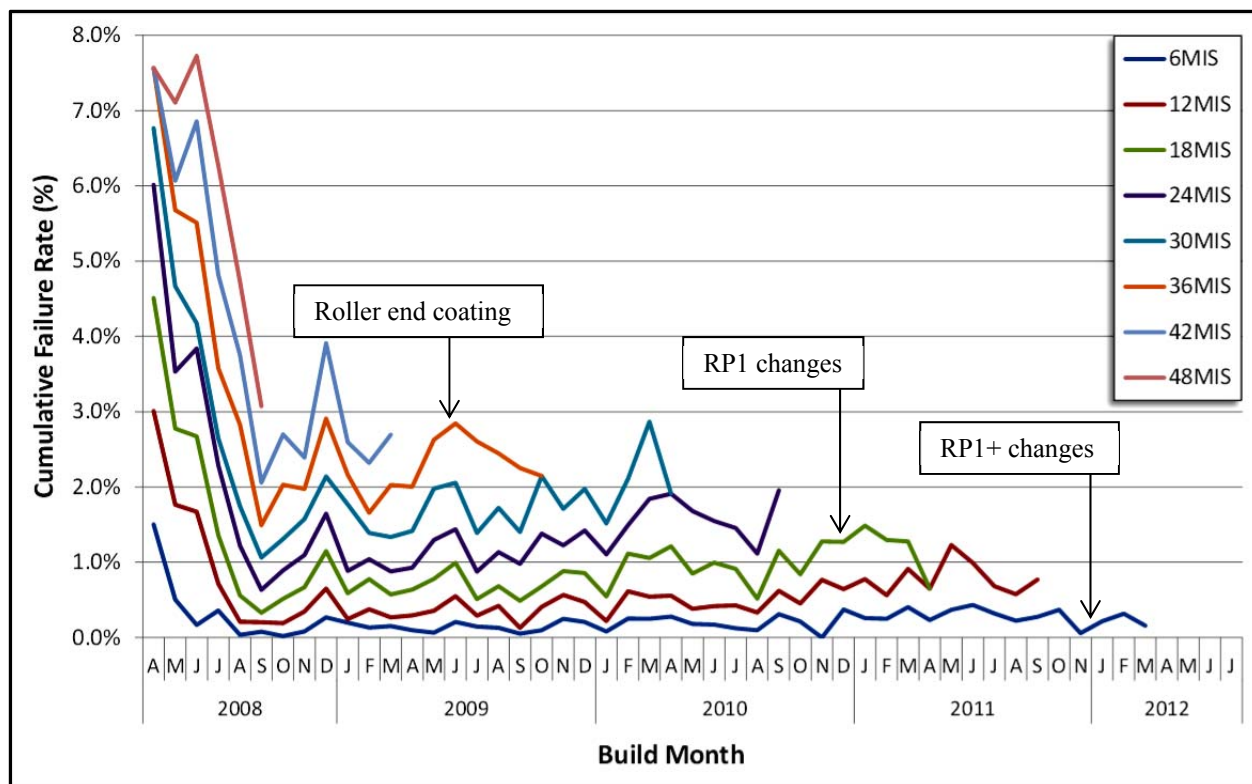
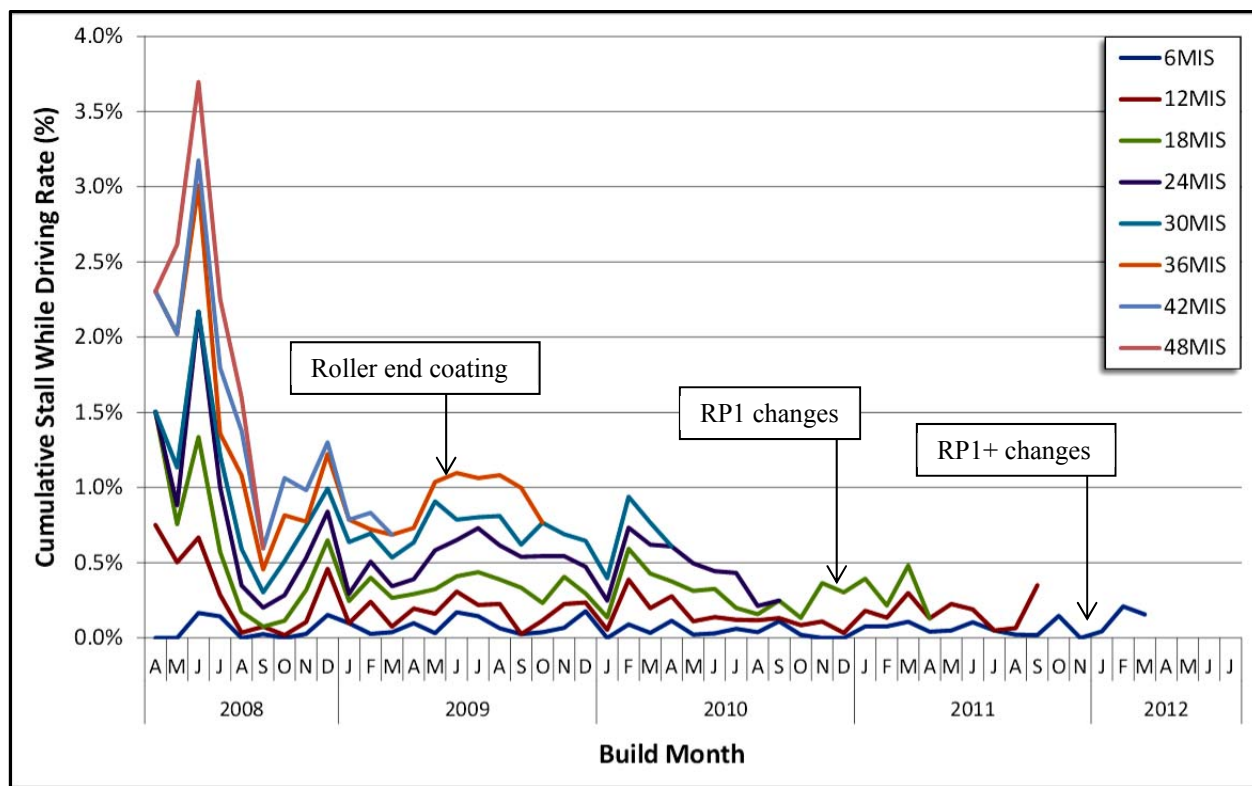
Analysis of HPFP drivetrain failures and related stalls by month of production shows elevated rates in the early production ramp-up period for the Jetta vehicles (Figures A5 and A6). No obvious changes in field experience corresponding with drivetrain design changes are evident, although the data was limited for the most recent design release when this data was captured in late 2012.

**Figure A5. Cumulative Failure Rates by Build Month, HPFP Drivetrain Failures, Excluding Known Misfuels (CP4.1 pumps).**

**Figure A6. Cumulative Stall Rates, HPFP Drivetrain Failures, Excluding Known Misfuels (CP4.1 pumps).**

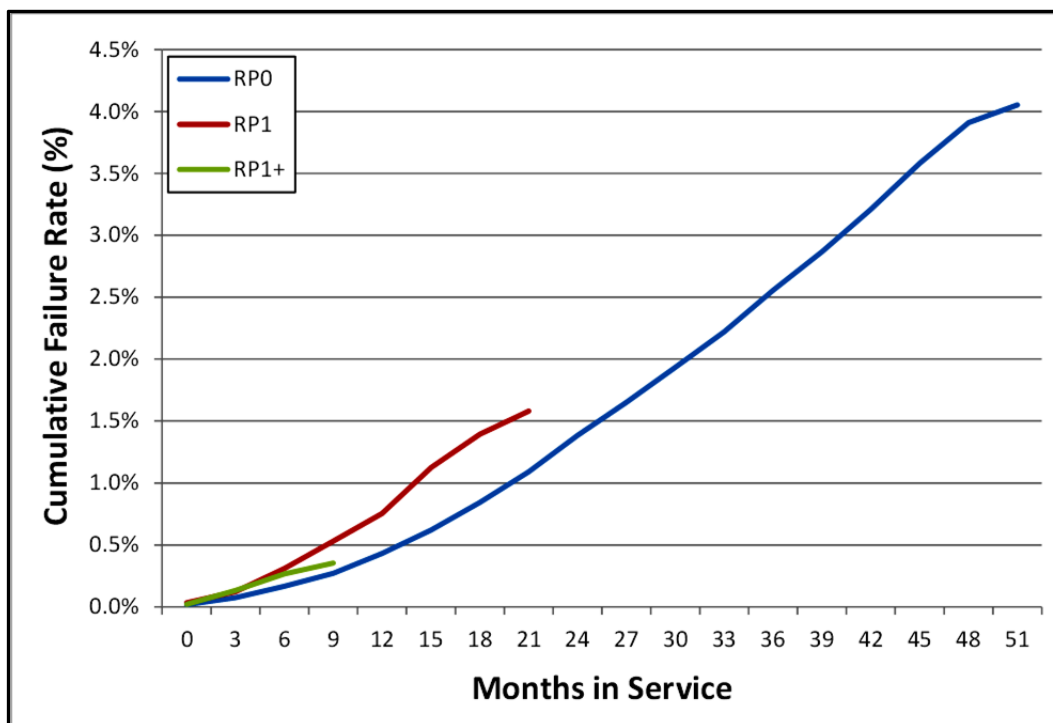
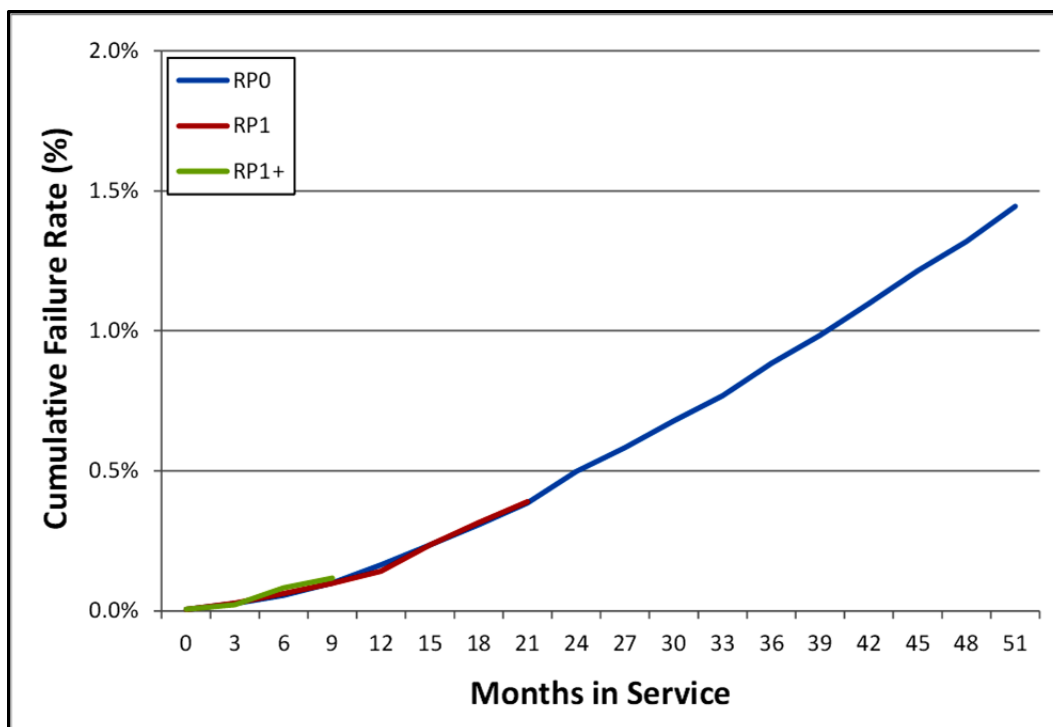
**Design level.** Analysis of HPFP drivetrain failure and related stalling rates by time in service for each of the three design levels for the CP4.2 pumps shows slightly higher rates for the RP1 design for HPFP drivetrain failures (Figure A7), but no significant difference when filtered for engine stall

Figure A7. Cumulative Rates by Months in Service and Design Level, HPFP Drivetrain Failures, Excluding Known Misfuels (CP4.1 pumps).

Figure A8. Cumulative Stall Rates by Months in Service and Design Level, HPFP Drivetrain Failures, Excluding Known Misfuels (CP4.1 pumps).

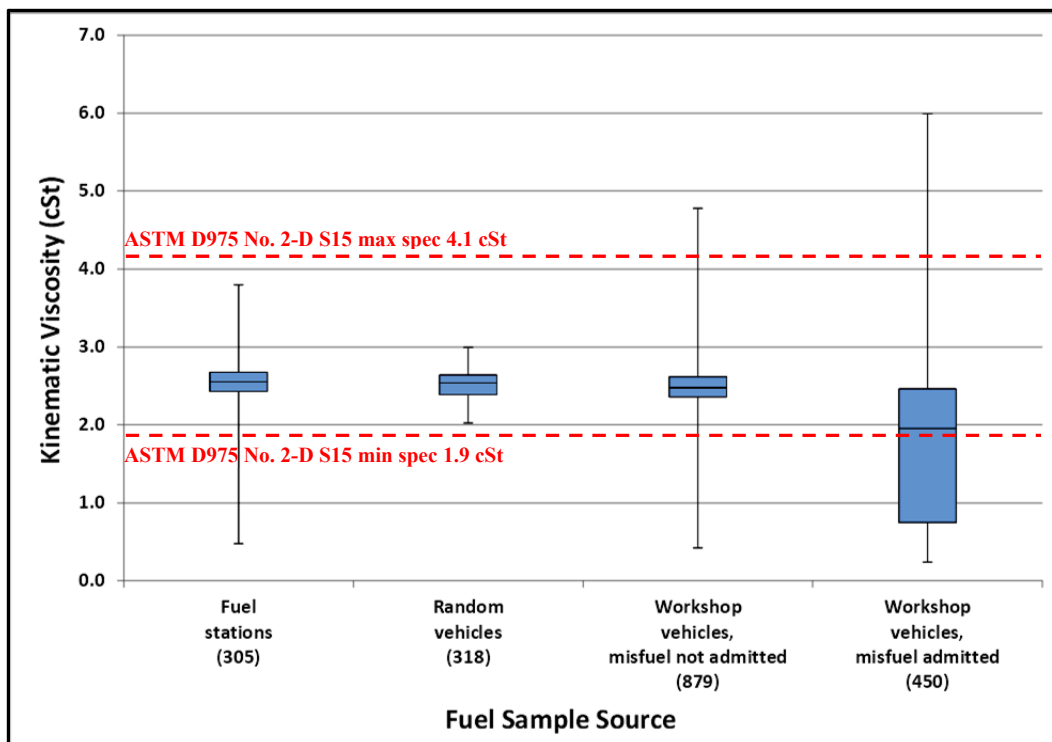
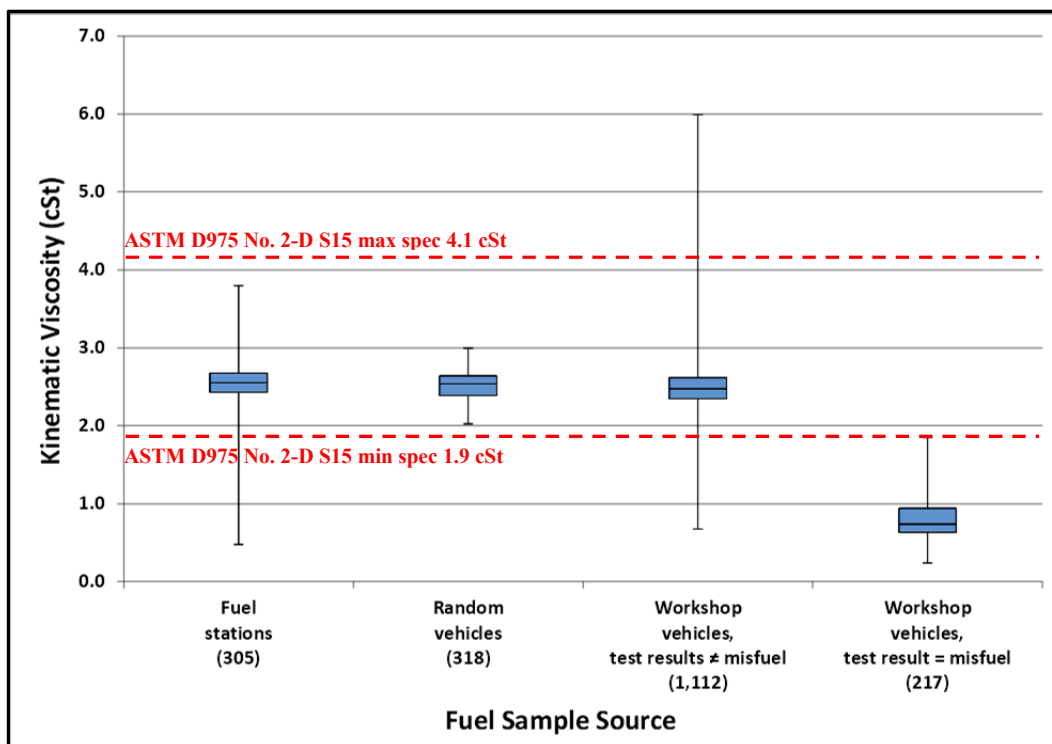
Viscosity test data for vehicles with pumps replaced in Volkswagen's Workshop Program that were not classified as acknowledged misfueling incidents are similar to the data from the two control groups (Table 10 and Figure A9). The results for the vehicles Volkswagen classified as misfuels were significantly different. The results also indicate that many of the vehicles Volkswagen classified as misfuels did not show evidence of gasoline in the test data. The differences between workshop misfuel and non-misfuel data sets are even more evident when the misfuel incidents are determined by fuel test results (Table 10 and Figure A10).

Figure A9. Volkswagen Fuel Viscosity Testing by Sample Group, Workshop Groups Based on Volkswagen Assessment of Complaint & Field Report Records.

Figure A10. Volkswagen Fuel Viscosity Testing by Sample Group, Workshop Groups Based on Test Results (Misfuel determined by: Kinematic Viscosity < 1.9 cSt AND Flash Point ≤ amb temp).

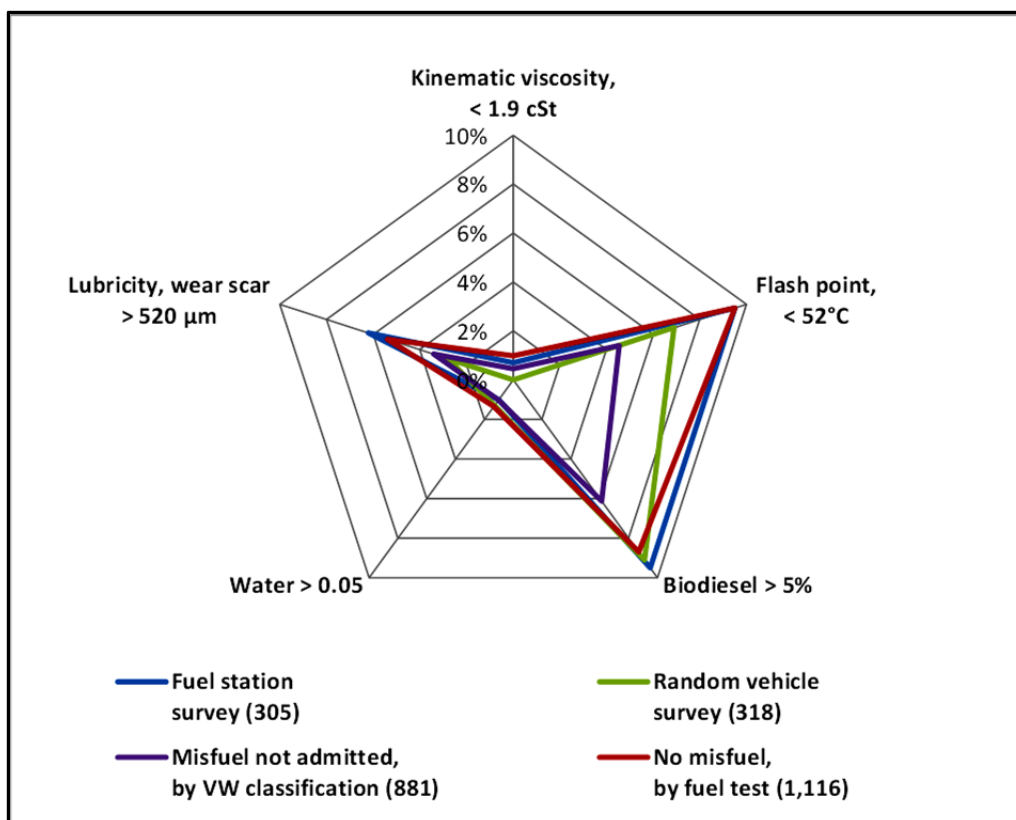
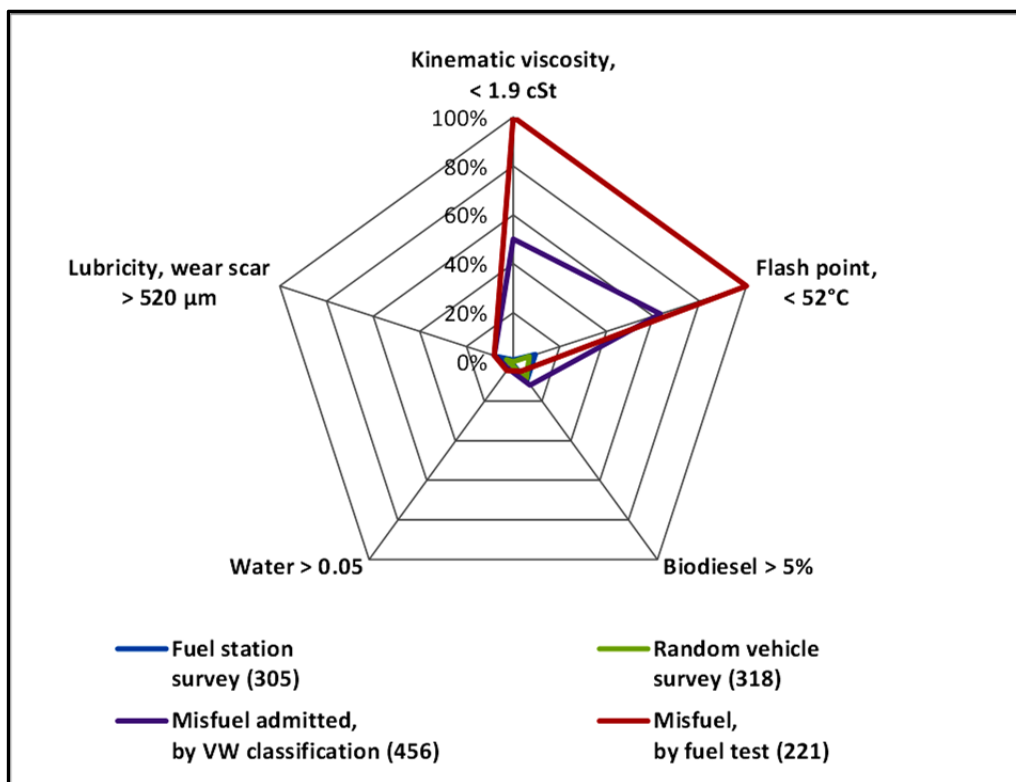
Figures A11 and A12 provide comparisons of the fuel sample groups for other fuel properties of interest, again showing that the workshop vehicles with no indication of misfuel were most similar to the results observed in the fuel station and random vehicle control groups.

Figure A11. Fuel property out-of-specification results (%), control groups vs "no misfuel" groups.

Figure A12. Fuel property out-of-specification results (%), control groups vs misfuel groups.

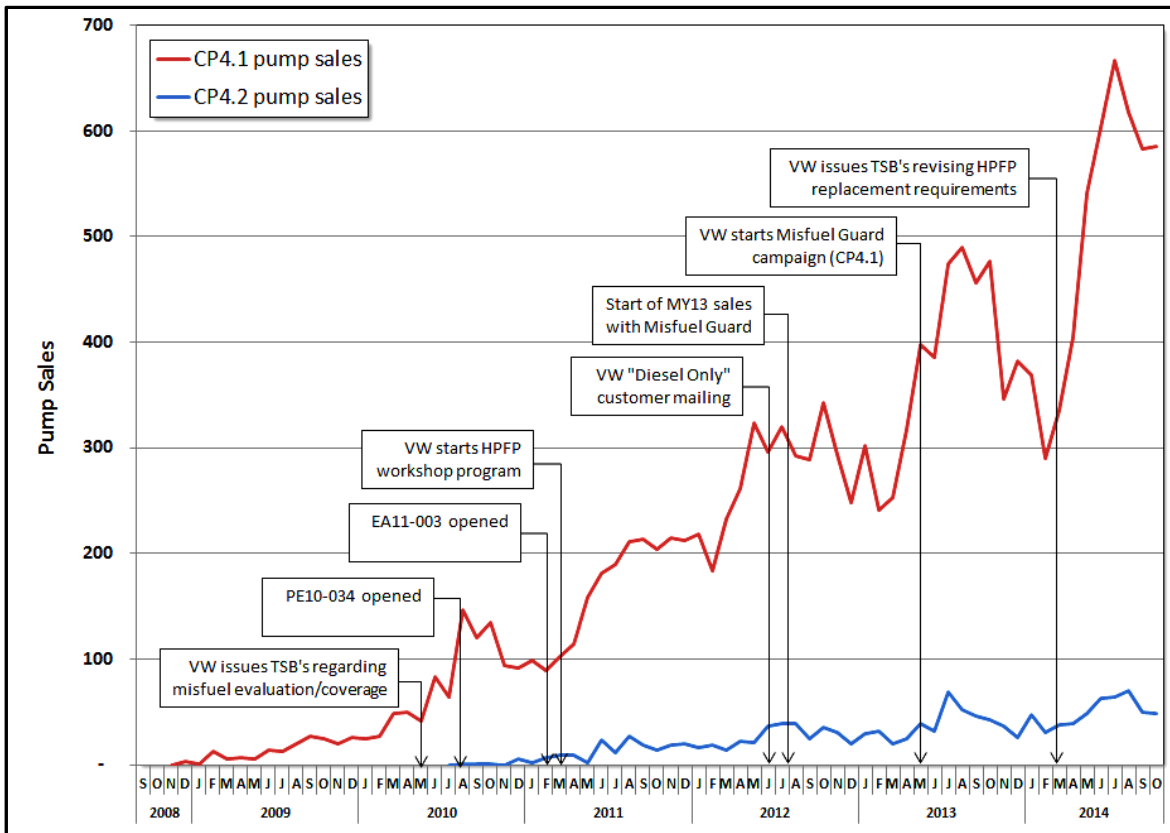
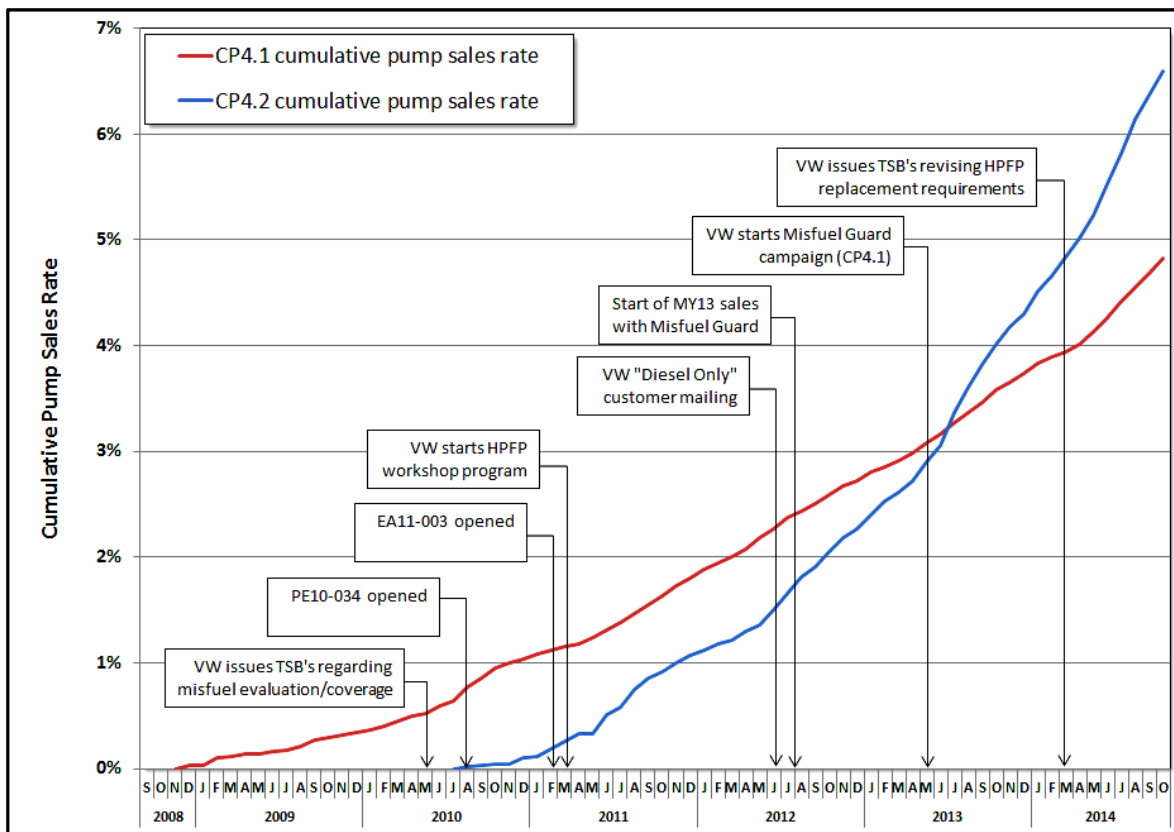
**Part sales.** Analysis of HPFP part sales trends does not appear to show any influence from Volkswagen’s implementation of misfuel prevention devices in production in MY 2013 starting in the summer of 2012, from Volkswagen’s Diesel Only owner advisory program, from the more recent service campaign to add such devices to most of the subject vehicles that were sold without them, or from the revisions to repair procedures in early-2014 that were intended to eliminate the requirement to replacement pumps that were not damaged simply because the metering valve had been removed to inspect for metal particles. The part sales show a seasonal influence with sales increasing in summer months each year and a progressively increasing rate of sales per total vehicles in service (Figures A13 and A14).

Figure A13. Part Sales Trend by Month Sold.

Figure A14. Cumulative Pump Sales Rates by Month  
(Cumulative Pump Sales as Percentage of Cumulative Vehicles Sales).
