Closing Report – EA11-007
(Formerly PE10-040)

Risk of Wheel Separation Due to Wheel Mounting Stud Fractures
Caused by Diminished Clamp in Model Year 2009, 2010, and 2011
DRV (formerly DoubleTree RV) Recreational Vehicles

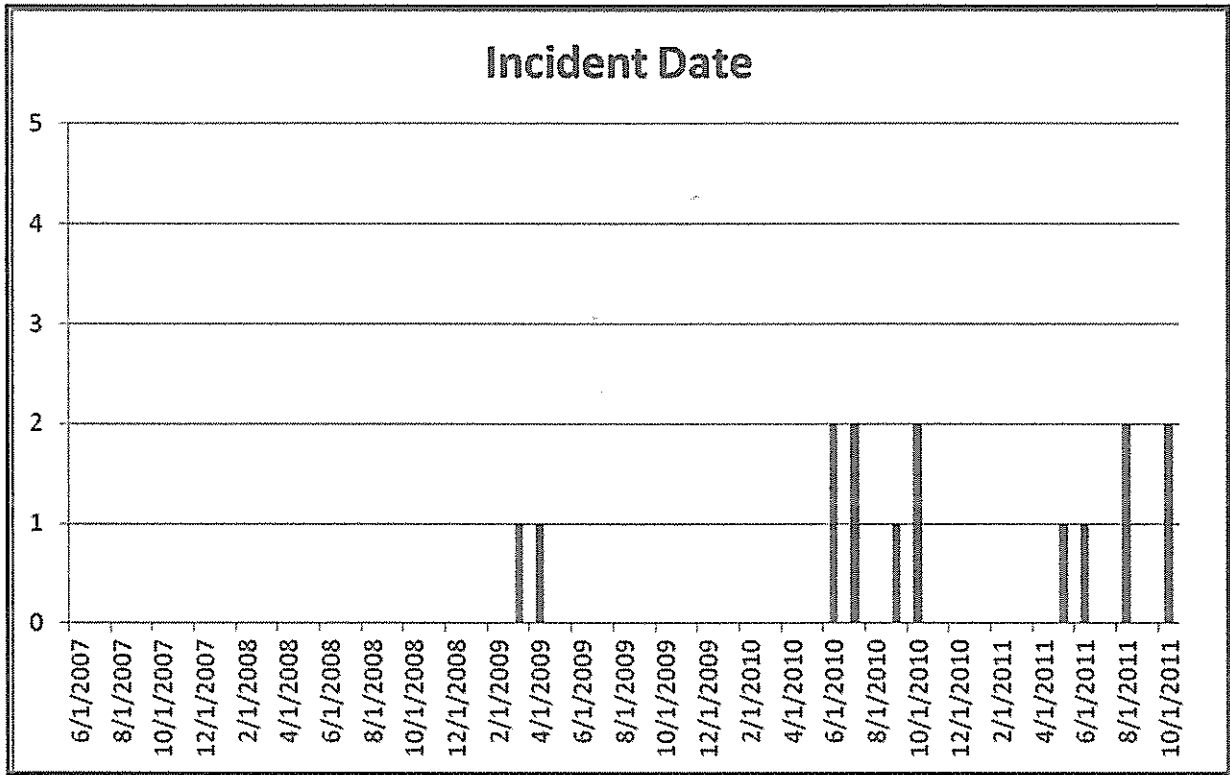
Chart 1 (below) depicts the known partial or complete separation by incident date.

The incident data depicted consists of (a) the five incidents identified at the initiation of PE10-040 in October 2010; (b) incidents numbered 11 and 13 which had occurred prior to October, 2010, but had not been reported to DRV / ODI until after these owners became aware of DRV's investigation activity through the DRV advisory letters prompting the affected owners to report their earlier-occurring incidents; and (c) incidents that occurred during the investigation.

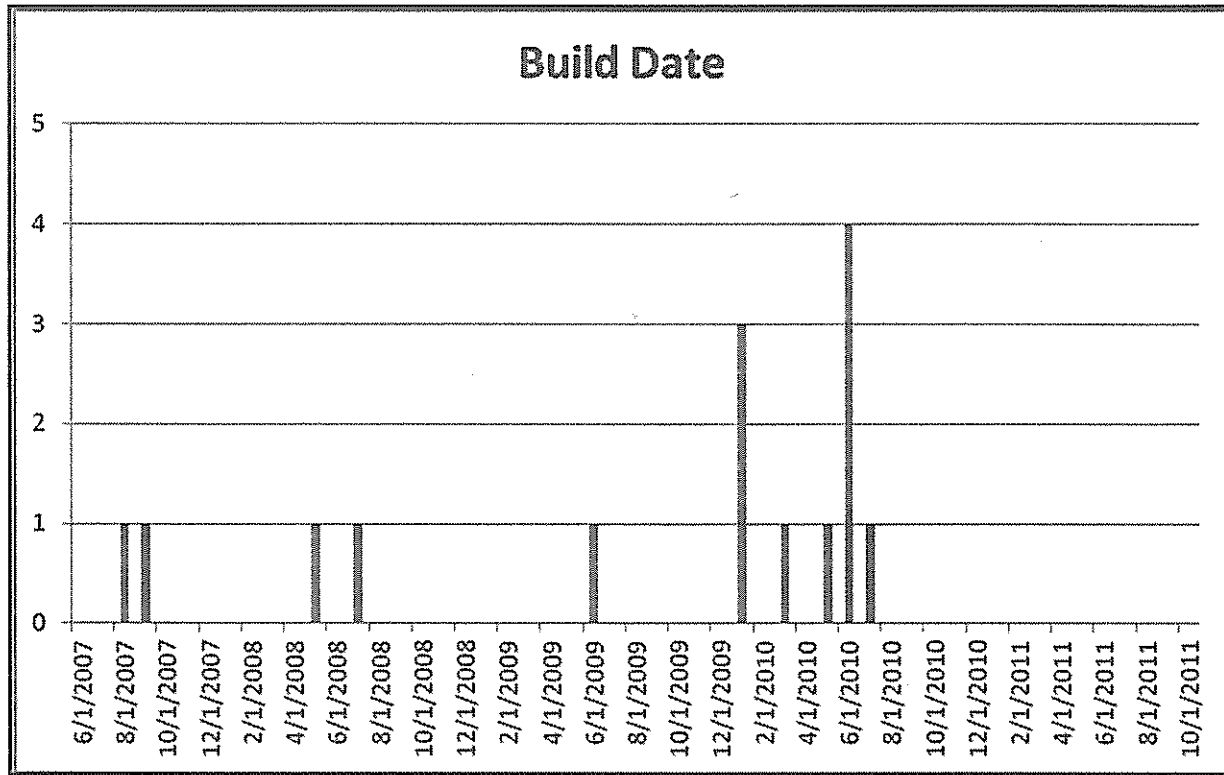
Chart 2 (below) depicts the known partial or complete wheel separations by vehicle build date.

As can be seen in Chart 2 above, there have been no reported complaints pertaining to vehicles manufactured after October, 2010, the general time period that corresponds to the initiation of PE10-040 and in the approximate time period of the paint removal procedure (January 2011) summarized in Section 7, "Product Changes" above.

The absence of post-October 2010 complaints supports the suspicion that excess paint in the hub and wheel clamp face has been a pertinent contributor to wheel clamp loss and subsequent wheel separation incidents.

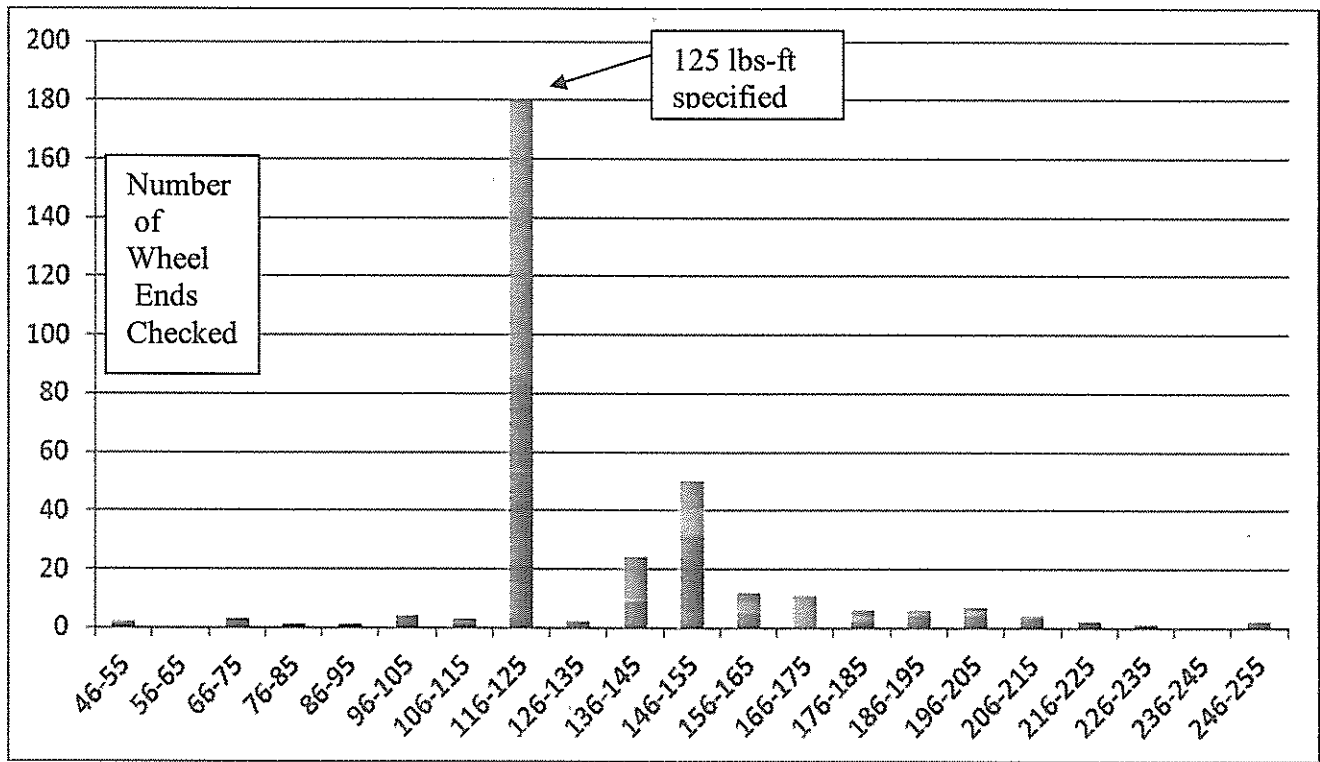
Measured Wheel Mounting Nut Torque

Summary of In-service Wheel Nut Torque Audit - 10 Vehicles Equipped with 16" Wheels (9/16" stud)

13 wheel end nuts (4%) were measured at less than 115 lb-ft.

125 wheel end nuts (39%) were measured at more than 135 lb-ft.

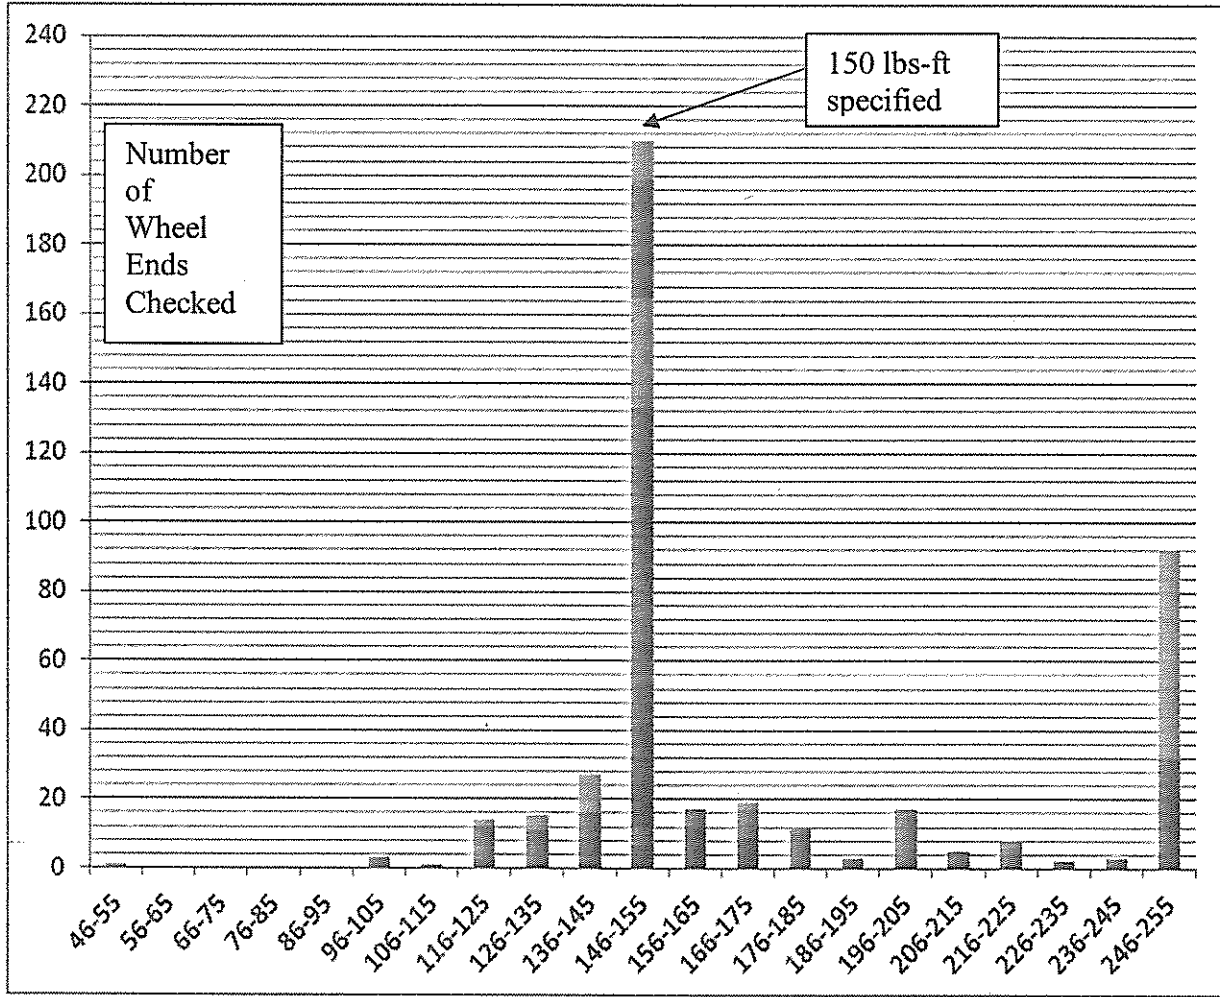
Summary of In-service Wheel Nut Torque Audit – 14 Vehicles Equipped with 17-1/2” Wheels (5/8” stud)

33 wheel end nuts (7%) were measured at less than 135 lb-ft.

161 wheel end nuts (36%) were measured at more than 165 lb-ft.
