Meeting with NHTSA

December 12, 2012

EA11-003 TDI High Pressure Fuel Pump

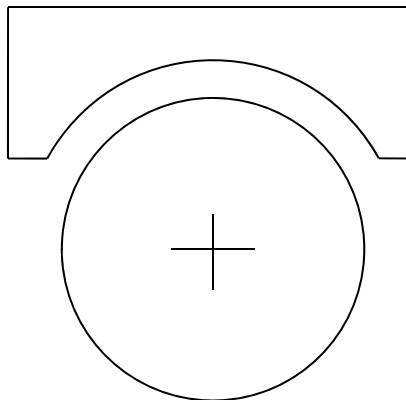
Proper Viscosity
>1.9 cSt

- Proper lubrication
- Proper distance of surfaces

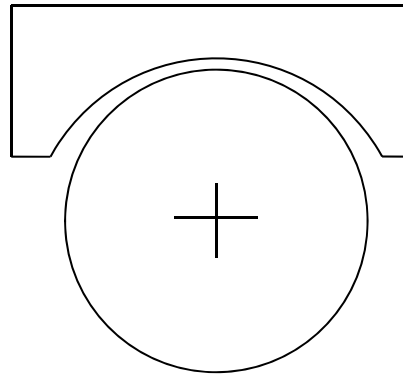
Reduced Viscosity
<1.9 cSt

- Lubrication impaired
- Reduced distance of surfaces

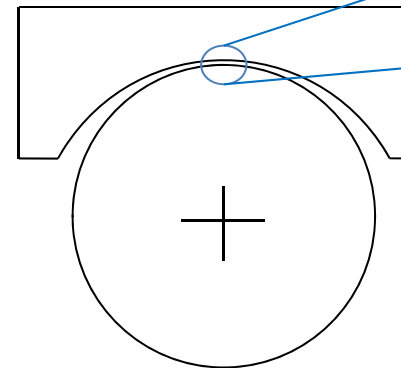
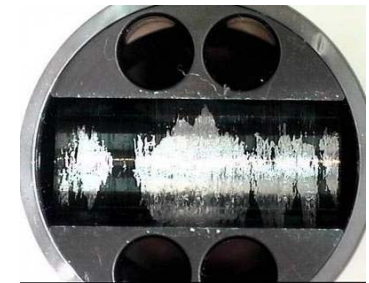
Viscosity too low
<1.5cSt

- Lubrication interrupted / Surfaces in contact
- Mixed friction / Abrasion of coatings

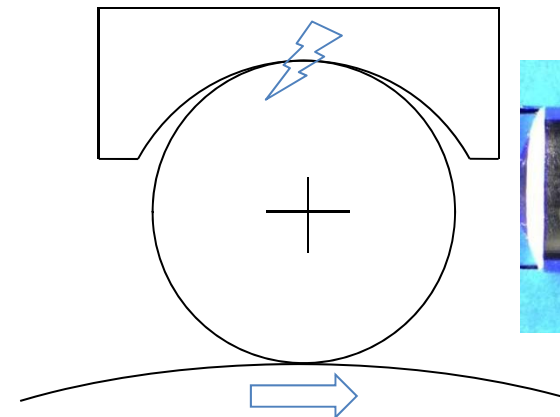
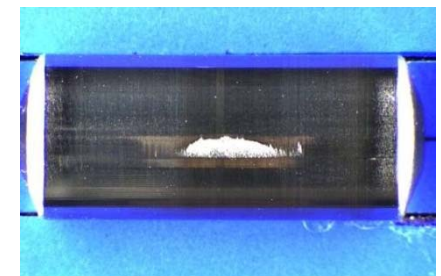
- Roller is stopped and slides on camshaft
- Brake marks / damage to surfaces

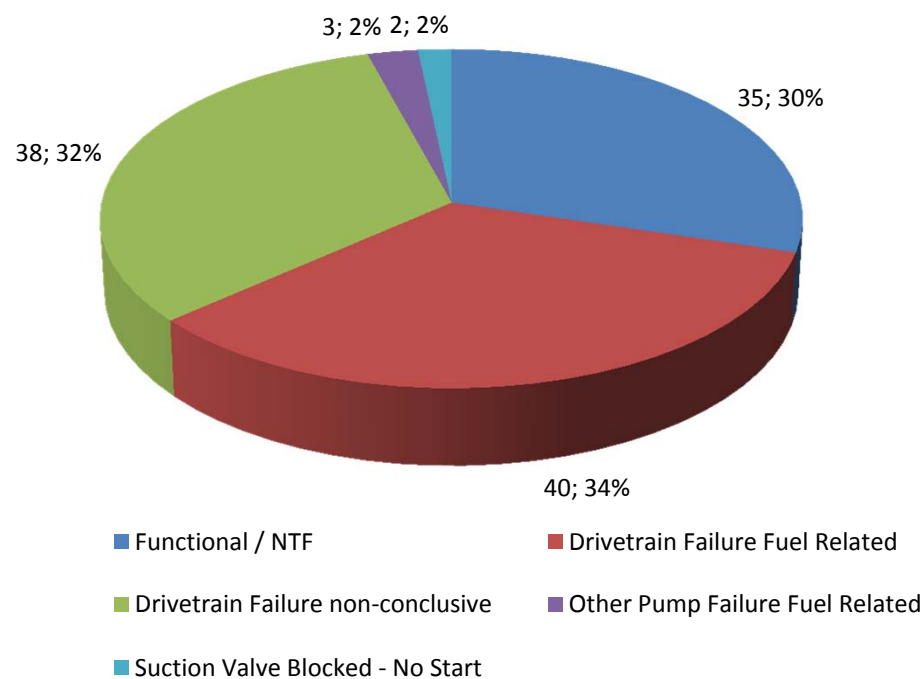
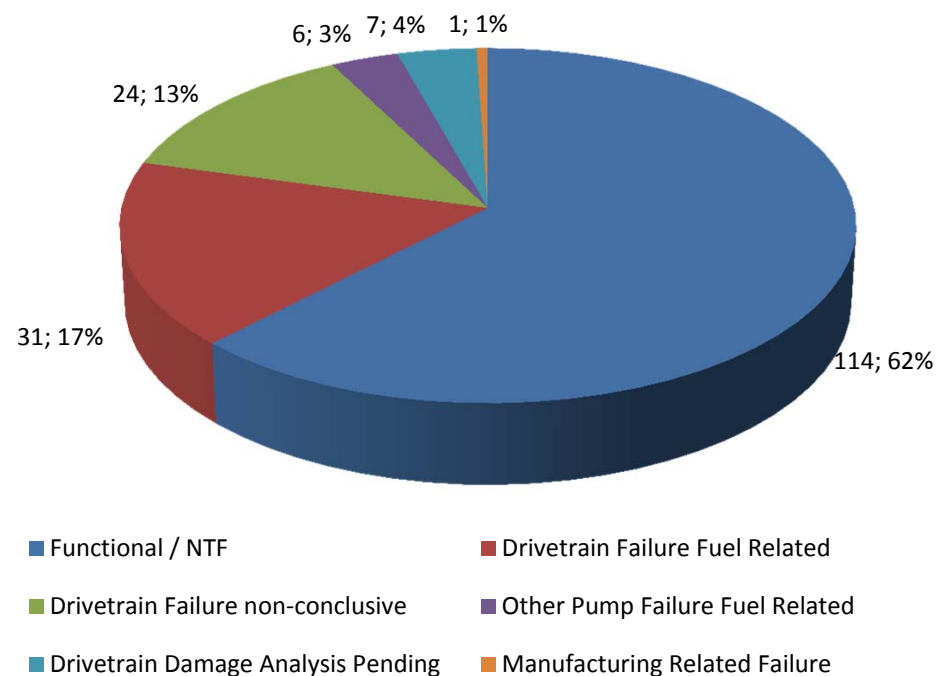
- RP0 HPFP exhibit a damage rate of 2/3 and 1/3 no-trouble-found (NTF)
- RP1/1+ HPFPs show 2/3 of NTF results and 1/3 with damage to the pump.
- The majority (>80%) of the 8D identify either NTF or fuel related failures as cause, while the remainder does not allow a conclusion – but may also be misfuel caused.

- RP1/1+ pumps are more robust against bad fuel and can also tolerate more gasoline than RP0 pumps
- Volkswagen started to collect pumps, when RP1 was in production. This increased the amount of HPFP replacements available for 8D analysis.

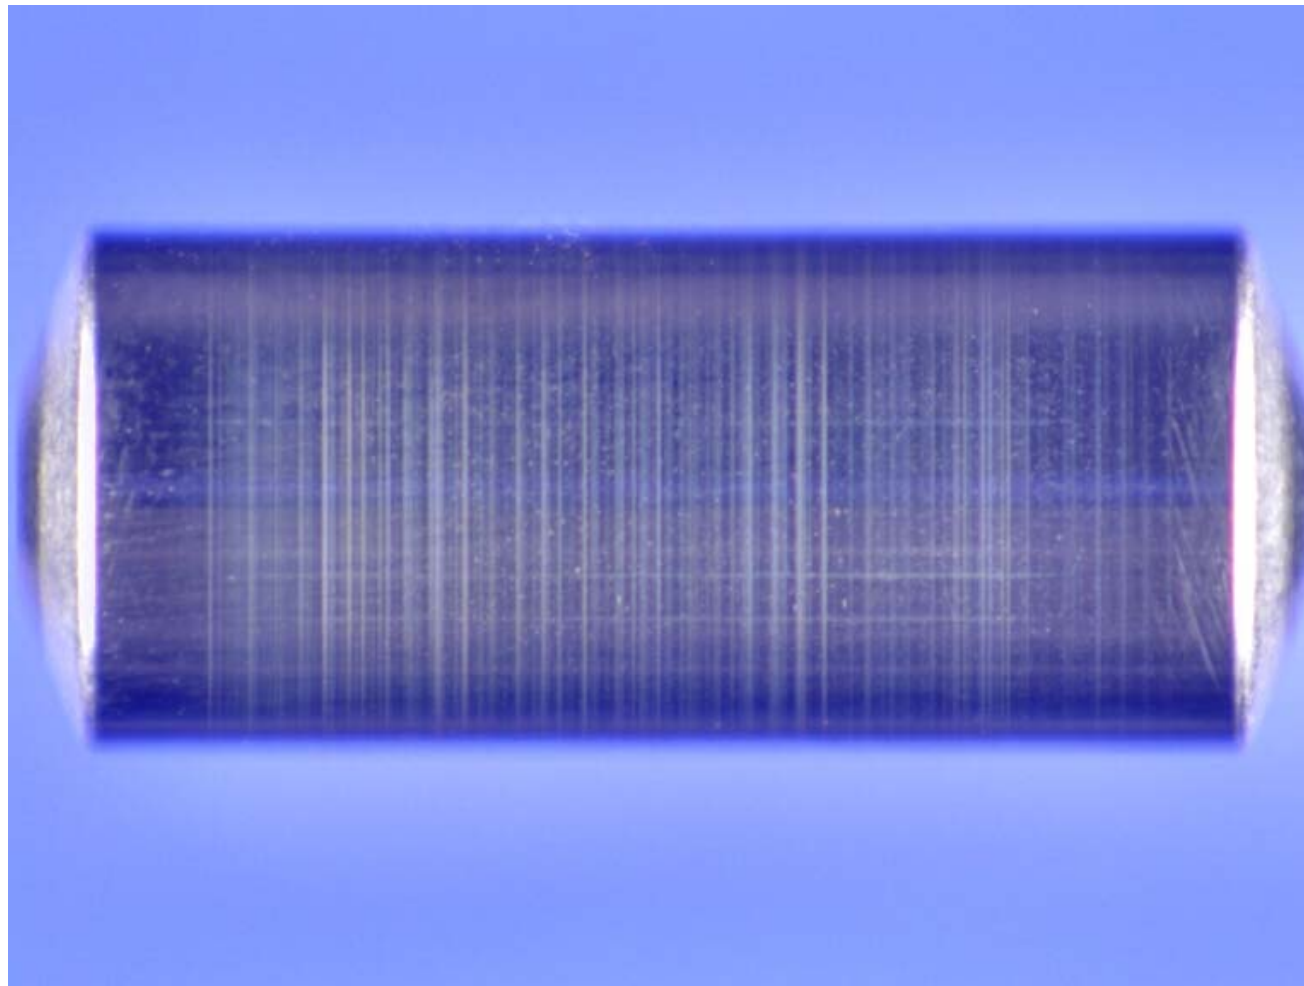
Misfueling Test #1 Misfuel Rate 5%

Non-critical standstill lines detected.

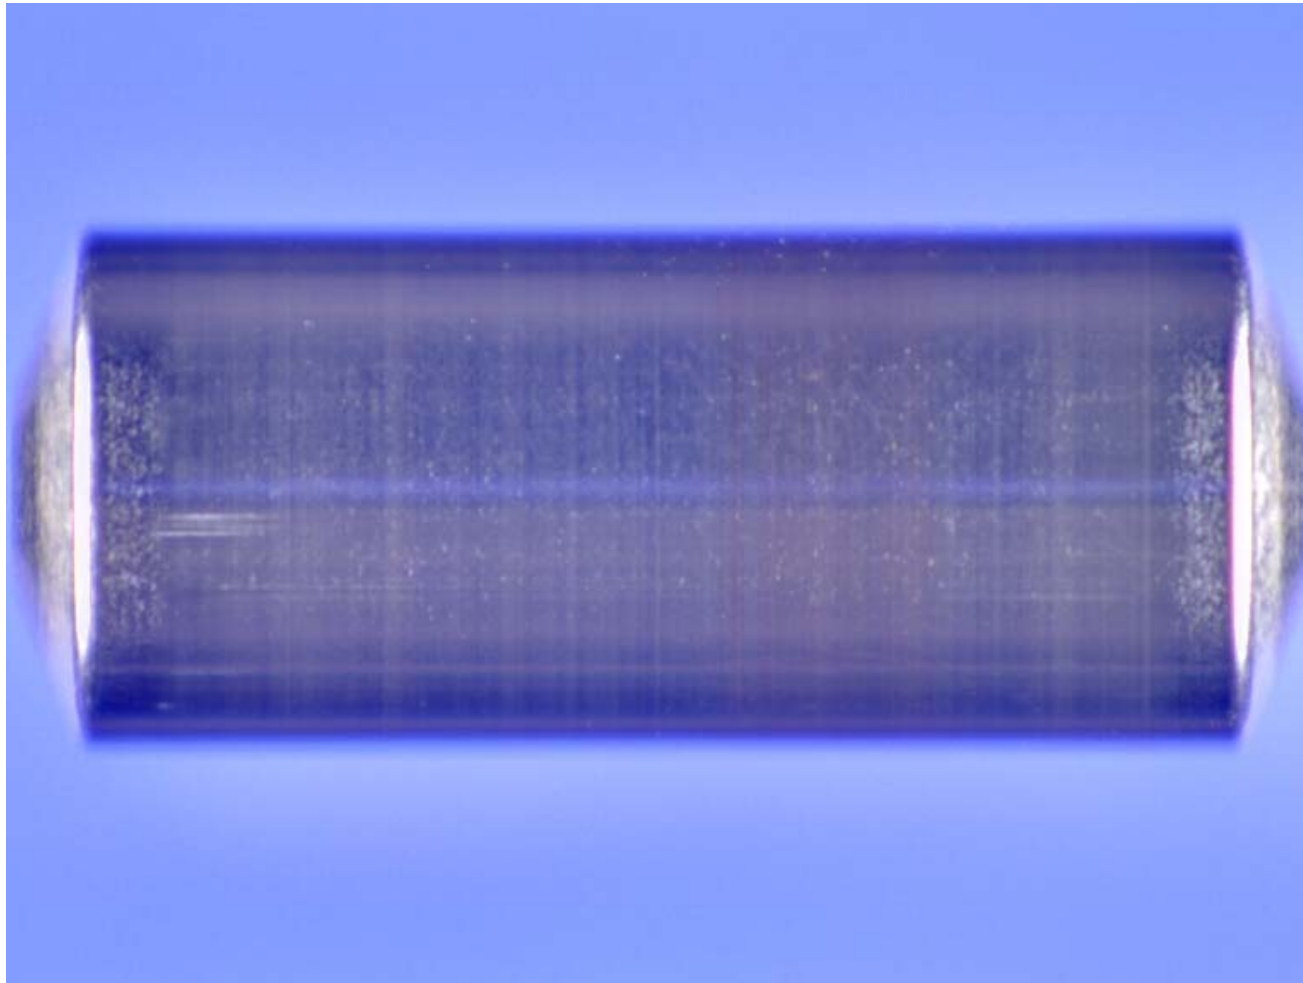
Misfueling Test #2 Misfuel Rate 80%

Non-critical standstill lines detected.

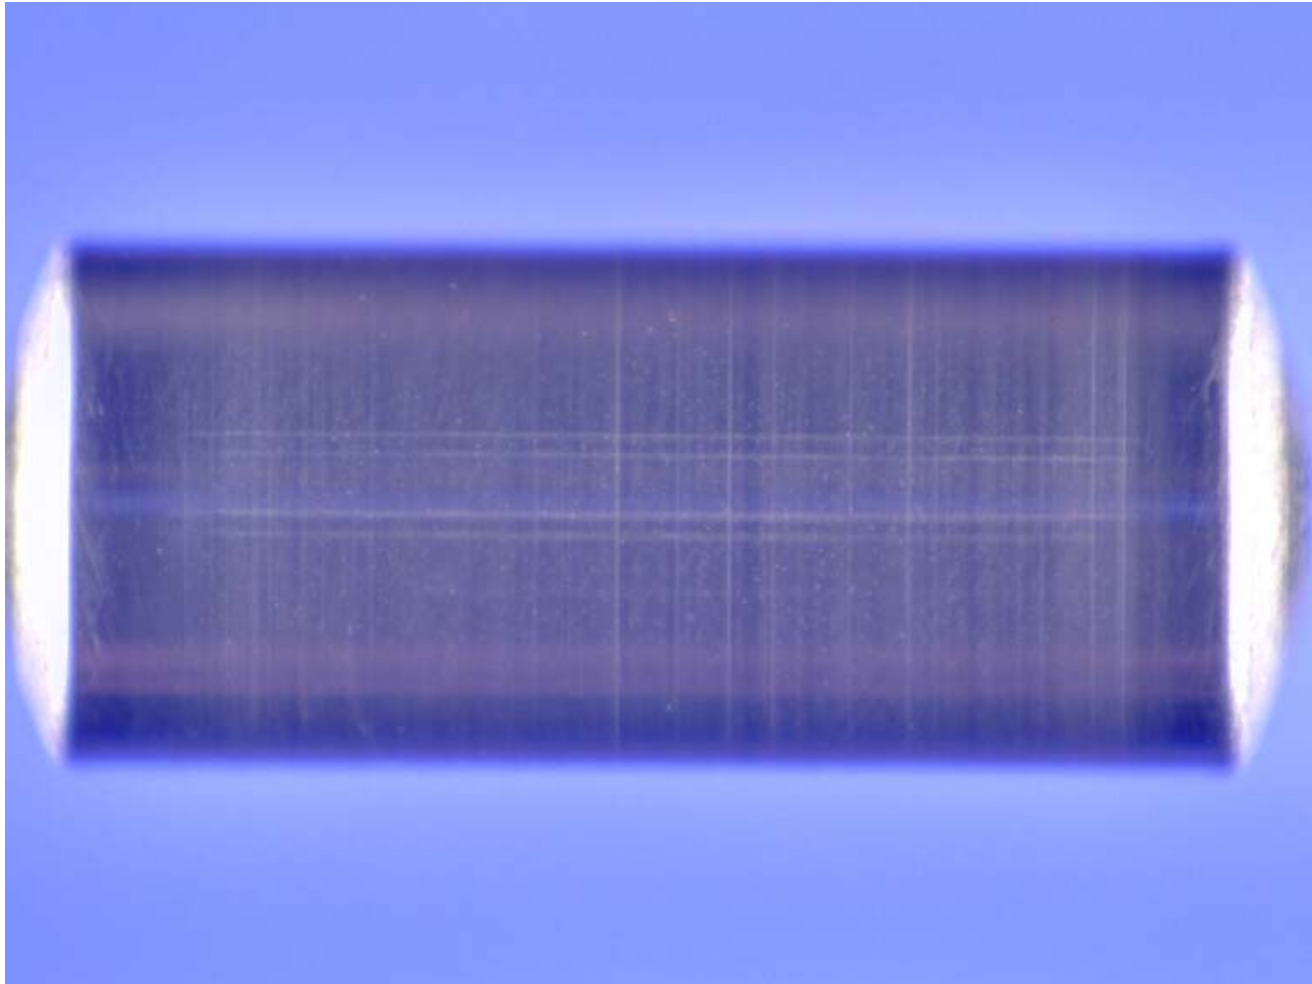
Misfueling Test #3 Misfuel Rate 85%

Non-critical standstill lines detected.

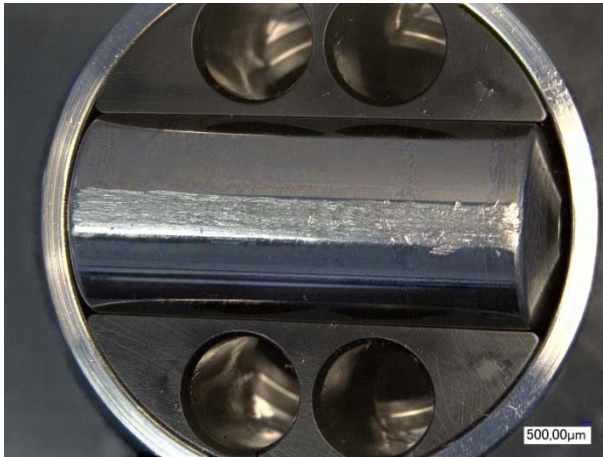
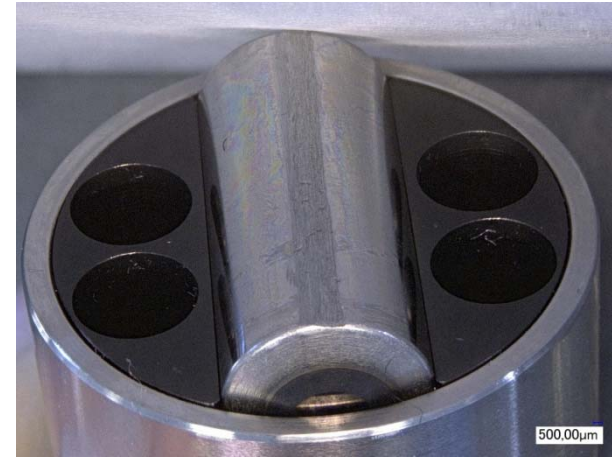
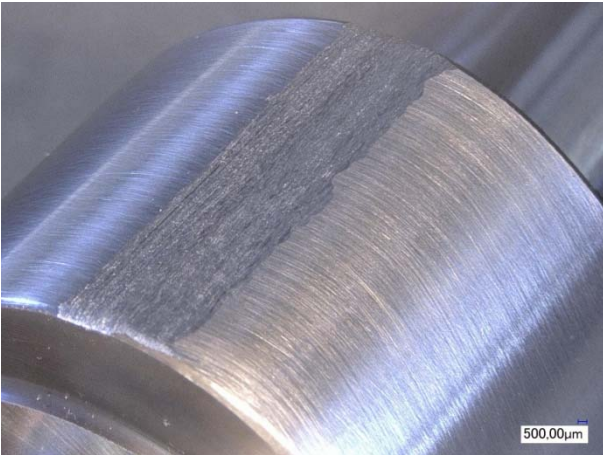
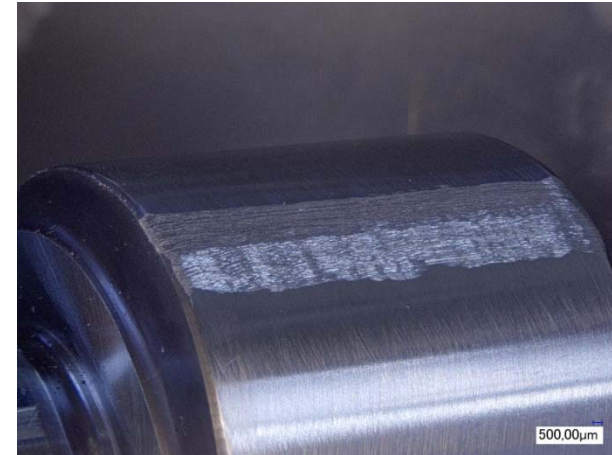
Roller and Cam Damage Pattern / Artificial damage, simulating a severe brake mark

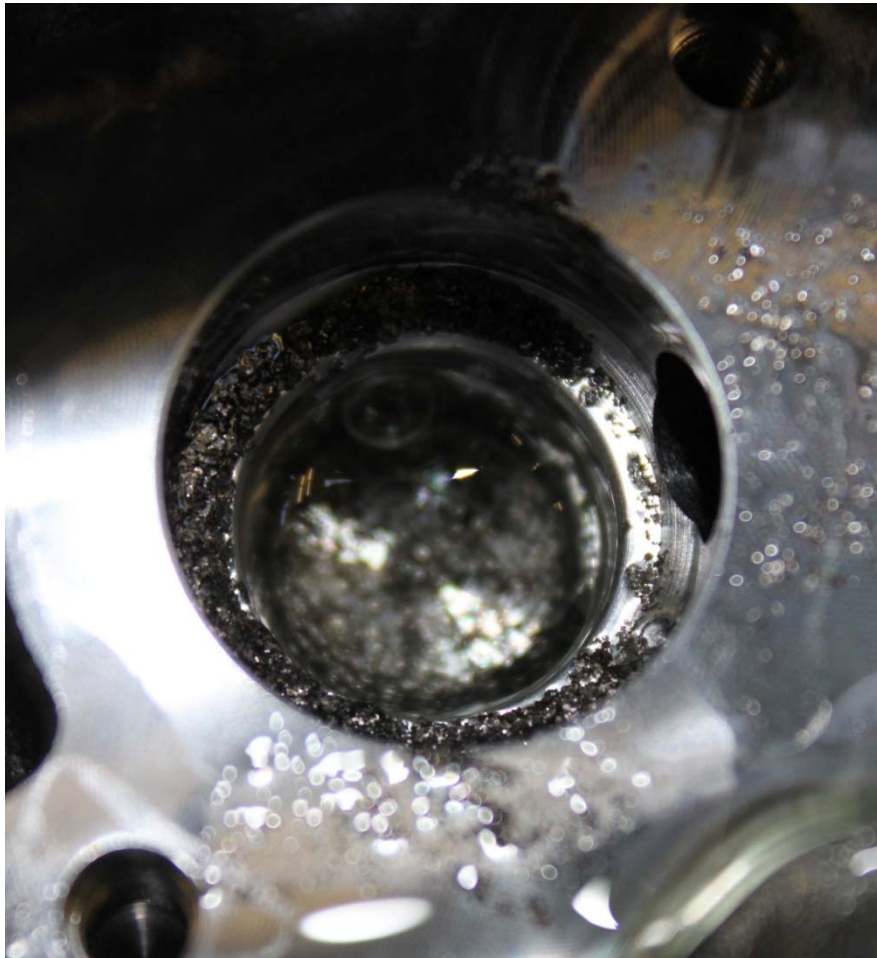
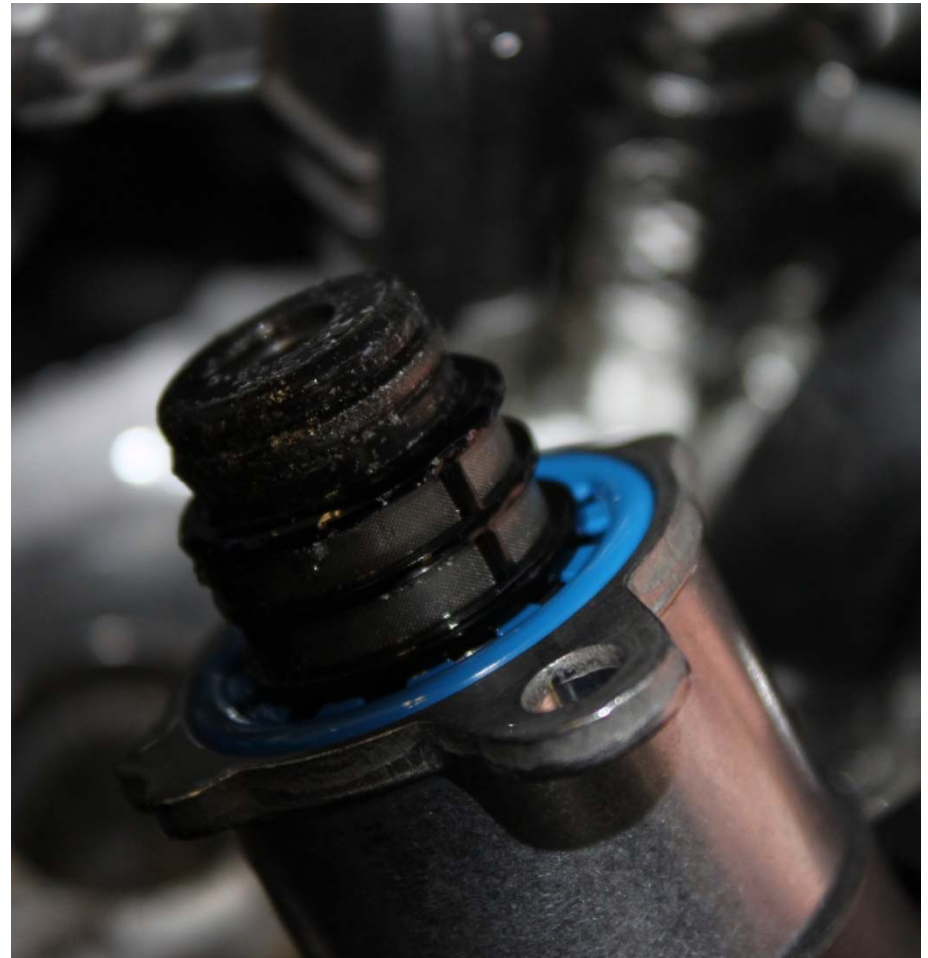
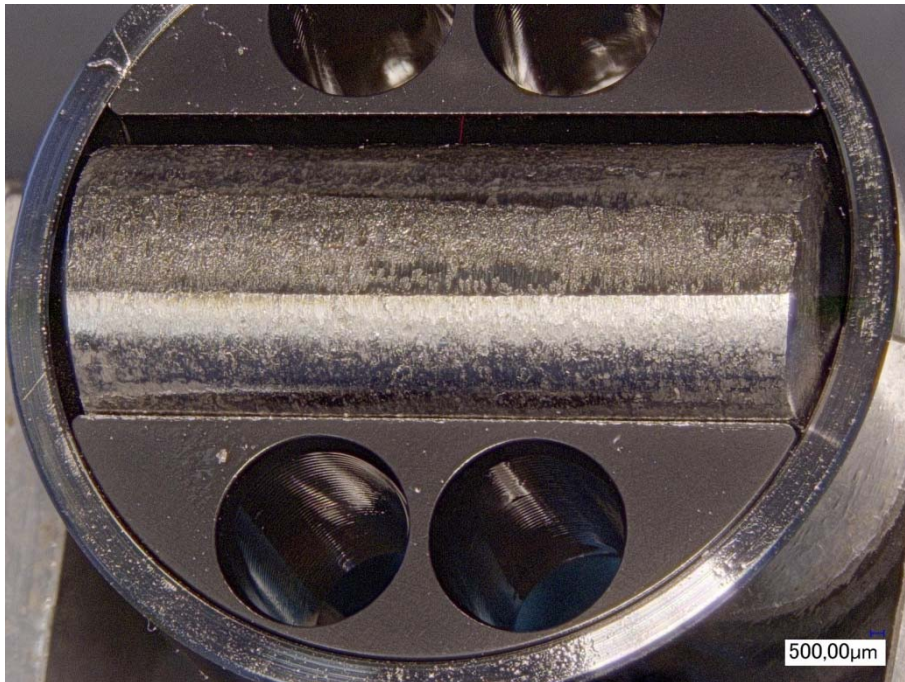
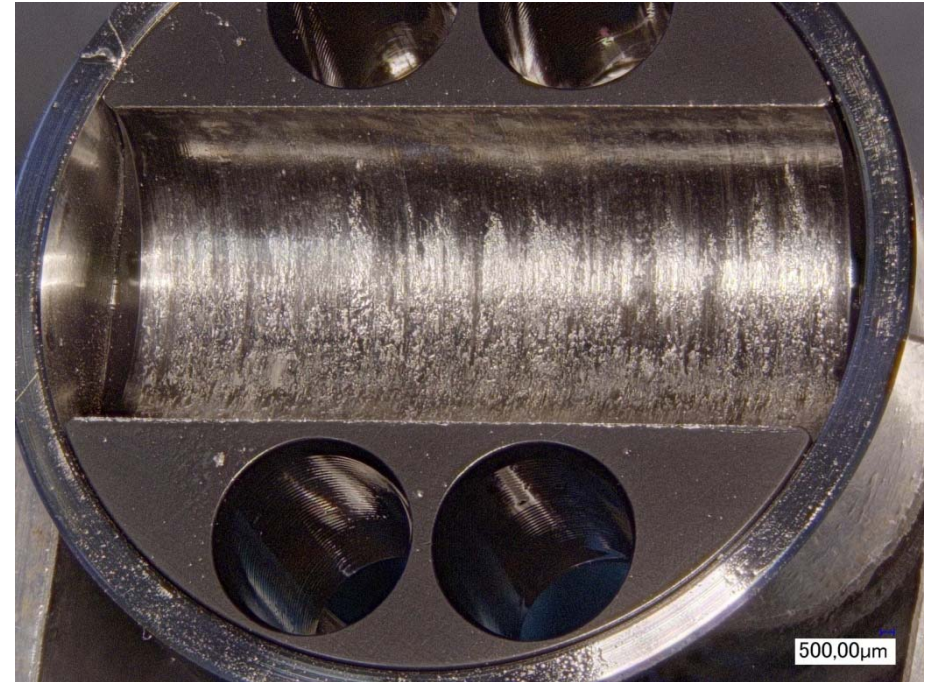
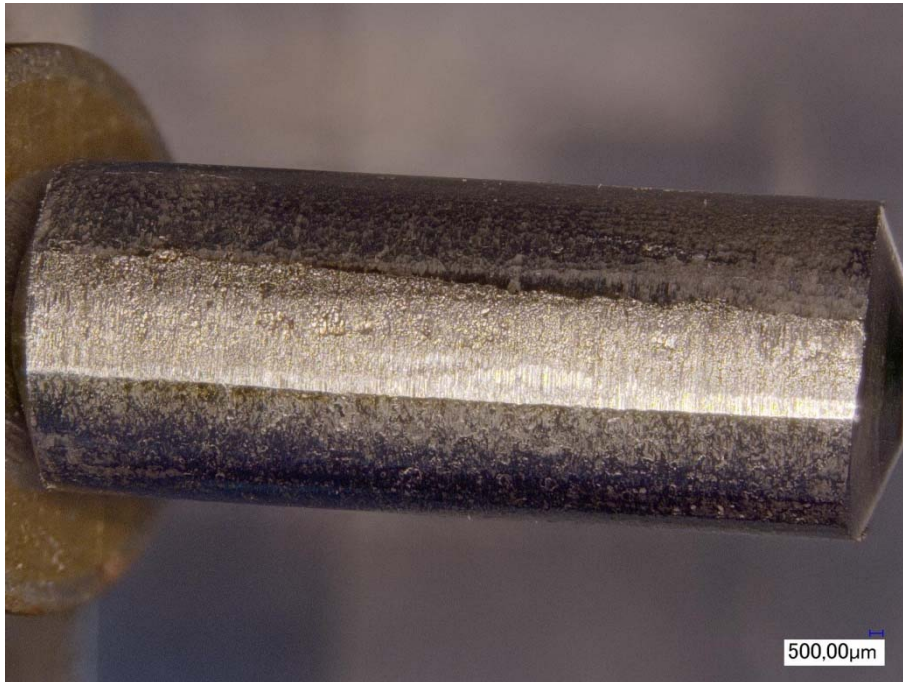
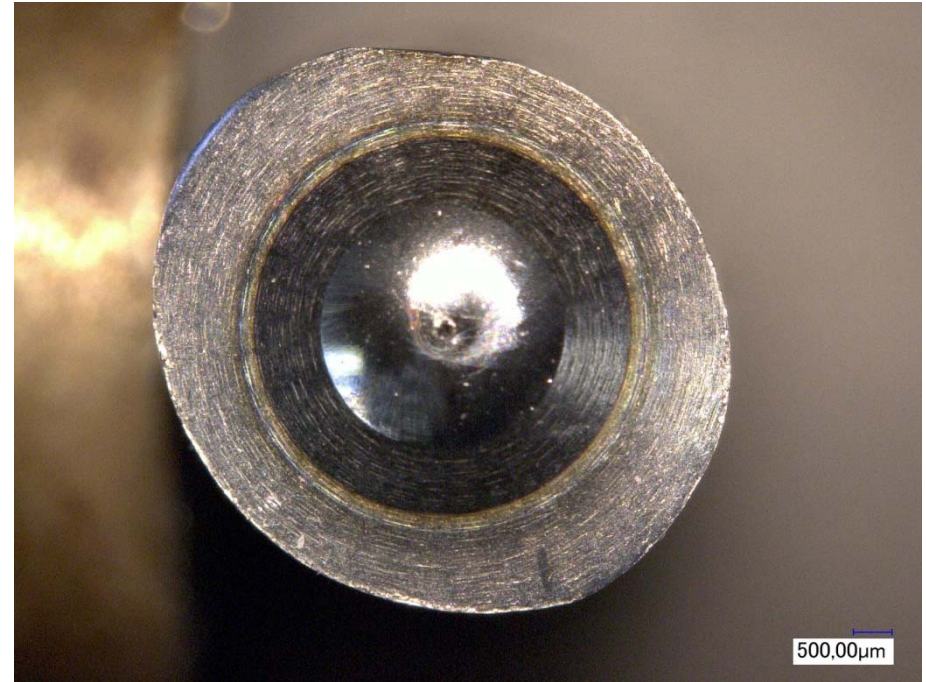
- About 23 min engine warm up
- Warning Light (Glow Plug) coming up within initial acceleration up to 78 ^{km}/_h (about 50 mph)
➡ Trigger for Limp Home Mode
- About 43 min driving cycle with flashing glow-plug indicator light and reduced performance
- Significant loss of pressure supply from HPFP in the final 5 minutes of the test
- End of test after 66 minutes at 58.4 km (36,3 miles)
- Metal flakes found in HPFP did not cause engine shutdown, plunger displacement was reduced and impaired fuel supply (see pictures)

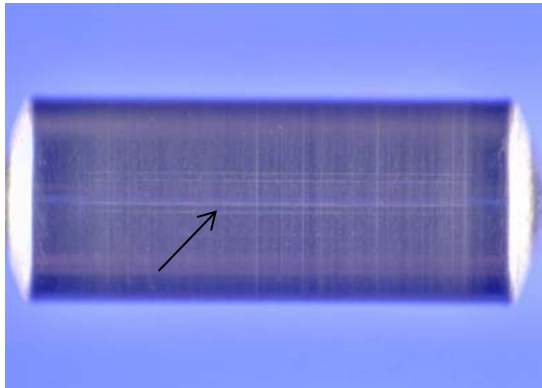
Standstill Lines

- Standstill lines are only visually detectable surface smoothing lines. Such smoothings are not measureable and without negative effect on durability of the HPFP.
- Standstill lines may appear after long periods without operating (initial slip when pump starts to rotate) and when lubrication is impaired and roller speed is reduced for short instances (also slip between roller and camshaft).
- Brake marks are measurable abrasions of the roller surface, damaging the surface structure of the roller.
- Having damaged the surface, the roller may not withstand the pressure during operation and material may further deteriorate due to fatigue (→ HPFP drivetrain failure)
- Brake marks appear when lubrication is interrupted, the roller is stopped and the camshaft slides under the roller.
