**Follow Up Meeting with NHTSA**

**December 20, 2012**

EA11-003 TDI High Pressure Fuel Pump

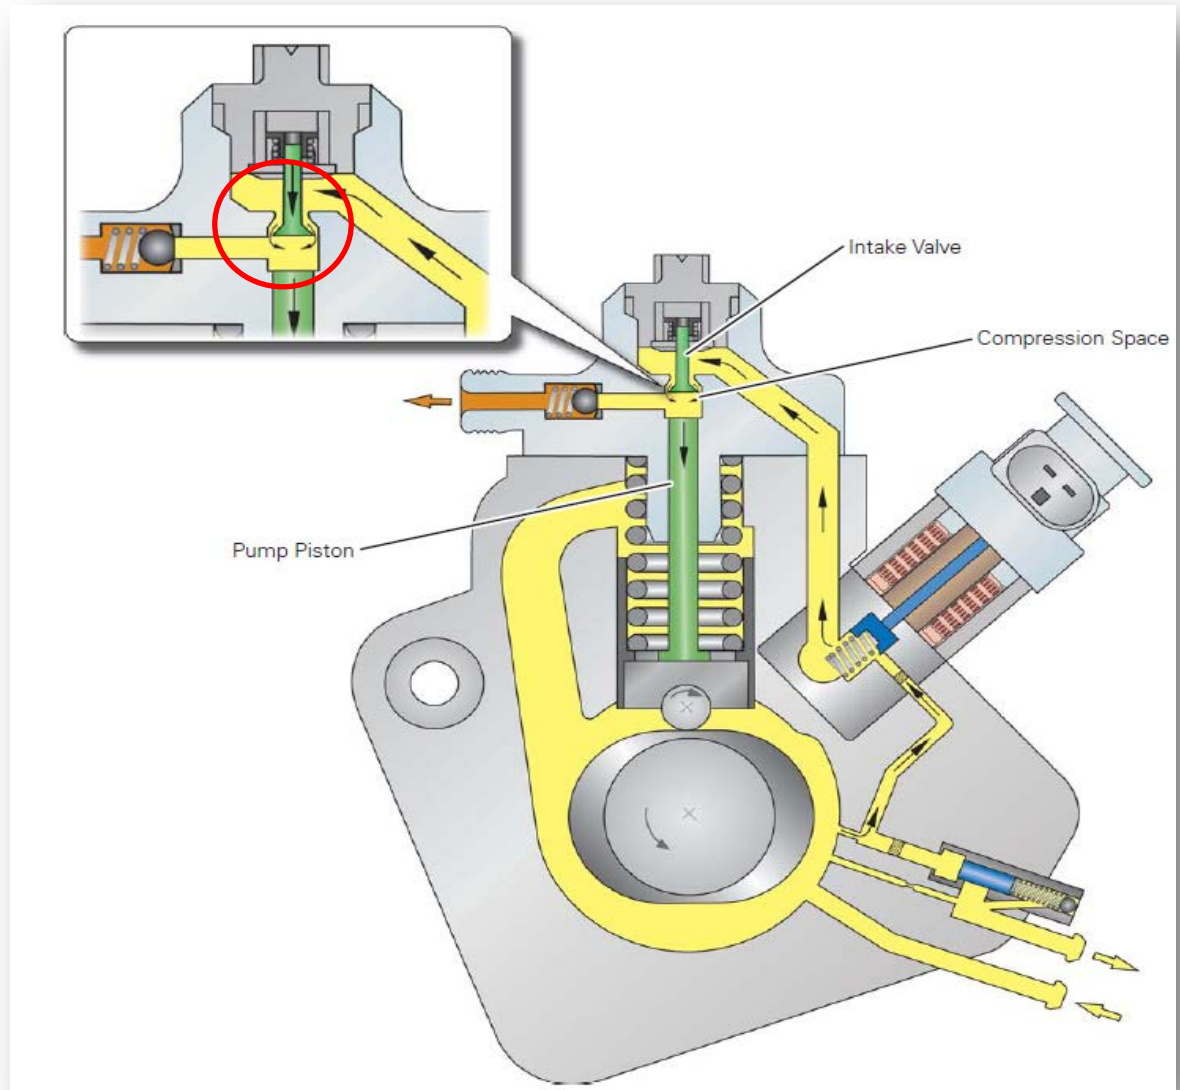
- 2) Using pump diagram and 8D reports/pictures, review following failure modes and mechanisms for each and all expected DTCs
  - a. No start condition – including review of the two related 8D reports – *Both incidents were caused by use of improper fuel (deposits detected during analysis - 4VW0994, 4VW1026) and diagnostic logs were not available for each VIN – REFERENCE PAGE 6 (metallic flakes)*

Metallic flakes may lodge at the seat of the suction valve when fuel velocity is zero (when engine is turned off).

As no pressure build up is possible under this condition (as the valve remains open) there is a no-start condition with the engine.

Metallic flakes remain in position between valve face and valve seat, due to return spring pressure on the valve.

No longer possible with RP1 HPFP due to additional strainer at suction valve.

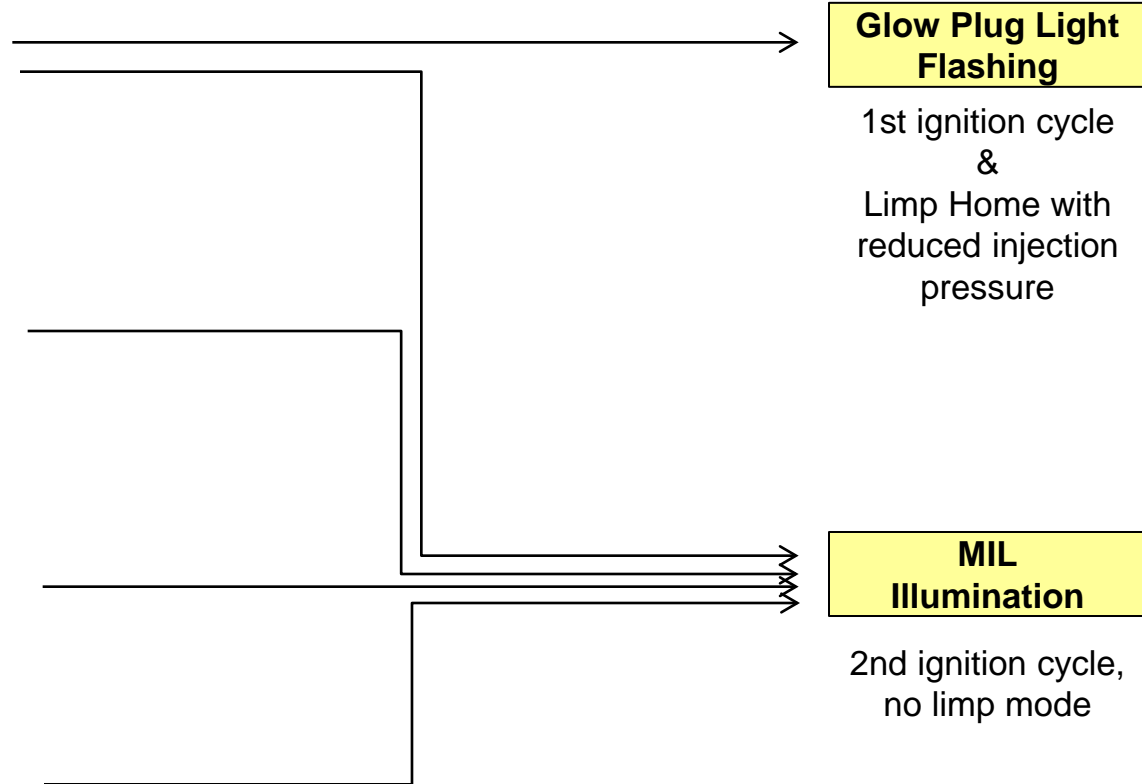
P0087/88

Rail pressure control  
(e.g. pressure commanded by the ECU cannot be reached)

P0191

Adaptation of pressure control valve  
(e.g. comparison of commanded to actual value)

P020A...D

Combustion Position Control  
(e.g. ignition timing)

P0263/266/269/272

Adaptation of minimum injection

**Glow Plug Light Flashing**

1st ignition cycle &  
Limp Home with reduced injection pressure

**MIL Illumination**

2nd ignition cycle, no limp mode

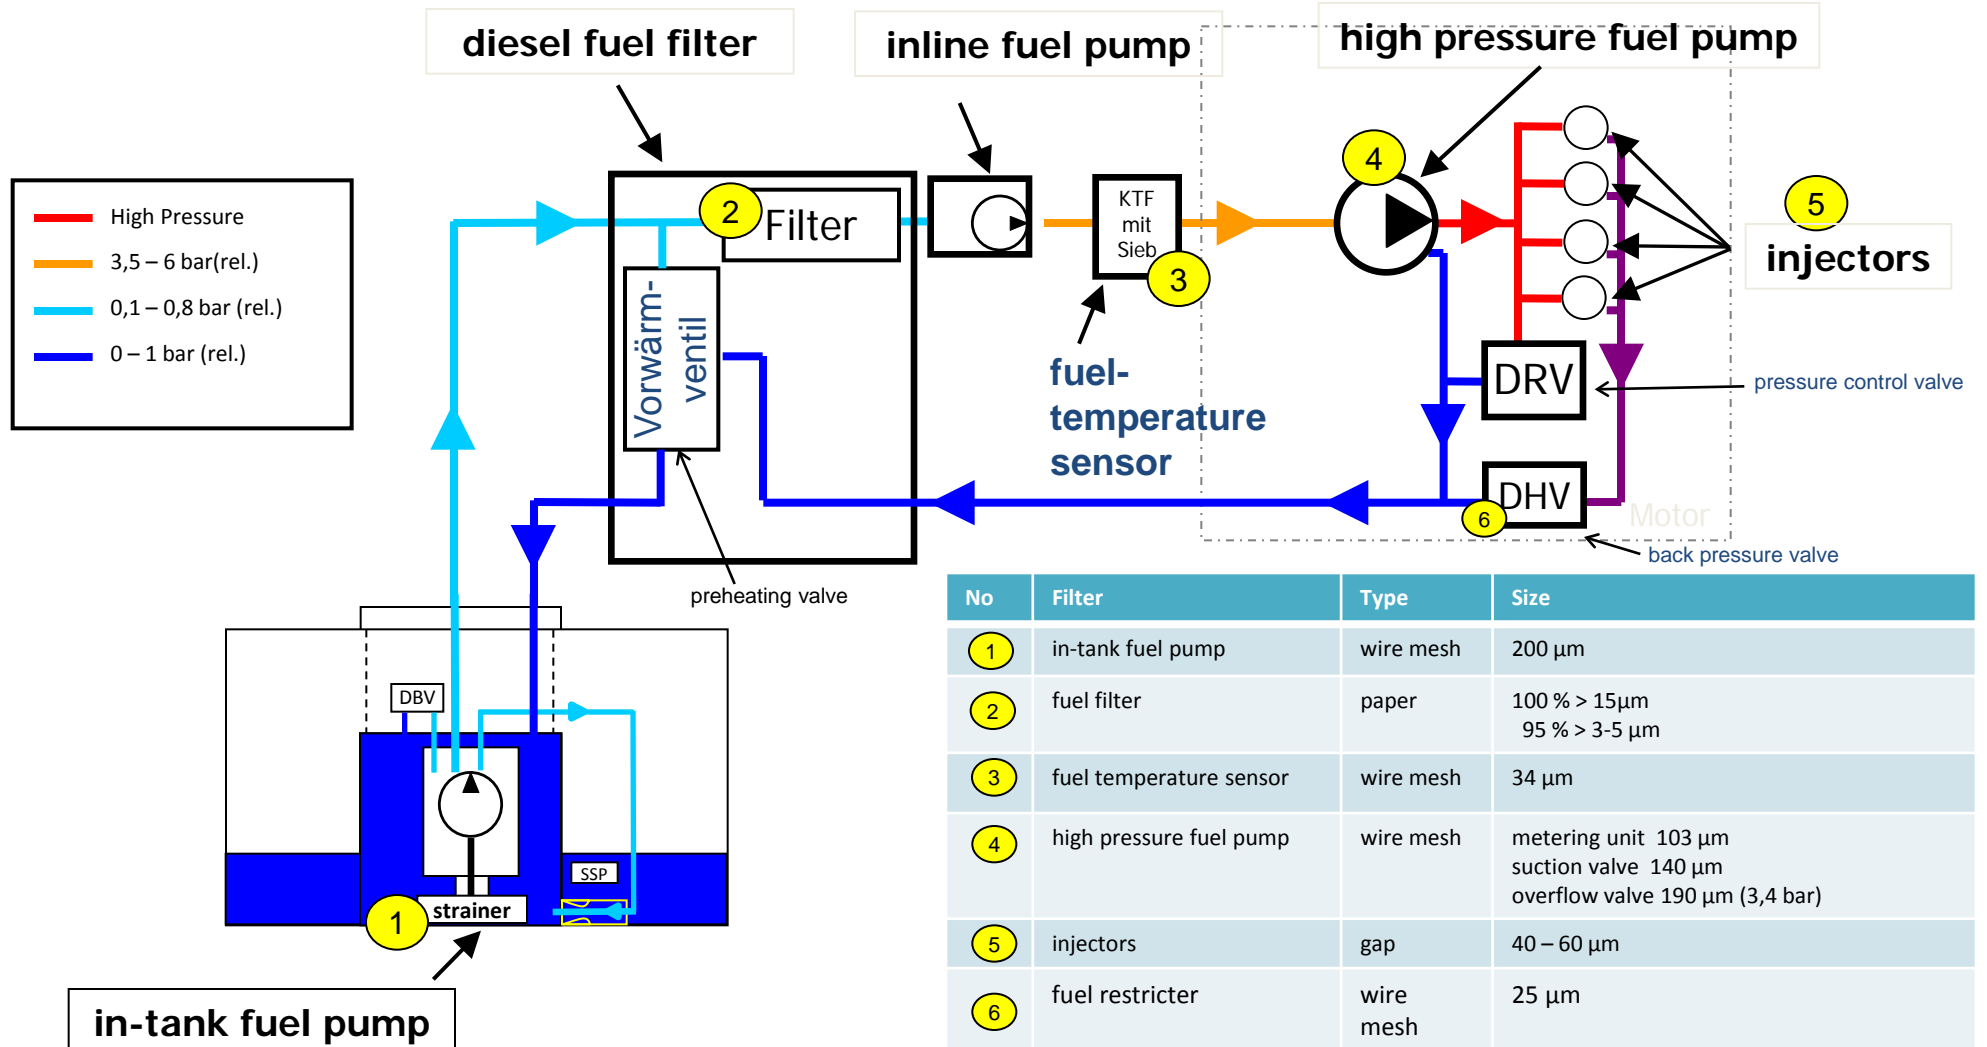
# Fuel System Filtering/Screening – CP4.1 shown

- b. Locations in fuel system– *REFERENCE PAGE 12*
  - c. What components are affected by metal debris? – *All fuel system components will be contaminated and require replacement. Volkswagen has not identified other fuel system related component failures (in-tank pump, in-line pump, fuel injector, etc) as these are replaced as “consequential” to the repair. “Consequential” items are not analyzed, as they are required replacement items.*

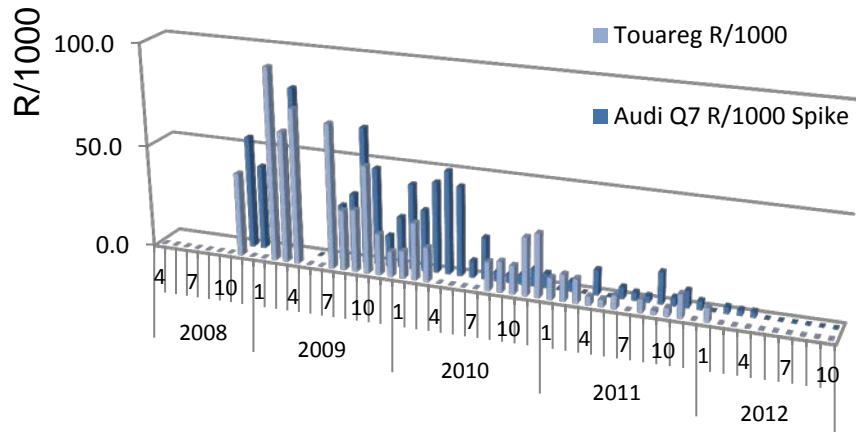
## Q7 vs. Touareg

Does the misfuel protection not work?

Volkswagen considers several reasons as the cause for Q7 being „over represented“

- AdBlue filler neck close to fuel filler neck (this was the reason to implement the misfuel restrictor in the Q7) ; AdBlue commonly being refilled with bottles (misfuel restrictor allows 6L/min „emergency fueling“) → several Q7 AdBlue incidents found (Touareg has AdBlue filler neck in the trunk...)
- Small population: Few HPFP replacements have huge effect on rates, statistical evaluation is rather weak
- Expensive premium vehicle: Dealers may be more willing to replace HPFPs to keep customers happy, although it would not be necessary
- Use of adapters to override misfuel inhibitor (sold by dealers and at every fuel station) → some misfuels detected in data / fuel samples
- Misfuel by roadside assistance occurred when refueling with spare can
