| | <h1>TRIP REPORT</h1> <p>Matsonford Road, Conshohocken, PA</p> | Trip Date | 11/02/11 |

Project. No./ Title: DCD 2183: 2003-2012 Thomas Built Bus CNG Tank Abrasion (ODI PE11-029)

Background/Purpose: Background: At the request of ODI and to support Investigation PE11-029, 2003 - 2012 Thomas Built Saf-T-Liner HDX CNG Bus VRTC has been asked to inspect CNG buses on the east coast.

Objective: To evaluate clearance between the CNG tanks and the CNG tank support assembly on various busses in the school bus fleet.

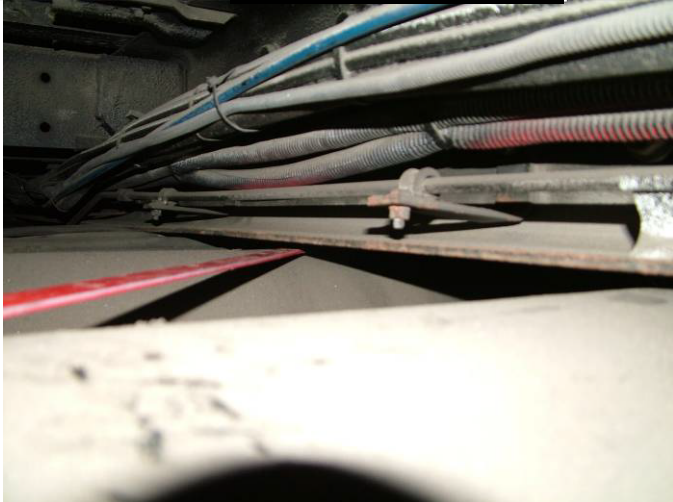
| Results - Details | | | | | | | |
|---|---|---|---|---|---|---|---|
| 3 | 17 | 1T7YR4F25A1 | 21,045 mi | 1760 psi | VRTC | PASS | Bus at LM High School |

Checking Tank on Bus 17 with Shim

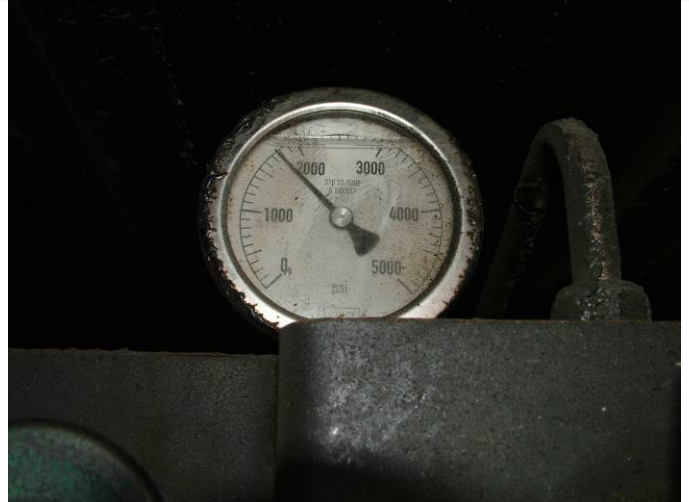
Bus 17 CNG tank Pressure @ 1760 psi

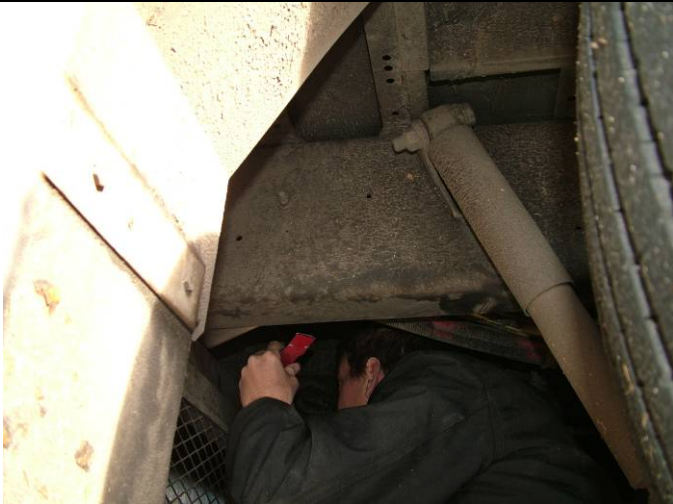
Inspection of Tank Clearances on Bus 17

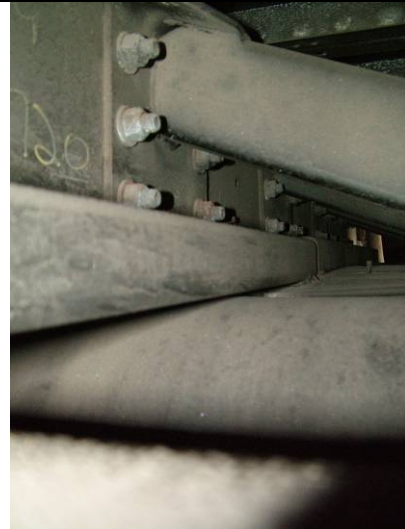
Typical Tank Clearance on Bus 17

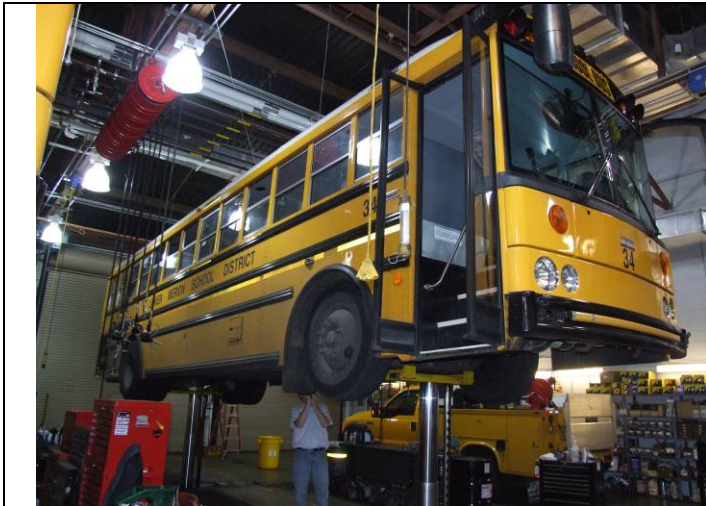
| Results - Details | | | | | | | |
|---|---|---|---|---|---|---|---|
| 1 | 34 | 1T7YR4F29A1 | 21,924 mi | 2500 psi | VRTC | PASS | Bus at maintenance garage |

Inspection of Bus 34 At Maintenance Garage

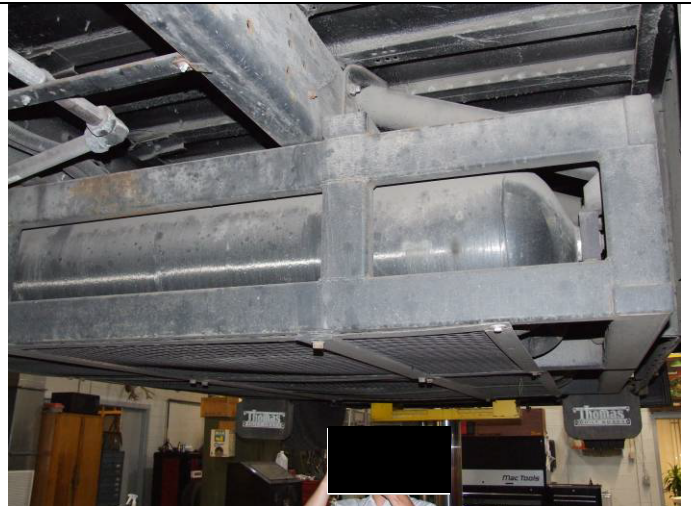
Bus 34 Showing Tank in Support Frame

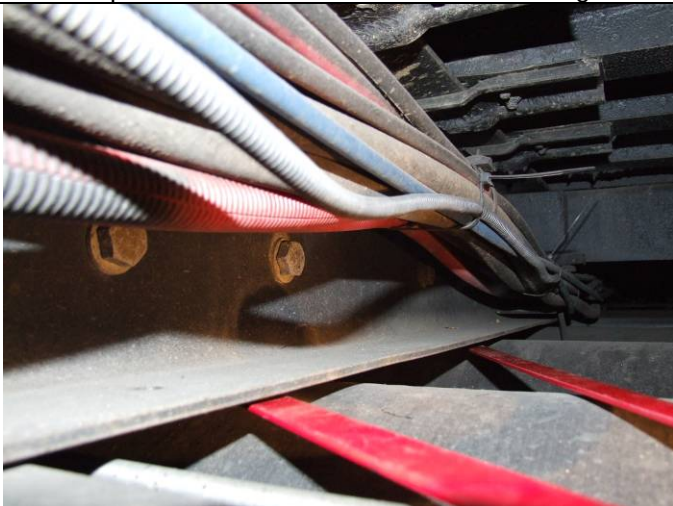
Bus 34 was as follows (tank 1 being in front and tank 5 being to the rear of the bus; + equals loose fit; units = inch):  
1L=0.203+, 2L=0.240, 3L=0.240+, 4L=0.171, 5L=0.203, 1R=0.203+, 2R=0.203, 3R=0.240, 4R=0.203+, 5R=0.240+.

Checking Clearances on Bus 34 with Shims

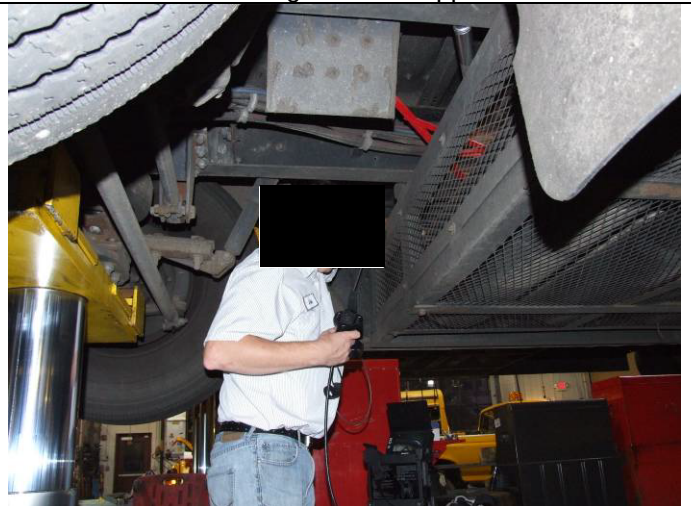
Checking Clearances on Bus 34 with Borescope

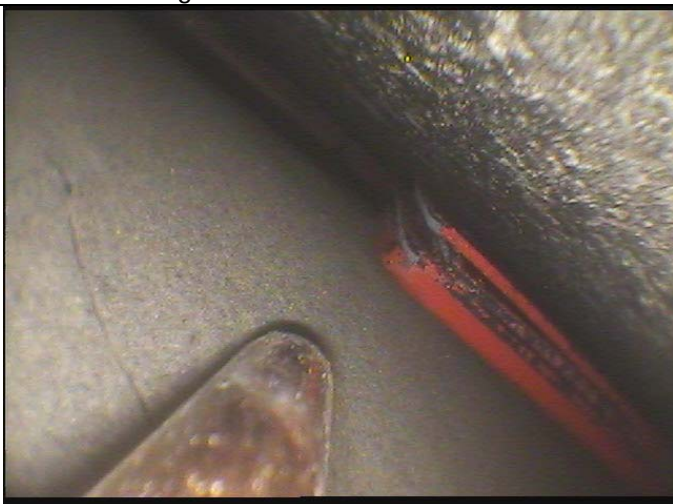
Detail of Borescope Inspections Showing Multiple Shims

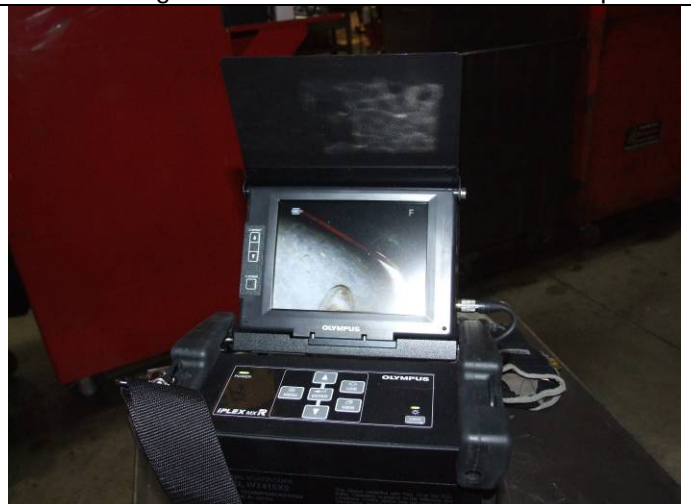
Borescope Used in Inspection of Bus 34 in Garage

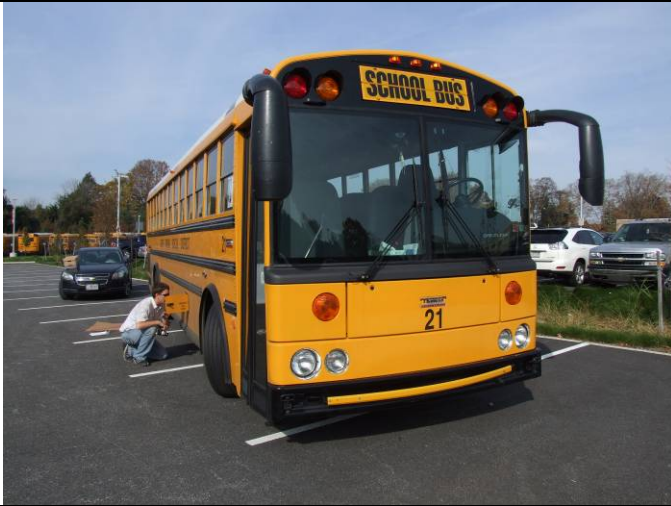
Bus 21 at Elementary School

| Results - Details | | | | | | | |
|---|---|---|---|---|---|---|---|
| 5 | 21 | 1T7YR4F22A1 | 24,287 mi | 1700 psi | VRTC | PASS | Bus at elementary school |

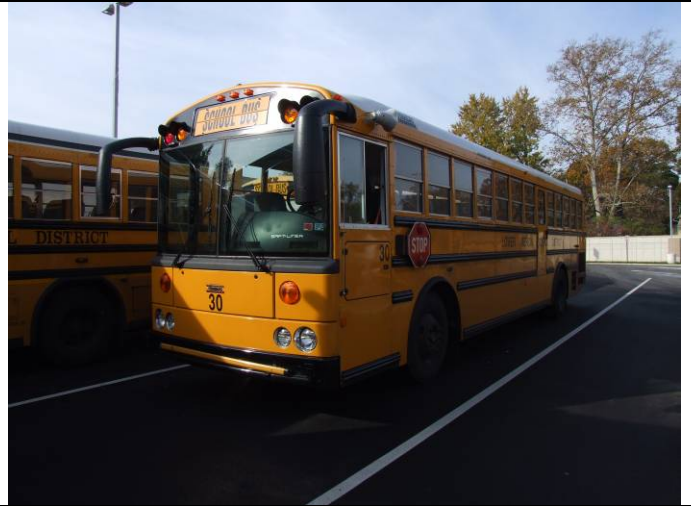
Bus 30 at High School

| Results - Details | | | | | | | |
|---|---|---|---|---|---|---|---|
| 4 | 30 | 1T7YR4F24A1 | 21,728 mi | 2500 psi | VRTC | PASS | Bus at LM High School |
