EA11-007 – Index of Laboratory Reports

QA Lab Report No. 4398

SUBJECT: Paint Thickness

OBJECT: Determine the mode and possible cause of breakage.

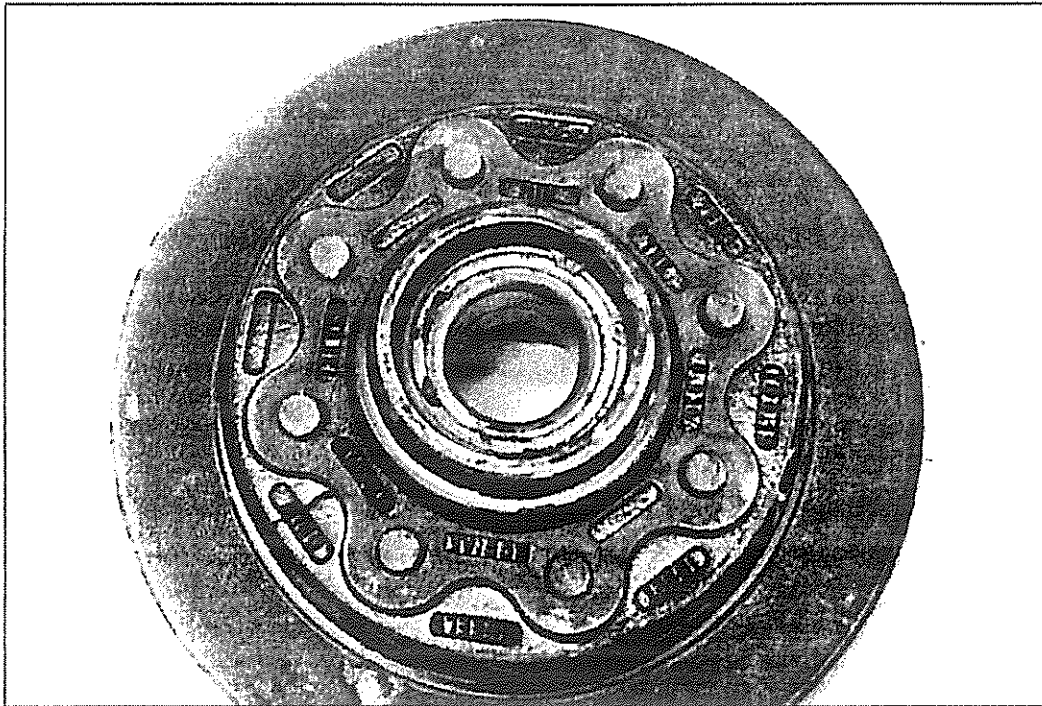
Paint was worn off the entire mounting face of rotor 1 (Figure 1). Some paint remained on the hub face between the boss contact faces on rotor 2 (Figure 2). The as-painted rotor had paint on all contact surfaces (Figure 3).

Figure 1. Rotor sample 1 – showing that the paint had been worn off the entire mounting face, leaving paint only on the cast surface

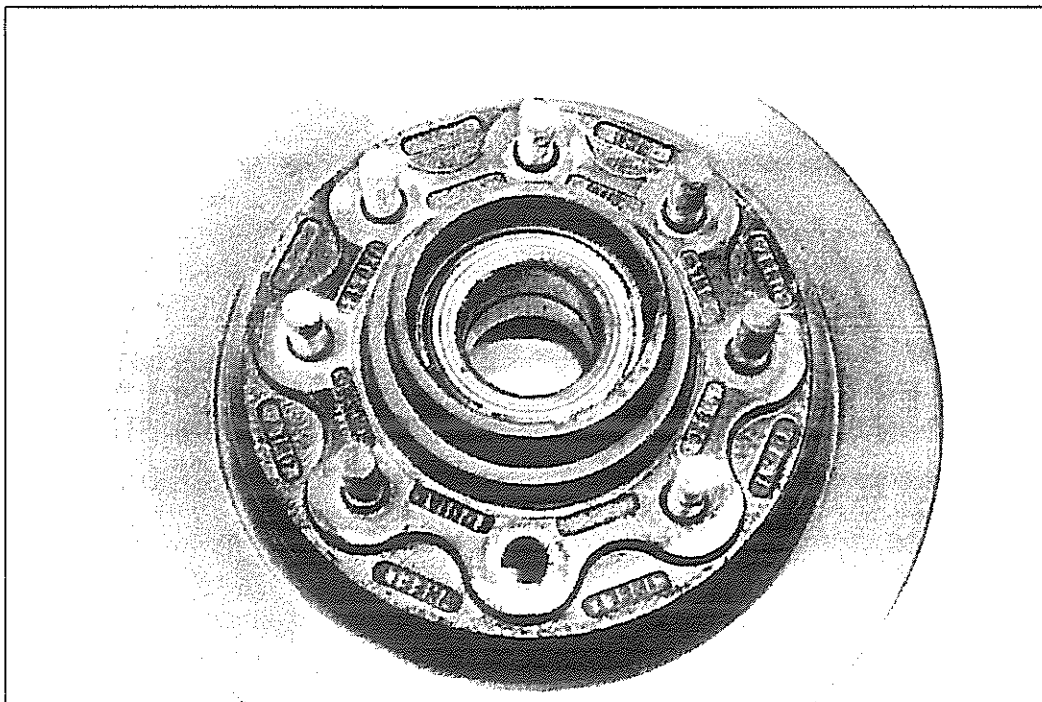
Figure 2. Rotor 2 – paint was worn off the contact surface, but remained on the face between the bosses and on the cast surface

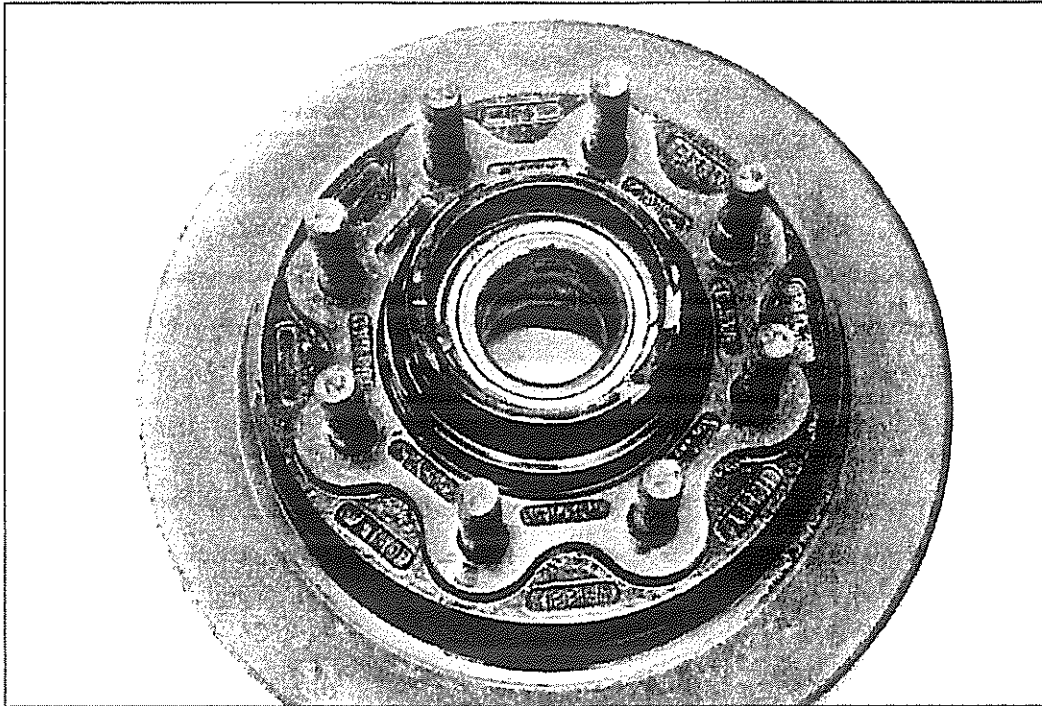
Figure 3. Rotor 3 -- showing paint on the entire mounting face and on the cast face

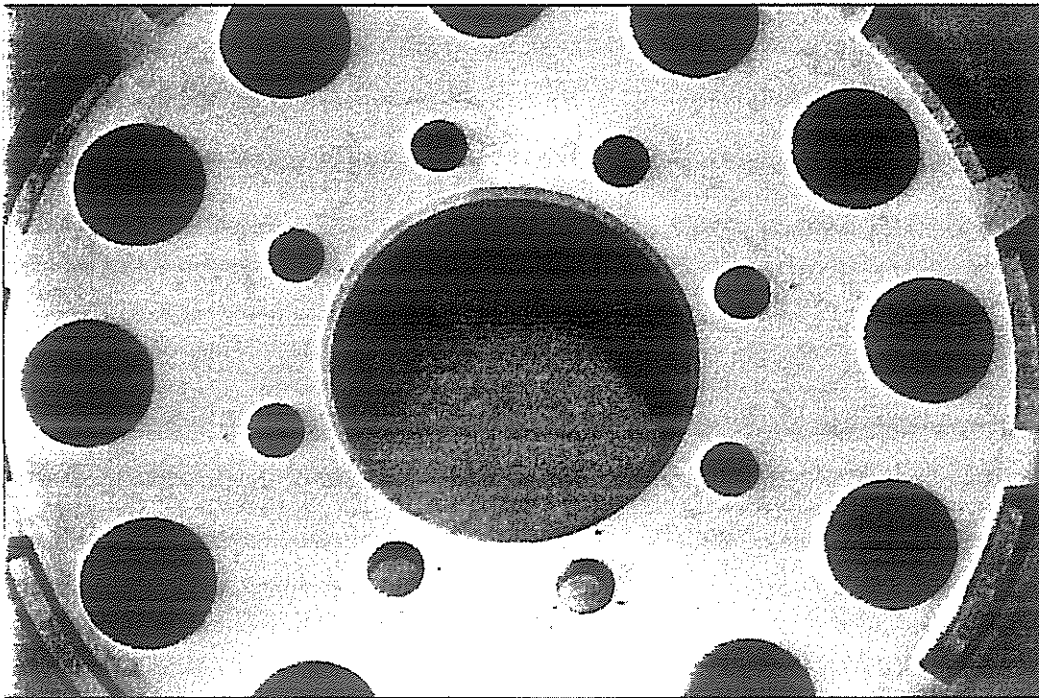
The mounting face on the wheel exhibited an outline of contact with the rotor face (Figure 4).

Figure 4. Wheel faces -- showing the apparent outline of the contact face with the rotor

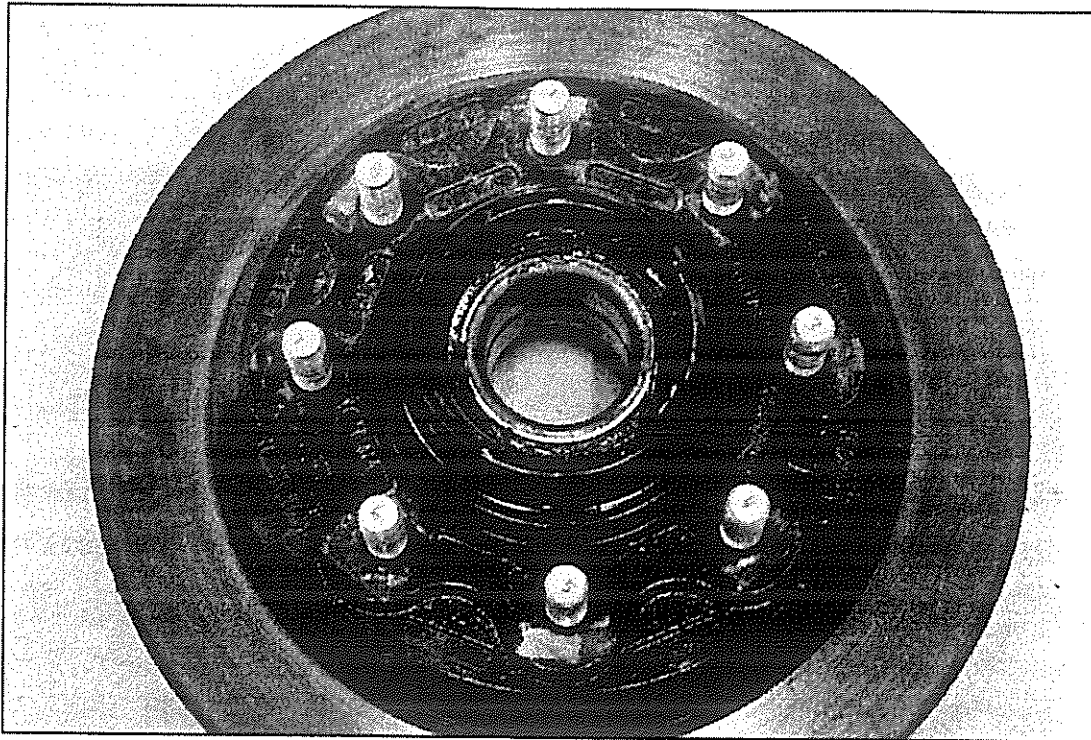
Figure 3. Left front rotor showing wear on the hub mounting face in the inboard and outboard areas adjacent to the wheel bolt

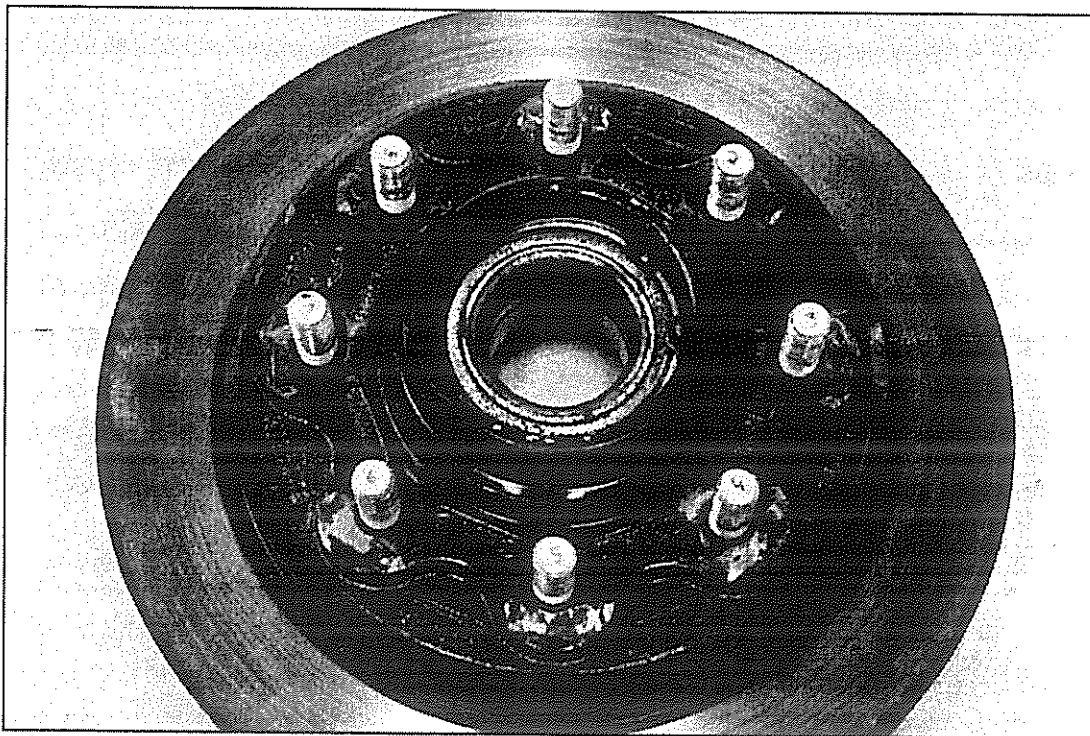
Figure 4. Right front rotor showing wear on the hub mounting face in the inboard and outboard areas adjacent to the wheel bolt

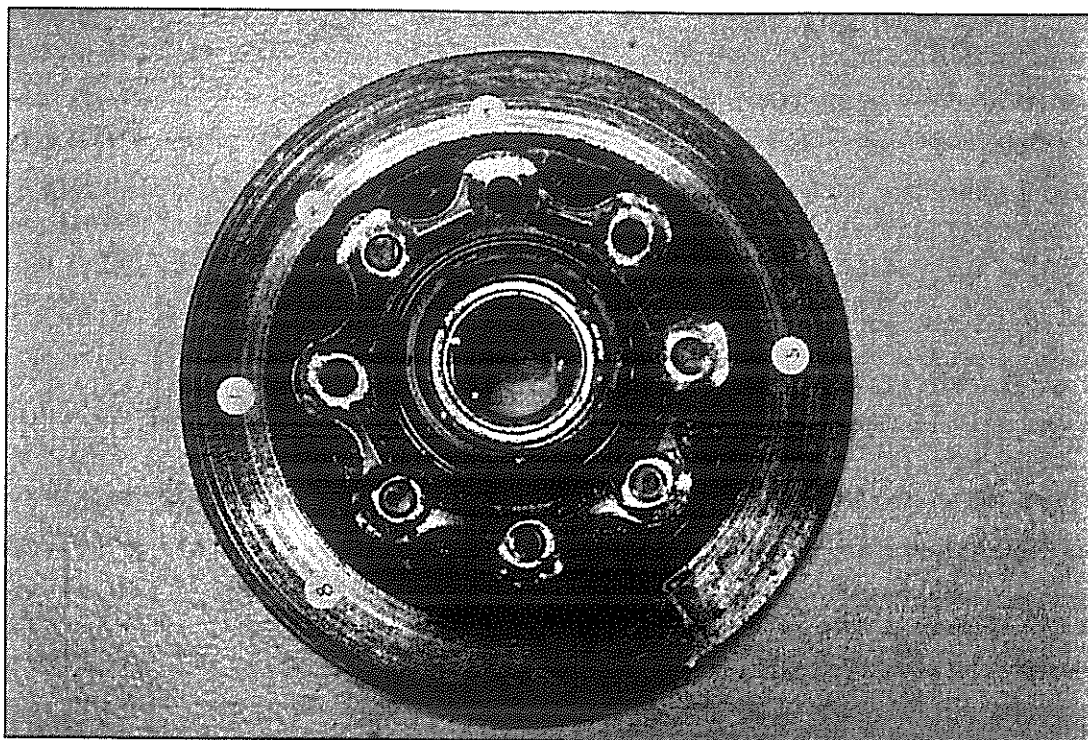
Figure 1. Left rear rotor showing wear on the hub mounting face in the inboard and outboard areas adjacent to the wheel bolt

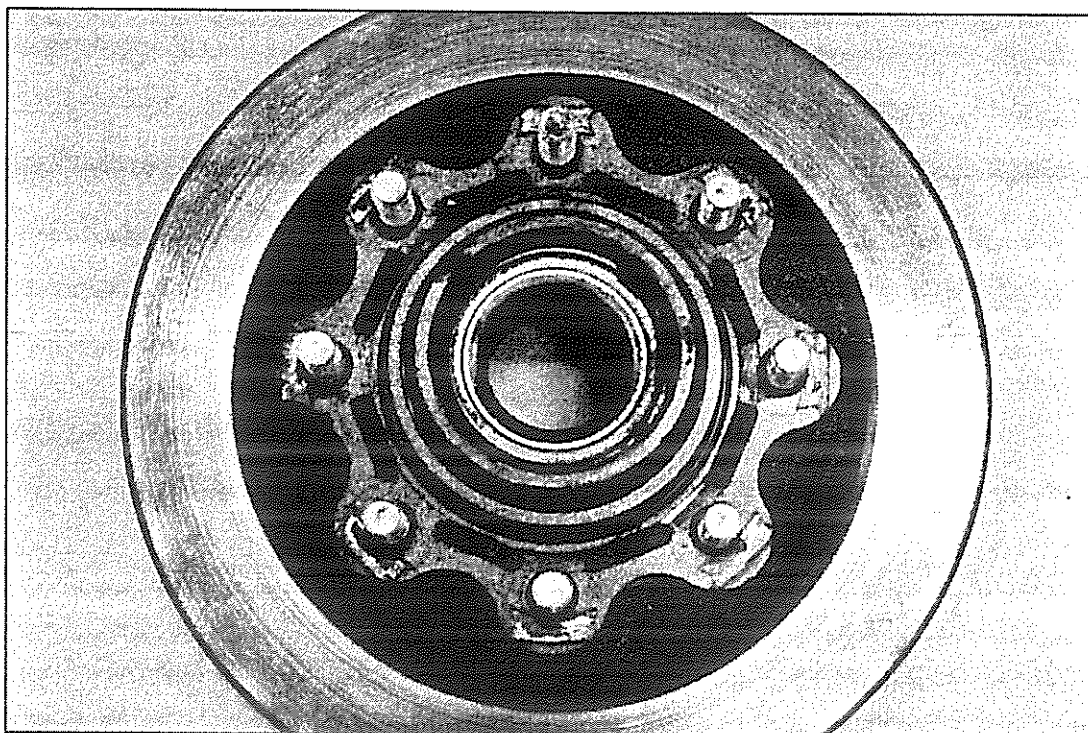
Figure 2. Right rear rotor showing that the wear was located primarily on the hub face outboard of the wheel bolt

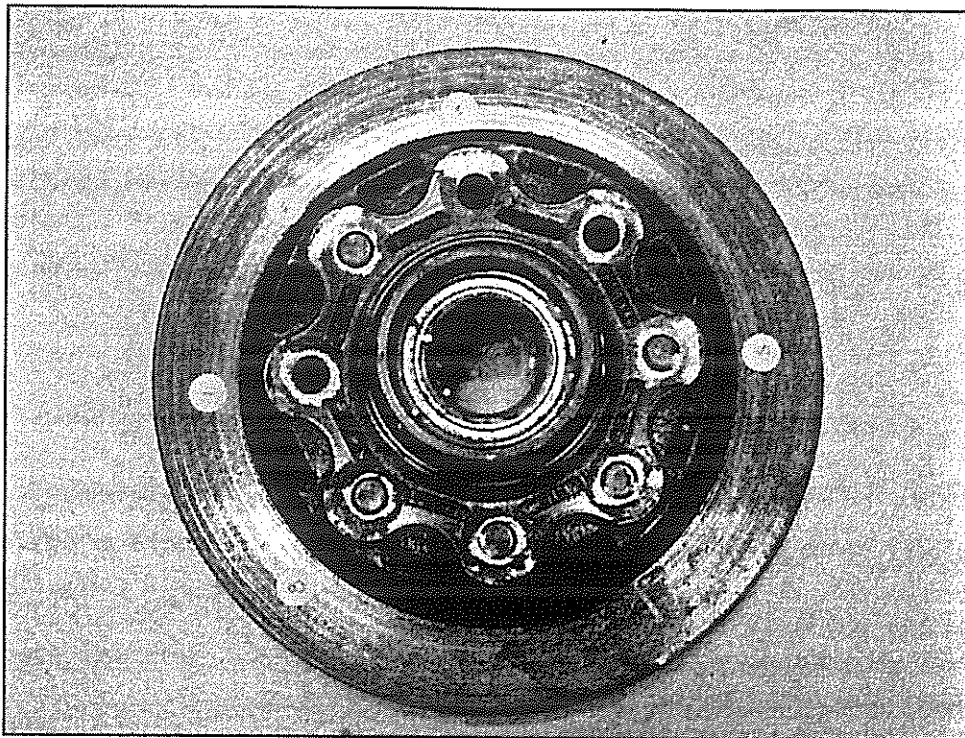
Bolts 1, 3 and 4 were missing from the rotor (Figure 1). Wear on the mounting face revealed that the wheel had been loose. This wear was not uniform. Head and serration ends of bolts 2 and 5 to 8 remained in the assembly. All five bolts broke at the thread runout (Figures 2 to 5). Some post fracture damage to the fracture faces was apparent along with wear and damage to the taper sections on the bolts. All thread ends and nuts were missing.

Figure 1. Three of the eight wheel bolts were missing from the rotor assembly – missing bolts were from locations 1, 3 and 4 (*location numbers assigned by DRV personnel*)

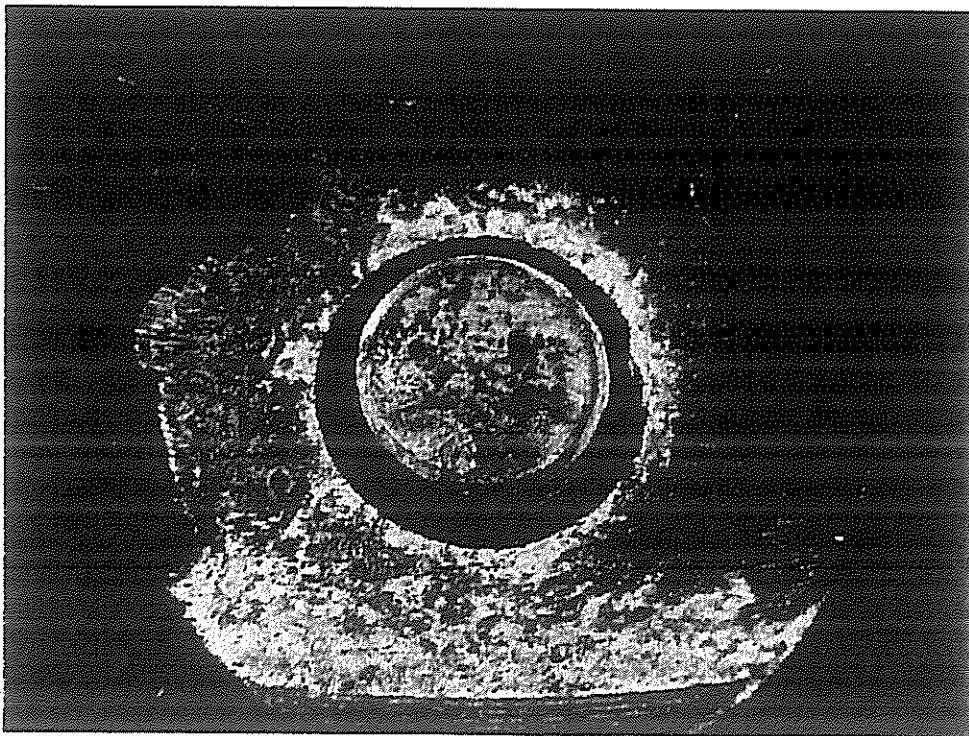
Figure 2. Bolt 2 broke at the thread runout – the mounting face exhibited non-uniform contact based on the wear

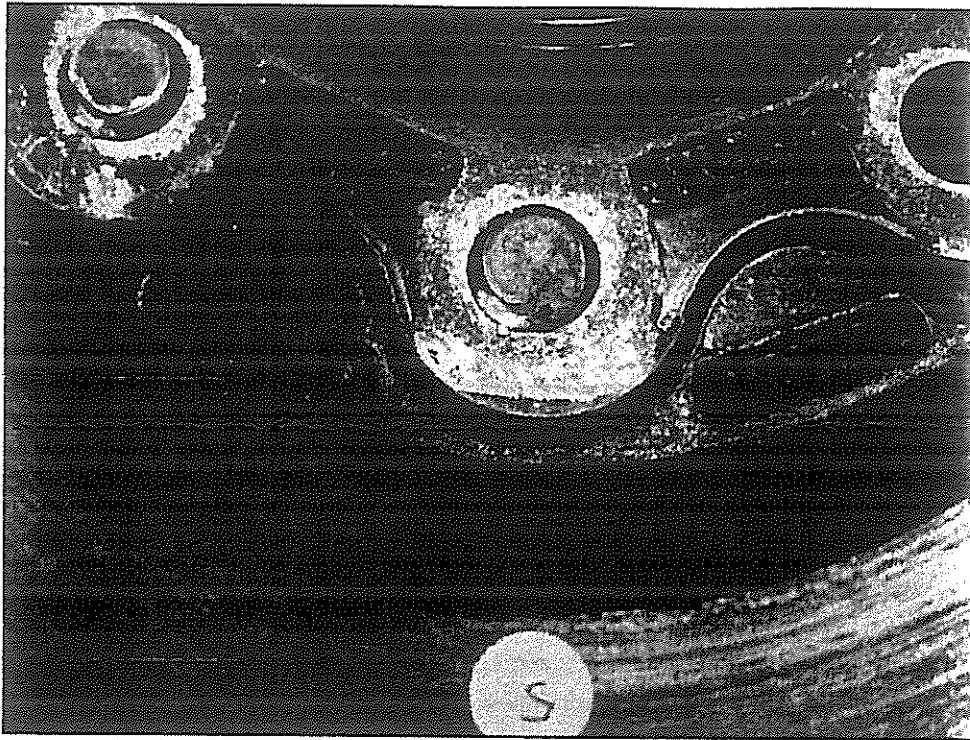
Figure 3. Showing the location of fracture on bolts 5 and 6 was at the thread runout – edges of the bolts to the taper were damaged by looseness of the wheel

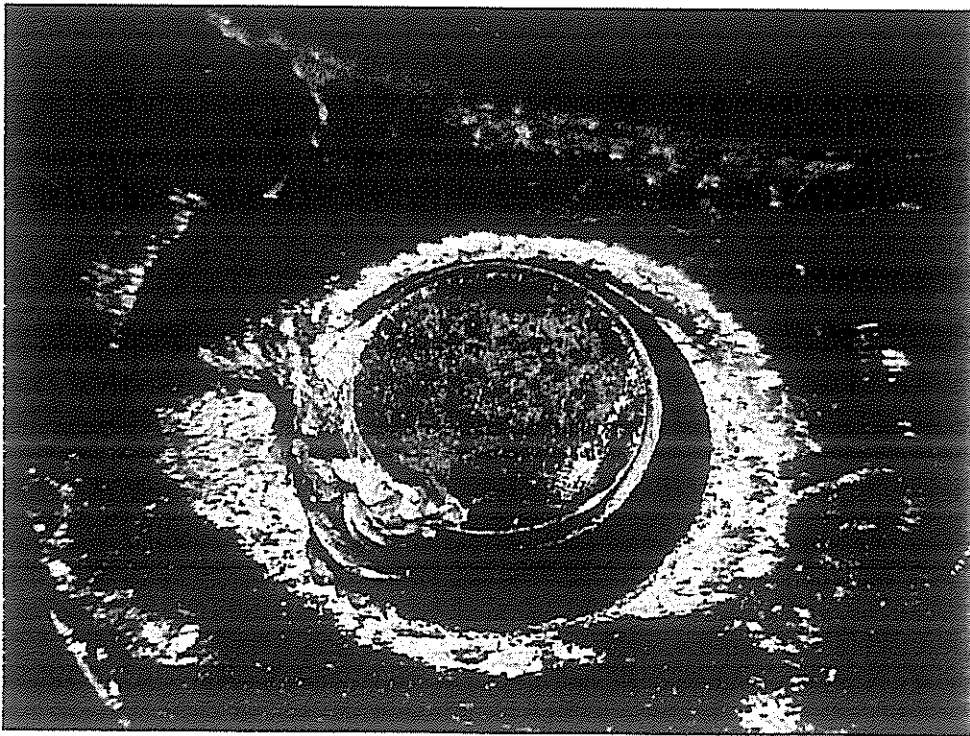
Figure 4. Showing the location of fracture on bolt 7 at the thread runout – edges of the bolt and fracture were damaged by looseness of the wheel

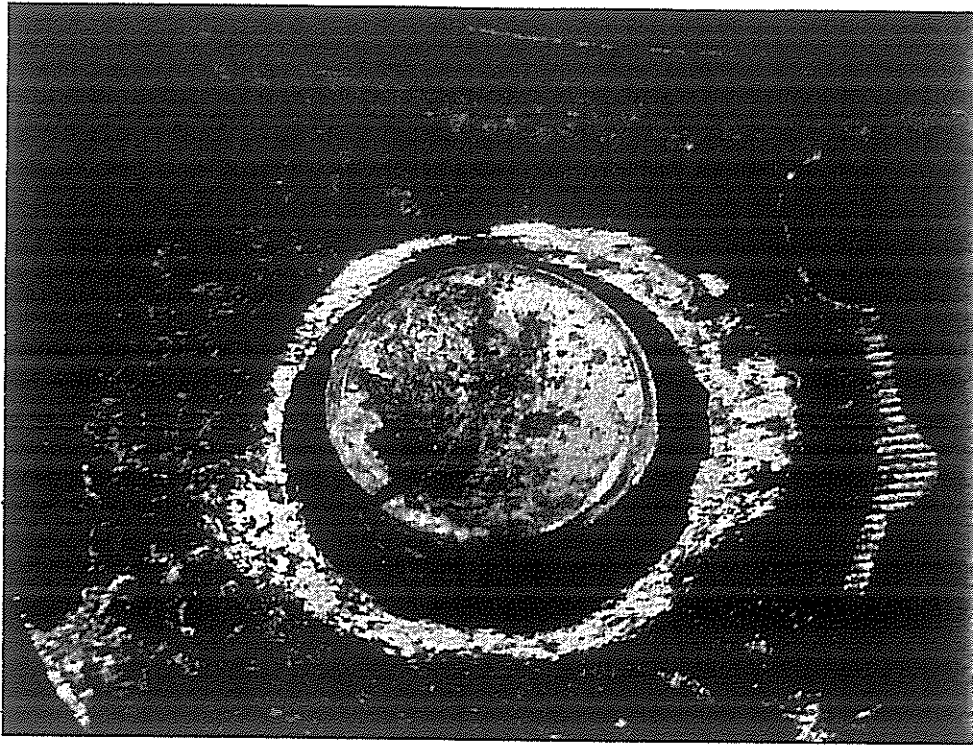
Figure 5. Showing the location of fracture on bolt 8 at the thread runout – edges of the bolt and fracture were damaged by looseness of the wheel

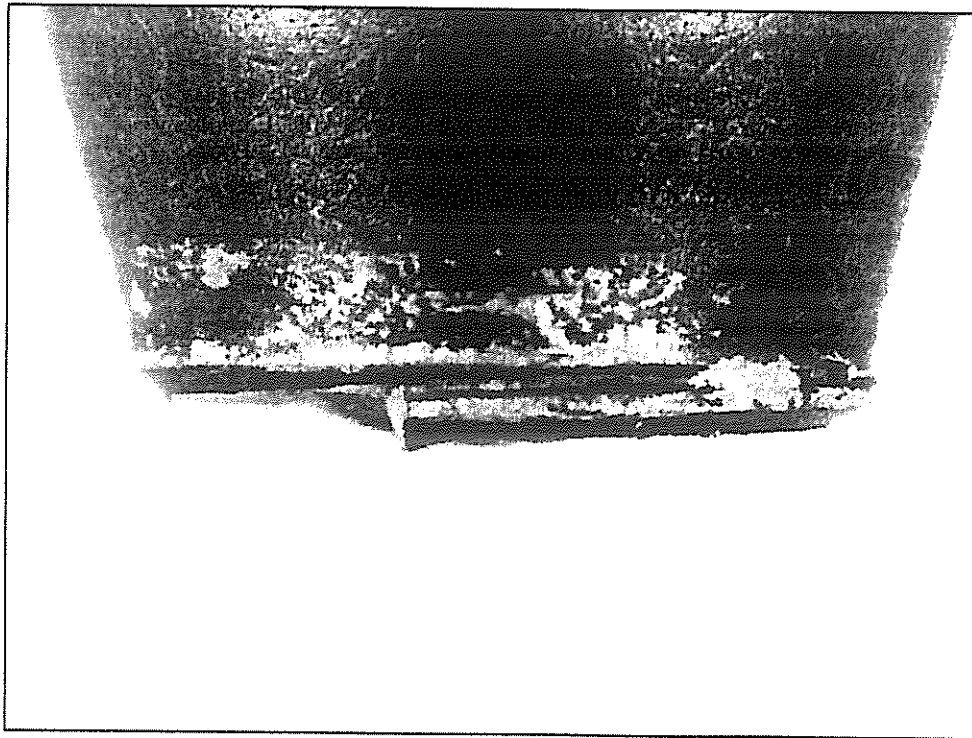
The separate loose bolt broke at the thread runout (Figure 6). Wear on the taper to the serration section also showed that the wheel was loose. This bolt fit loosely in location 3 and it turned freely within the rotor. It did not fit in

Figure 6. Location of the fracture on the separate loose bolt that was submitted with the rotor assembly

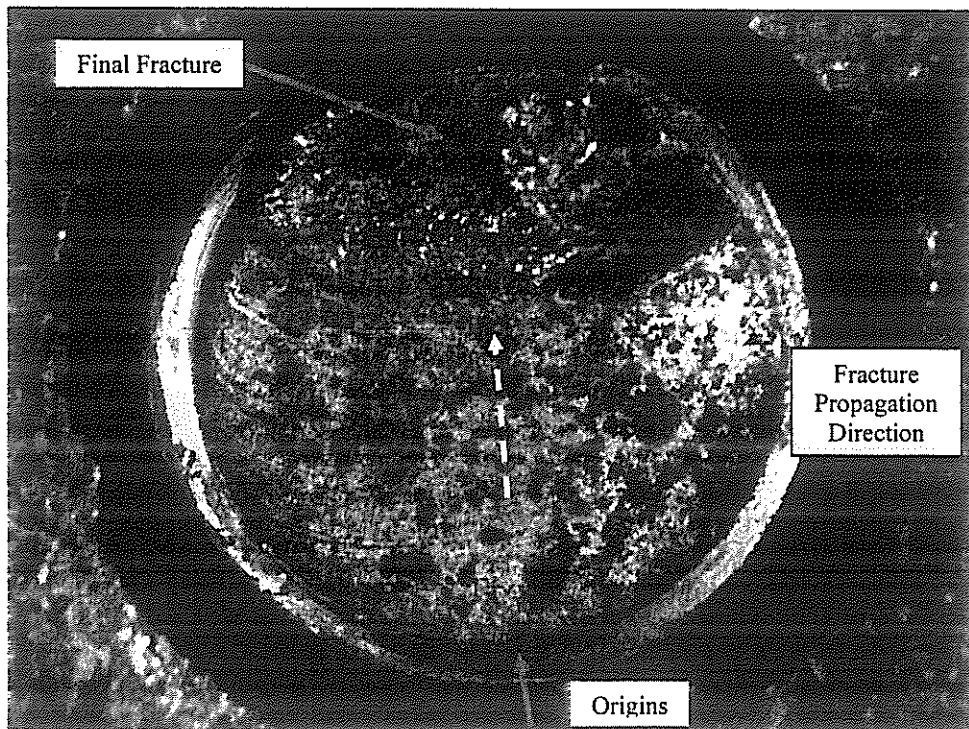
Bolt 2 fracture features revealed that breakage originated off the thread root in an area near the inner diameter of the hub (Figure 8). Multiple fatigue origins were revealed by the ratchet marks or steps on one side. Fatigue, as revealed by the beach marks, extended across 70 percent of the bolt cross section before final fracture on the other side. No defects such as seams or pre-existing cracks were found in association with the origin.

Figure 8. Bolt 2 – fracture features revealed that breakage occurred in unidirectional bending fatigue, with origins at a slight angle to the hub axis – centerline is down

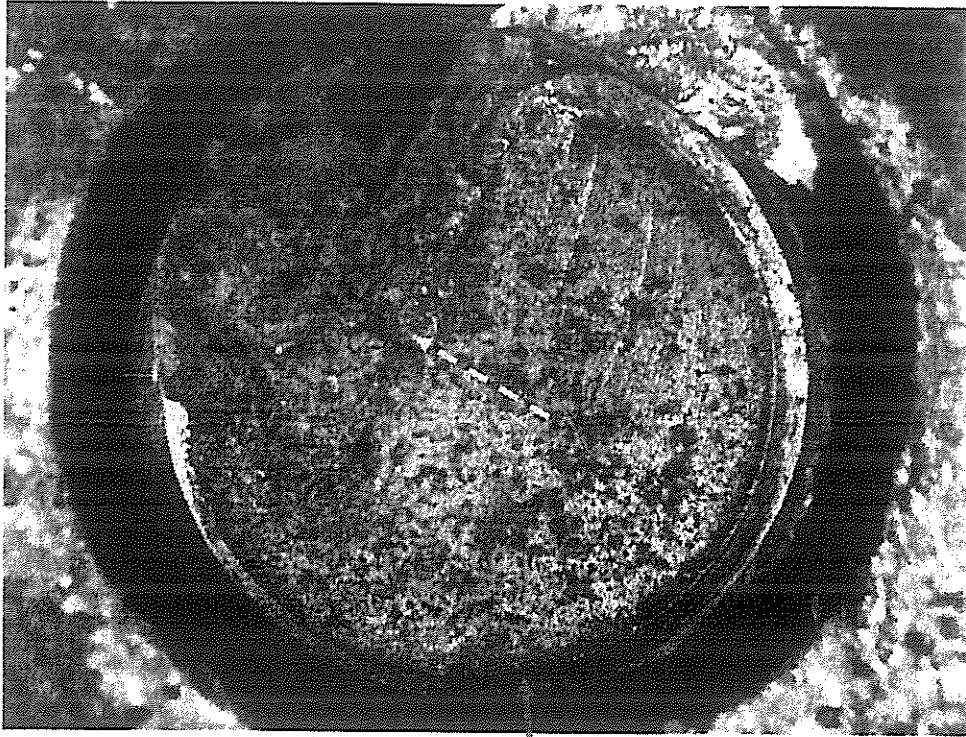
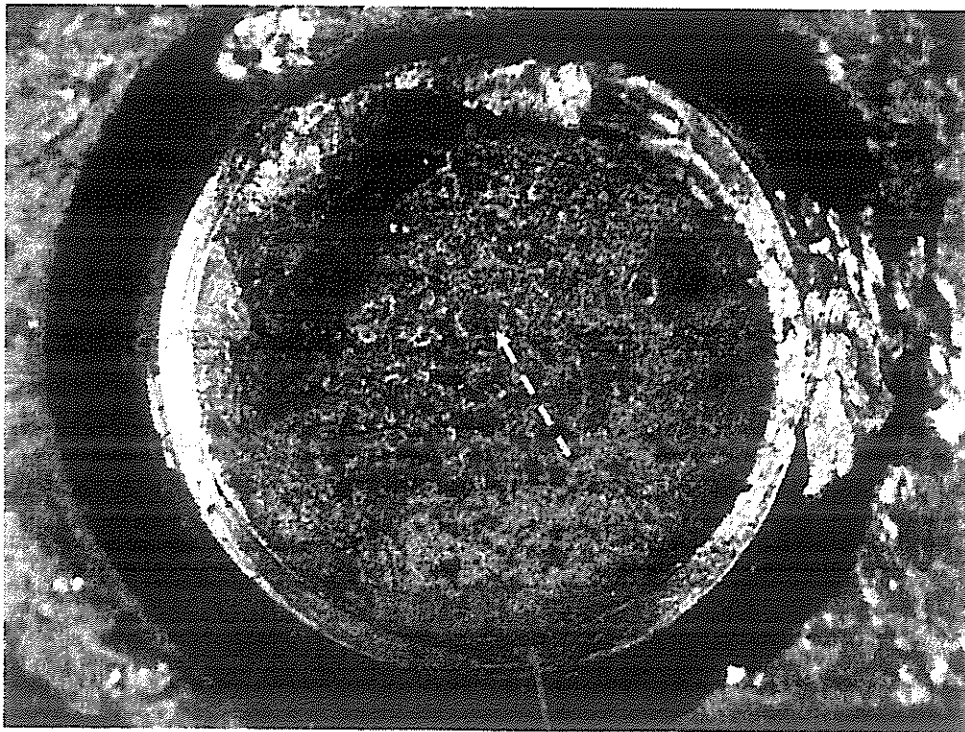
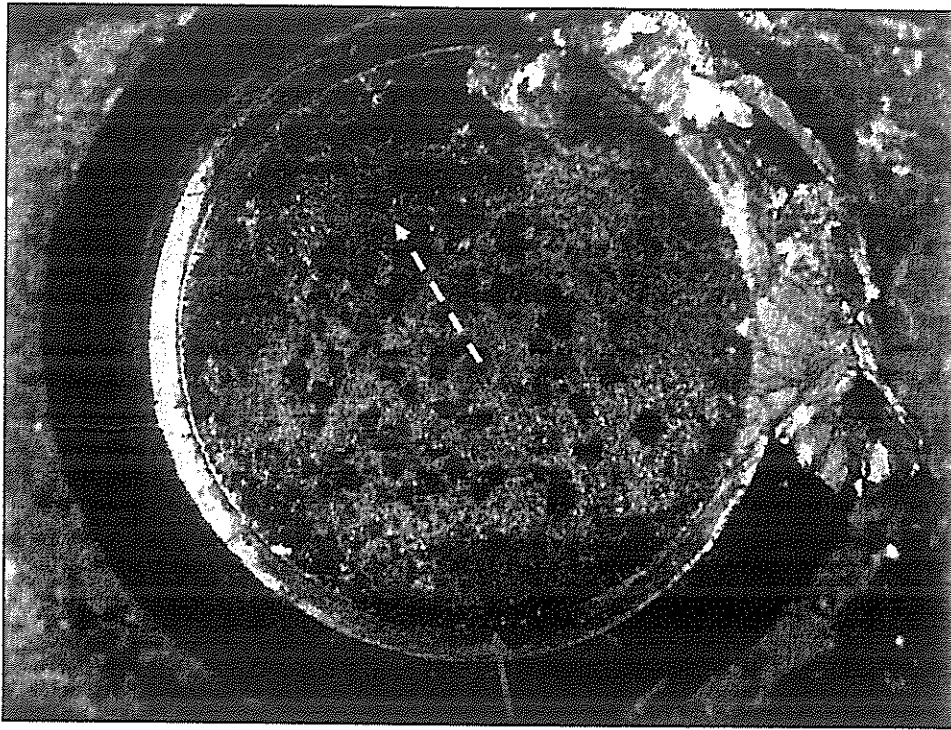
Bolts 5, 6 and 7 (Figures 9 to 11) exhibited fracture origins near the same relative orientation as that of Bolt 2; however, the direction of propagation changed shortly after initial crack formation. Fatigue crack propagation extended across approximately 60 percent of the cross section. Final fracture was at an angle to the hub axis and to that of the fracture in bolt 2.

Figure 9. Bolt 5 – fracture features revealed that breakage occurred in unidirectional bending fatigue, but origins were originally nearer the inner diameter – centerline is down

Figure 10. Bolt 6 – fracture features revealed that breakage occurred in unidirectional bending fatigue, with origins at an angle to the hub axis – centerline is down

Figure 11. Bolt 7 – fracture features revealed that breakage occurred in unidirectional bending fatigue, with origins at an angle to the hub axis – centerline is down

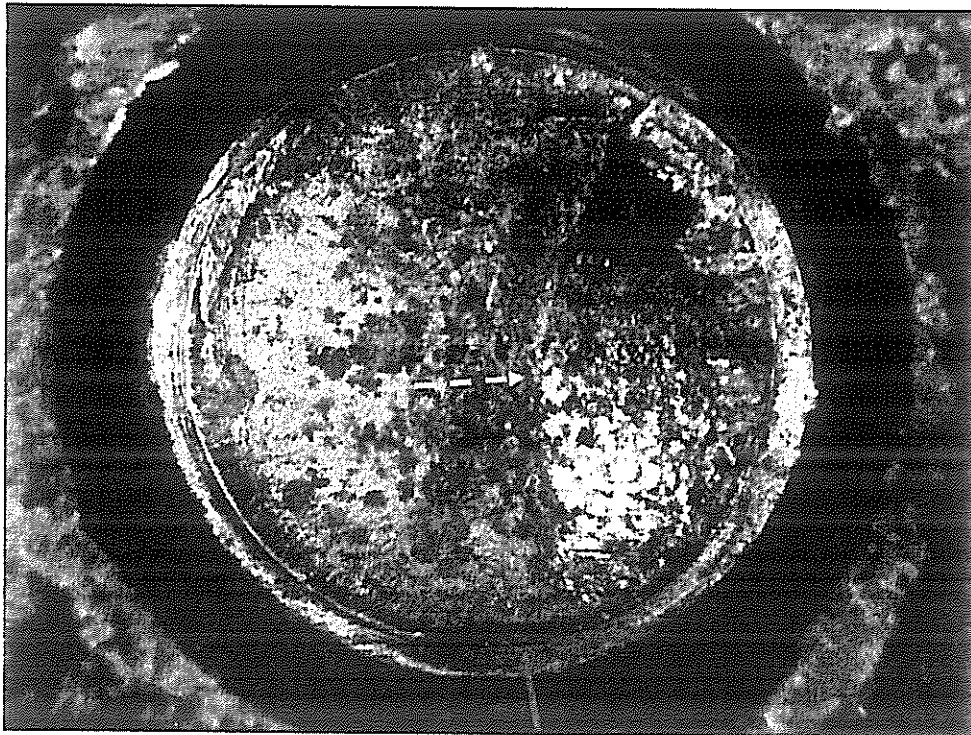
Bolt 8 (Figure 12) exhibited a similar location of the initial fatigue crack origins, but the direction of fracture changed significantly, with final fracture in a circumferential direction.

Figure 12. Bolt 8 – fracture features revealed that breakage originated in unidirectional bending fatigue near the inner diameter, but the direction of propagation changed

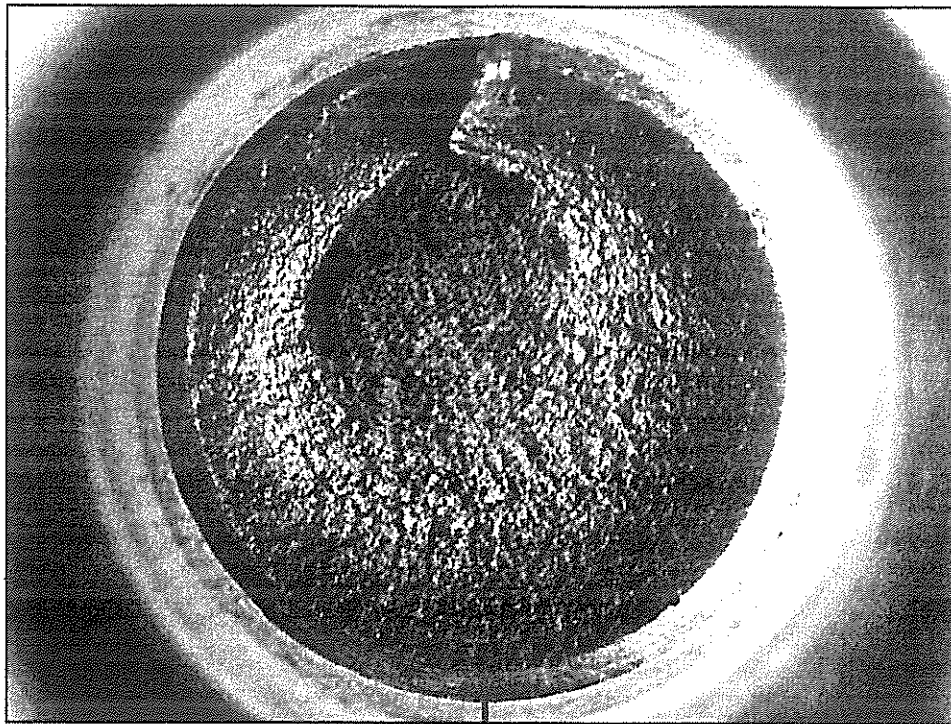
Fracture features on the loose bolt (Figure 13) were significantly different from those on the five bolts that remained in the hub. Although there was an arc section that exhibited initial bending fatigue origins, the majority of the fracture progression occurred in what appeared to be rotating bending fatigue. In order for this bolt to be subjected to rotating bending fatigue, it would have to rotate within the hub so that the bending fatigue load would be applied at different orientations. As noted earlier, rotation was possible in location 3 in that the serrations were ineffective in holding the stud in place. Final fracture in the center occurred as the result of a tensile overload, most likely during the final separation of the wheel joint.

Figure 13. Loose bolt – although there appear to be some primary bending fatigue origins along the bottom edge, a majority of the fracture occurred in rotating bending fatigue

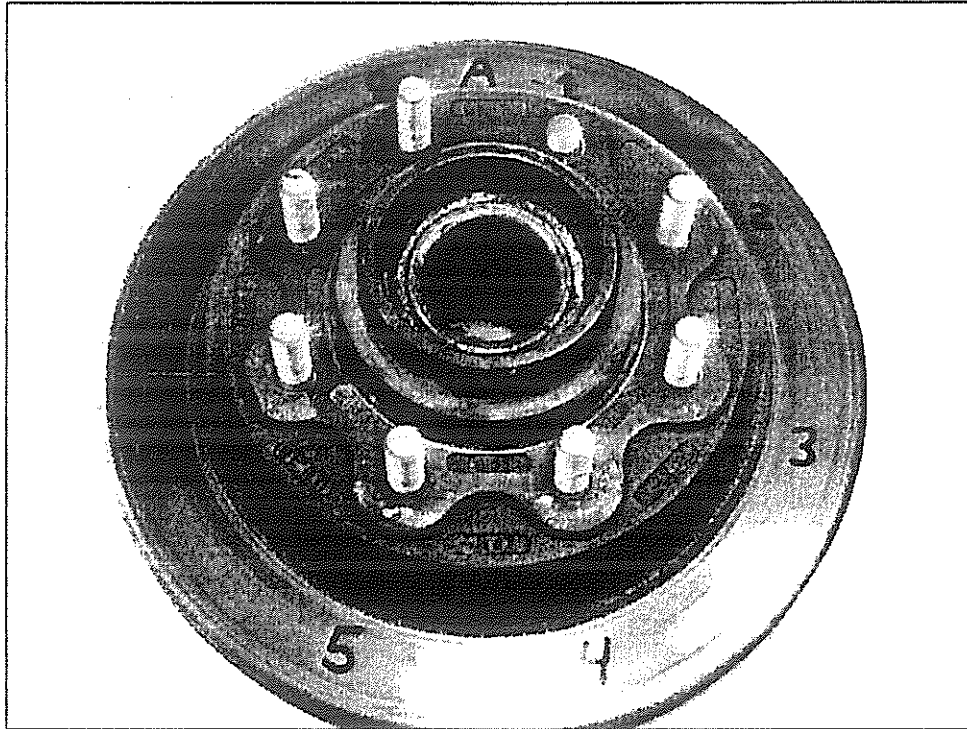
Figure 1. Brake rotor "A" showing scattered wear in the D position

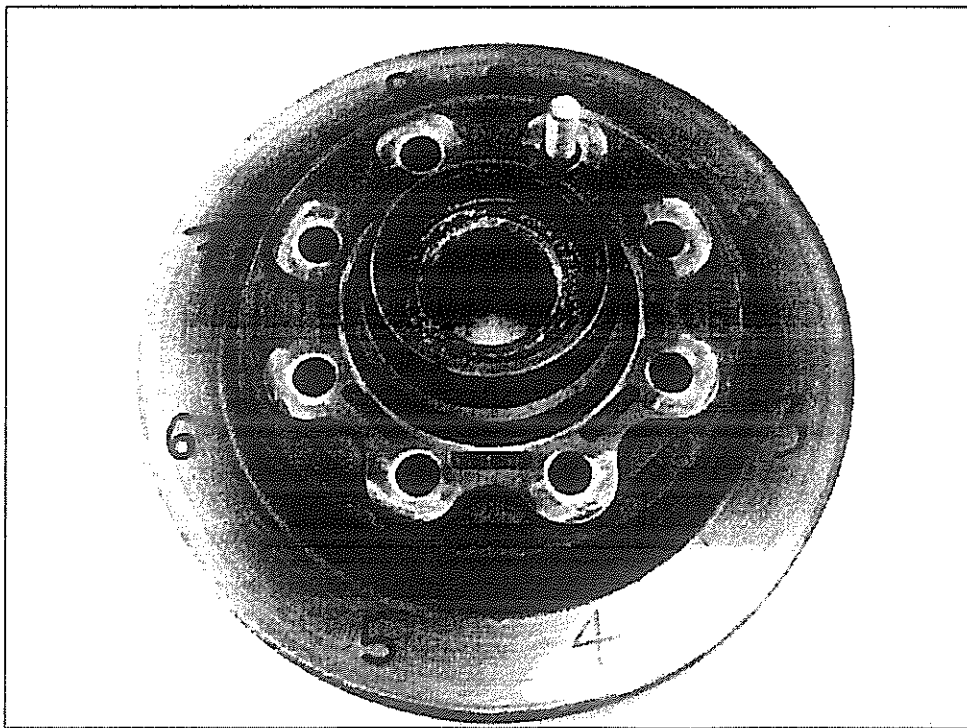
Figure 2. Brake rotor "B" showing scattered wear in the C and consistent wear in the D positions

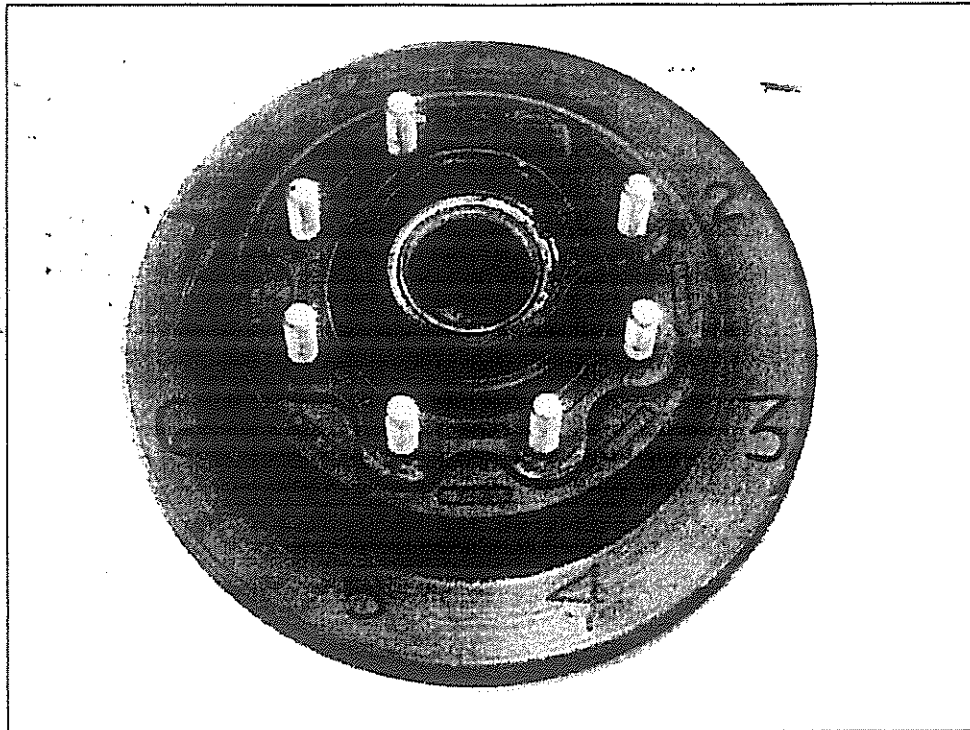
Figure 3. Brake rotor "C" showing consistent wear in the D position

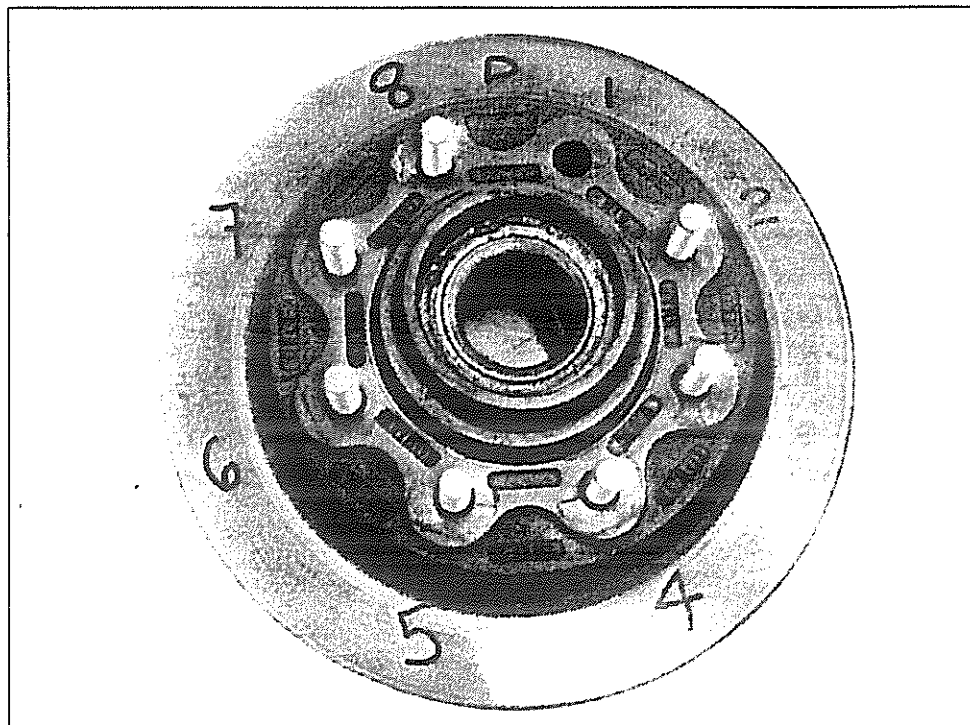
Figure 4. Brake rotor "D" showing consistent wear in the D position

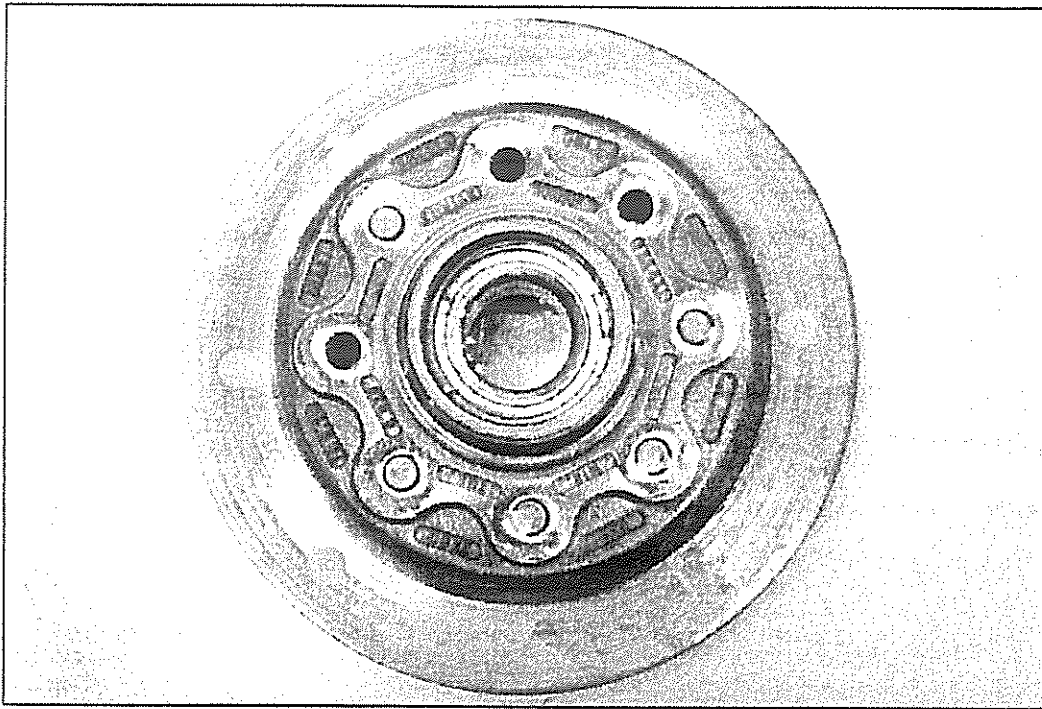
Figure 1. Showing the hub had bolts missing in locations 1, 3 and 4 – the other 5 bolts remained in the hub, but were later pressed out for examination of the hole surface

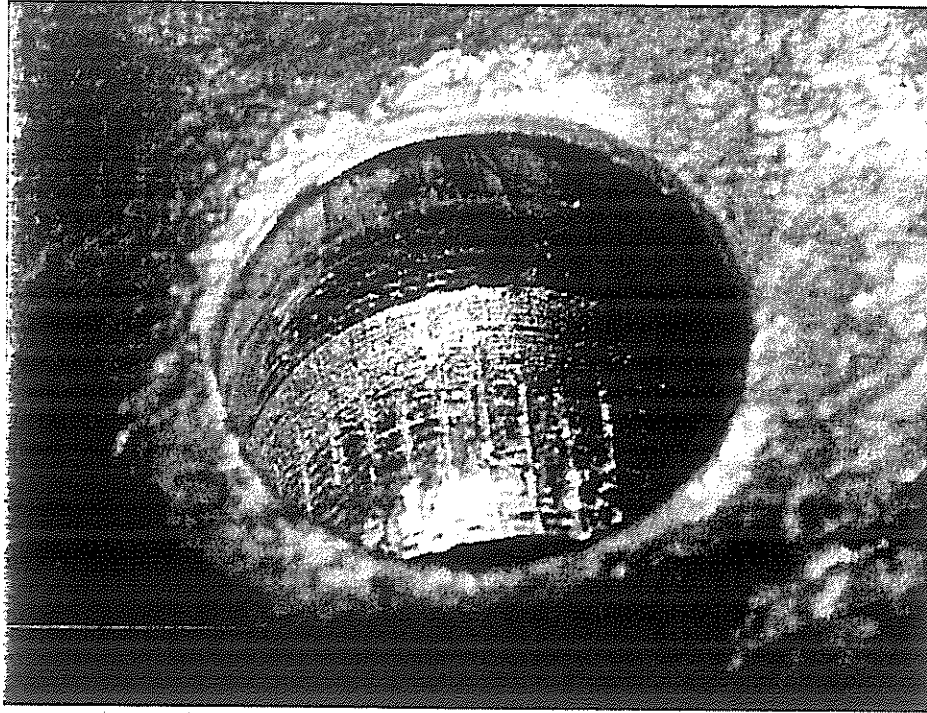
Hole locations 5, 6 and 3 exhibited wear features indicative of wheel bolt rotation. The cause of bolt rotation is unknown, but it could have occurred during assembly, when the bolt torque was checked, or during joint breakage.

Figure 5. Location 5 – serration marks from the bolt extended from the inside toward the outside for an appropriate length – paint was removed when the bolt spun in the hub

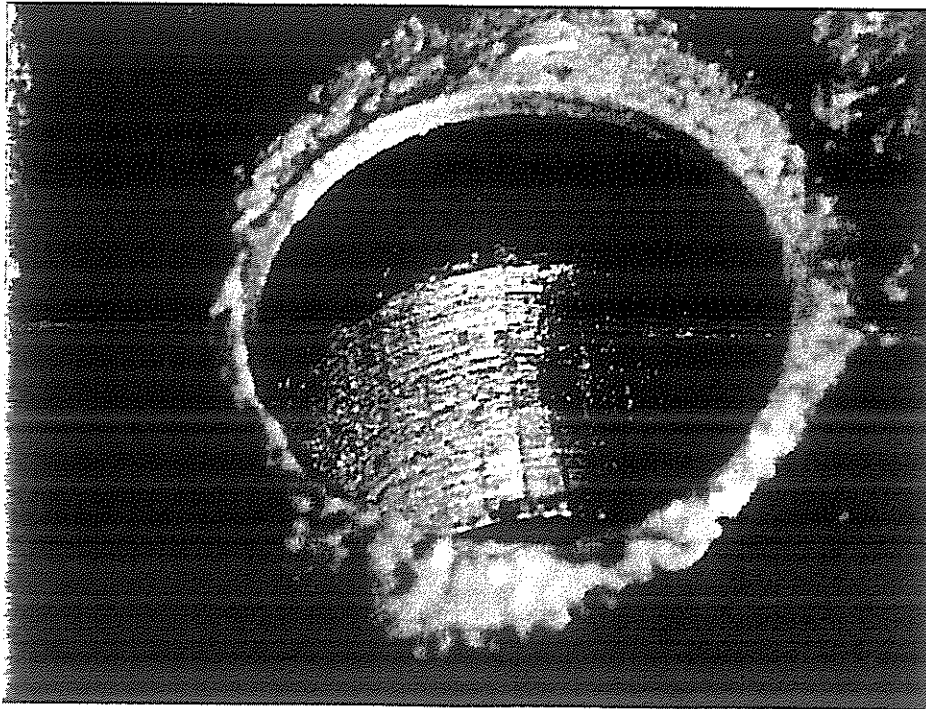
Figure 6. Location 6 – serration marks from the bolt extended from the inside toward the outside for an appropriate length – paint was removed when the bolt spun in the hub

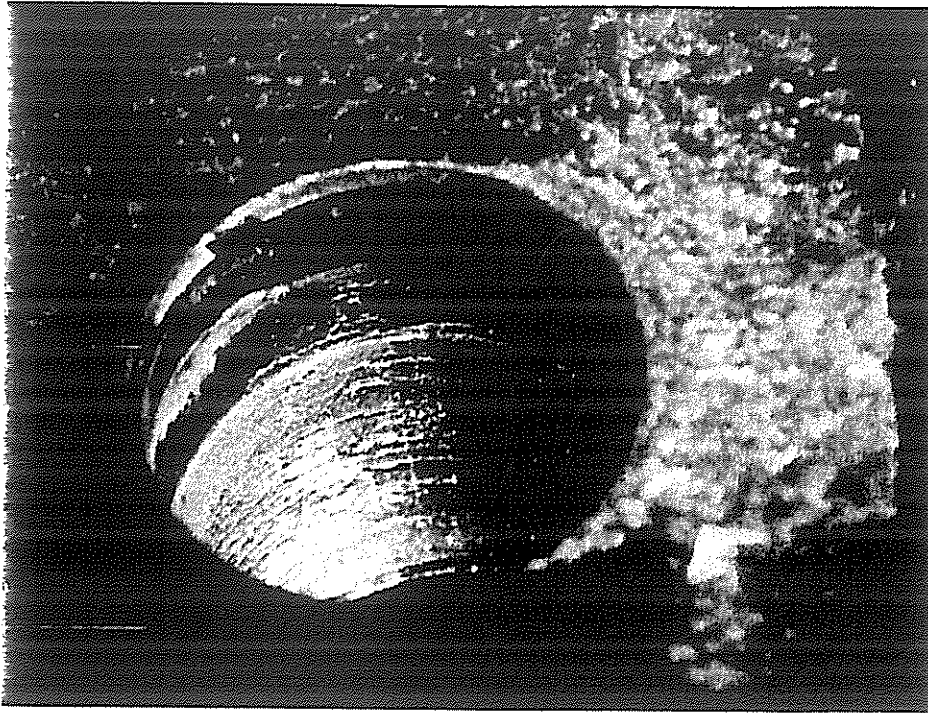
Location 3, which corresponds to one of the missing bolts, exhibited a high level of wear (Figure 7). Serration grooves appeared to have been almost completely worn off. This surface suggests that the bolt rotated within the hole and that its movement was not restricted.

Figure 7. Location 3 – serration markings were almost completely worn off the surface apparently as the result of the bolt rotating in the hole

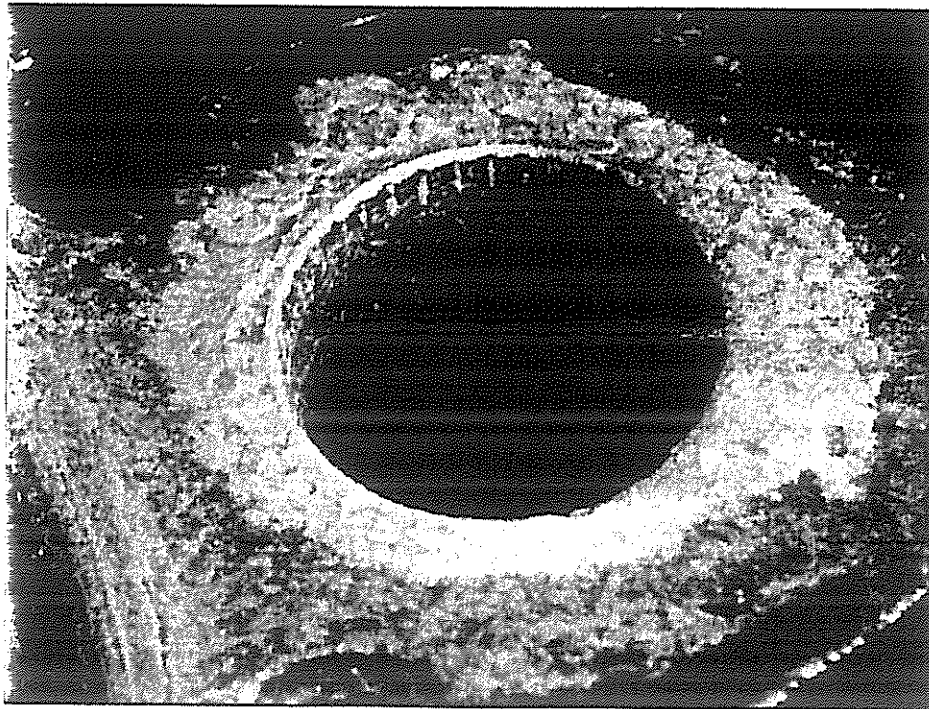
Hole surfaces in locations 1 and 4 exhibited serration marks that extended through the hub. Since the serration length on the bolt is less than the full length of the hole, it is believed that the broken bolt may have been pulled through the hole after the head broke off.

Locations 1 and 4, the other two locations where bolts were missing, exhibited wear and serration marks that extended the full length of the hole (Figure 8 and 9). Serration markings for the full length suggest that the bolt was pulled through the hole. In order for the bolts to pull through the hub, the heads would have had to break off.

Figure 8. Location 1 – serration marks were found extending for the entire length of the hole and the surface was worn, which removed all paint
