EA11-007 – Index of Laboratory Reports

QA Lab Report No. 4398

SUBJECT: Paint Thickness

OBJECT: Determine the mode and possible cause of breakage.

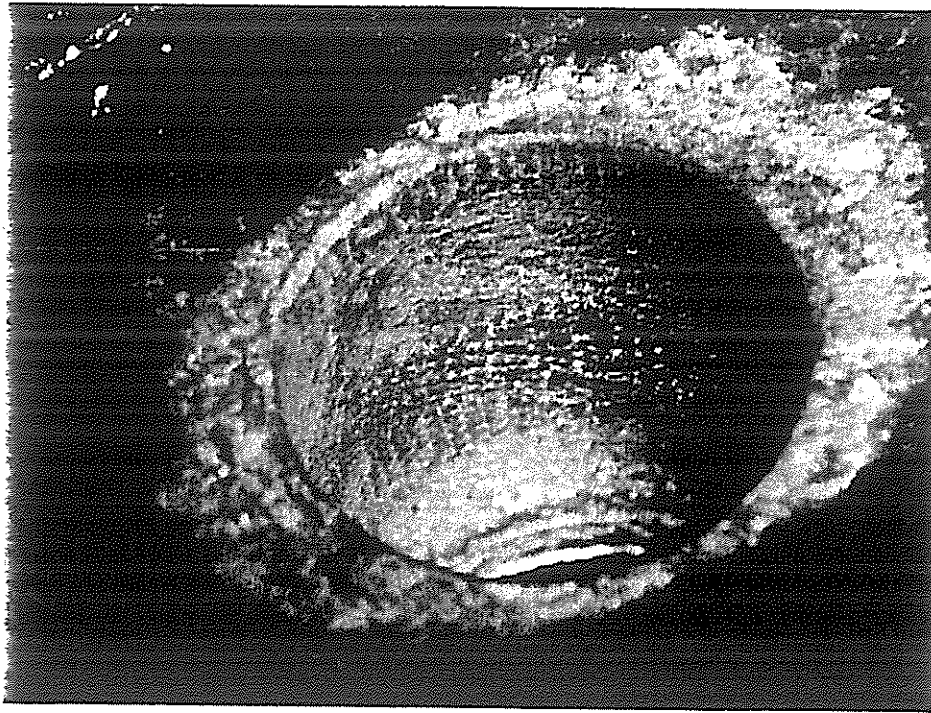
Hole surfaces in locations 1 and 4 exhibited serration marks that extended through the hub. Since the serration length on the bolt is less than the full length of the hole, it is believed that the broken bolt may have been pulled through the hole after the head broke off.

Locations 1 and 4, the other two locations where bolts were missing, exhibited wear and serration marks that extended the full length of the hole (Figure 8 and 9). Serration markings for the full length suggest that the bolt was pulled through the hole. In order for the bolts to pull through the hub, the heads would have had to break off.

Figure 9. Location 4 – serration marks were found extending for the entire length of the hole and the surface was worn, which removed all paint

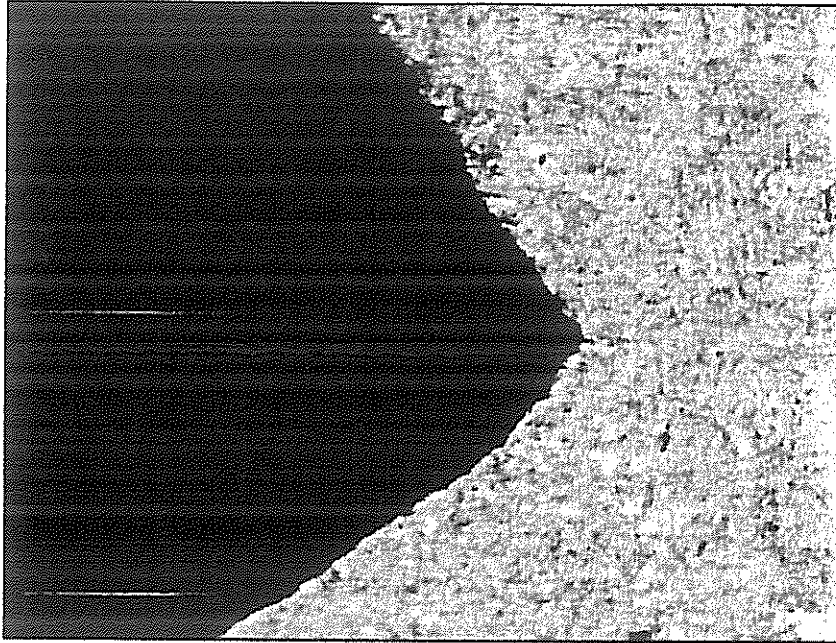
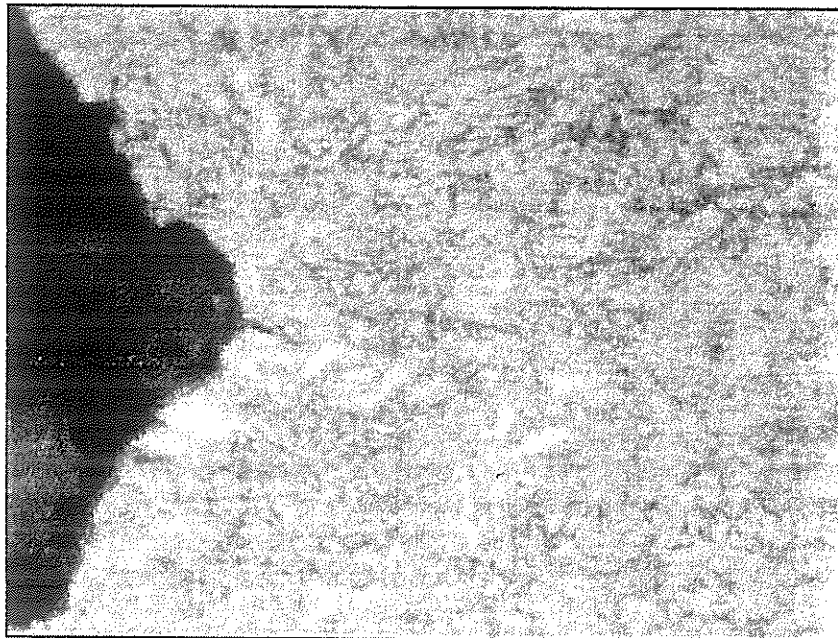
Figure 1. Right Front, Bolt 6 – showing a sharp corner at the bottom of the thread root at the thread runout – a grain boundary is seen at the bottom of the corner, but this did not appear to be a crack.

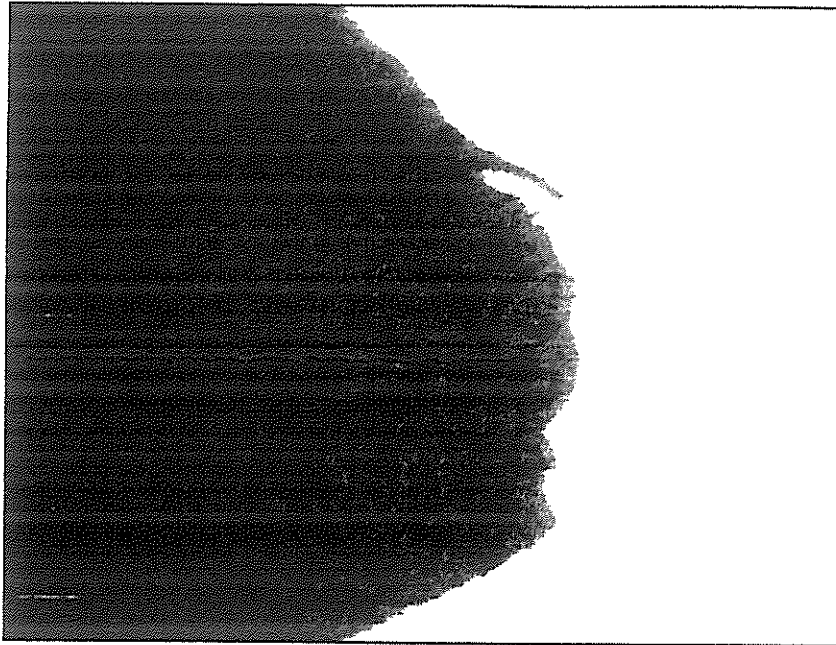
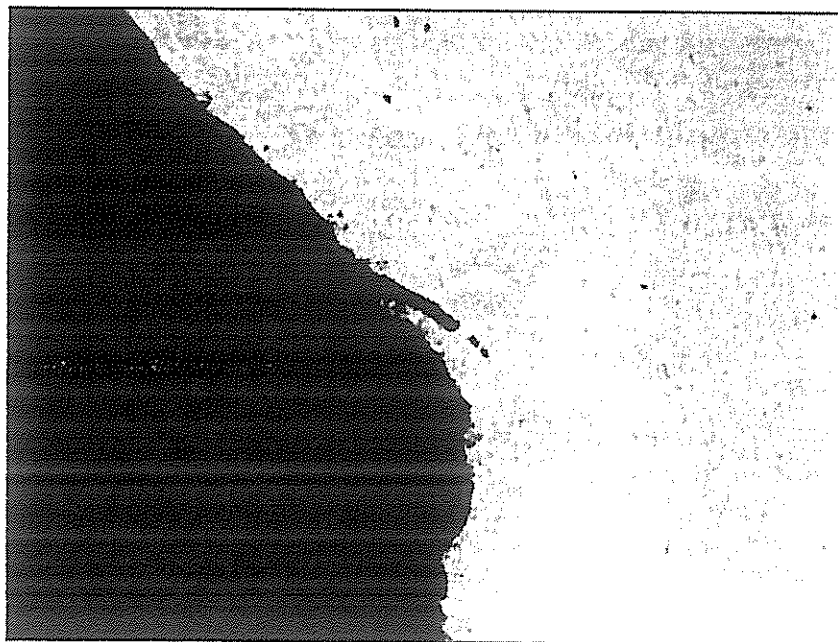
Figure 2. Right Front, Bolt 6 – this cross section at 90 degrees to Figure 1 shows a small lap from thread rolling in the bottom of the thread profile near the thread runout – no evidence of cracking was observed in association with the lap

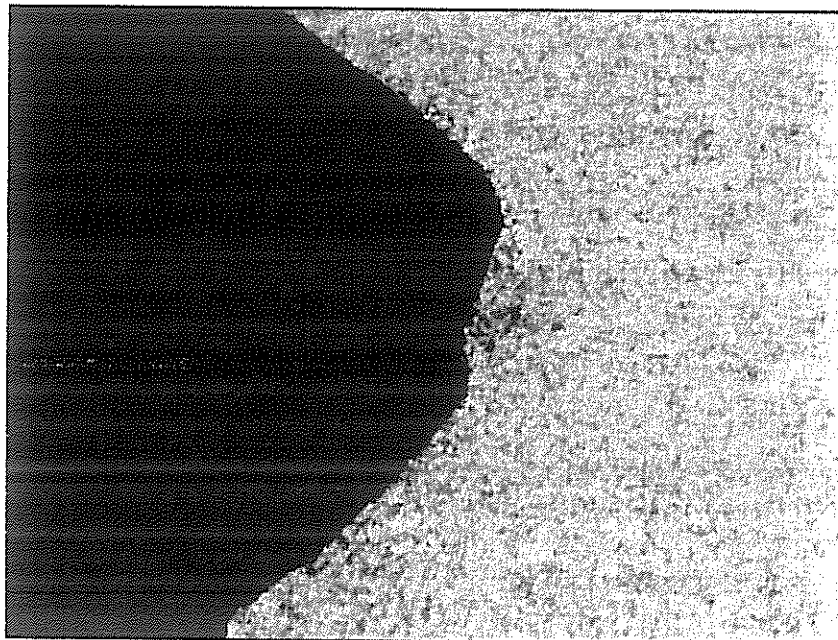
Figure 3. Right Front, Bolt 8 – showing a small lap from thread rolling in the bottom of the thread root at the thread runout – there was no evidence of crack propagation off the lap

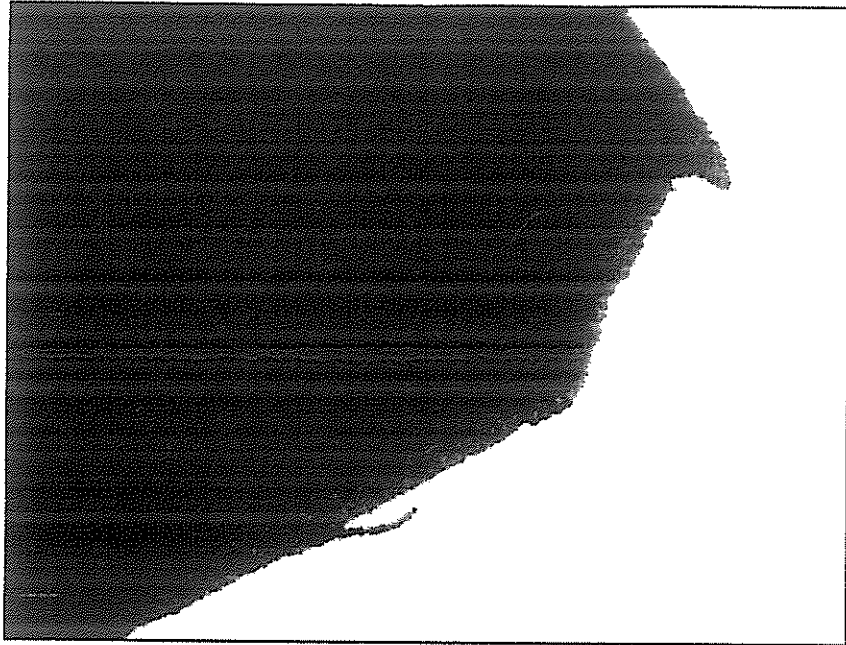
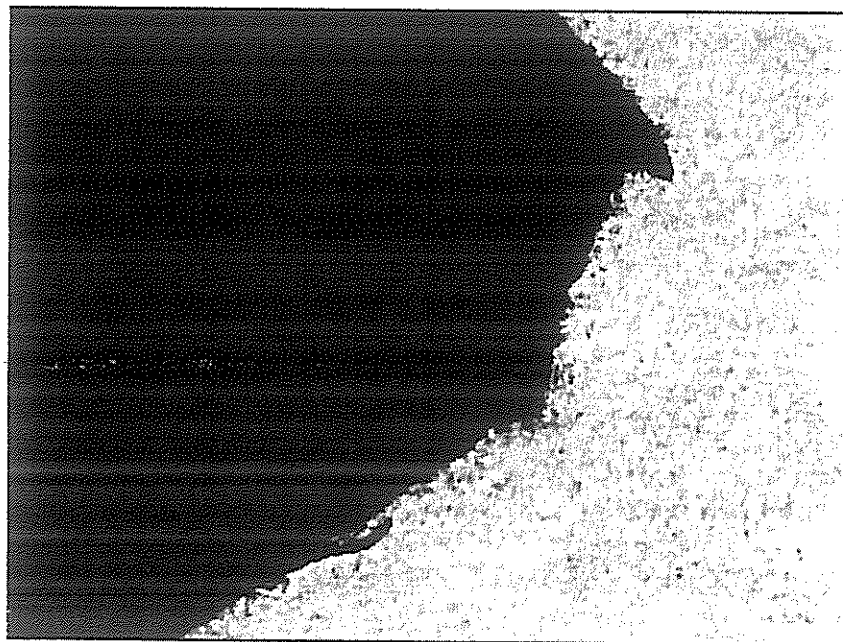
Figure 4. Left Front, Bolt 5 – showing a sharp bottom corner in the thread root and a small lap on the thread flank at the thread runout – there was no evidence of crack propagation

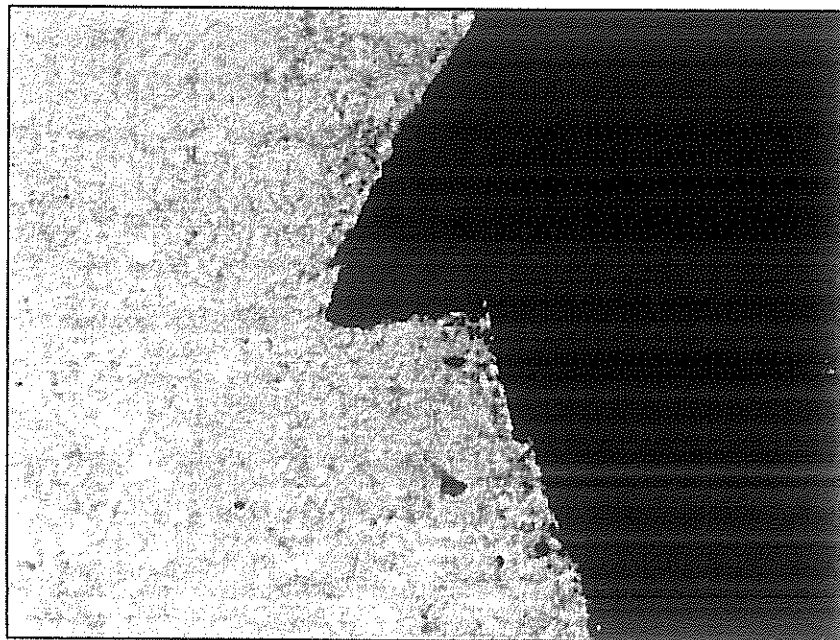
Figure 5. Left Front, Bolt 8 – showing a sharp corner in the bottom of the thread at the thread runout – there was no evidence of crack propagation off the corner
