PRODUCT SAFETY RECALL

SUBJECT: Shift Lever Indicator May Not Display Correct Gear

MODELS: 2008-2010 Chevrolet Malibu
2008-2010 Pontiac G6
2007-2010 Saturn AURA
Equipped with 4-Speed Automatic Transmission (ME7/MN5)

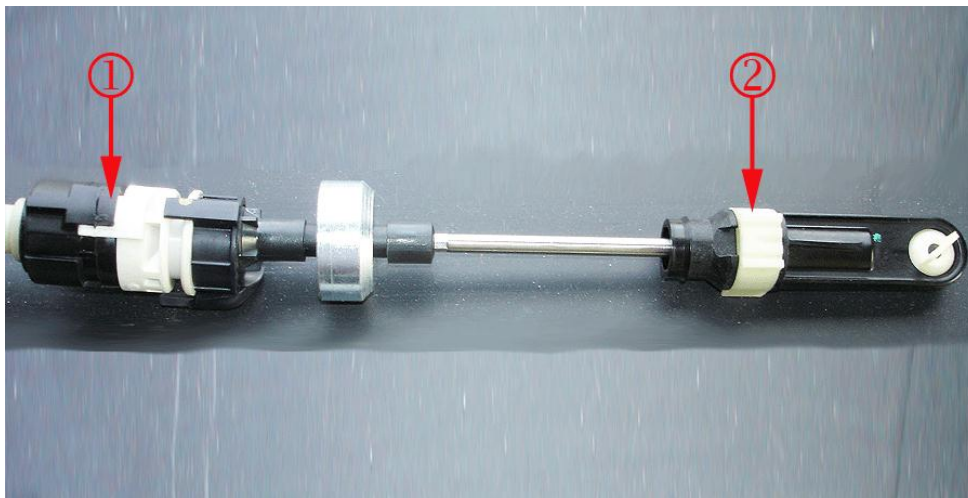
2269489

- (1) Shift Cable Locking Tabs
- (2) Shift Cable Adjuster Locking Clip

1. Open the hood and locate the transmission shift cable.
2. Determine if the transmission shift cable locking tabs are fractured and separated.

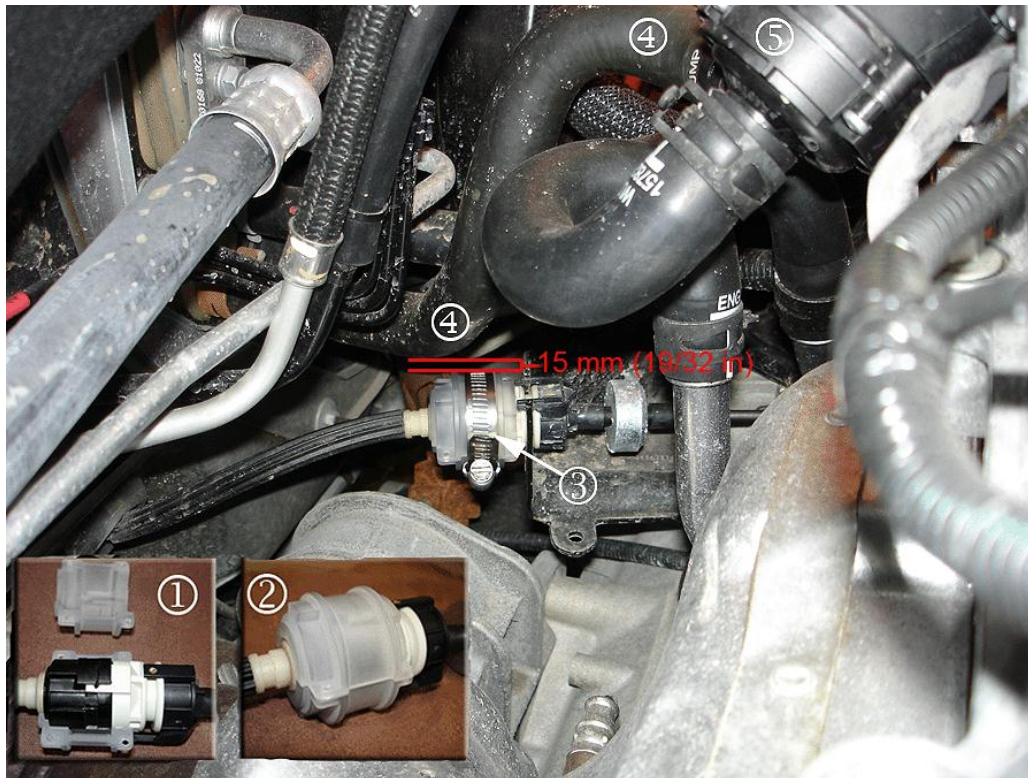
2269484

- (1) Clam Shell in Two Pieces
- (2) Clam Shell Around Shift Cable Locking Tabs
- (3) Clamp on Clam Shell
- (4) Inlet Coolant Hose and
- (5) Heater Cooler Pump.

3. Install the clam shell (1) (2) over the shifter cable locking tabs.

4. Install the service clamp over the clam shell (3). Position the clamp fastener head away from the inlet coolant hose (4). **Tighten the clamp to 4 N·m (35 lb-in).**
5. Ensure that there is 15 mm (19/32 in) of clearance between the inlet coolant hose (4) and the clam shell (3). On hybrid equipped vehicles, it may be necessary to reposition the inlet coolant hose (4) to achieve the required 15 mm (19/32 in) of clearance. **To reposition the inlet coolant hose (4) on hybrid equipped vehicles, locate the heater cooler pump (5) and perform Steps 5.1-5.4.**

Caution: Do not kink or damage the inlet coolant hose (4) when repositioning the hose to obtain the 15 mm (19/32 in) clearance. To avoid damaging the hose clamp, use J-38185 or equivalent hose clamp pliers to loosen the hose clamp.

- 5.1. Using J-38185 or equivalent hose clamp pliers, loosen the inlet coolant hose (4) connected to the heater cooler pump (5). Note the location of the clamp on the inlet coolant hose (4).
 - 5.2. Rotate the inlet coolant hose (4) clockwise until 15 mm (19/32 in) of clearance between the inlet coolant hose (4) and clam shell (3) is achieved.
 - 5.3. Ensure that the inlet coolant hose clamp is secure on the inlet coolant hose (4) in the production location.
 - 5.4. Install the generator control module cover. Refer to *Generator Control Module Cover Replacement* in SI.
6. Close the hood.
