## #11175A: Special Coverage Adjustment -Shift Lever May Not Display Correct Gear - (Feb 11, 2013)

Models: 2007-2008 Saturn AURA

Equipped with 4-Speed Automatic Transmission (ME7/MN5)

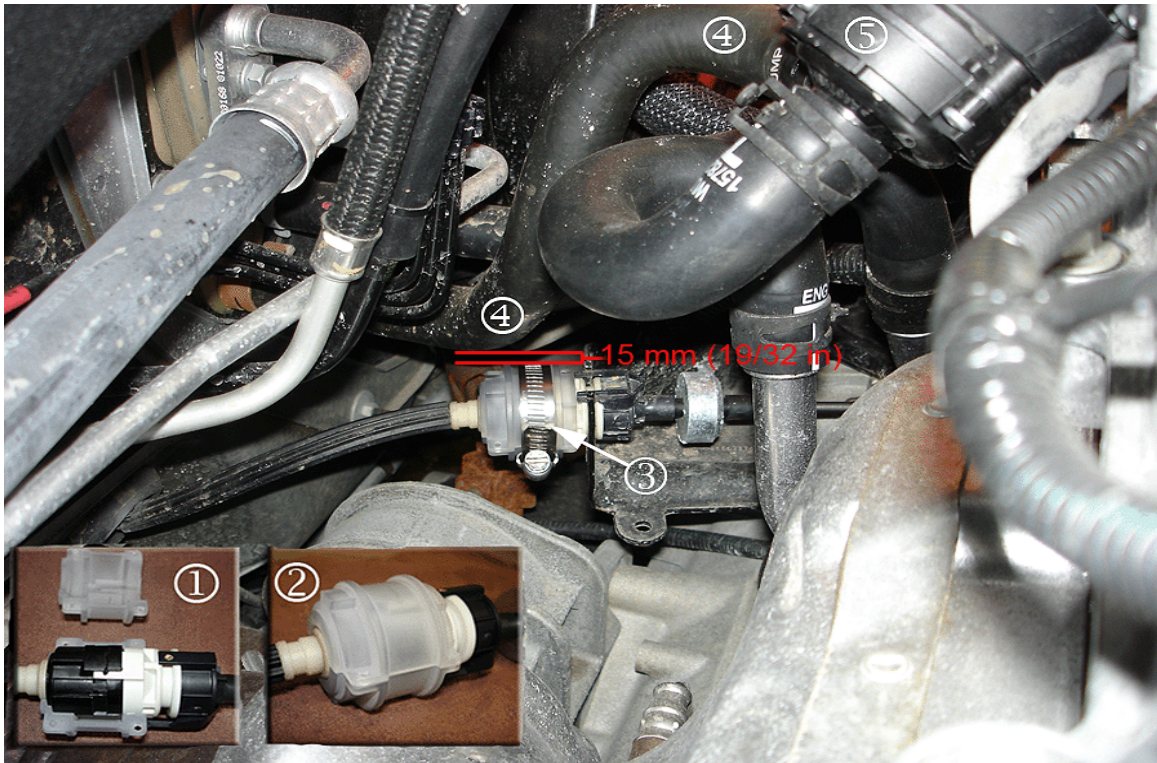
Note: Hybrid vehicle shown. Combustion engine vehicle is similar.

1 – Clam Shell in Two Pieces

2 – Clam Shell Around Shift Cable Locking Tabs

3 – Clamp on Clam Shell

4 – Inlet Coolant Hose and

5 – Heater Cooler Pump.

5. Install the clam shell (1) (2) over the shifter cable locking tabs.
6. Install the service clamp over the clam shell (3). Position the clamp fastener head away from the inlet coolant hose (4). *Tighten the clamp to 4 N·m (35 lb-in).*
7. Ensure that there is 15 mm (19/32 in) of clearance between the inlet coolant hose (4) and the clam shell (3). On hybrid equipped vehicles, it may be necessary to reposition the inlet coolant hose (4) to achieve the required 15 mm (19/32 in) of clearance. *To reposition the inlet coolant hose (4) on hybrid equipped vehicles, locate the heater cooler pump (5) and perform Steps 5.1-5.4.*

- 7.2 Rotate the inlet coolant hose (4) clockwise until 15 mm (19/32 in) of clearance between the inlet coolant hose (4) and clam shell (3) is achieved.

- 7.3 Ensure that the inlet coolant hose clamp is secure on the inlet coolant hose (4) in the production location.
