## #11342E: Customer Satisfaction - Enhancements for Side Impact Pole Performance - (May 3, 2012)

Subject: 11342E – Enhancements for Side Impact Pole Performance

Models: 2011-2012 Chevrolet Volt

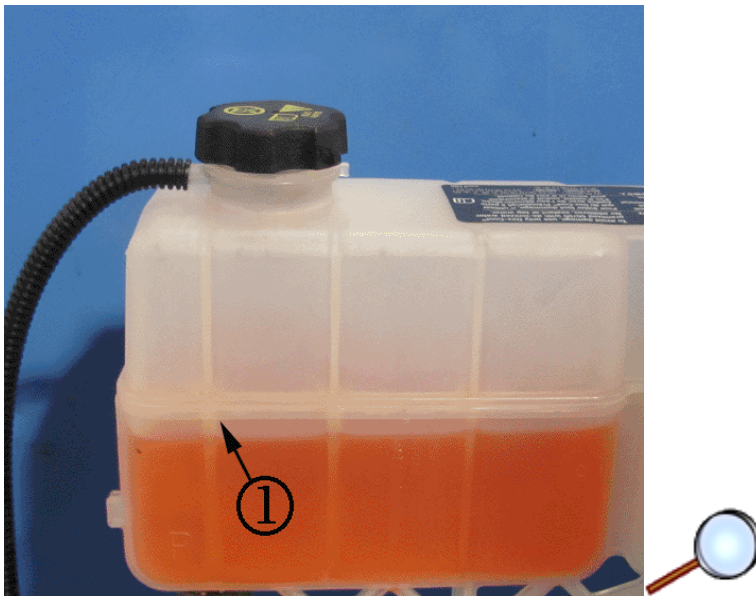
- If the coolant level of the drive motor cooling system reservoir is below the seam of the reservoir (1), perform leak inspection diagnostics BEFORE proceeding to the service repair in this bulletin. Refer to SI for the appropriate leak inspection diagnostic information. Submit a warranty claim for leak inspection diagnostics and service repairs. After completing the inspection and repairs, proceed to the service repairs in this bulletin.
- If the drive motor cooling system reservoir is NOT below the seam of the reservoir (1), proceed to the service repairs in this bulletin.
