## VOLKSWAGEN DEALERSHIP COMMUNICATION

Subject: August 2010 Customer Notification - Voluntary Emissions Service Action 28F3 -Ignition Coils

**Subject: 2001-2007 Volkswagen Gasoline Engine Vehicles  
Inspect, and If Necessary, Replace Ignition Coils**

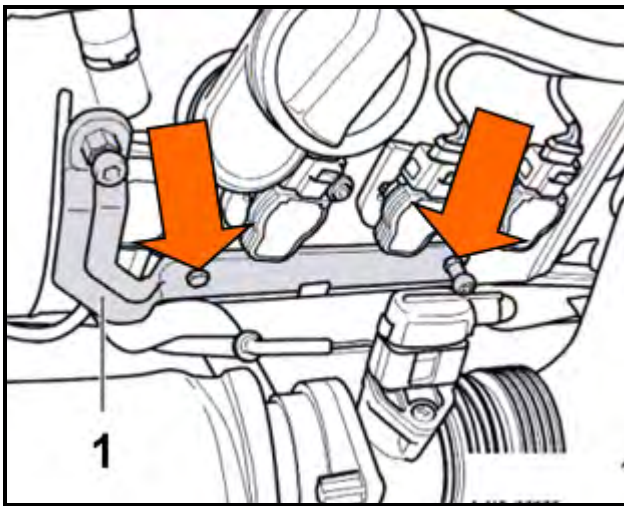
⚠ Note: To remove ignition coils, place the T40039 on the top-most thick rib -arrow- of the ignition coil with power output stage  
The lower ribs may be damaged if they are used
