EA11-003

VW

6/15/2012

WAVE 10

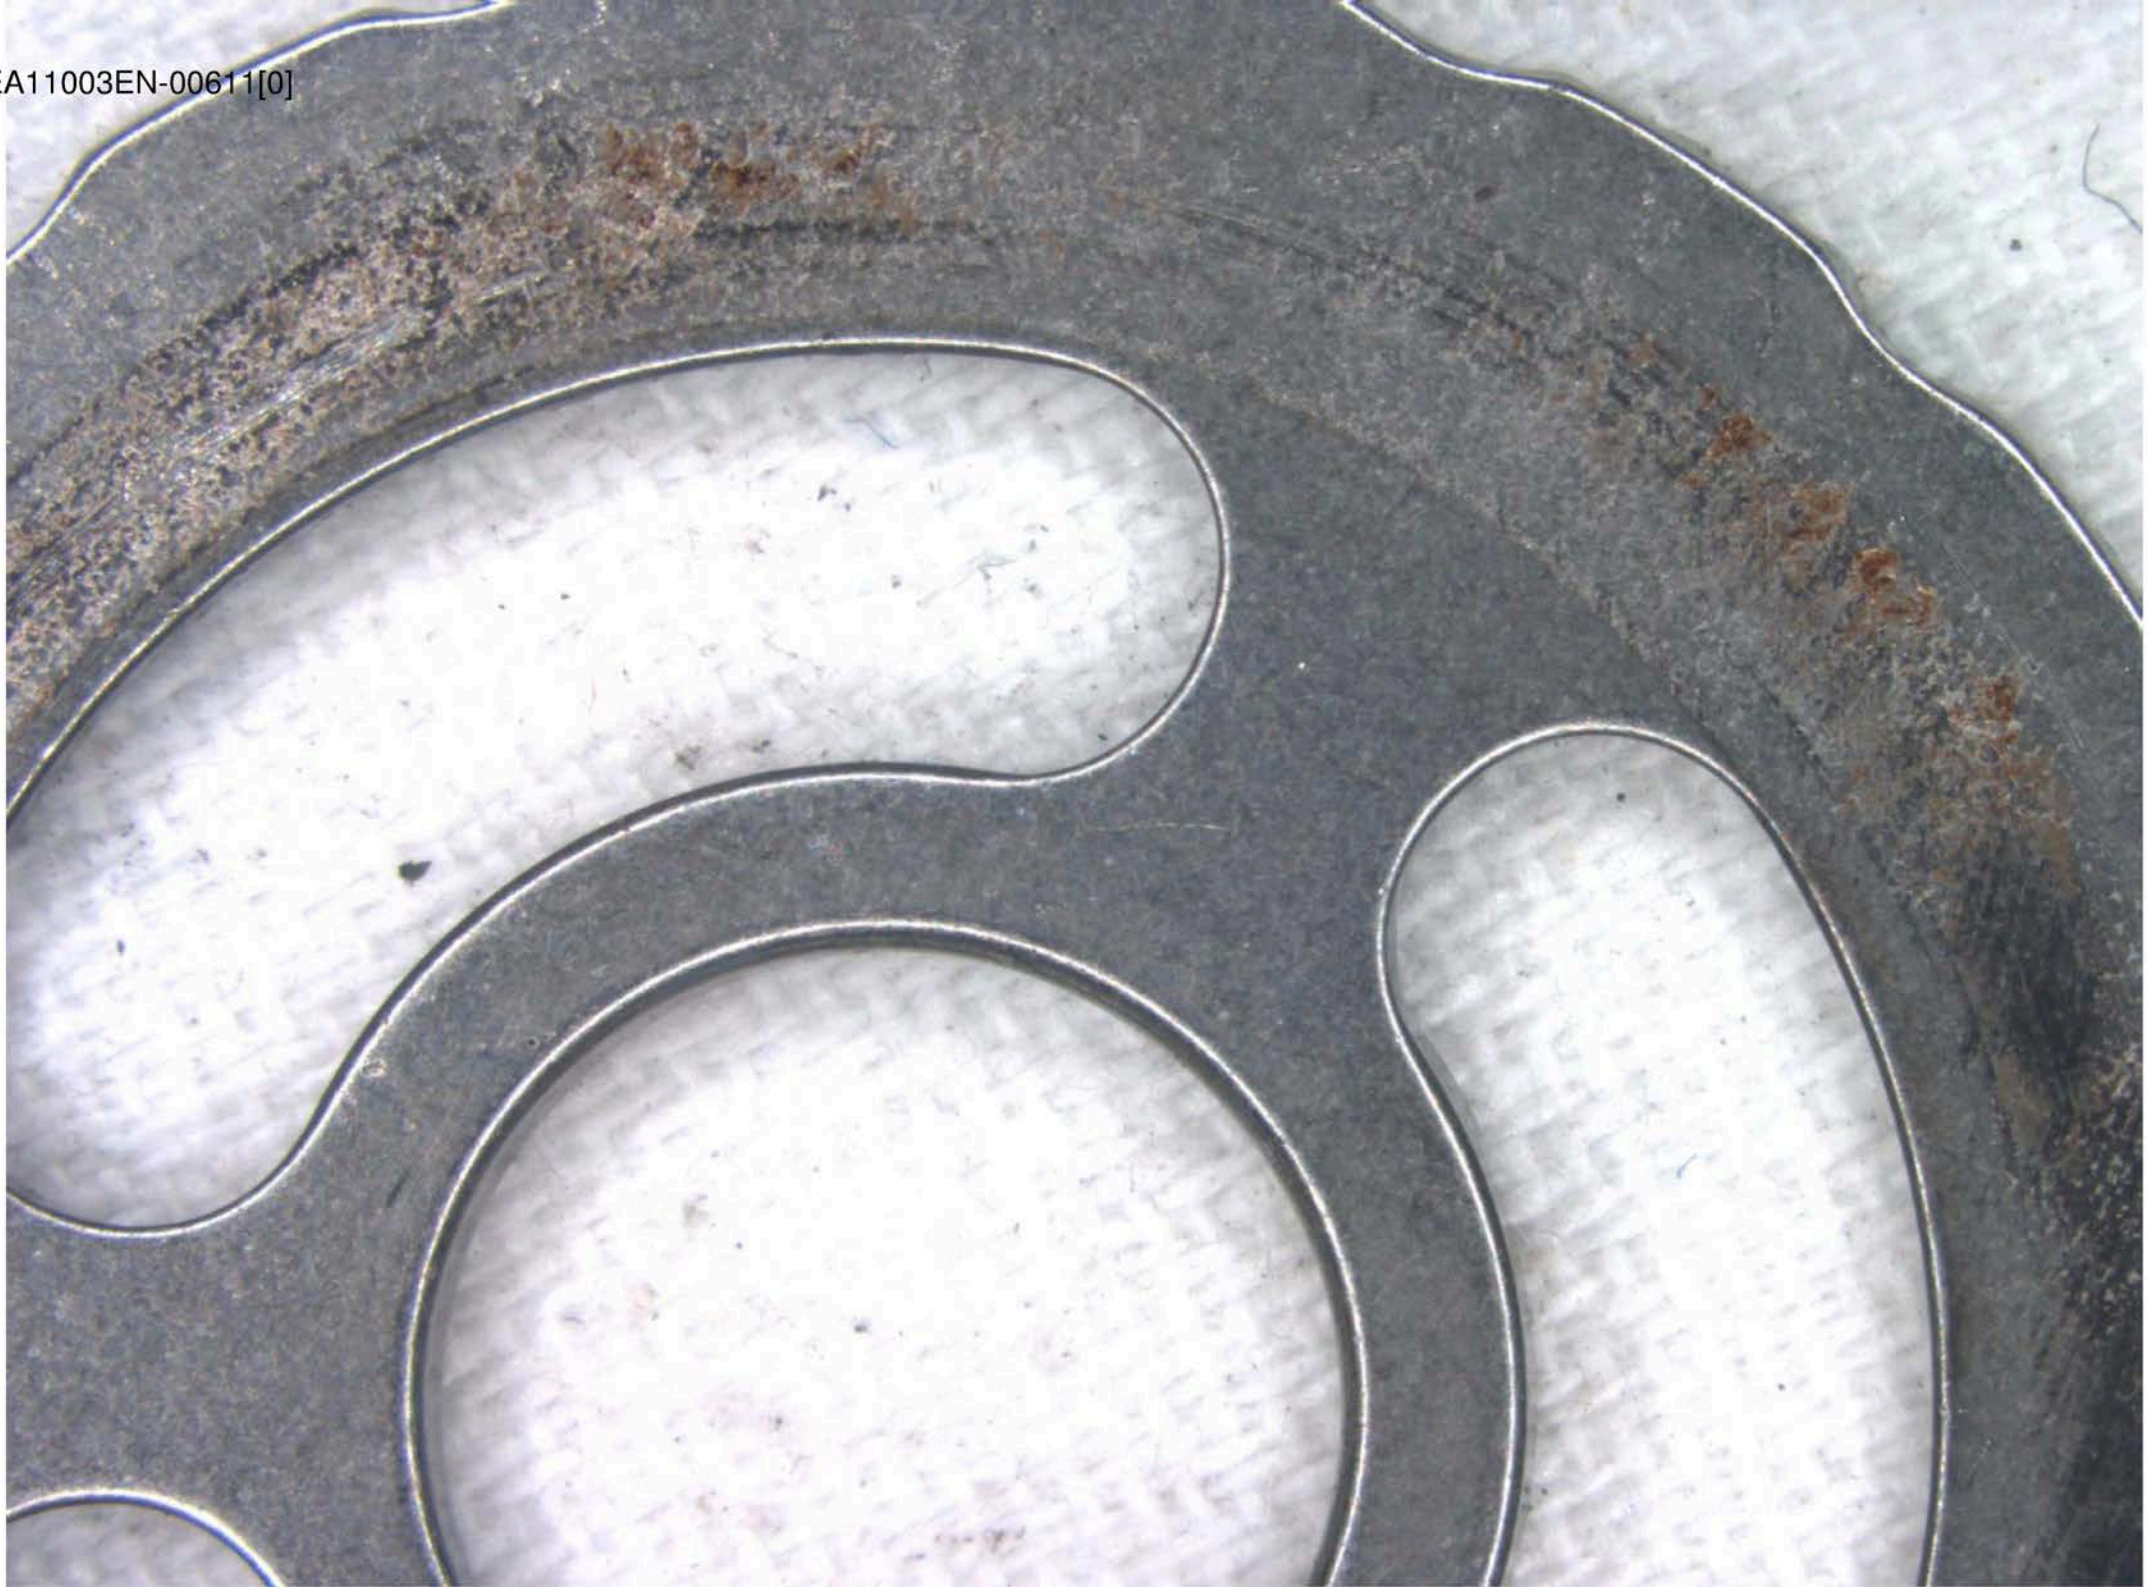
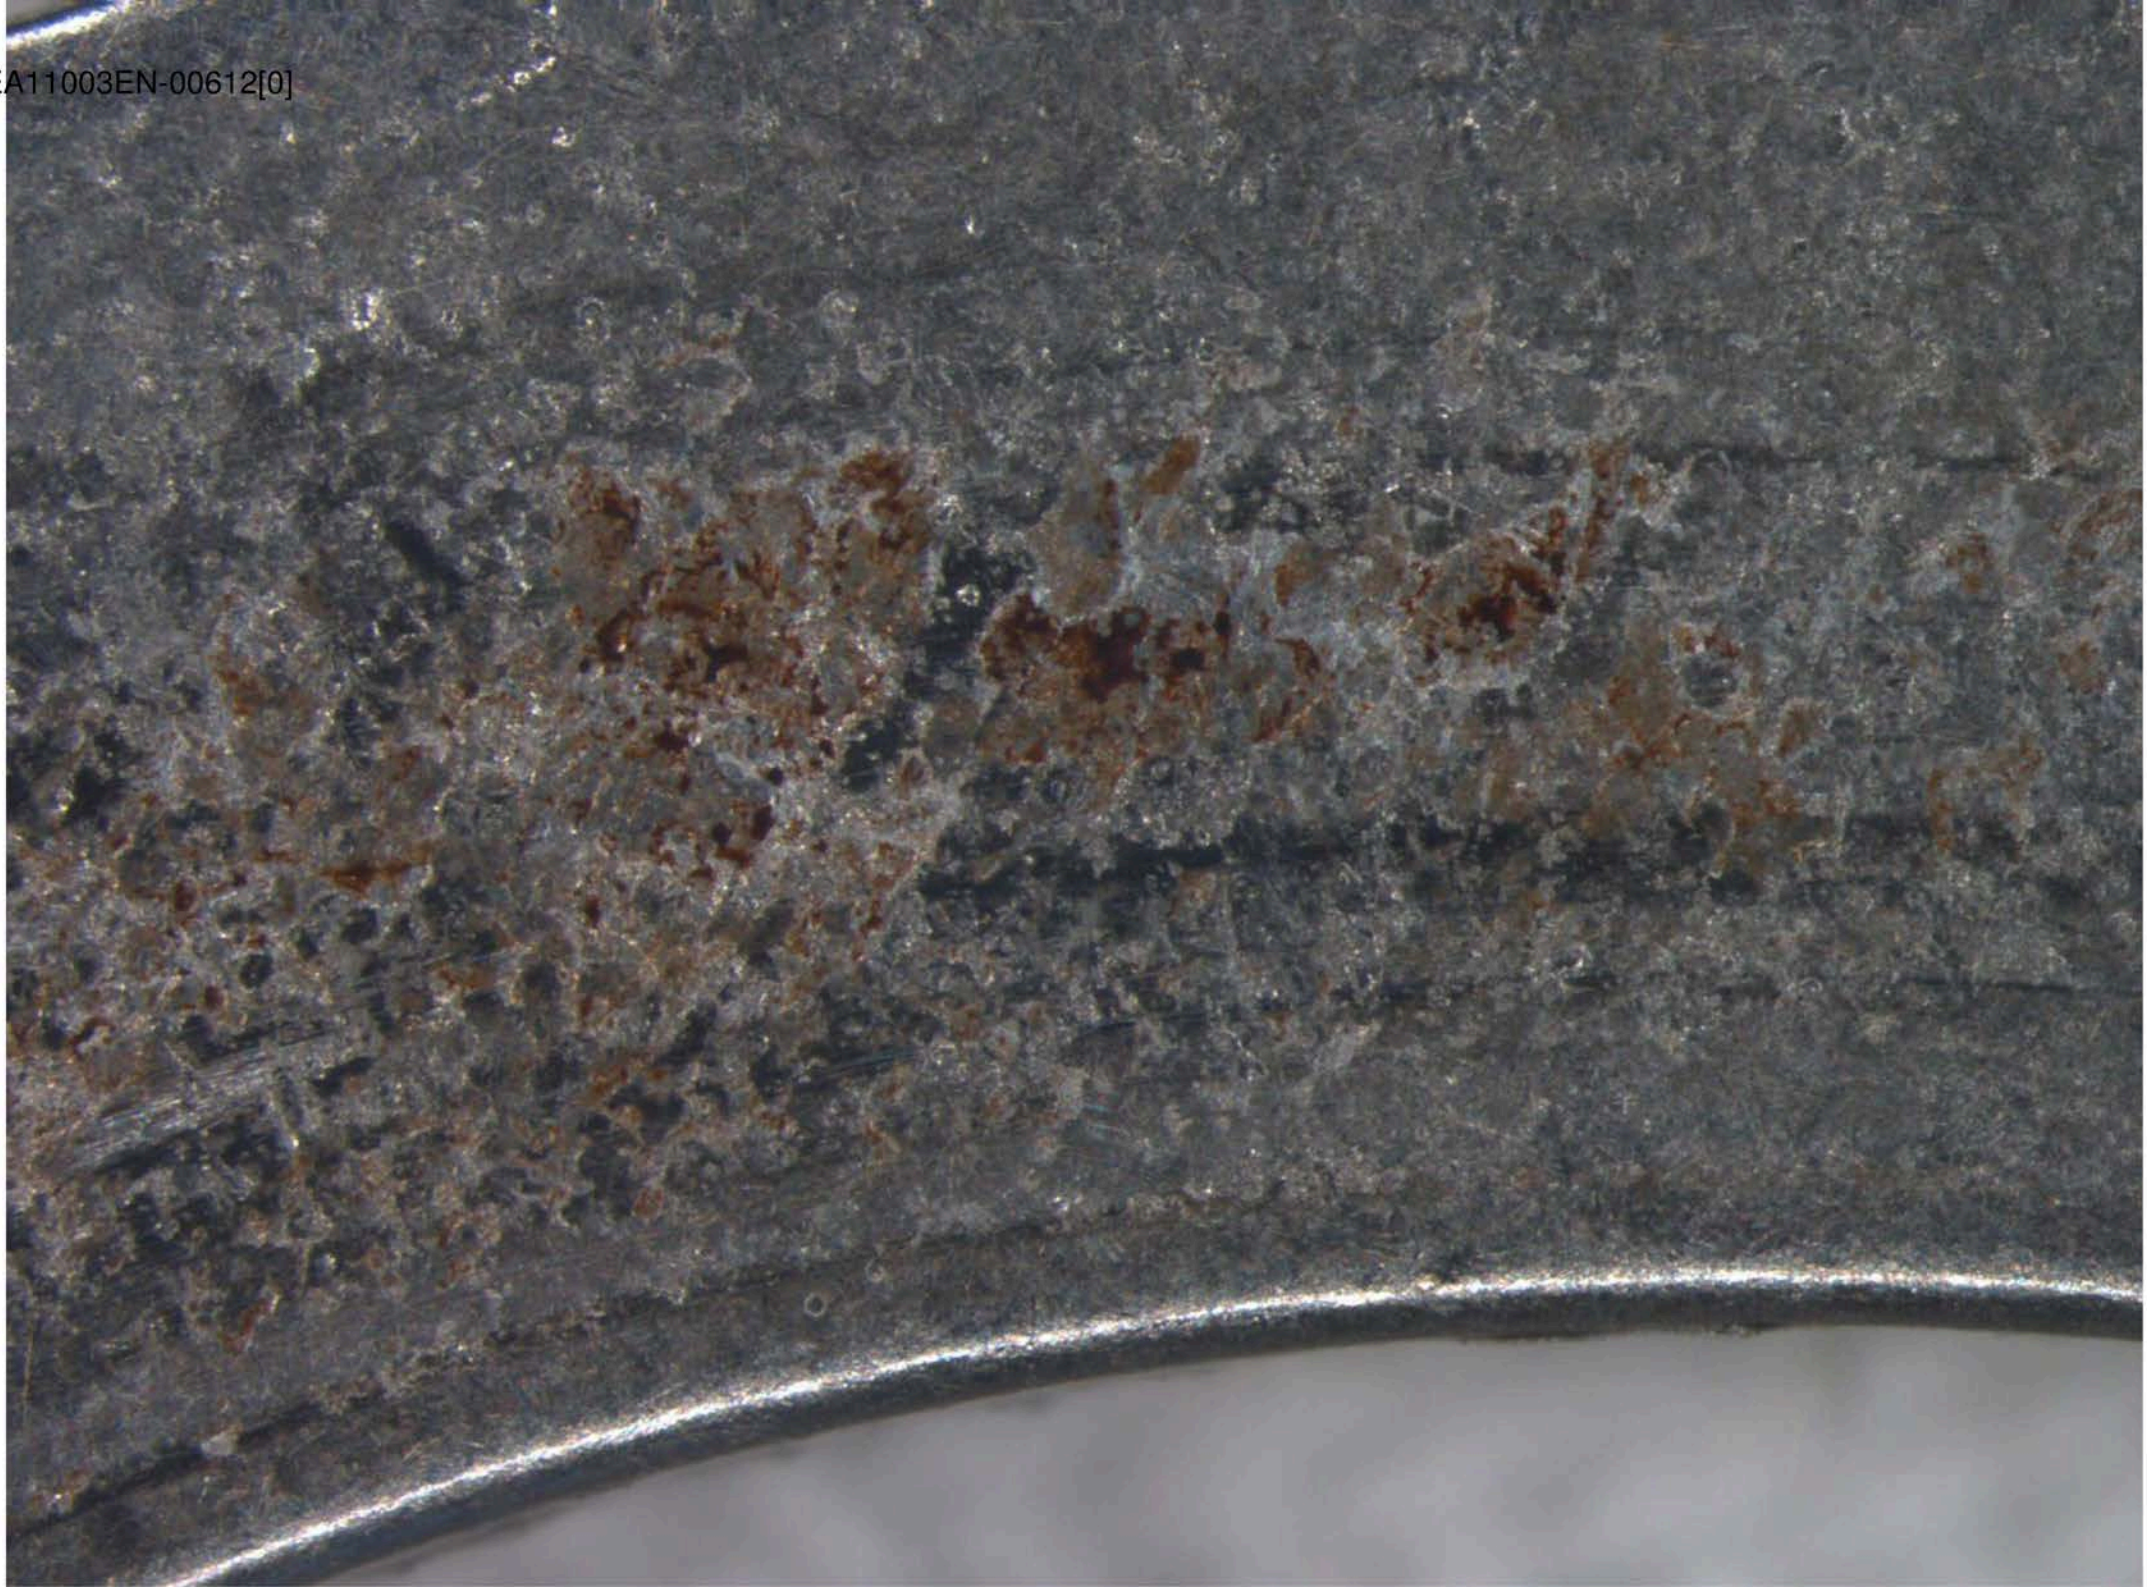
The 2nd return feed pump from the Audi USA tests (0445010613 #080428-0876 with 141925km) has Category I drivetrain damage and also indications of water in fuel at RS, tappet body, tappet spring and spring plate. VVT-No. 2009-CP4_0500

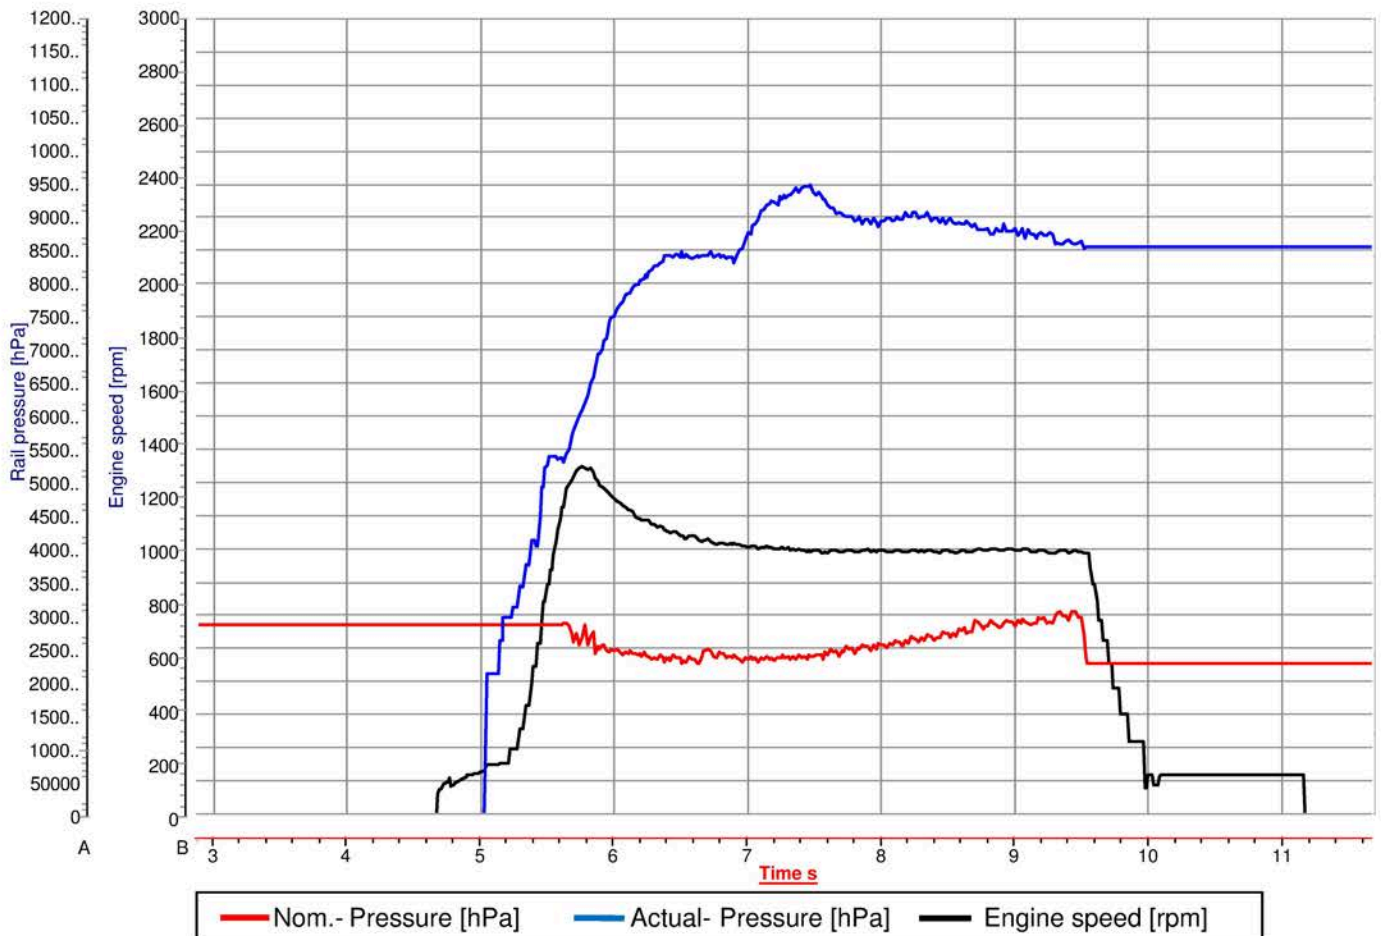
Fig. 1: Taking stock of the rail pressure regulator after starting the engine

Fig. 1 shows the error pattern upon arrival. After the engine start, the system cannot regulate the rail pressure. The actual pressure very quickly exceeds the threshold in the diagnosis which caused the engine to cut out.

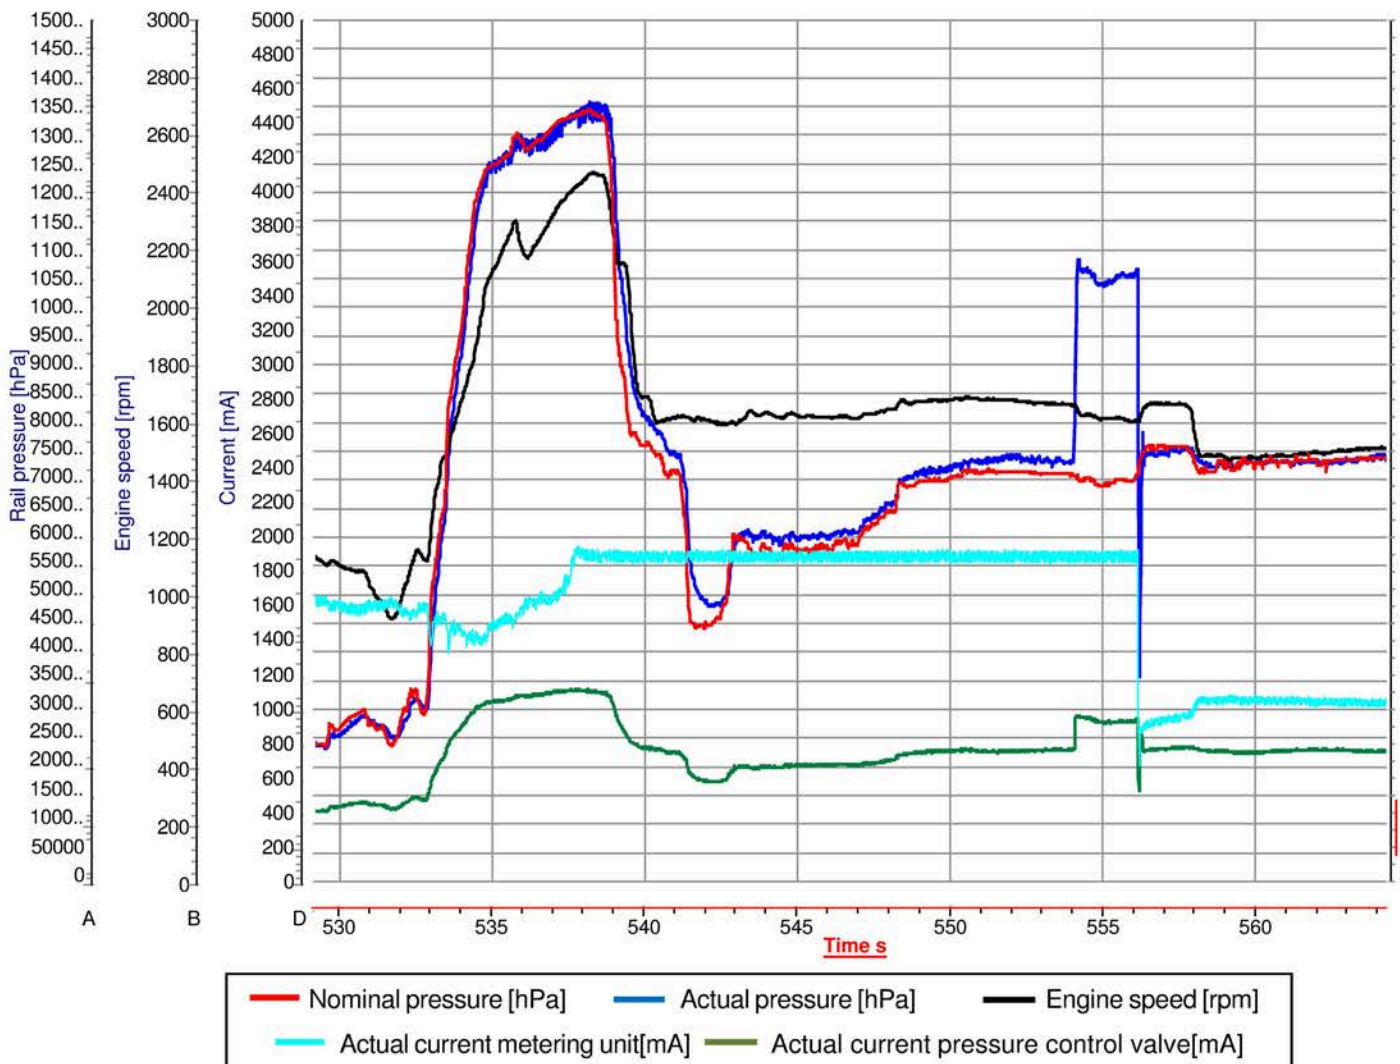
Fig. 2: Excerpt from measurements with switch over from CPC-(PCV+UM) to metering unit regulation

Fig. 2 shows an excerpt from the measurements taken during a test drive after the repairs above were made.

The vehicle started up and remained in driving condition as long as the rail pressure was being controlled via the pressure control valve **and** metering unit.

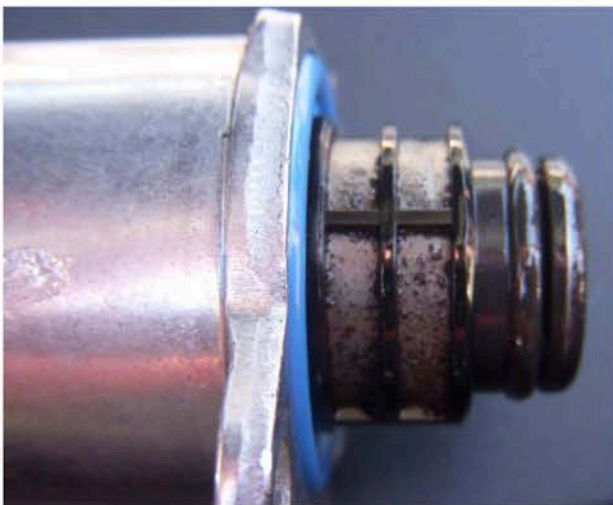
- After removing the metering unit, clear contamination could be seen (see Fig. 1+2) which impaired pressure regulation. The same deposits were found in the replaced rail and in the fuel filter (Fig. 3).

Dirt got into the injection hydraulics via the fuel tank and caused the fault pattern described above.

Fig. 1: Dirt in the metering unit

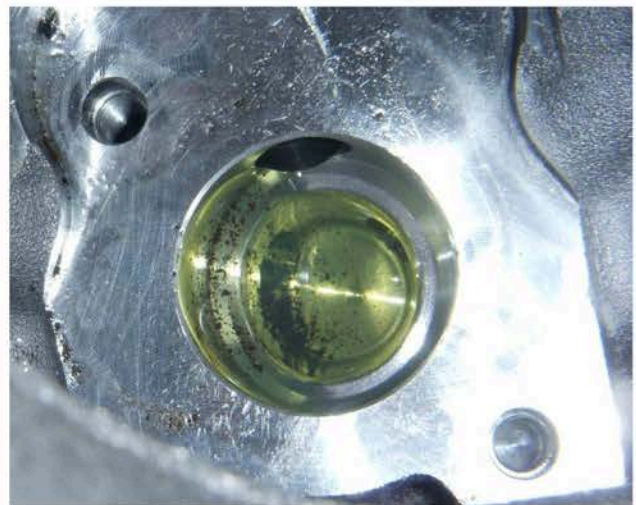
Fig. 2: Dirt, photo of metering unit

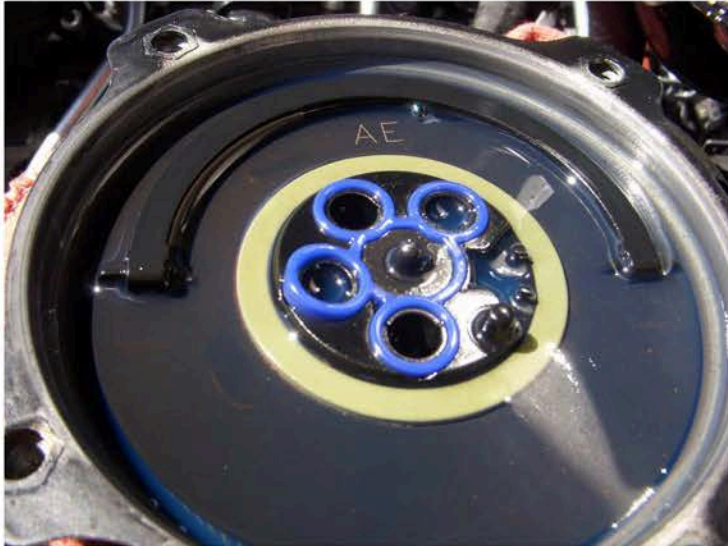
Fig. 3: Film of dirt on the fuel filter

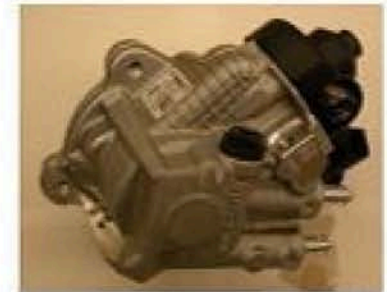
High pressure fuel pump

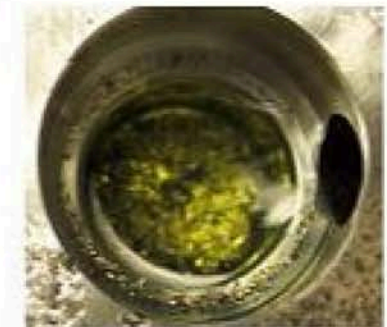
Metal in high pressure pump
