CR pump CP4 - Findings report		Report no. 19427																																																															
				Date 11.01.2008																																																															
Department: Non-responsive content removed	Person responsible: Non-responsive content removed	Telephone: Non-responsive content removed	Use <table border="1" style="float: right;"> <tr> <td>internal</td> <td></td> </tr> <tr> <td>external</td> <td style="text-align: center;">x</td> </tr> </table>		internal		external	x																																																											
internal																																																																			
external	x																																																																		
To: Non-responsive content removed																																																																			
Attn. of: Non-responsive content removed

Pump type: CP4.1S_348_2x5.25_REC_3.3_1.95_MT4.2	Customer: VW	Project: R4 2,0 BIN5	Project/ design sample version C / C2

CP4 – Findings on VW R4 2.0 BIN5 / #686-0163

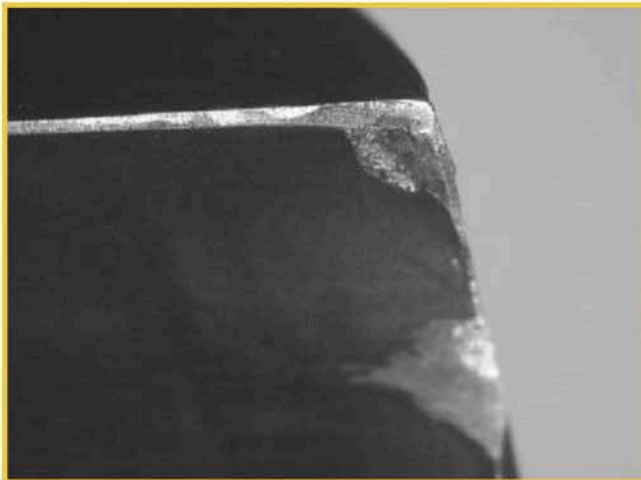
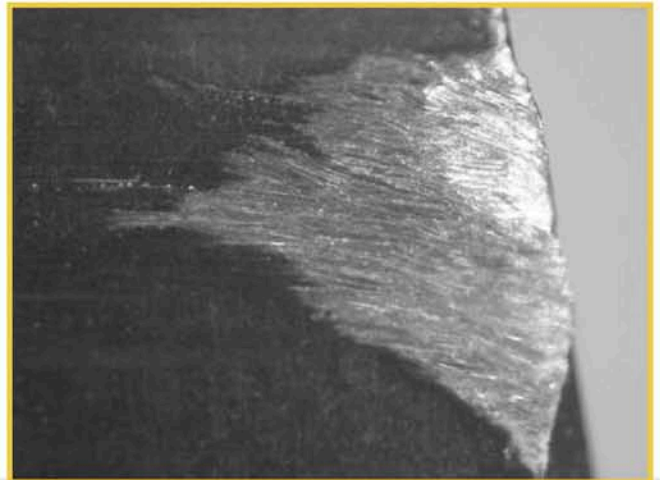
Mechanical manipulations

- ➔ at the edge of the roller borehole across the entire width
- ➔ at the edge of the roller borehole from the inside out

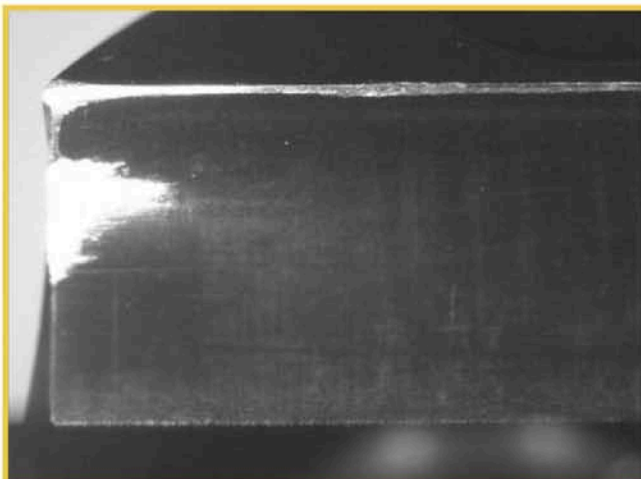
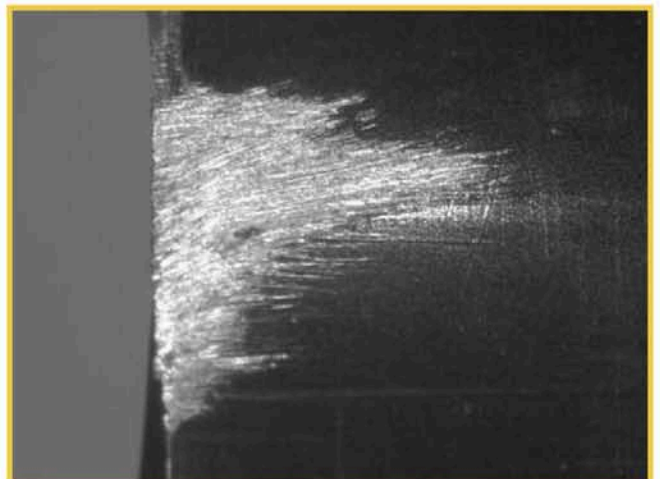
Mechanical manipulations

- ➔ at the edge of the roller borehole across the entire width
- ➔ at the edge of the roller borehole from the inside out

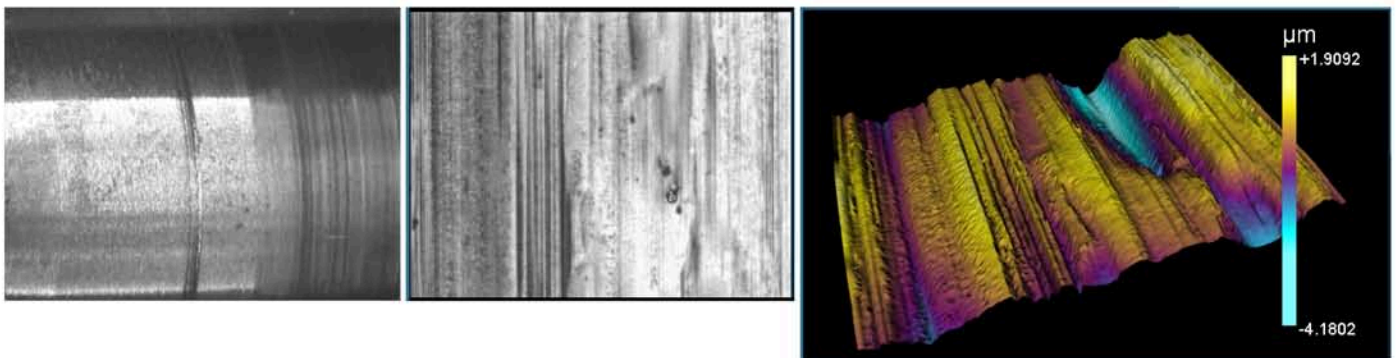
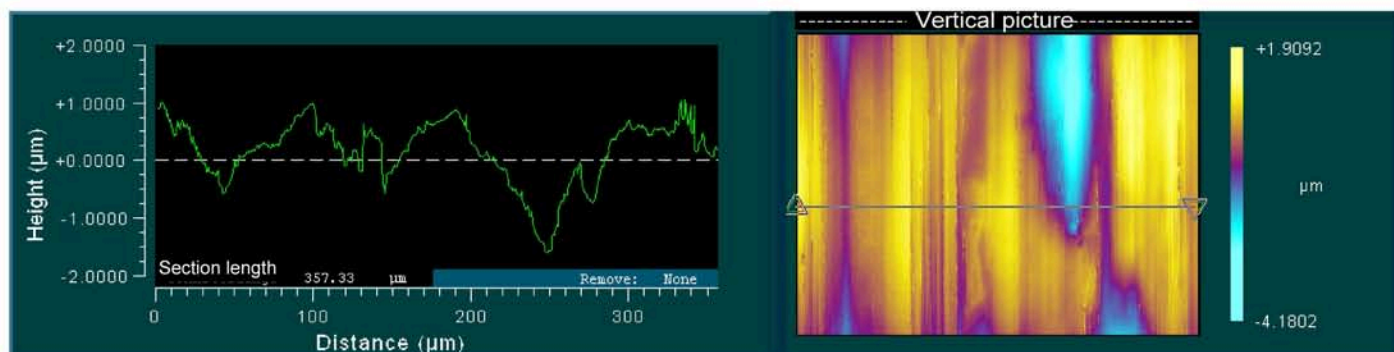
- ➔ a total of 3 dig-in marks of various depth detectable
- ➔ maximum dig-in depth of approx. 5 µm in depth and 100 µm in width (little wear)
- ➔ digging in is irregular, i.e. structure (jaggy marks)
- ➔ no defect and no wear detectable on the shaft saeal

- ➔ The low-temperature leakage is ascribed to the structured digging in

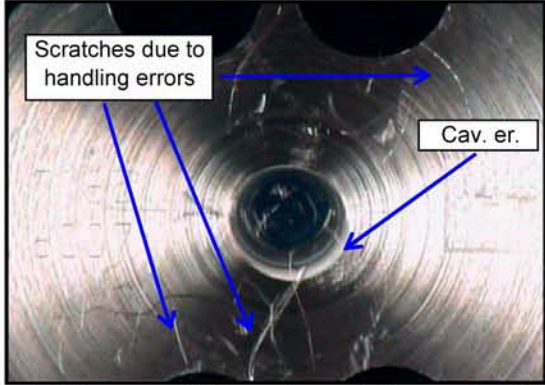
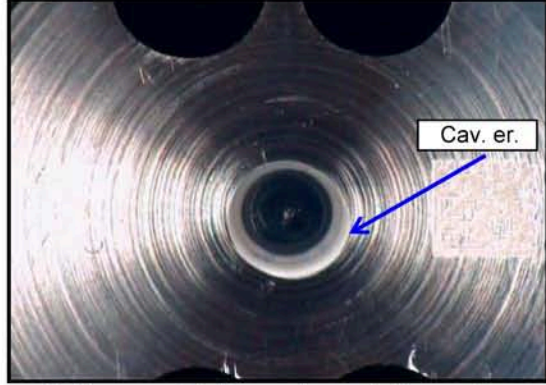
- Wear due to cavitation erosion on the roller supports (HP piston contact area) is increased but non-critical.

Fig. 1: Roller support left: annular cavitation erosion **Fig. 2:**

Roller support right: annular cavitation erosion

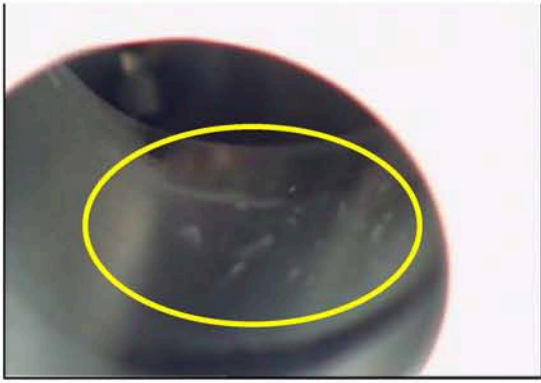
Fig. 7. Housing, tappet borehole at bottom

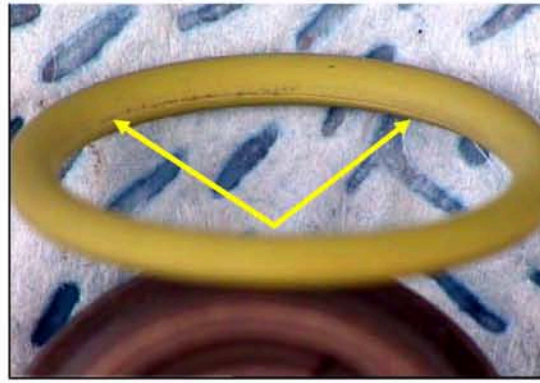
Fig. 8. O-ring of screw plug on cylinder head inside

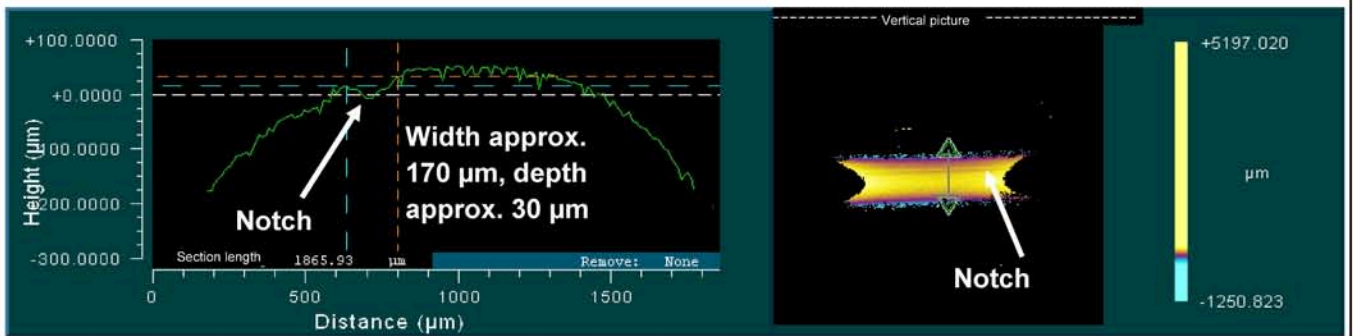
Fig. 9. WLI measurement of O-ring notch, profile section

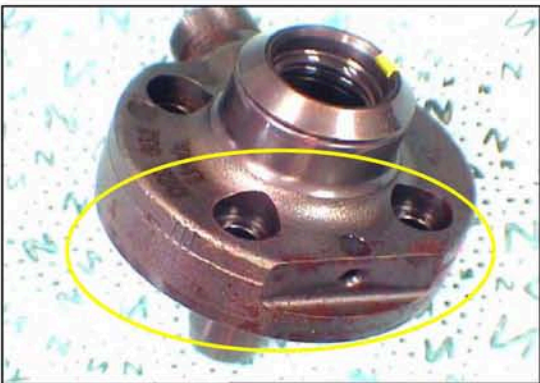
Fig. 3: Cylinder head, surface (rust)

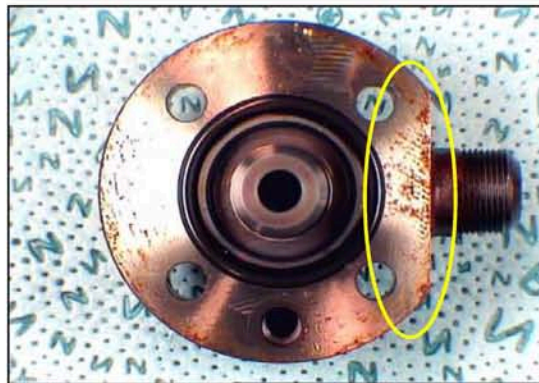
Fig. 4: Cylinder head, housing support face (rust)

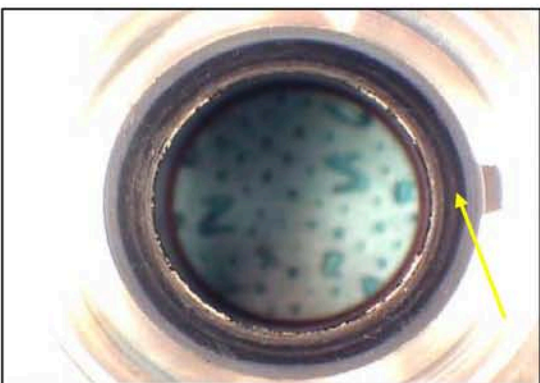
Fig. 5: Flanged bearing, axial (smoothing)

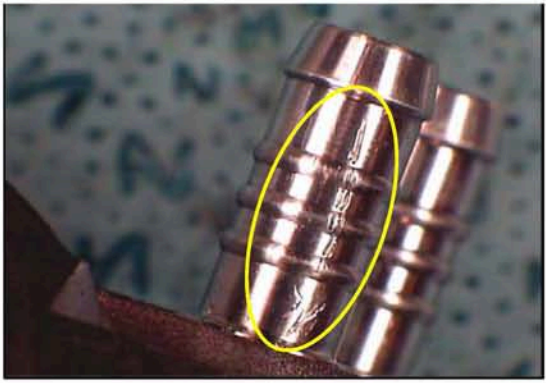
3.8 Miscellaneous
 Return connection with minor defect (see Fig. 7)

Fig. 7: Return connection (with minor defect)

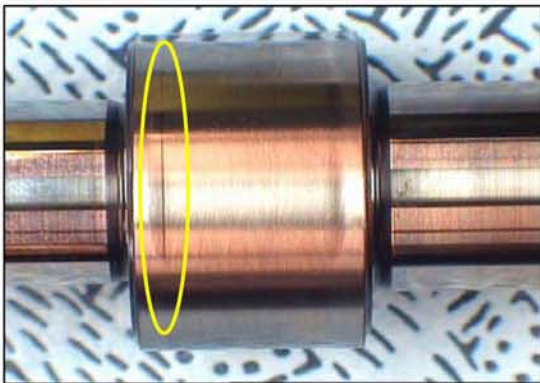
Fig. 1. Camshaft (smoothing mark)

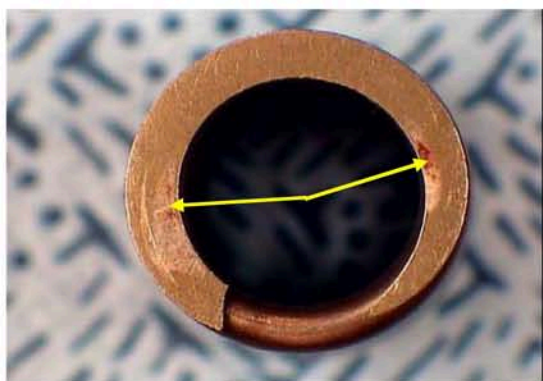
Fig. 9. Tappet spring, cylinder head side (oxides)

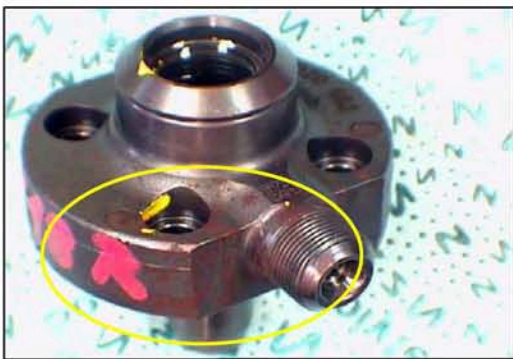
3.8 Miscellaneous	Rust on the outside of the cylinder head (see Fig. 3) and on the housing support face (see Fig. 4)			<table border="1"><tr><td></td><td>x</td><td></td></tr></table>			x							
	x

Fig. 2. Cylinder head, surface (rust)

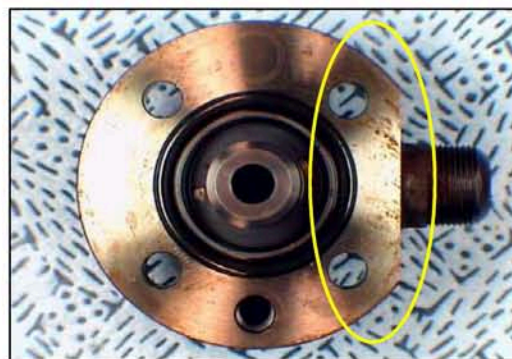
Fig. 4. Cylinder head. Housing support (rust)

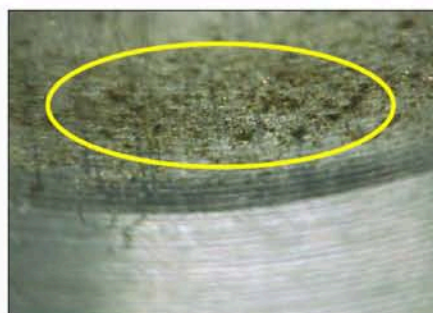
3.6 Boreholes - Tappet borehole with scoring by wear particles (Fig. 17) which are oxidized on the surface (Fig. 18). - Wear particles in the metering unit borehole (Fig. 19)			<table border="1"> <tr> <td><input type="checkbox"/></td> <td><input checked="" type="checkbox"/></td> <td><input type="checkbox"/></td> </tr> </table>		<input type="checkbox"/>	<input checked="" type="checkbox"/>	<input type="checkbox"/>									
<input type="checkbox"/>	<input checked="" type="checkbox"/>	<input type="checkbox"/>

Fig. 18. Tappet borehole, oxidized wear particles

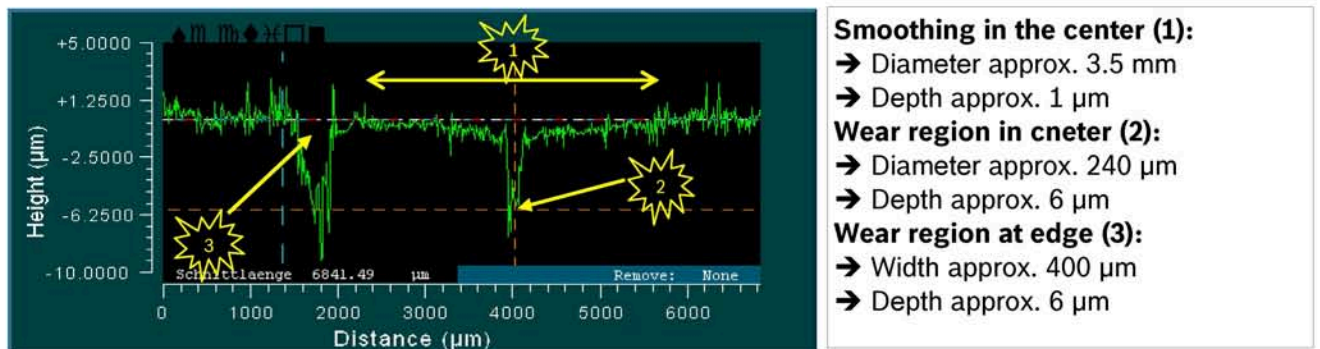
Cavitation erosion on the roller support backs on the piston foot support (see Fig. 1 and Fig. 2)
WLI measurement of the wear region (see Fig. 3)

Fig. 3. WLI measurement of roller support, piston contact surface

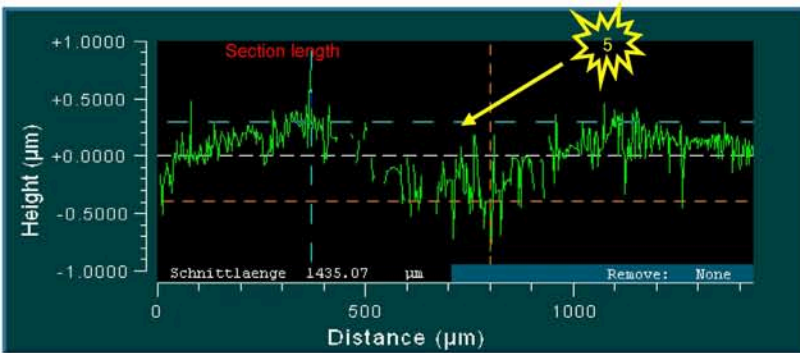
- Wear region in center (4):**
- ➔ Diameter approx. 510 µm
 - ➔ Depth approx. 2.5 µm
- Wear region at edge (5):**
- ➔ Width approx. 700 µm
 - ➔ Depth approx. 0.7 µm

Fig. 8. WLI measurement of HP piston foot ring area

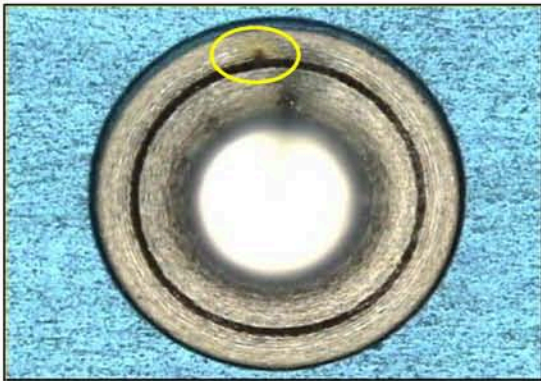
Fig. 9. Intake valve piston, sealing area (impression)

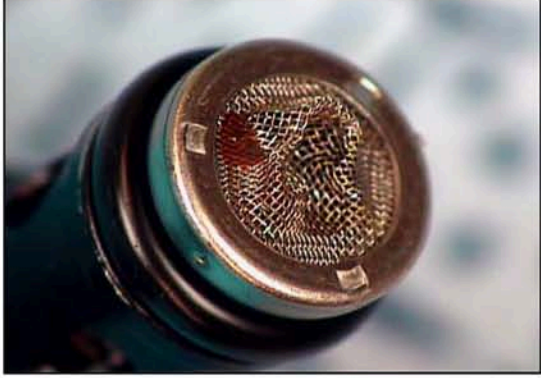
- The screen of the overflow valve is inverted and loaded with a reddish covering.
- From tests (see appendix CP4-2659) it can be assumed that the inversion of the screen was caused by high loading and increased pressure.

- Polymer carbonyl compounds are insoluble in the fuel and can therefore form deposits on components and lead to functional restrictions and even failures. The damage to the overflow valve screen is ascribed to this cause.
- A possible reinforcement factor for the cavitation erosion is a temporary lowering of the pump inside pressure due to a malfunction of the overflow valve.
- The pump **has passed** the endurance test.

Fig. 13. Overflow valve, screen (damage)

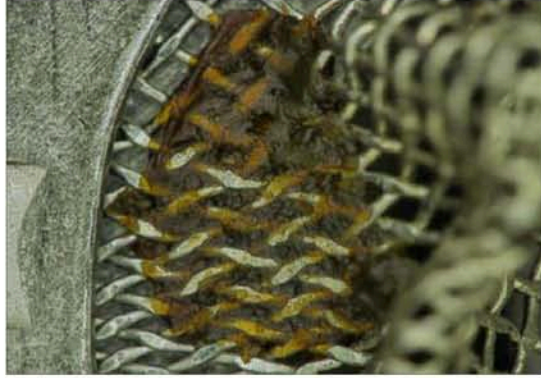
Fig. 14. Overflow valve, screen (covering)

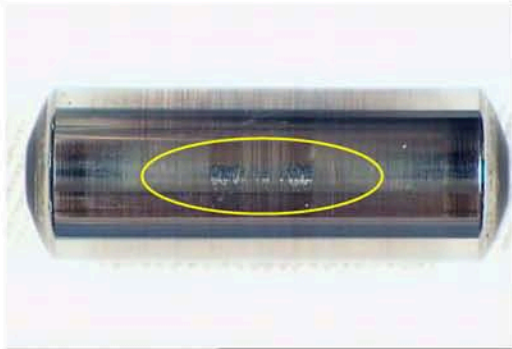
Fig. 1 Roller on the left, wear zone in the middle

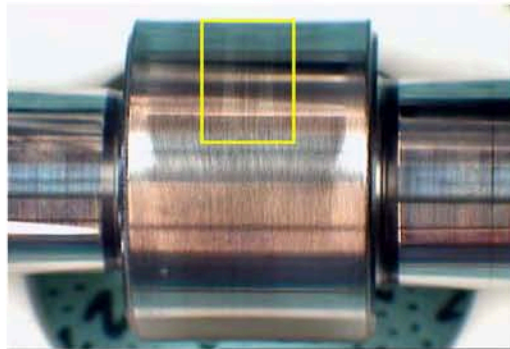
Fig. 2 Camshaft, smoothing marks on the cam ascent

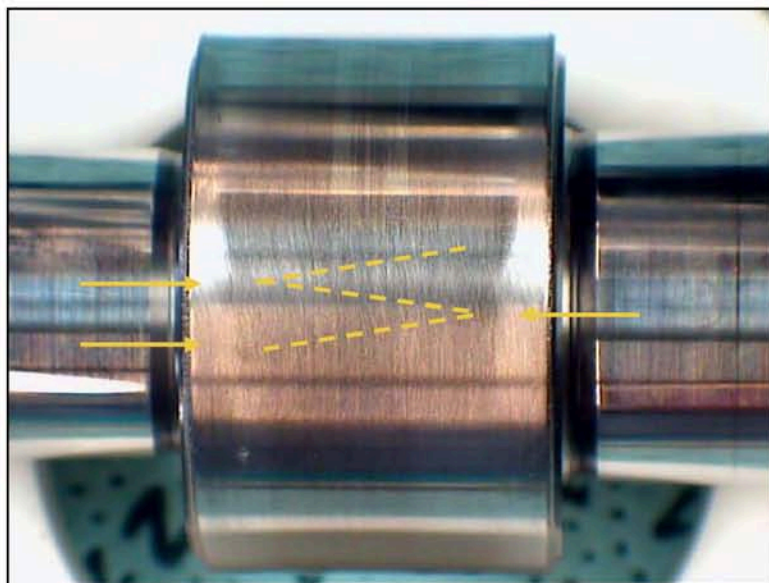
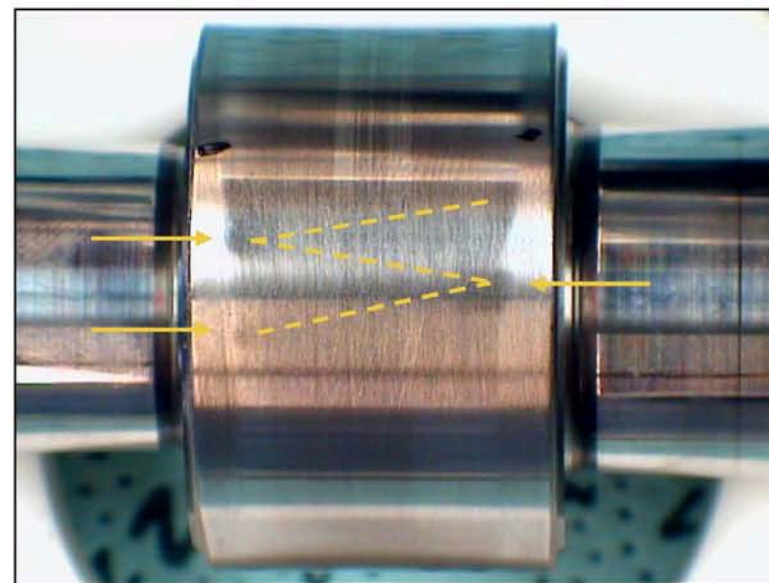
→ Semicircular imprint = Turning point of the roller

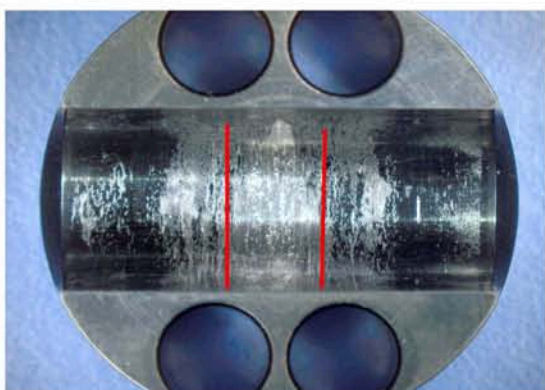
Fig. 1: Roller support, original damage caused by braking flat

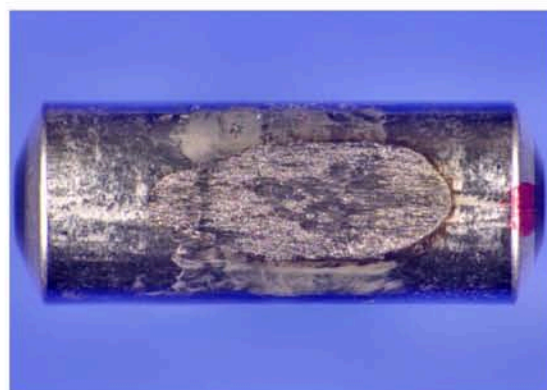
Fig. 2: Roller, running face

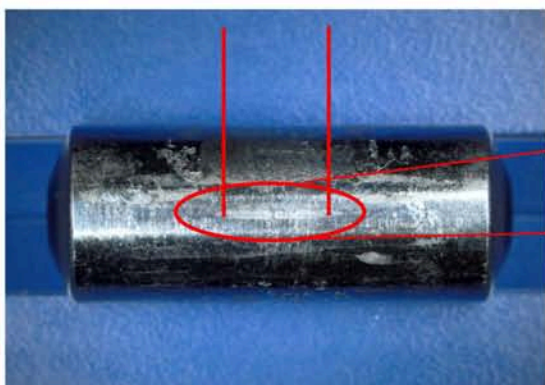
Fig. 3: Roller support, running face with braking flat

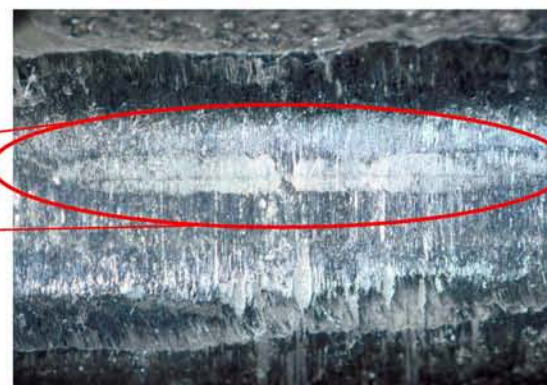
Fig. 4: Roller, braking flats detail

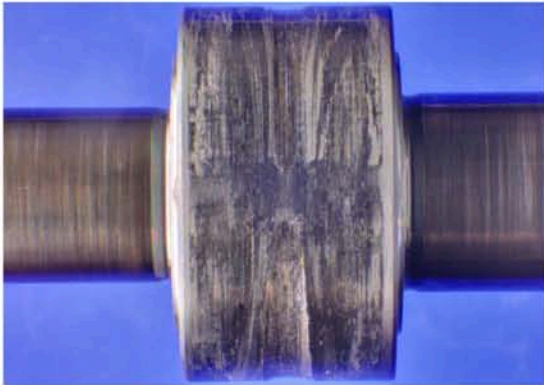
Fig. 5: Camshaft, cam track running face BDC

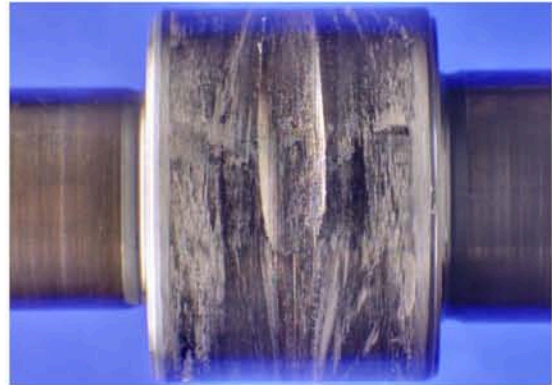
Fig. 6: Camshaft, cam track running face TDC

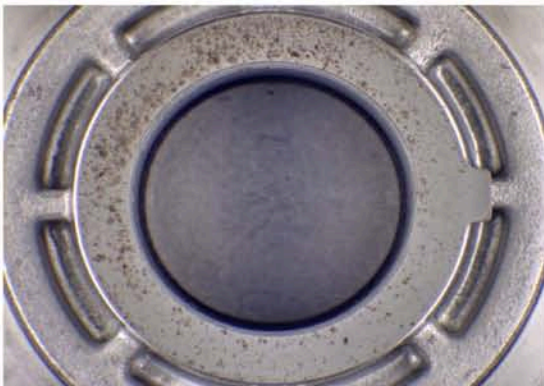
Fig. 7: Flanged bearing bushing axial, particle impressions

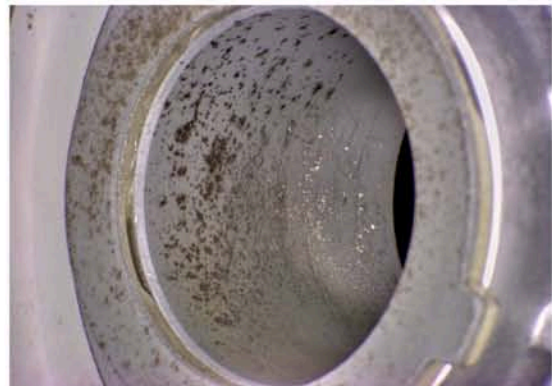
Fig. 8: Flanged bearing bushing, damage caused by particles

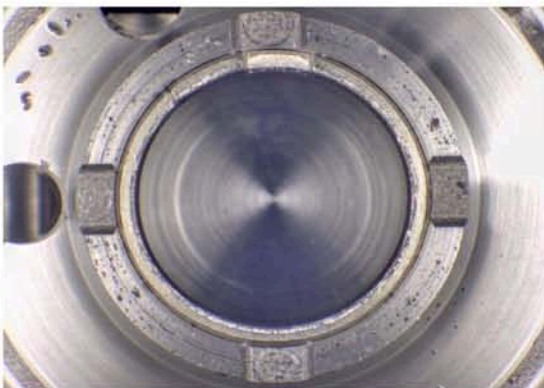
Fig. 9: Housing bearing bushing axial, particle impressions

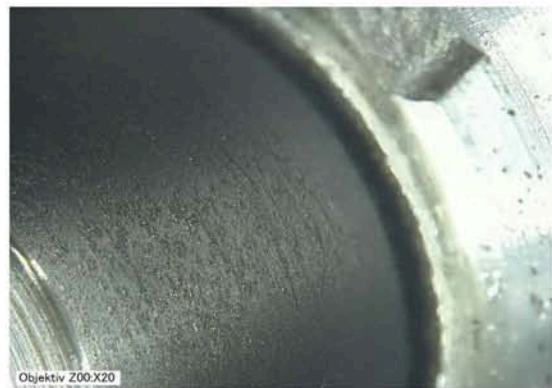
Fig. 10: Housing bearing bushing, damage caused by particles
