<p><b>Audi</b> Supplier Evaluation</p>	<h2>Technical audit of supplier (TAS)</h2>	<p>Order: TR107999 Date: 01/29/2008 Page: 1</p>
--	--	---

Audi AG, [redacted] Supplier Evaluation and Projects, D-85045 Ingolstadt	
<b>Supplier no.:</b> 1283 <b>Index:</b> 30 <b>DUNS no.:</b> 34-451-8522  <b>Address of supplier:</b> Robert Bosch GmbH [redacted] D-70469 Stuttgart Feuerbach	<b>Component description</b> Designation: Diesel high-pressure fuel pump CP4.X for 2.0l TDI, 2.7l TDI, 3.0 l TDI Common Rail parts no.: 03L 130 755A

**Reason for initiating TAS:** 0km and field failure of CP4.x pumps at Audi Győr, Neckarsulm, IN due to a metal chip in the intake valve;  
**Order:** Inspection of the cleanliness program in pump manufacturing (report 4 on the market launch of A4 (B8) Limousine)

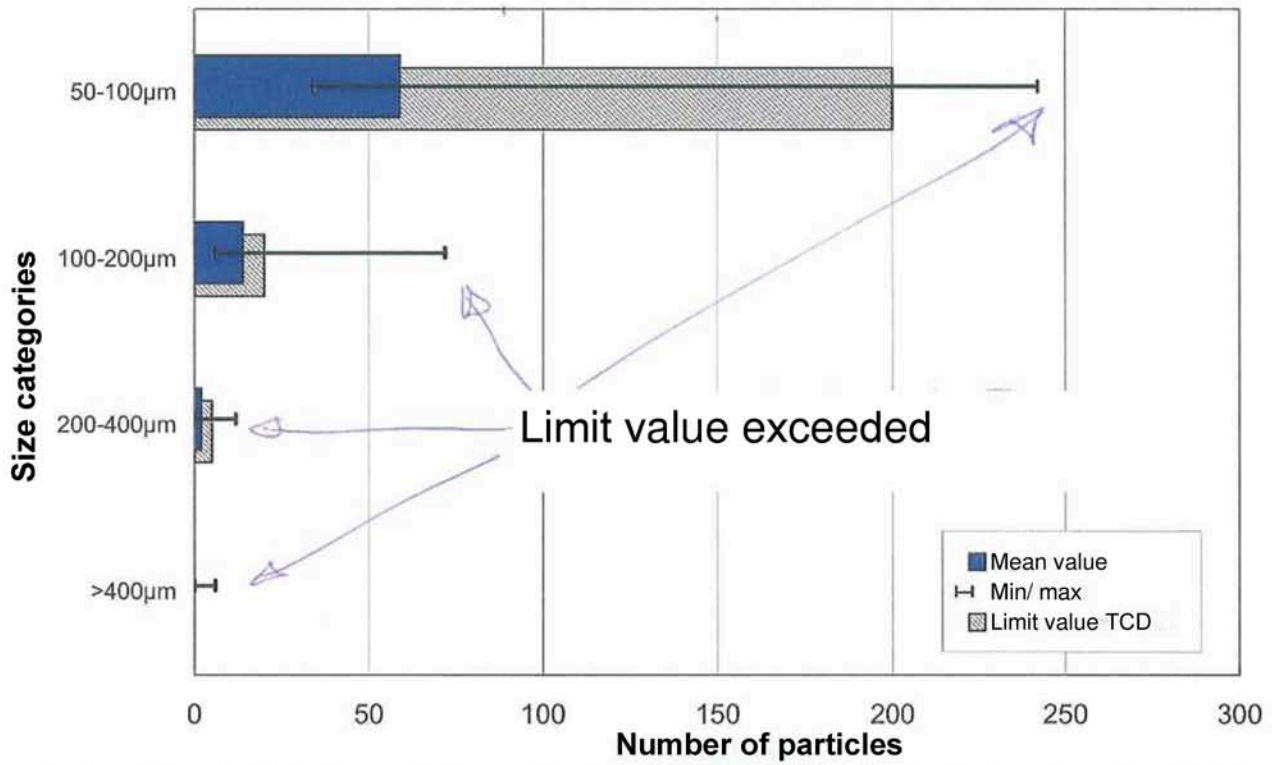
Appendix 1:

Product (CP4.1) HP area May 07 - Oct. 07  
ASSY High-pressure area pump

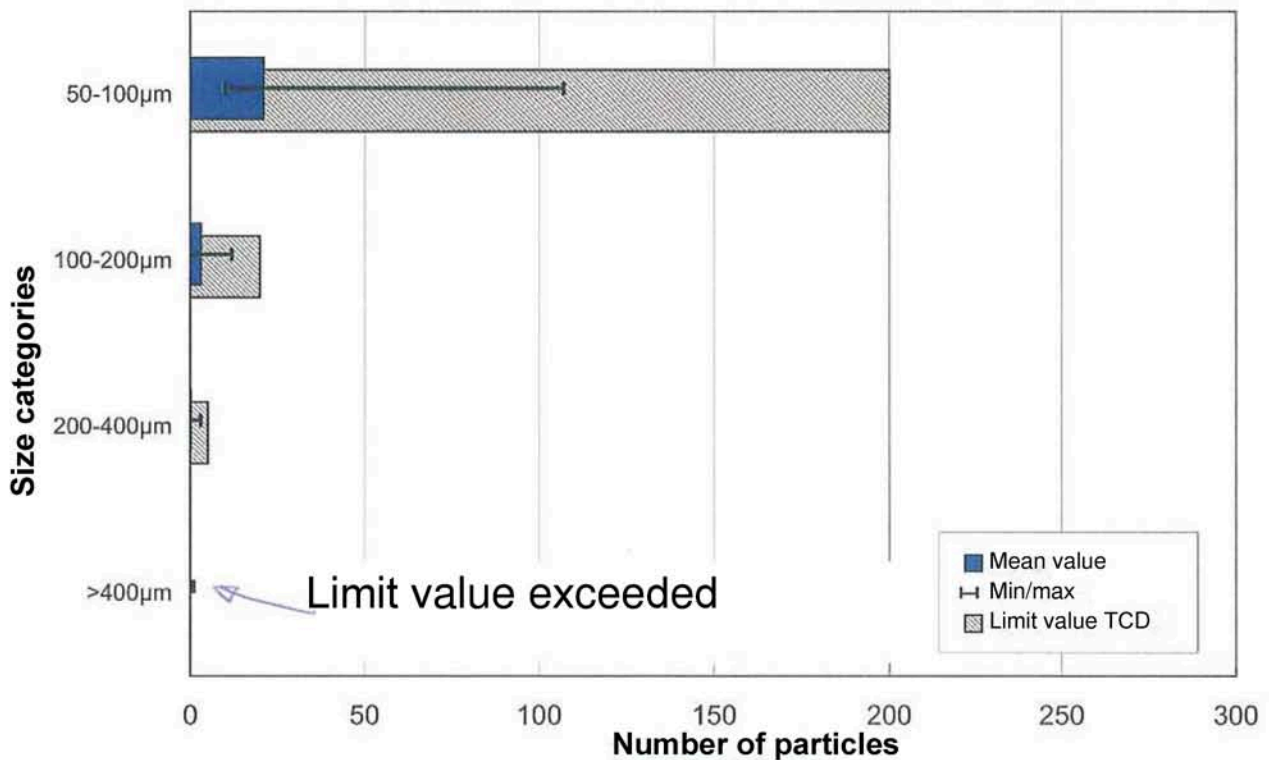
Product (CP4.1) HP area Nov.07 - Jan. 08

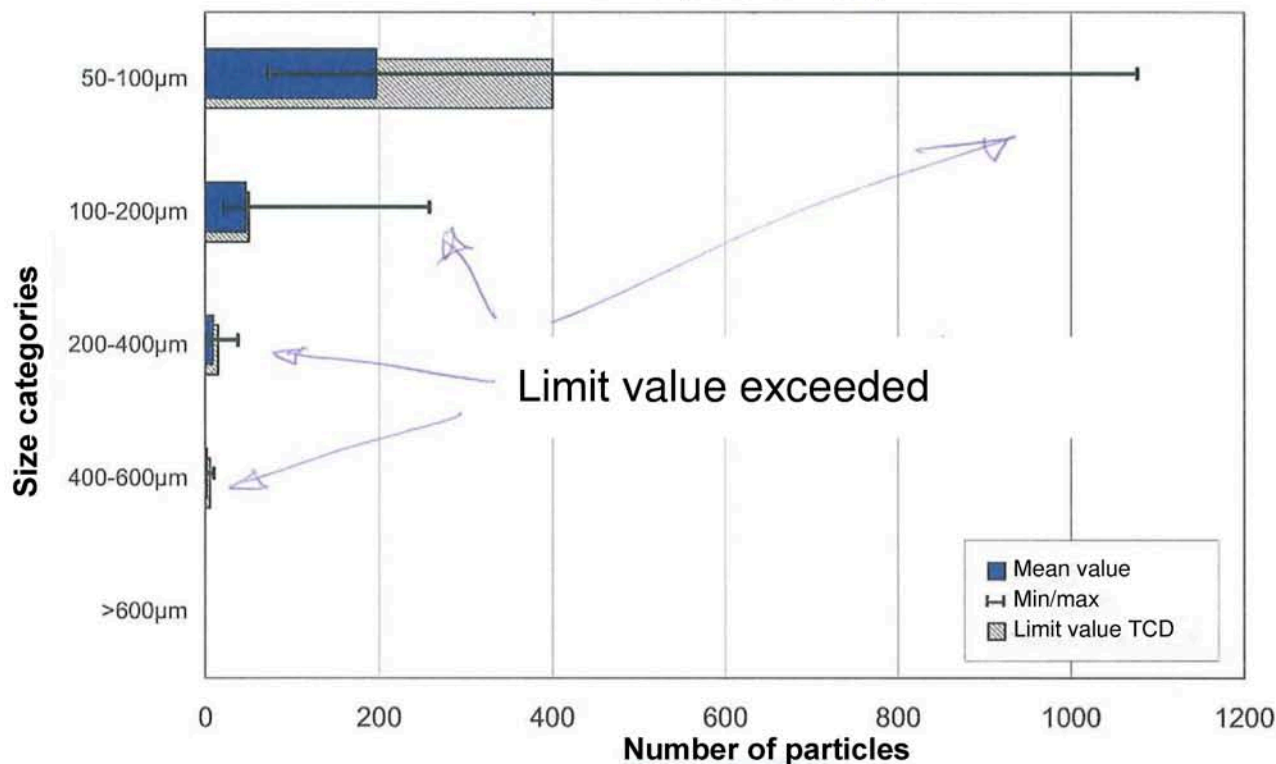
Appendix 2:

Product (CP4.1) LP area May 07 - Oct. 07

ASSY Low-pressure area pump

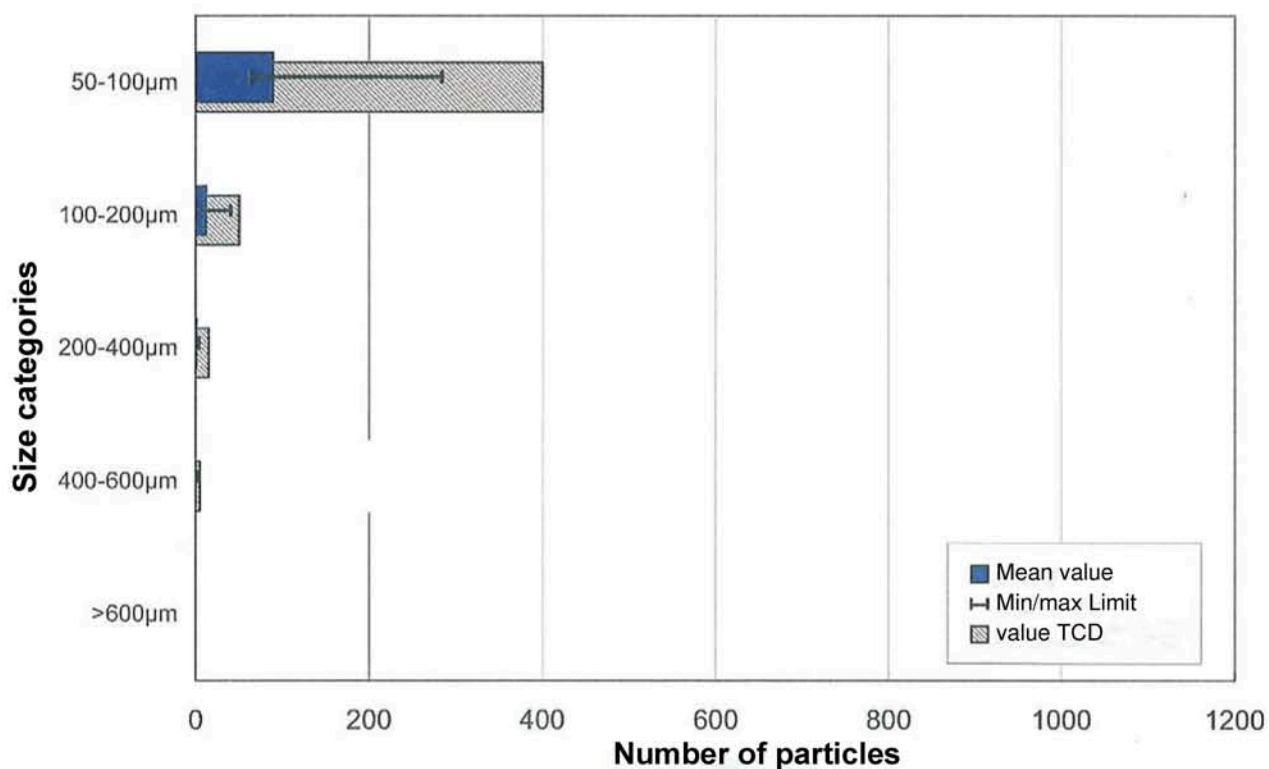
Product (CP4.1) LP area Nov. 07 - Jan. 08

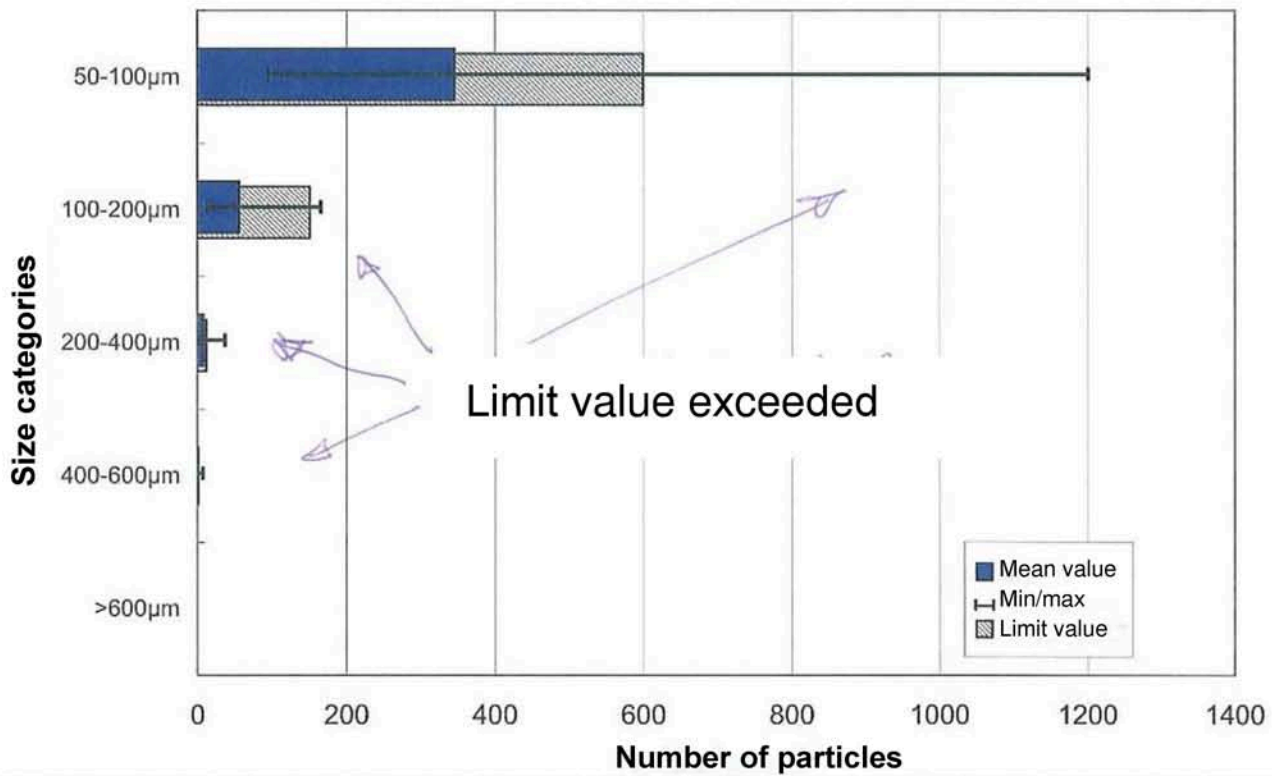
Appendix 3:

Housing May - Oct. 07

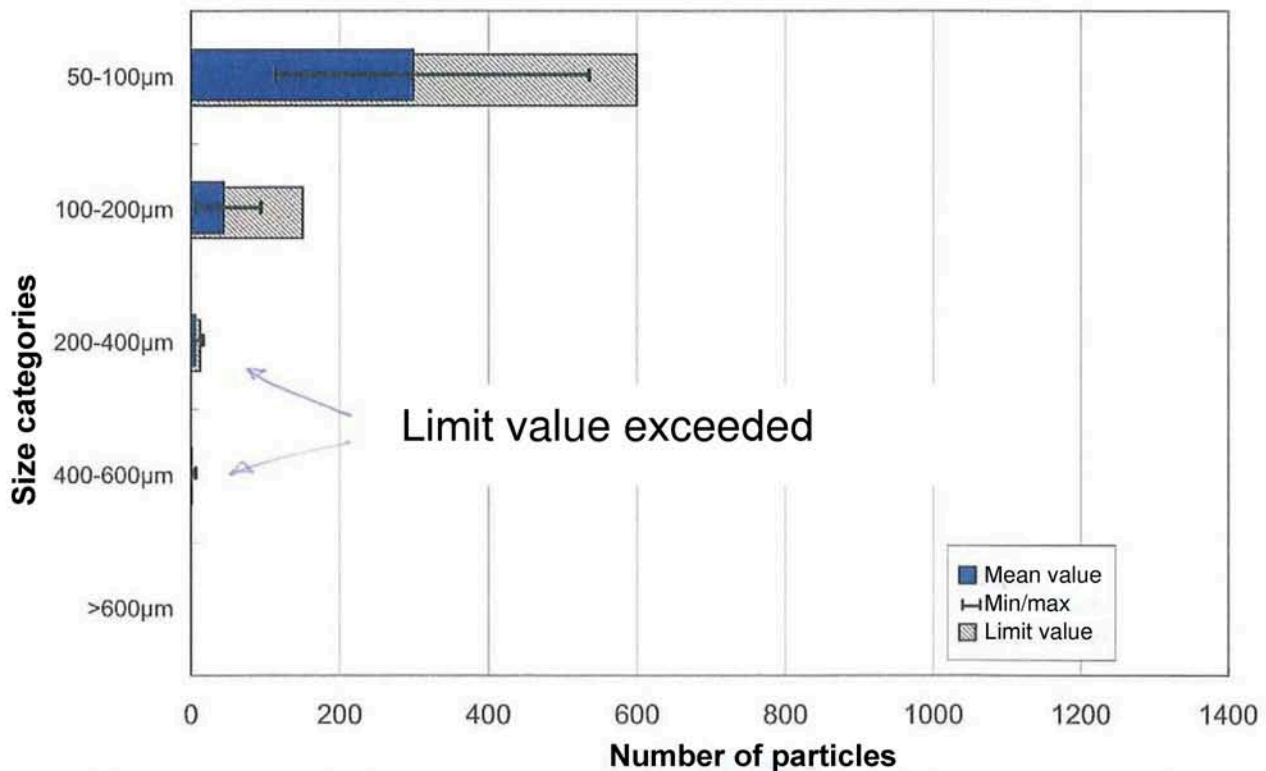
Housing Nov. 07 - Jan. 08

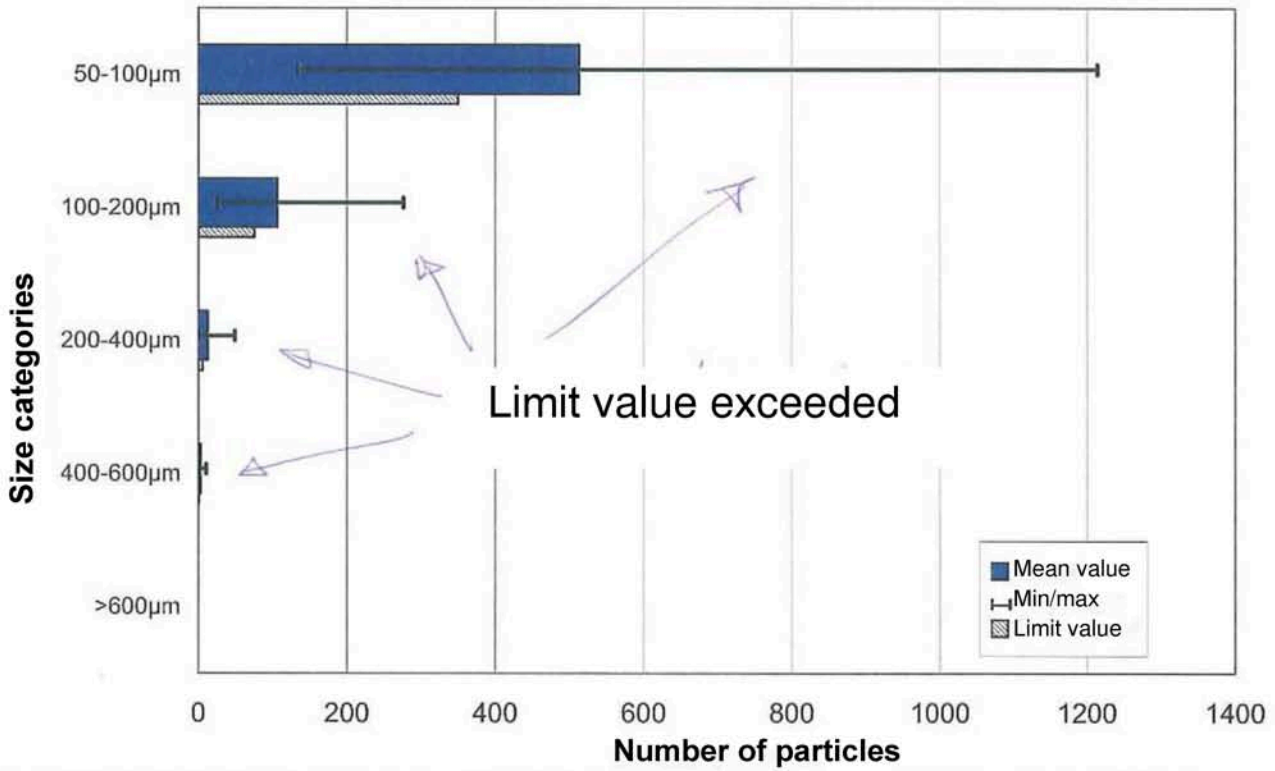
Appendix 4:

Flange May 07 - Oct. 07

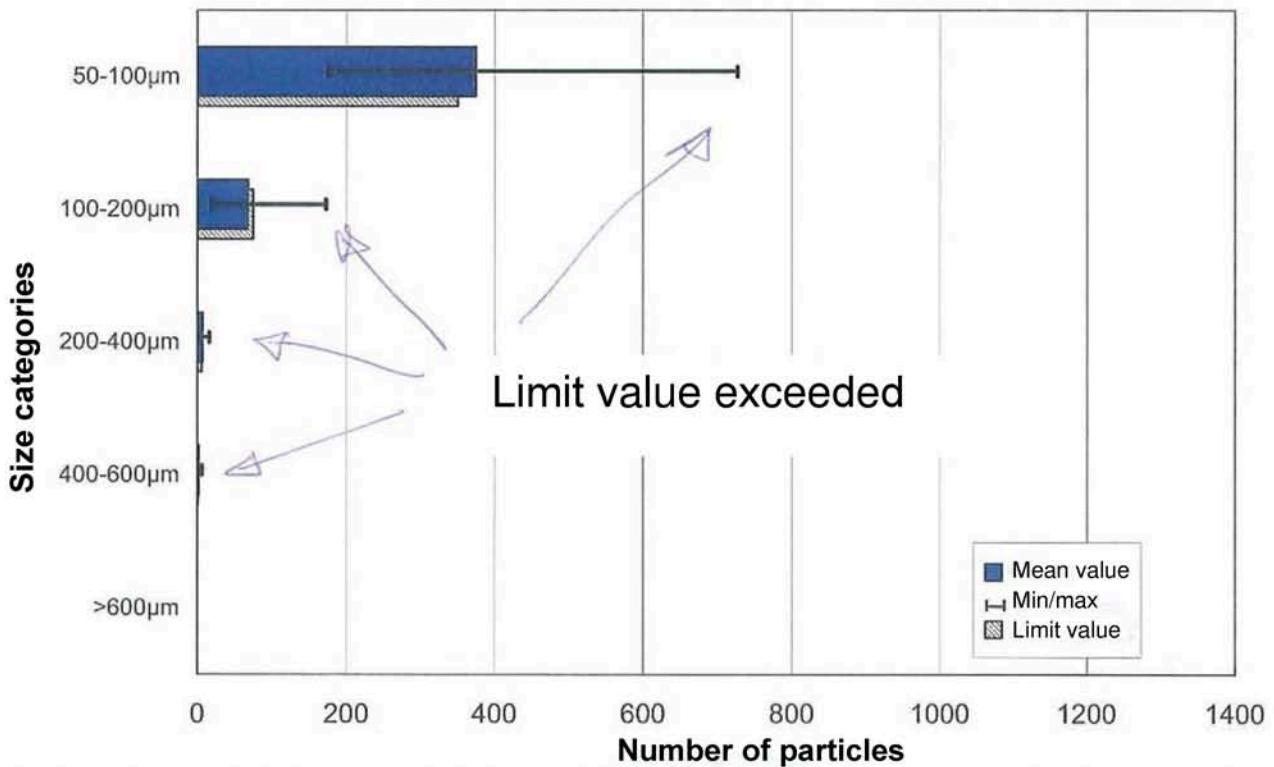
Flange Nov. 07 - Jan. 08

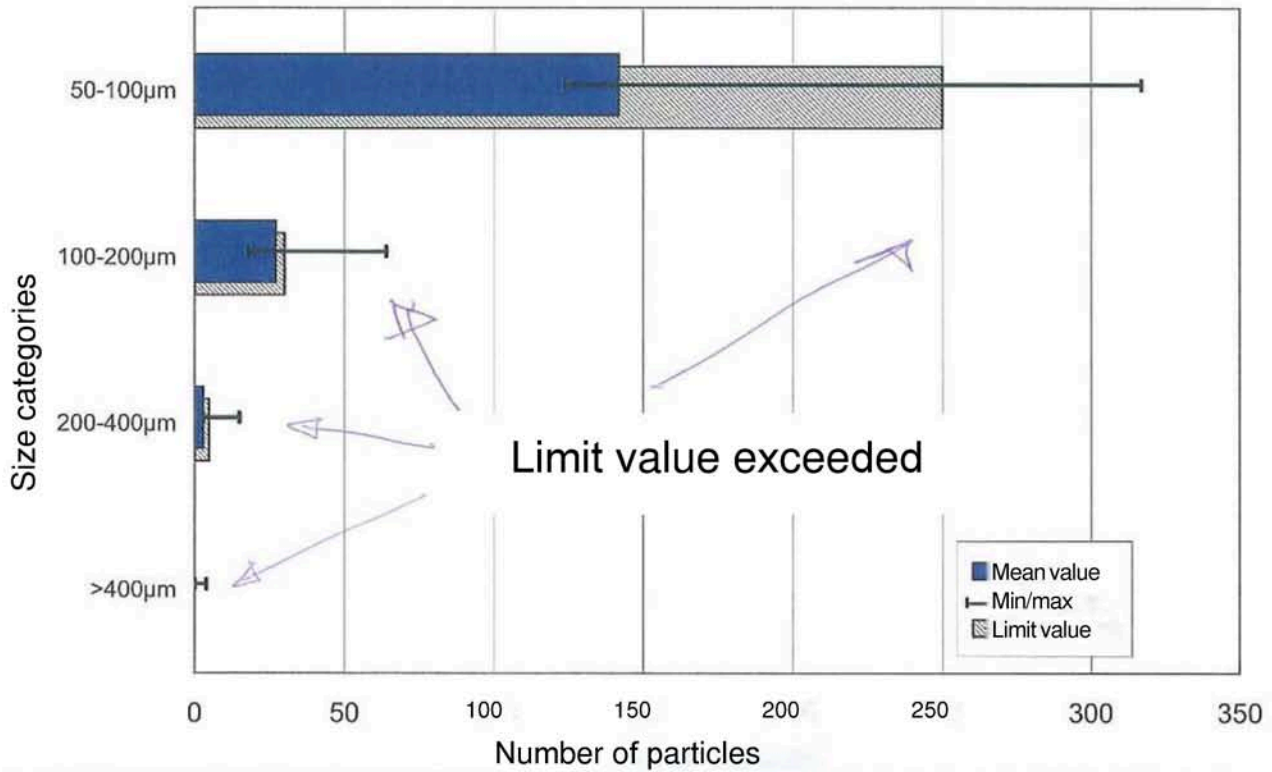
Appendix 5:

Component part Cylinder head May - Oct. 07

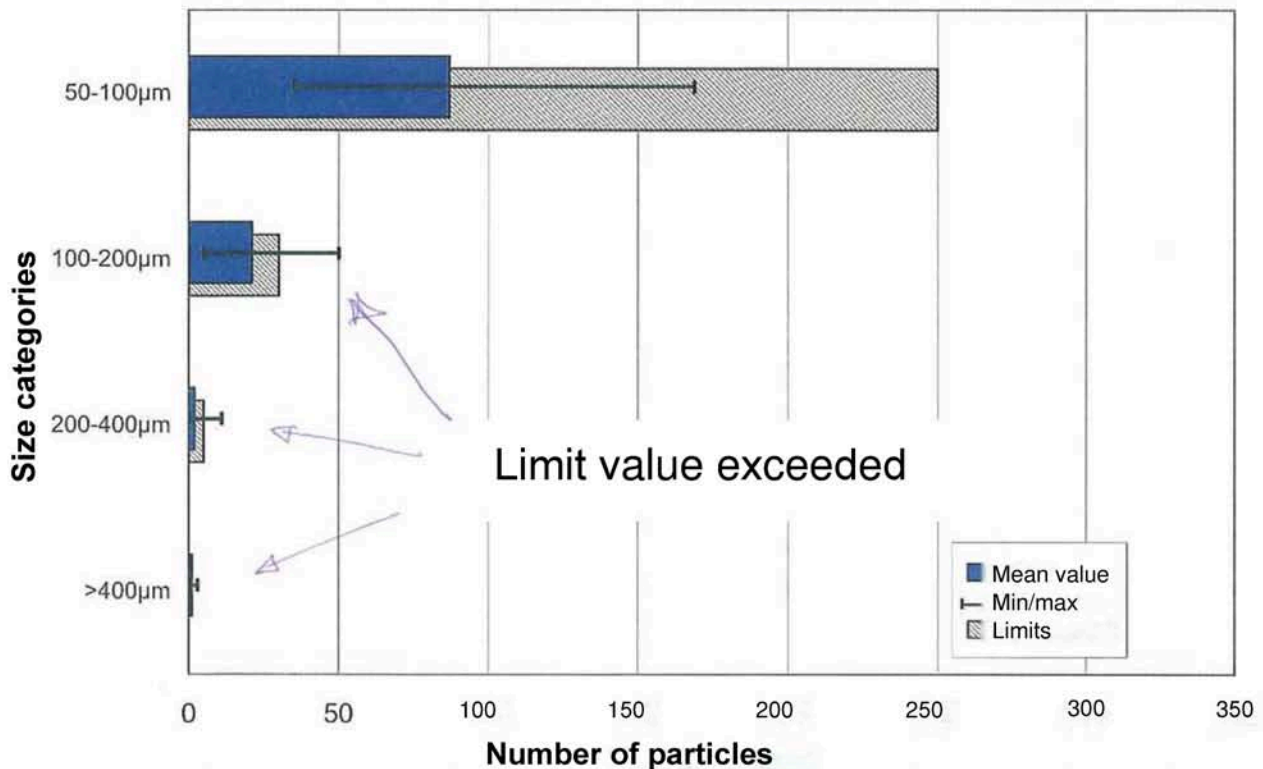
Cylinder head Nov.07 - Jan.08

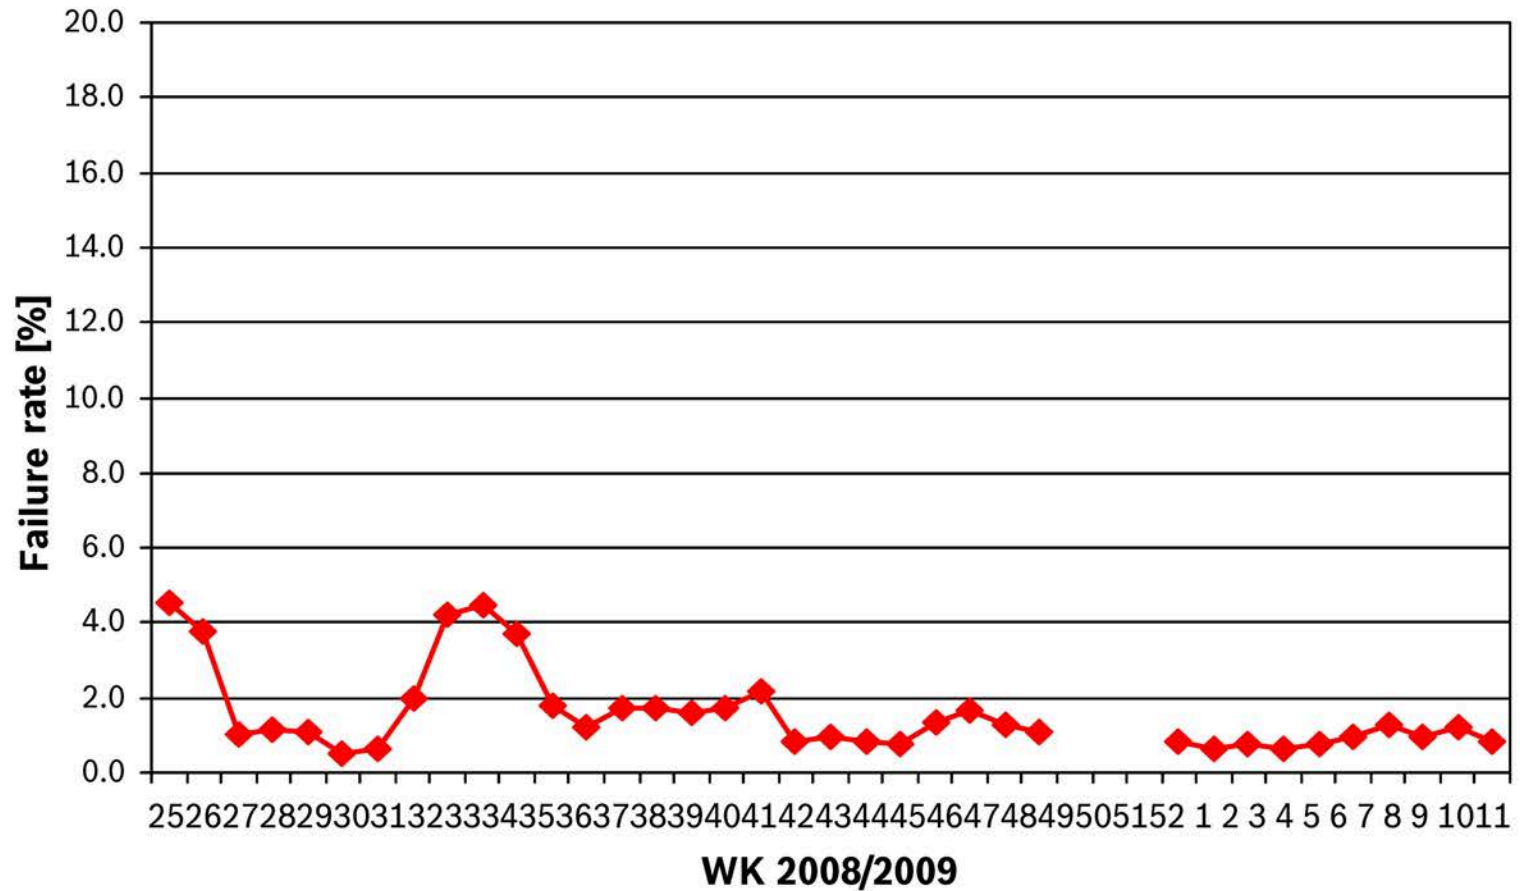
**FeP:** Visual check of MU4 (Failure rate due to particles in %)

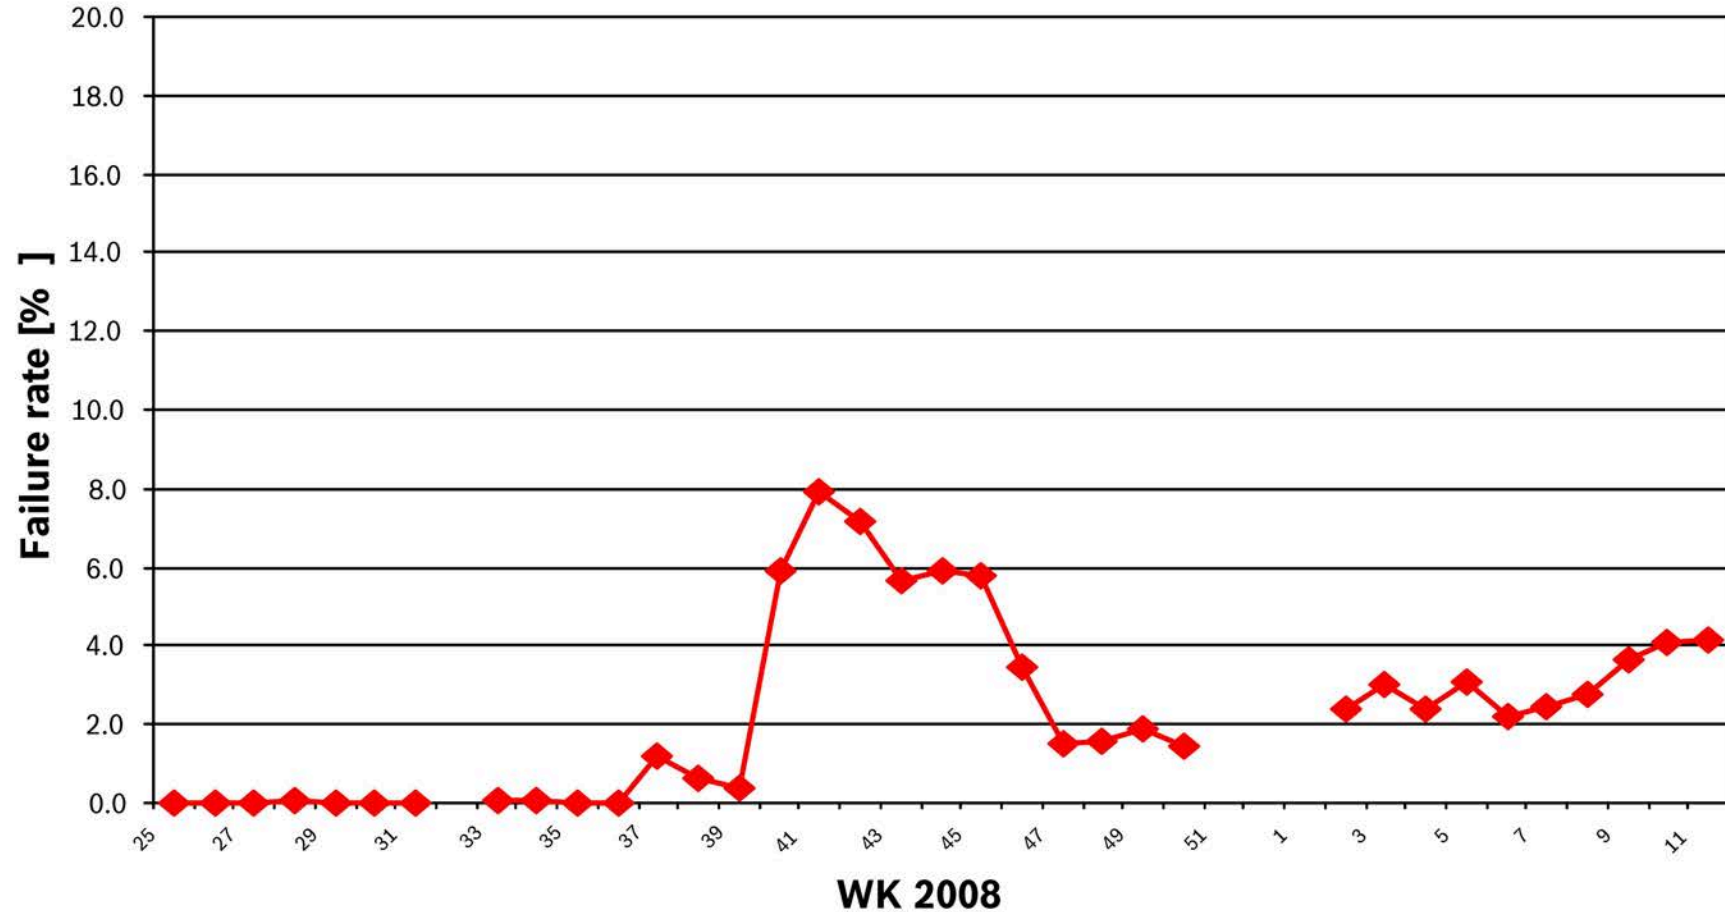
**JhP:** Visual check of MU4 (Failure rate due to particles in %)

Note: Due to holiday shutdown, there is no data available for WK 32-33.

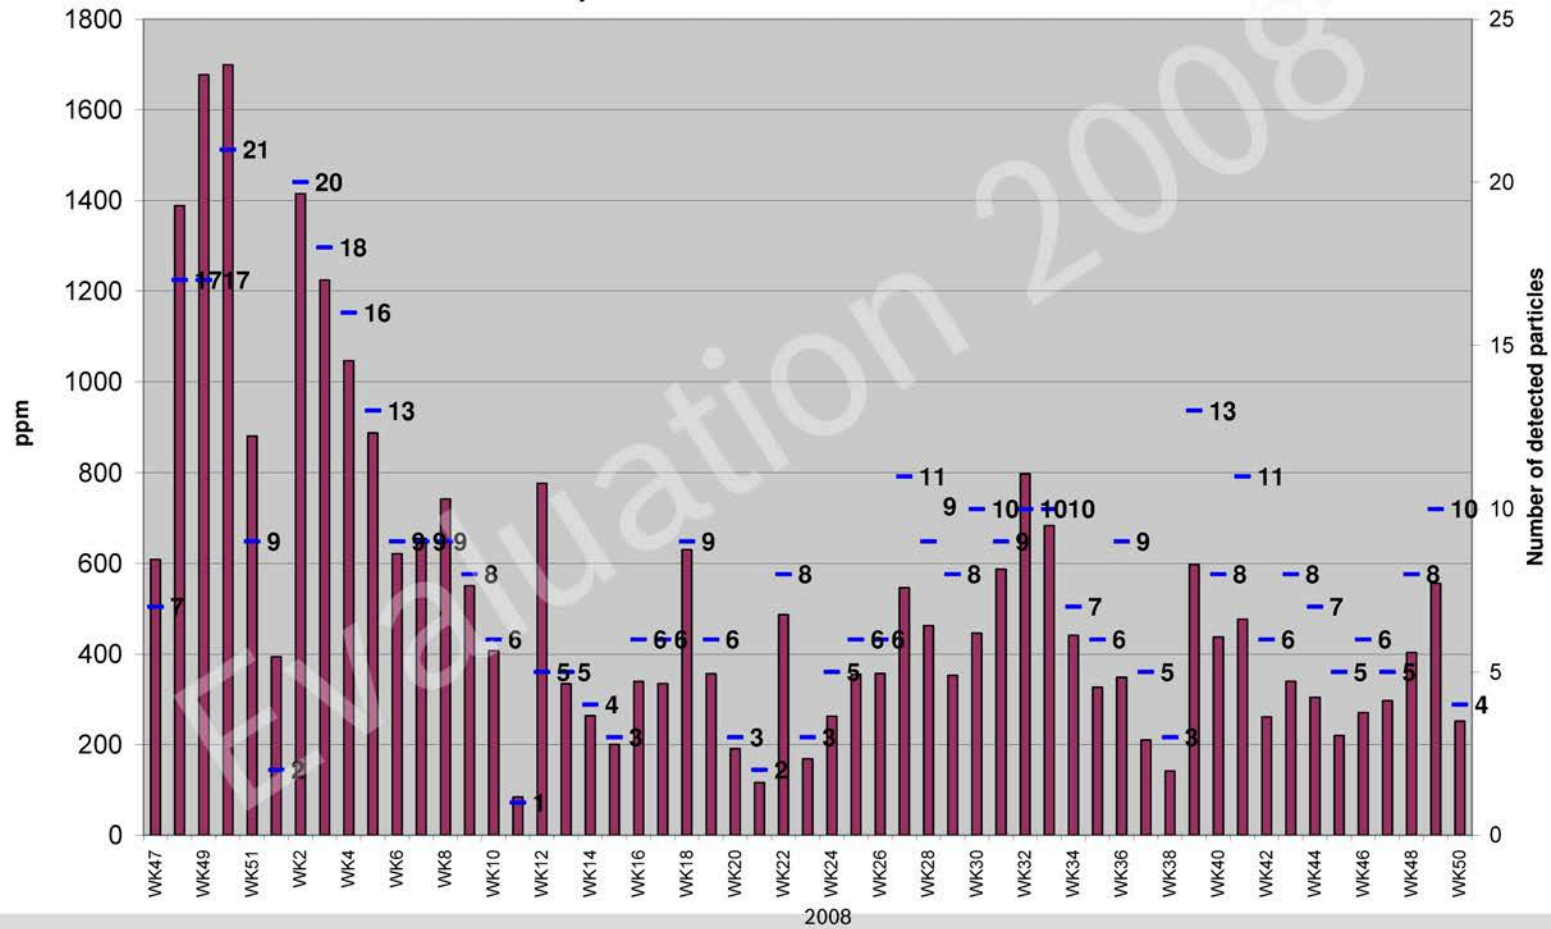
**FeP:** CP4 product, internal rail pressure failures with particles detected in the intake valve / non-return valve

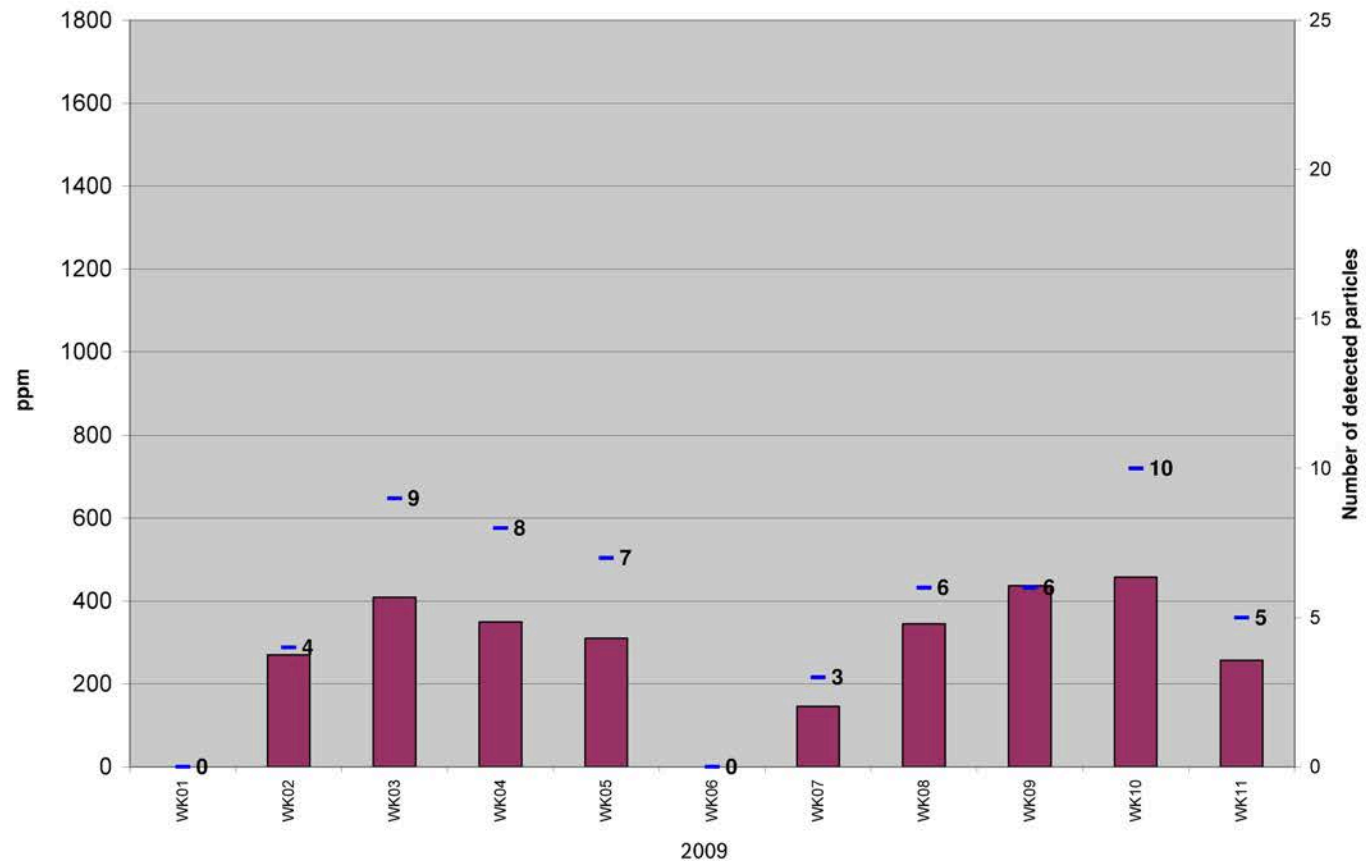
**FeP:** CP4 product, internal rail pressure failures with particles detected in the intake valve / non-return valve

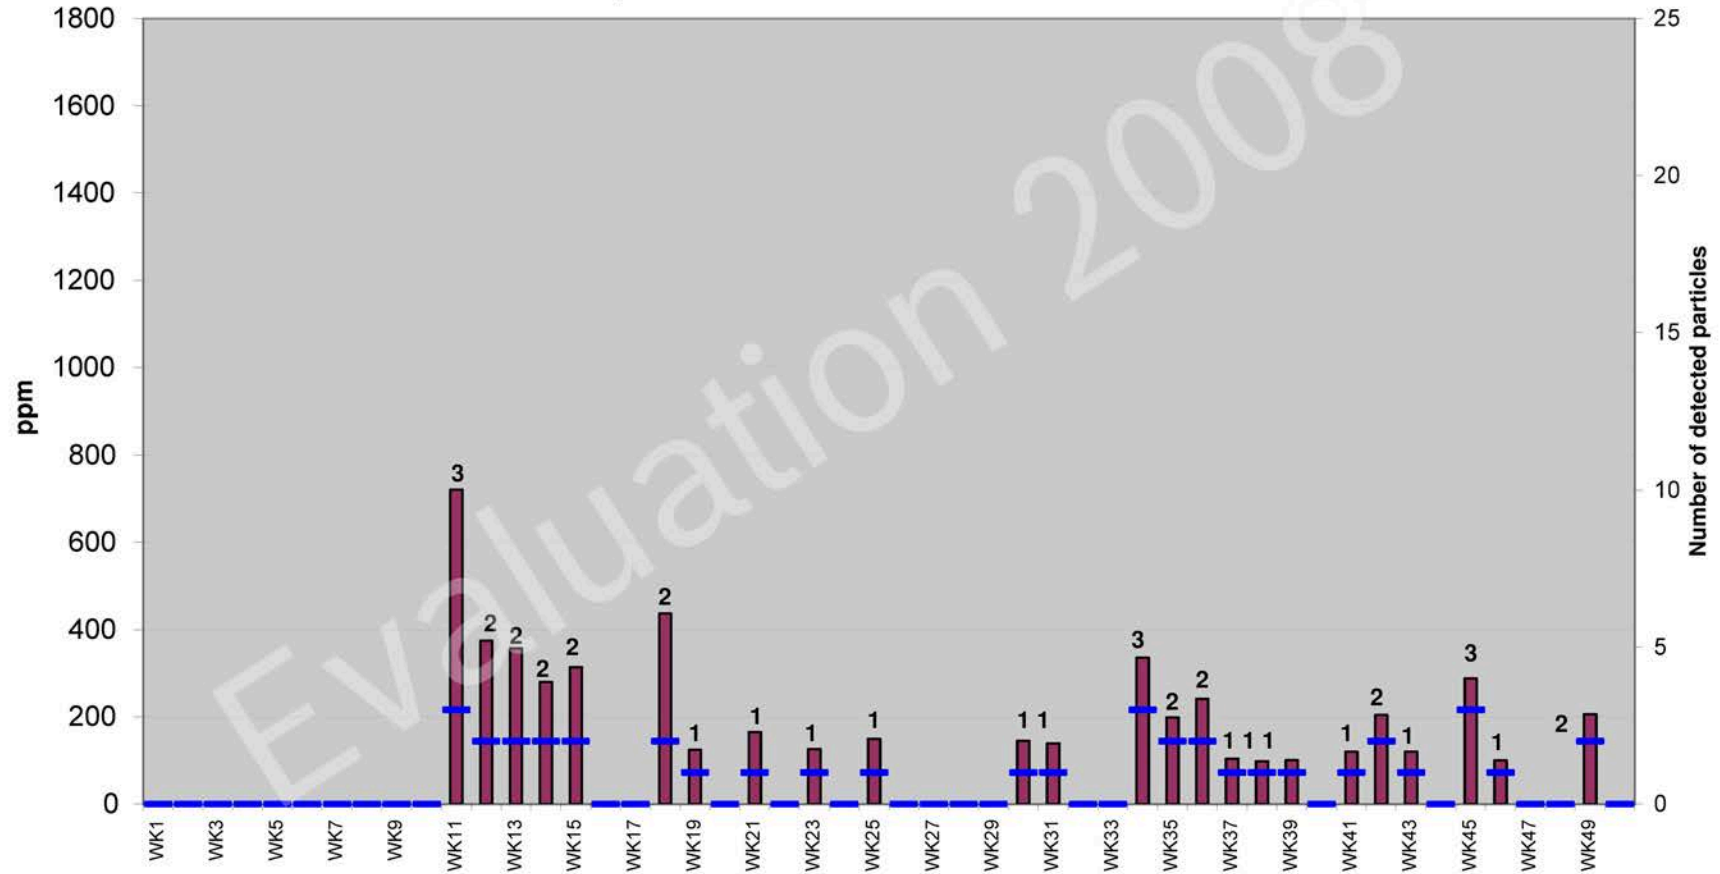
**JhP:** CP4 product, internal rail pressure failures with particles detected in the intake valve / non-return valve

Note: Due to holiday shutdown, there is no data available for WK 32-33.

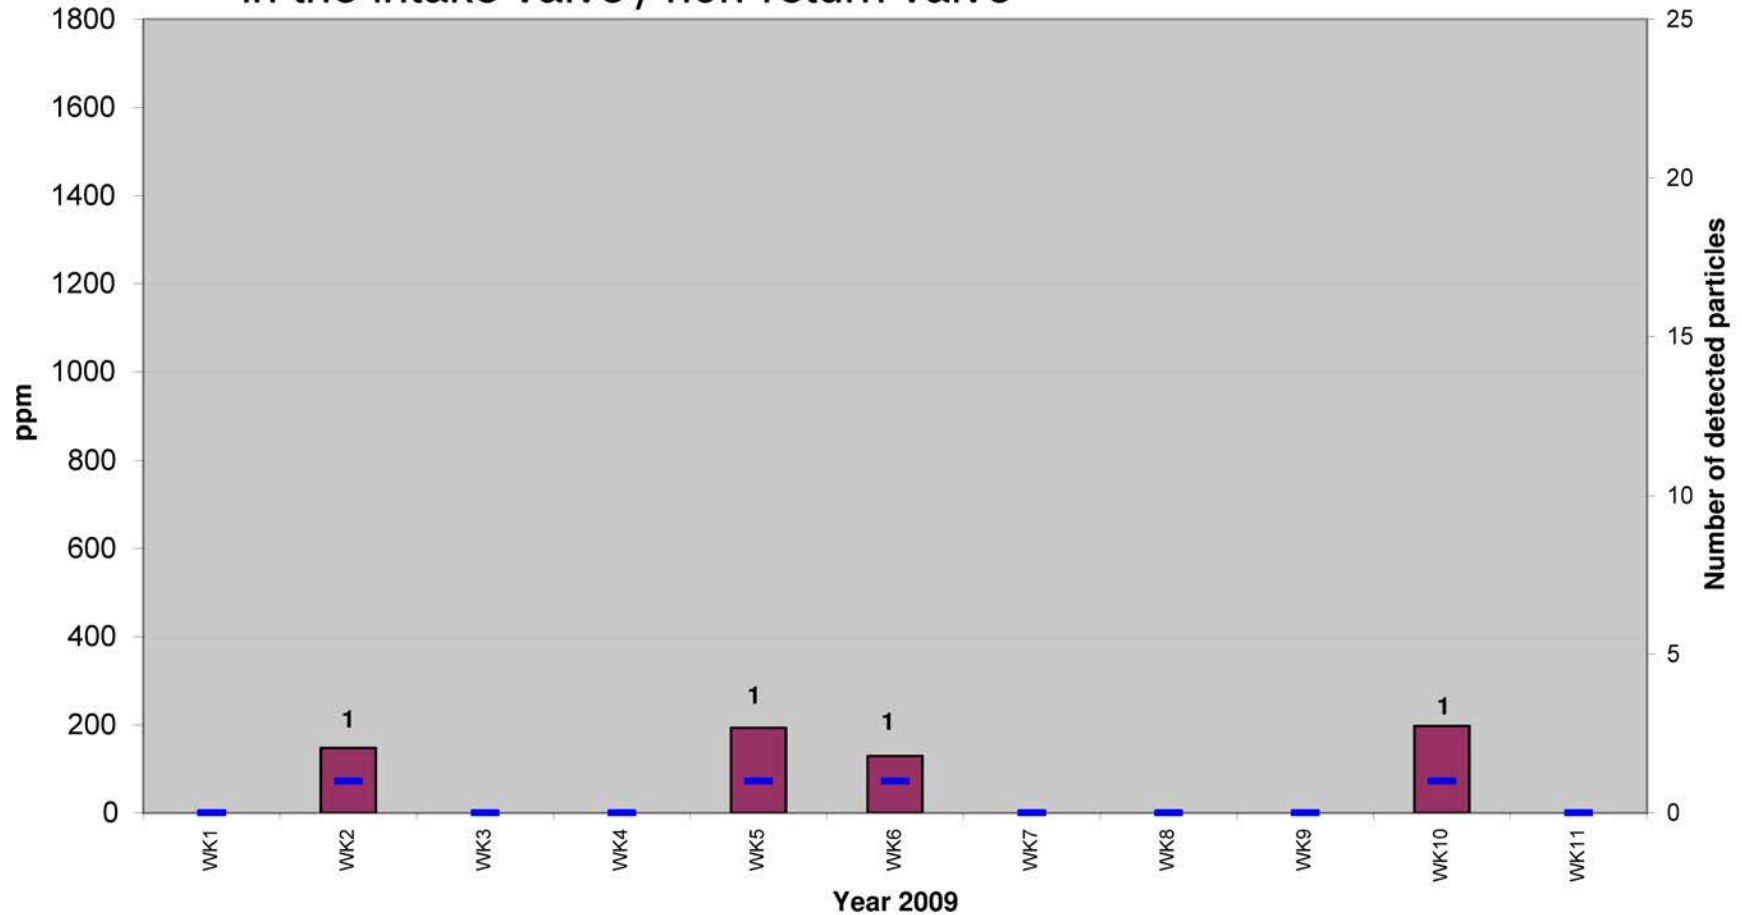
**JhP:** CP4 product, internal rail pressure failures with particles detected in the intake valve / non-return valve

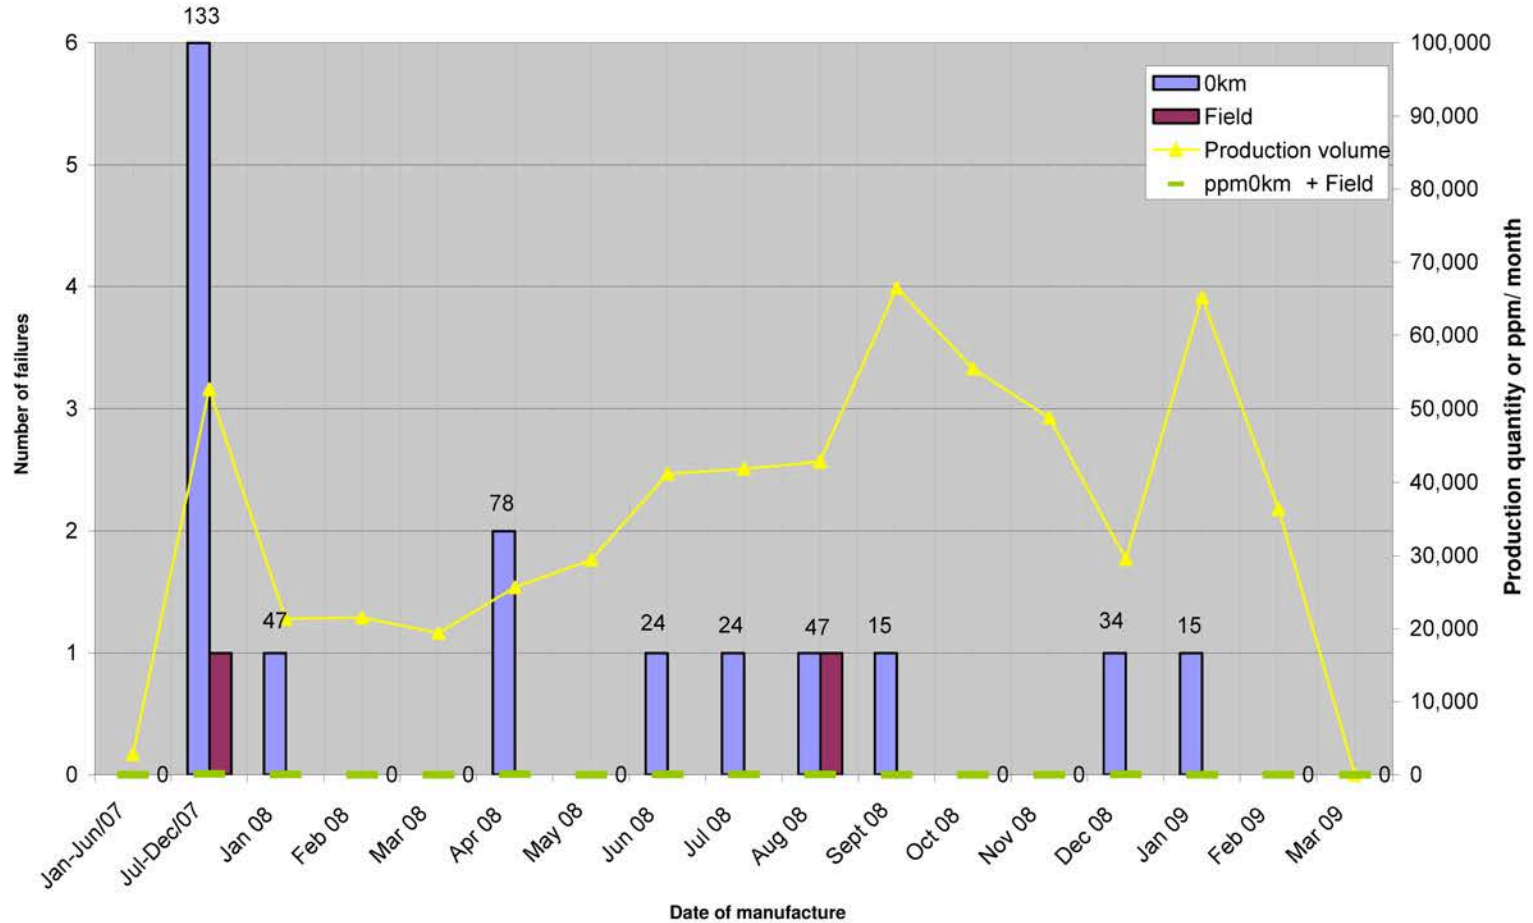
## FeP: Particle complaints confirmed in CP4 at VW/Audi

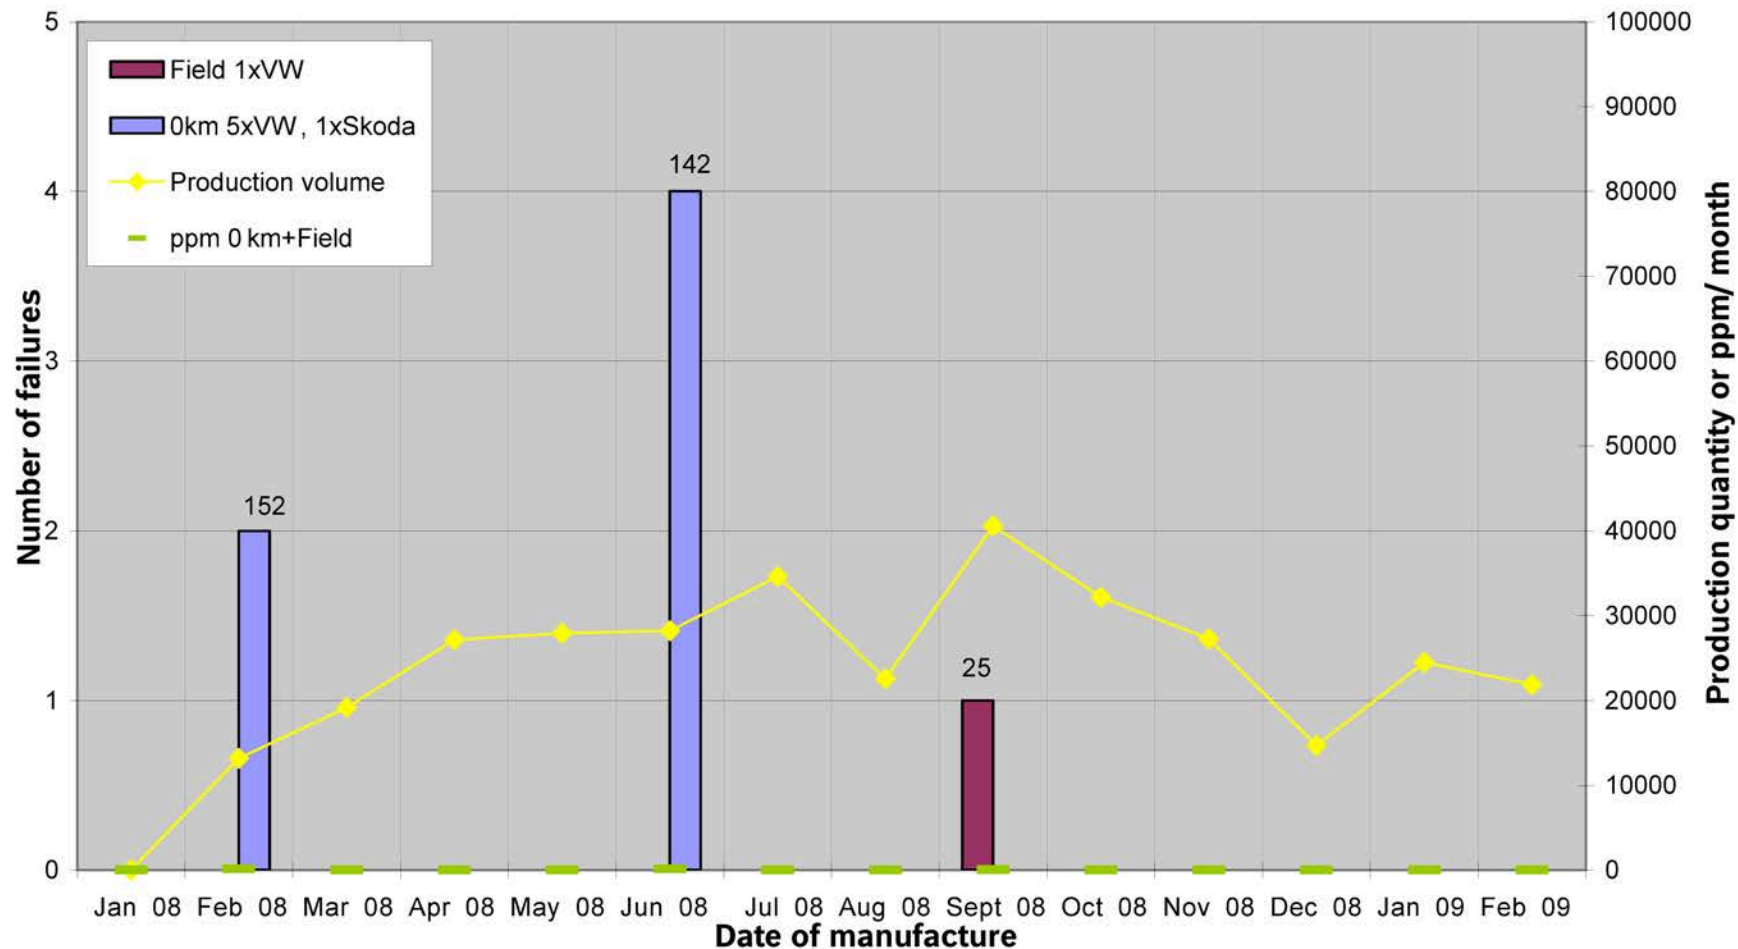
## JhP: Particle complaints confirmed in CP4 at VW/Audi
