Project 2.0I 103kW CR-TDI BIN5 US07

Status sheet: Engine

Failure of high-pressure pump

**Status V6 TDI Bin 5 in the Audi Q7
Relating to the high-pressure trouble ticket
SOP WK 47/08**

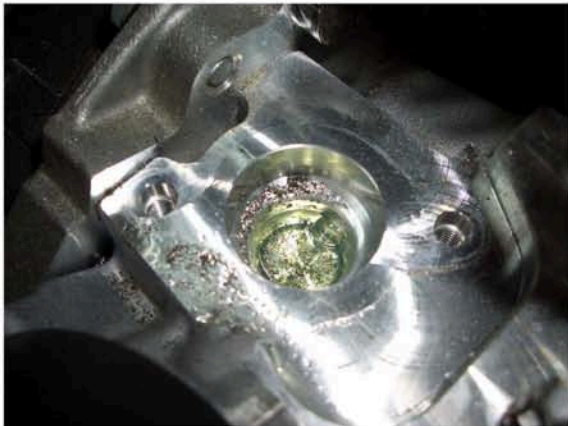
Component: fuel system	PPS: 48/07 NS: 05/08 SOP: 27/08	
Problem	Analysis	Assessment
<p> Initial message: 2/19/2008 Breakdown Engine will not restart after it has been switched off </p>

<p> Error in engine control unit fuel rail/system pressure too low (static) Deposits of metal particles found in the fuel tank, fuel filter, fuel conveyor unit of the tank and in the high-pressure filter pump </p> <hr/> <p> Measure </p> <p> Fuel sample is to be analyzed. Vehicle to be sent by air to Germany for analysis. </p> <p> Dates: Vehicle provision end of week 9 </p> <p> Further procedure: </p>	<div style="text-align: center;">

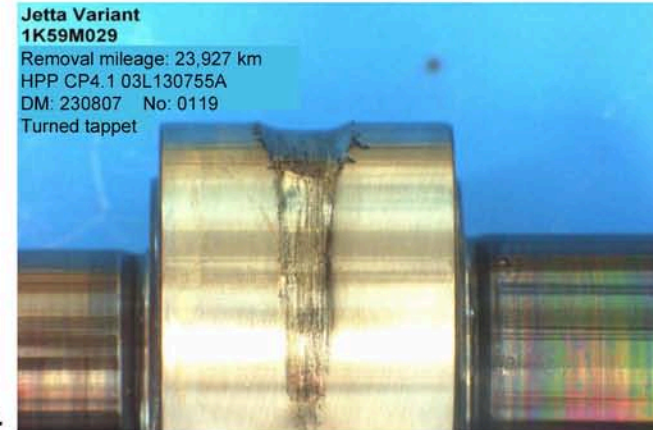
Cause: Roller tappet turned 90° because of vibration

Analysis: Deep groove on the camshaft.
Flattening on the roller, deposits in the tappet hole O-ring Metering unit (MU) damaged

Determination of C-layer adhesion roller support

Analysis of MU O-ring

Deposit analysis, housing/ tappet hole

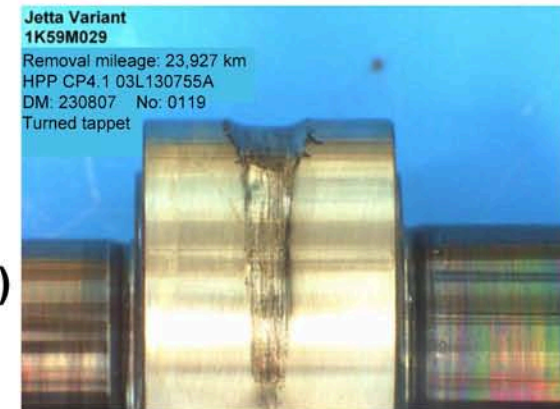
2.0I CR BIN5 LEV2 failure HP fuel pump

Fault: GQG-2 VEH. 1K59M029, “Serious problem from verification run GQG, metal particles in fuel system“

Cause: Massive wear and tear in drivetrain of high-pressure fuel pump
→ No pressure build-up due to damaged camshaft

- Outside standard (fuel quality not untypical in USA)
- Slightly raised flash point 44- 42°C

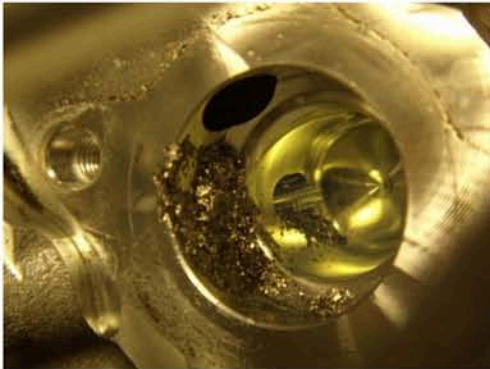
Problem: Engine died while driving at constant speed
 Engine will not restart. Fuel pressure too low (set = 300 bar, actual= 7 bar).

Metal particle found in high-pressure fuel pump

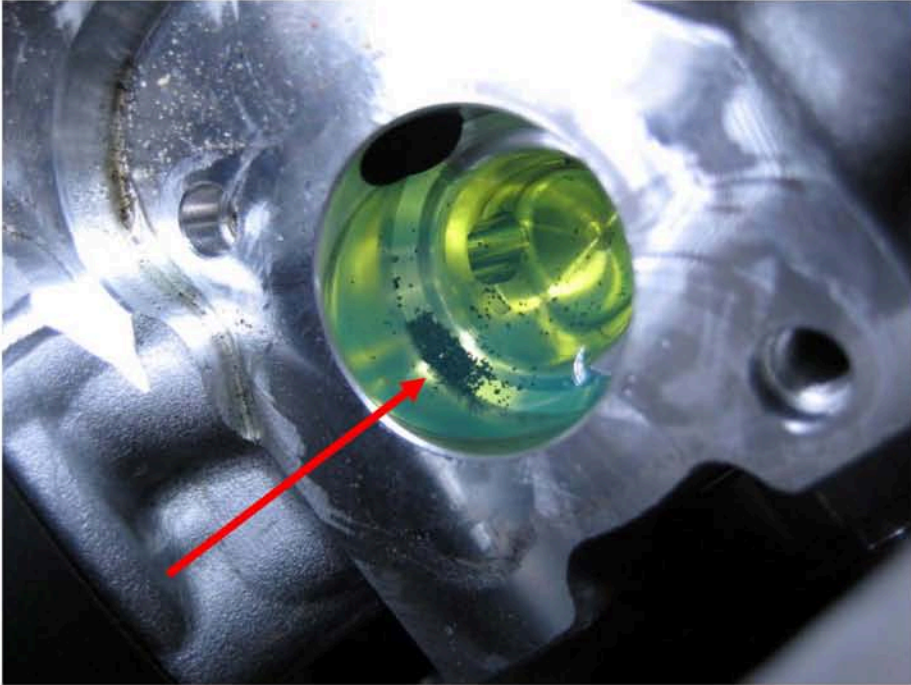
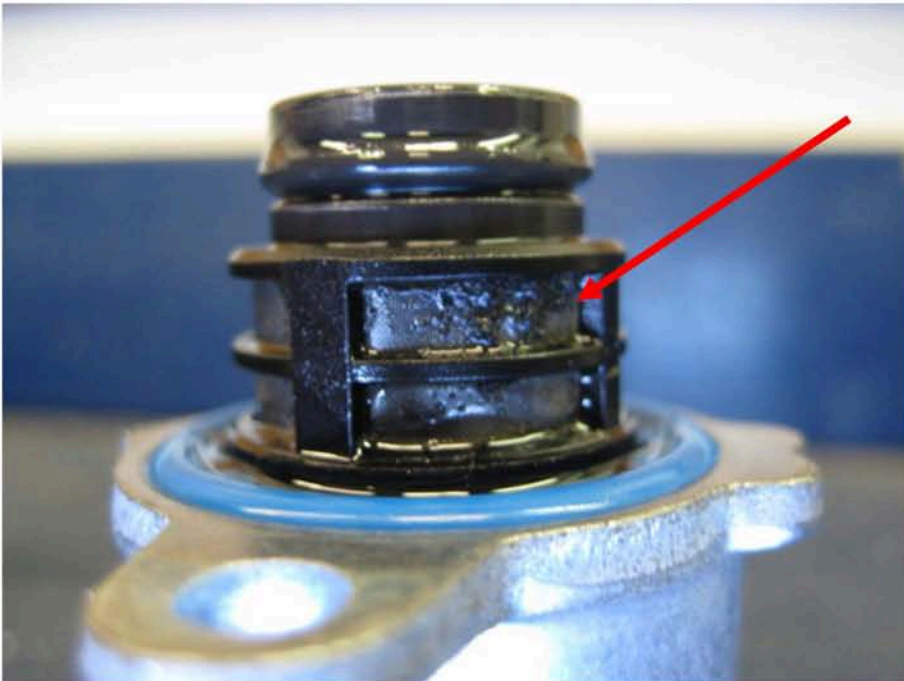
Vehicle AU716 98017 was leaky on the EGR system, seal for the intake line. See photos; OK again now, but the DPF still cannot be regenerated.

AU716 98017 does not have any output,
HPP is full of shavings

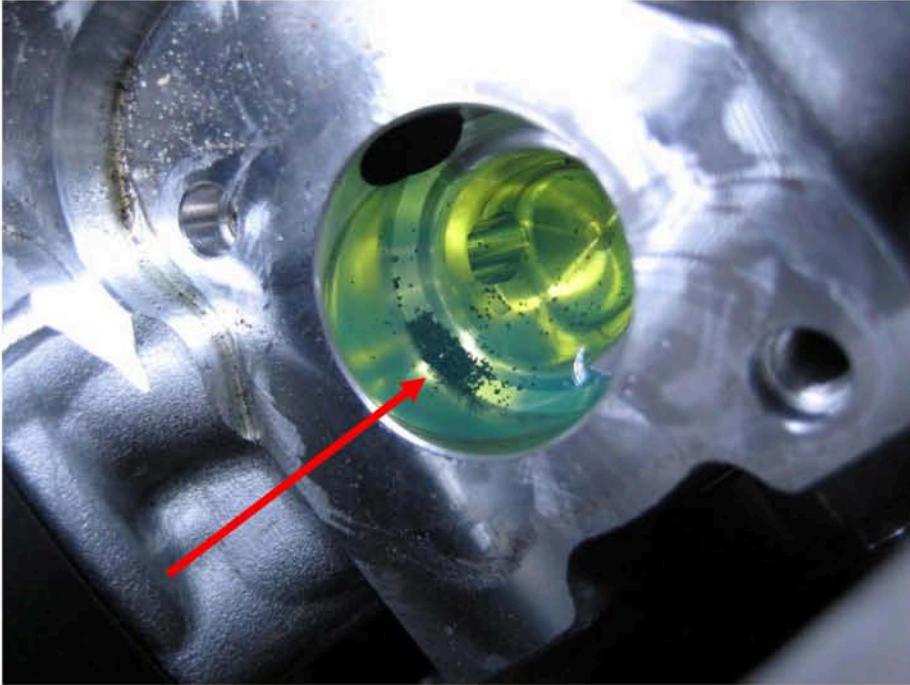
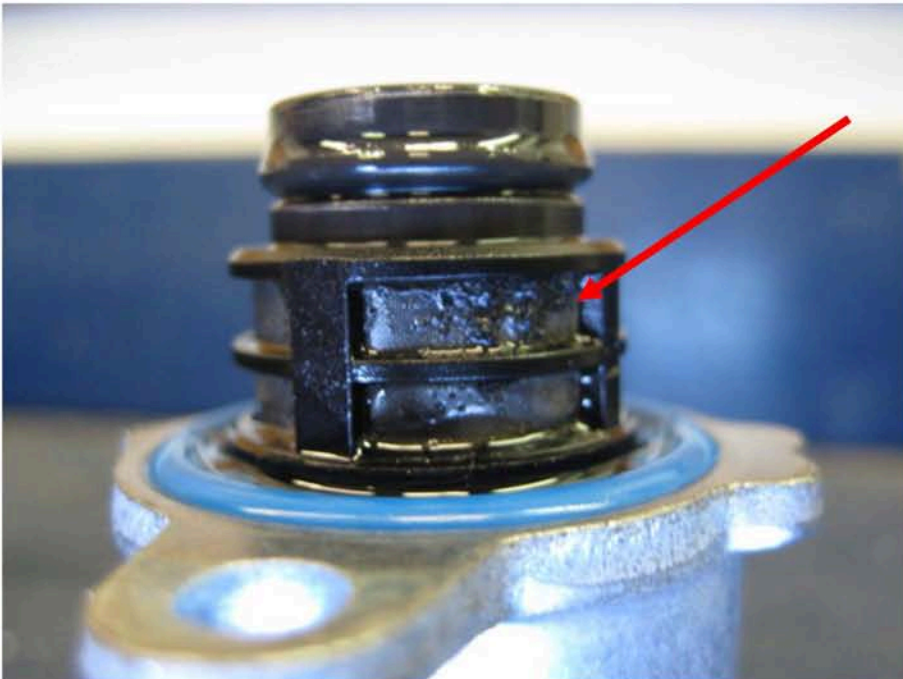
Vehicle AU716 98017 was leaky on the EGR system, seal for the intake line. See photos; OK again now, but the DPF still cannot be regenerated.

AU716 98017 does not have any output,
HPP is full of shavings
