Date: 17.03.2011 11:55:00  
Subject: Re: USA Failure RP1  
Attachments: [Lebenslauf USA-Pumpe.pdf](#)

**Subject:** USA Failure RP1

**Date:** 4/7/2010 8:21:20 AM  
**Topic:** 2.0 I TDI CR US\_07: Corrosion/water in the fuel/chips  
**Attachments:** [RE 578398 403158 escalation.msg](#)  
[FW 578398 403158 escalation.msg](#)

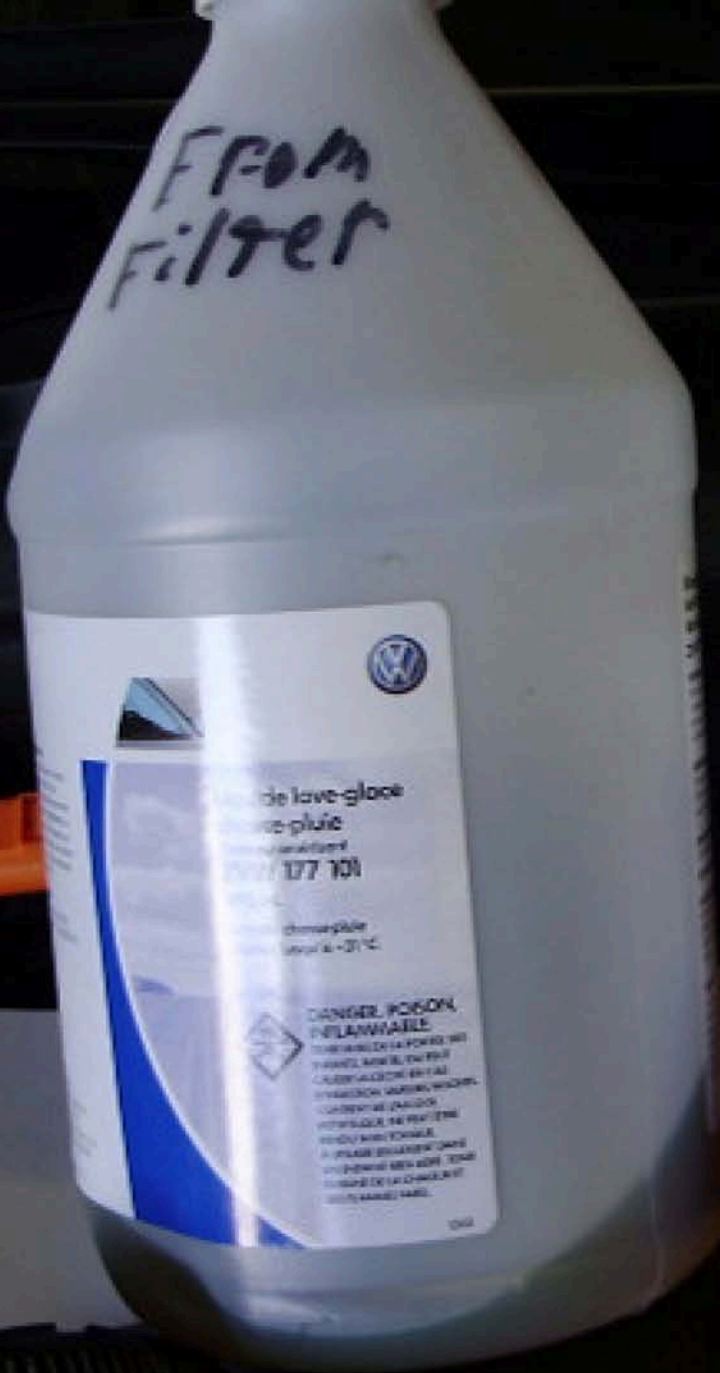
FROM  
Filter

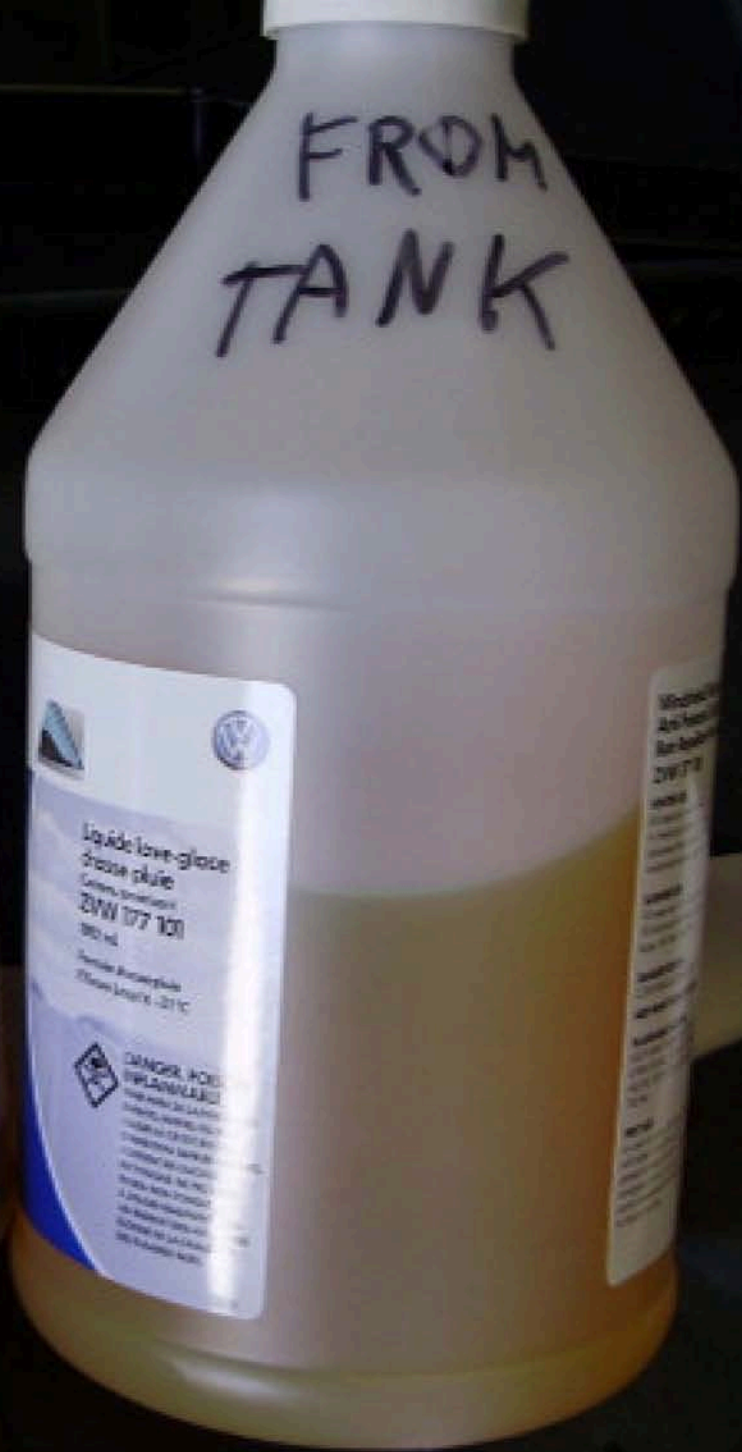
FROM  
TANK

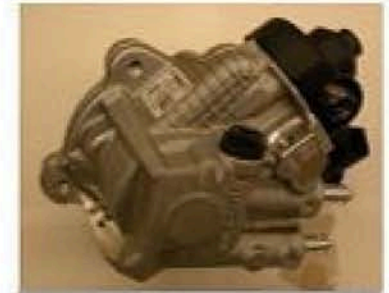
High pressure fuel pump

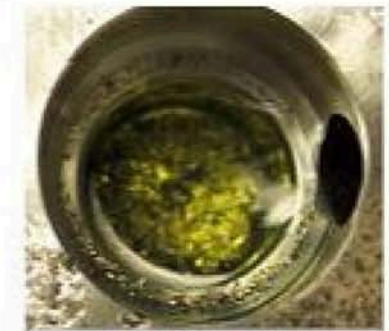
Metal in high pressure pump
