Warm-up report 2.0l R4 CR 105 kW in B8 Lim.

Warm-up report 2.0l R4CR 105kW in B8

Audi R4

Rail pressure too low, pump noise

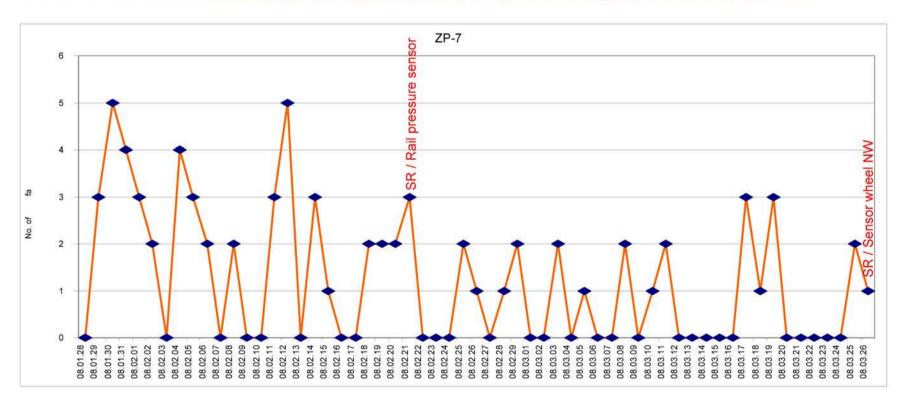
Problem: Rail pressure too low, pump noise

Cause: Power-train damage of high-pressure fuel pump

(Design fault for all Bosch customers)

DESIGN FAULT!

Roller in roller support (2)

Camshaft (3)

- 1. Click-clack check before delivery, D:05/10/2007
- 2. New switch process between flushing and inspection, D:05/30/2007
- 3. Noise measurement, D:06/18/2007
- 4. Optimization of test bench workflow, D:07/09/2007
- 5. CH assembly with 5° torsion suspension D:07/23/2007
- 6. Extension of high-load inspection point, D:10/01/2007
- 7. Friction coefficient check +/-10°, D:12/13/2007
- 8. Tappet laser scan, D:12/21/2007

- 1. Technical elimination measures with dates/persons responsible (for metal spatters in the roller, imperfections with elevations at outer edges of roller, etc.) expected of Bosch. D: 3/27/2008
- 2. Proposed concepts for distortion protection. T:Wk14/2008 (Meeting in WoB with TD).
- 3. Meeting with Bosch in Györ to examine the FFT booth once again and evaluate the recordings together. D:Wk14/2008
- 4. Fuel quality examination for all FFT booths. D:Wk14/2008
- 5. Assess storage concept of TD. D:Wk14/2008

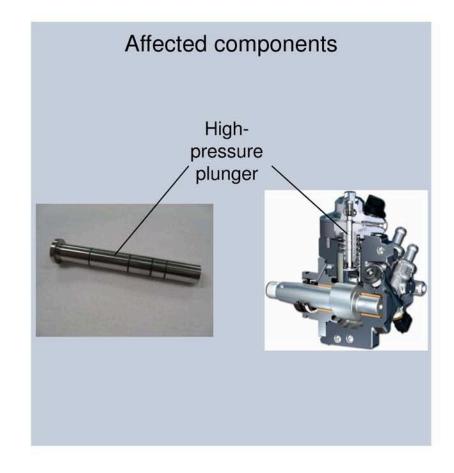
RP0: High-pressure plunger

Objective

- → Lower wear of HP plunger
- → Lower internal HP leakage

- → Optimized C2 layer on HP plunger
- → Reduced play between HP plunger and plunger guidance in cylinder head

- → Increased robustness against abrasive wear.
- → High hydraulic efficiency, even if low-viscosity fuels are used.

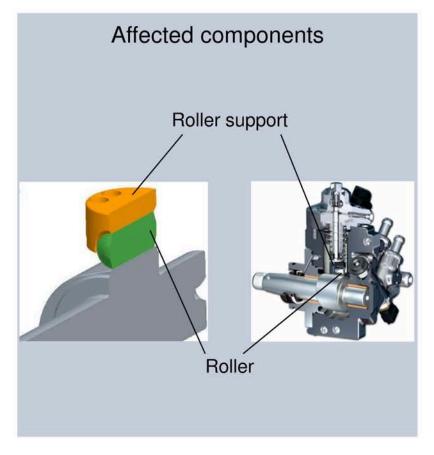
RP1: Roller / roller support

Improved formation of lubricating film between roller support and roller to reduce the mixed friction proportion for fuels with low viscosity.

- → Optimized C layer on C2.1 roller support: Reduction of roughness on surface
- → Less play between roller and roller support

Increase thickness of hydrodynamic lubricating film.

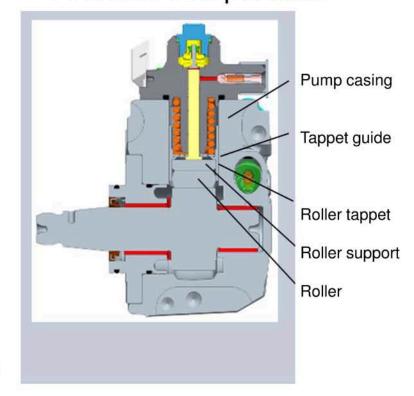
RP1+: Tappet assembly

- → Improved lubrication film formation on roller support and roller for reducing mixed friction proportion for fuels with low viscosity such as RP1
- → Increased robustness against wear, reduction of cavitation erosion due to lower tilting in the tappet guide
- → Reduced ticker tendency

- → Optimized C-layer roller support C3.1; reduced surface roughness, harder substructure
- → Low roller/roller support play
- → Reduction of radial play of tappet to casing
- → Reduction of axial play on the piston foot

- → Increased thickness of the hydrodyn. lubrication film
- → Reduced wear depths and cavitation erosion
- → Reduced impact speed of piston on RS

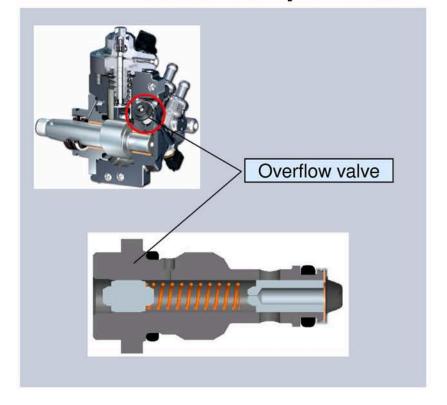
OV-b

→ Prevention of vapor bubble formation in the cam space.

→ Increasing the overflow valve opening pressure.

→ Increased fuel pressure level in the cam space.
