Agenda for 3. Audi CP4 zero-fault meeting on 04/10/2008 with a focus on drive-train damage

R4 CR TDI High-pressure fuel pump seized, noisy

The cause of drivetrain damage is operation with impermissible fuel qualities and/or high component function sensitivity

Drivetrain damage high pressure diesel fuel pump CP4.

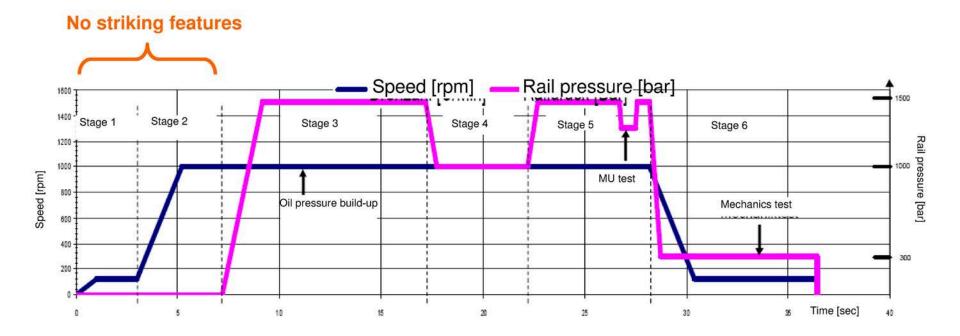
Detection of fault in the cold test curves

(e.g. on the engine Motor CAG 036236, but it manifests in the same manner in the other two failures)

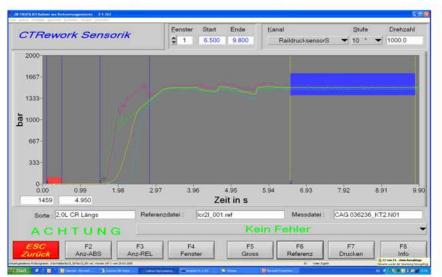
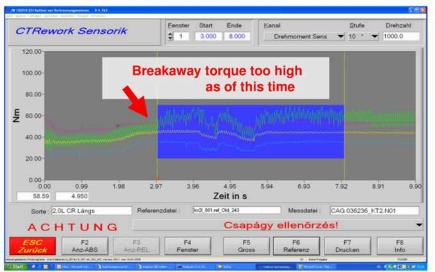
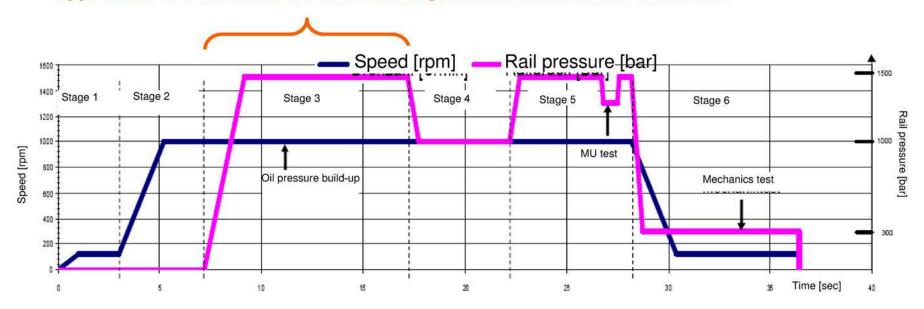
Rail pressure buid-up and kept stable, but the torque curve has run up since approx. the second third to a level that is greater than the reference curves

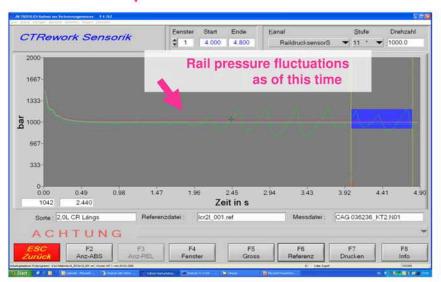
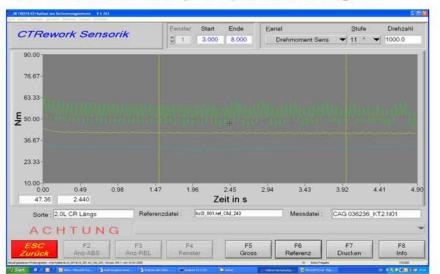
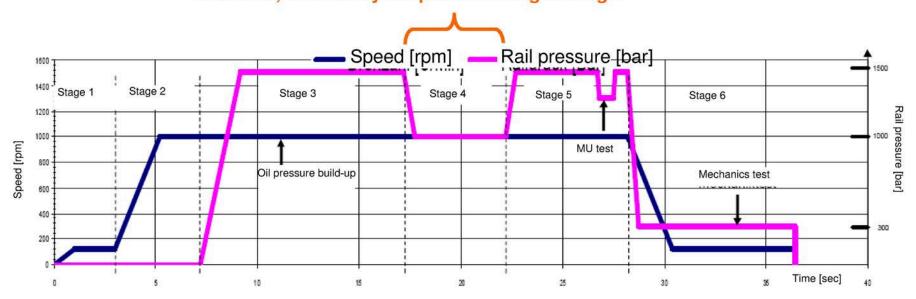
Within a few minutes, considerable rail pressure fluctuations occurred, breakaway torque remaining too high

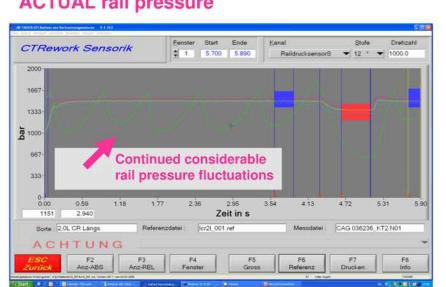
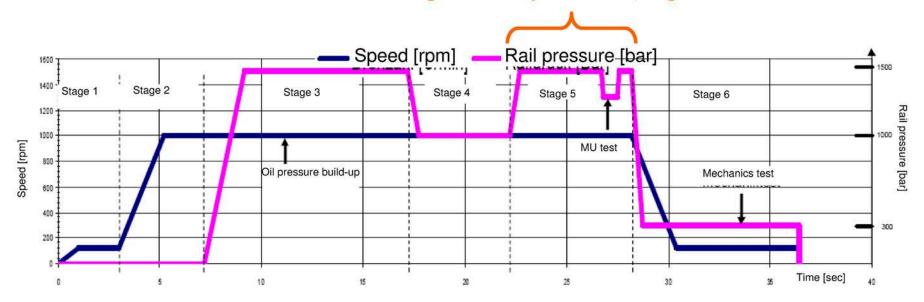
Rail pressure in the further phases of the testing were always unstable, engine not OK

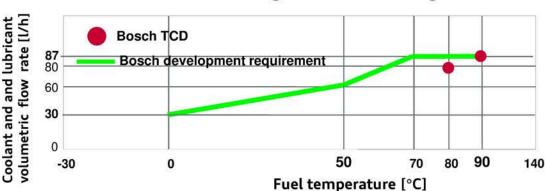
- ► Tank EFP (2bar) and inline EFP (6bar) connected in series
 - No on-demand delivery; EFPs always on full delivery
- Bosch TCD requirement for return volume (cooling and lubricating volume)
 - >= 80l/h <u>at</u> 80°C fuel temp. in HPP supply; >= 87l/h <u>at</u> 90°C
 - → The TCD is complied with in operation under all conditions; this also applies to the damaged vehicles (checked on 10 vehicles with drivetrain damage)

The TCD is complied with under all conditions

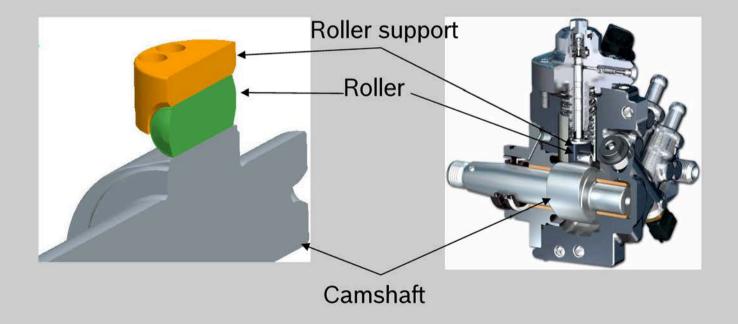
causes greater wear in the roller/roller support assembly
 (up to 200 [rpm]) at start (mixed friction area)

- Influence as emulsion, see lubricity & viscosity
- Free water (in droplet form) can result in hydrogen embrittlement / stress corrosion and thus to fatigue of the partner roller

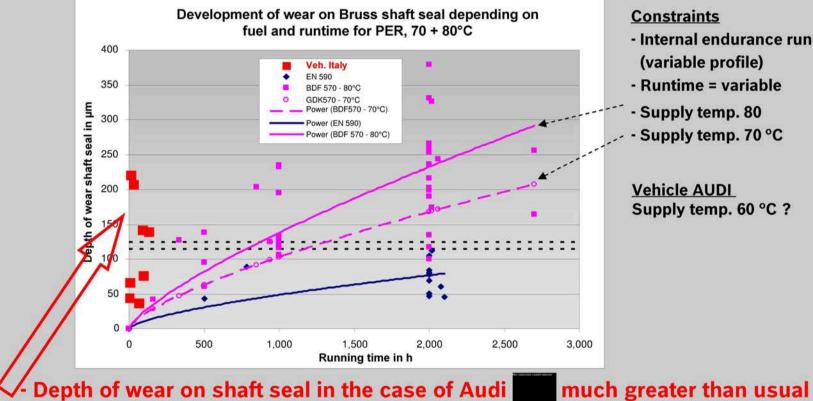
Dependence of shaft seal wear on fuel and runtime

EN590: Viscosity_{40°C} = 2.5 mm²/s, HFRR_{60°C} = 420 μ m BDF570: Viscosity_{40°C} = 1.9 mm²/s, HFRR_{60°C} = 570 μ m

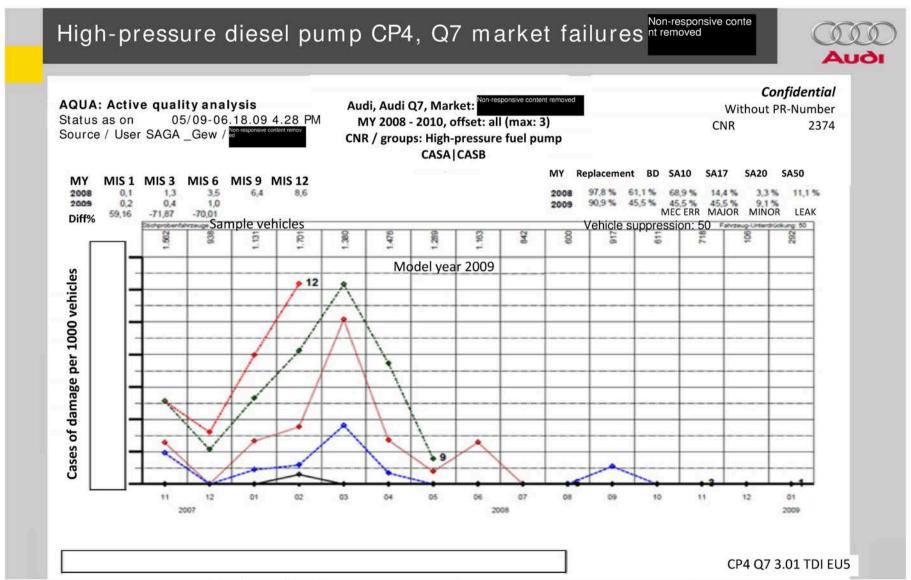
Note: Overall market in 27: Sharp decline in failures due to measures at Bosch.

There is continued lack of robustness with certain fuels worldwide.
