Direct Information System Service (DISS)

Date: 11/16/2010, 11:23:22 AM
Subject: Re: V6 TDI block

Subject: Re: Failure of high-pressure fuel pump diesel C.R. [REDACTED] market - Current situation for 4-cylinder Engines

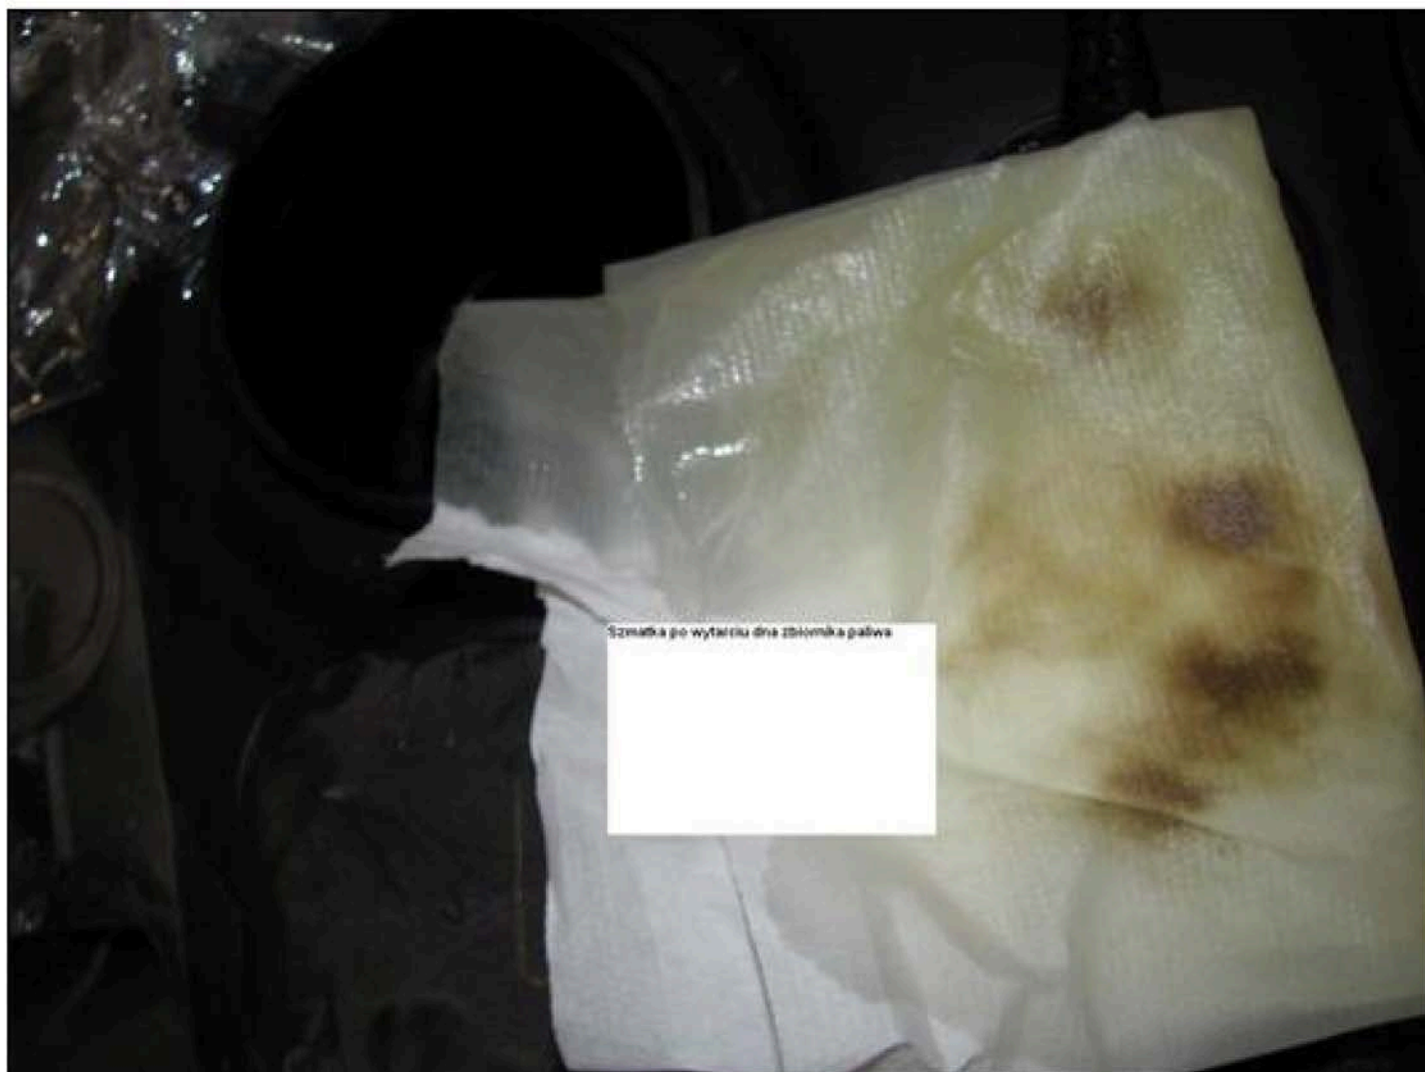
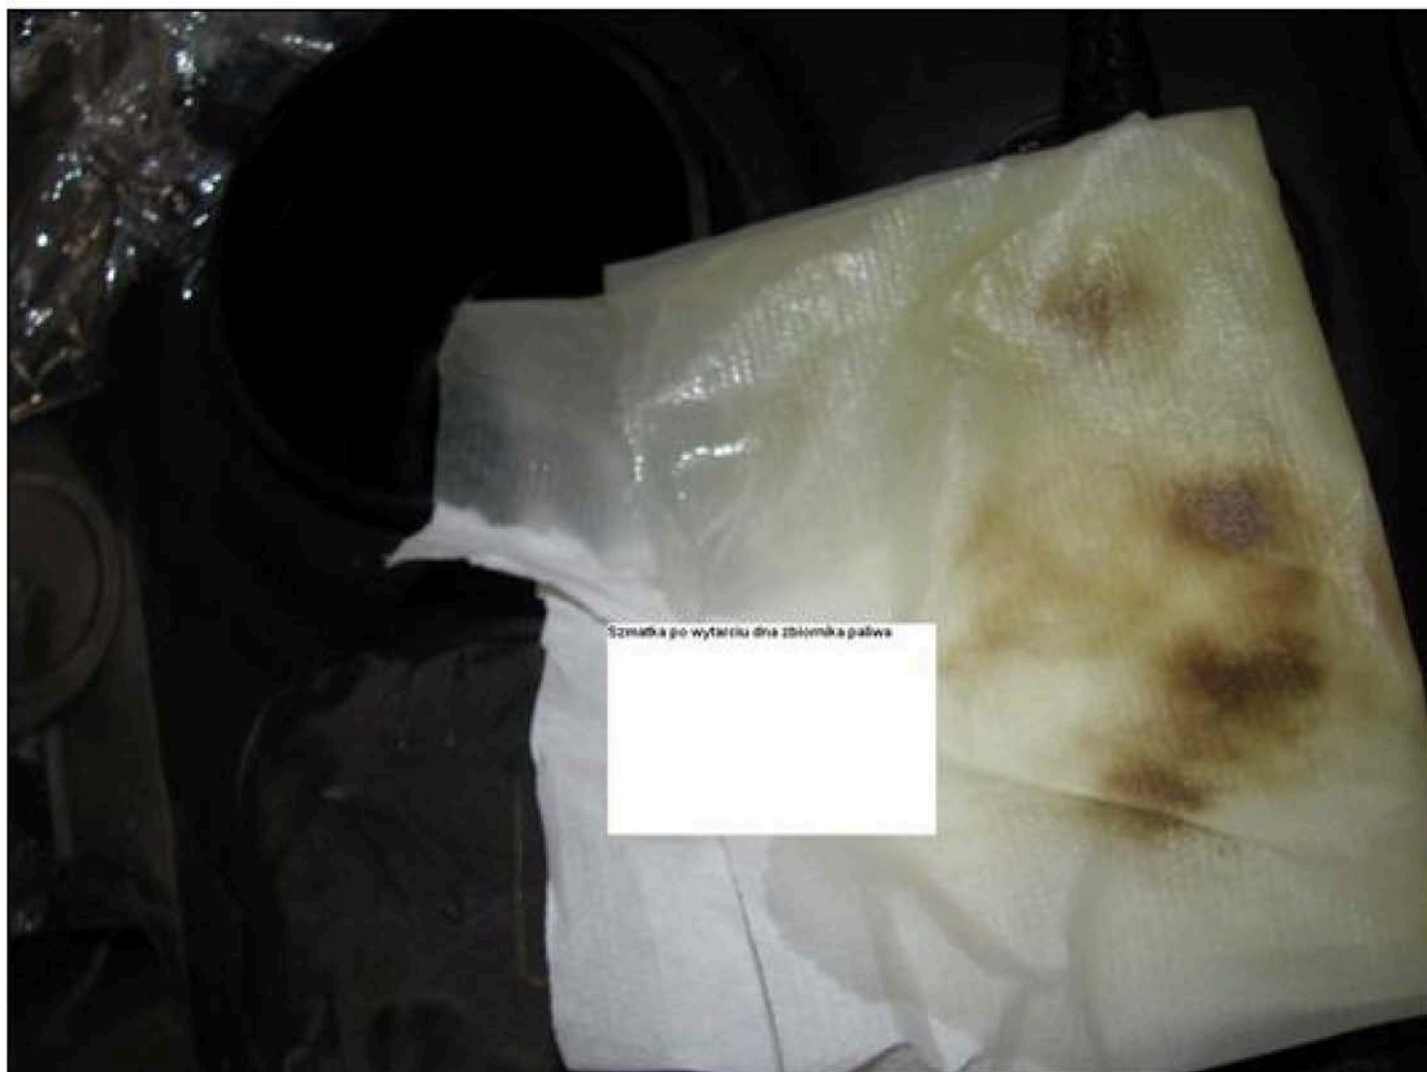
IMG_9634.JPG

Hello, [redacted] You should already be familiar with this subject from our phone calls and e-mails. At 8620 km, the entire fuel system, including tank, was exchanged and sent for analysis. The high-pressure fuel pump is damaged again (metal shavings). The fuel is currently being drained and the tank removed. The tank contained magnetic metal shavings and a mud-like contamination (see pictures). The tank pump contains a lot of dirt (picture 9628) - it is very fine sand (not plastic shavings!) + metal shavings. We also removed a fuel pipe between rail and injector - no rust marks can be seen. The customer has a company and purchases fuel wholesale (see last invoice - 5100 l) and fills his vehicles from his own filling station. We therefore assume that the damage was caused by poor fuel quality. The mechanical soiling can be dealt with by the fuel filter, it is possible that the fuel was also chemically contaminated. What do you think?
