Cleanliness concept of Bosch high-pressure pump 2.0-liter CR

Compliance with the VW standard 01134

Status V6-TDI Bin5 – MY09 / MY10
Failure HPP in EC ER

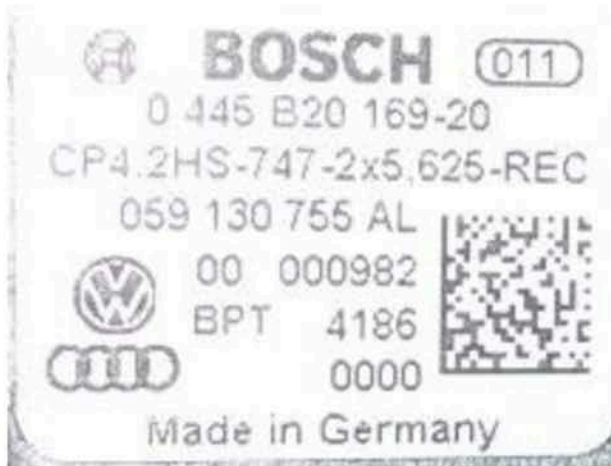
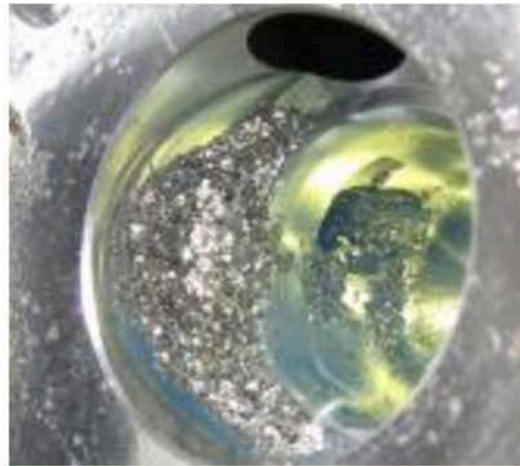
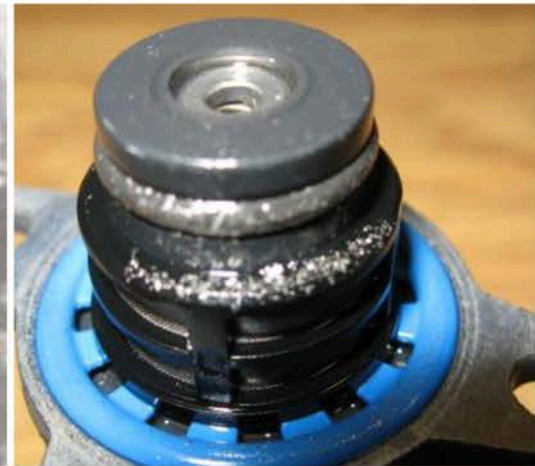
Analysis: Drivetrain damage with suspected sluggish roller

- Chips in high-pressure fuel pump and MU (metering unit).

- Minor traces of corrosion on tappet body and roller support

Vehicle: Q7 AU716 90229 MY10

mileage: 89,543 mls (144,075 km)

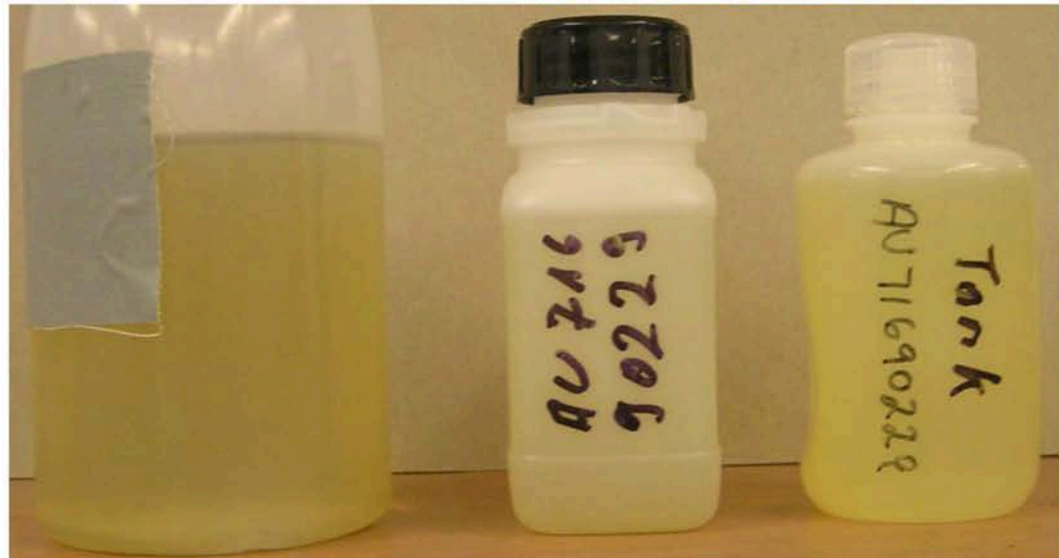
**Fuel samples:**

- Fuel filter
- Tank

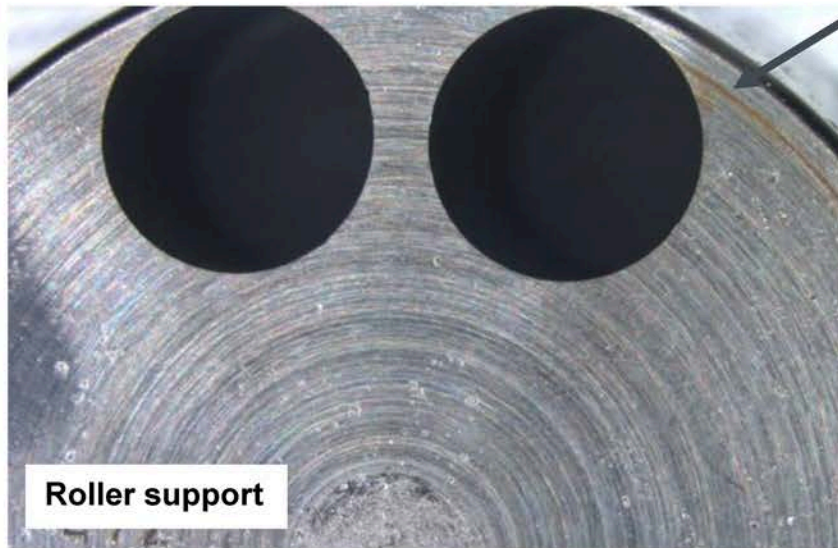
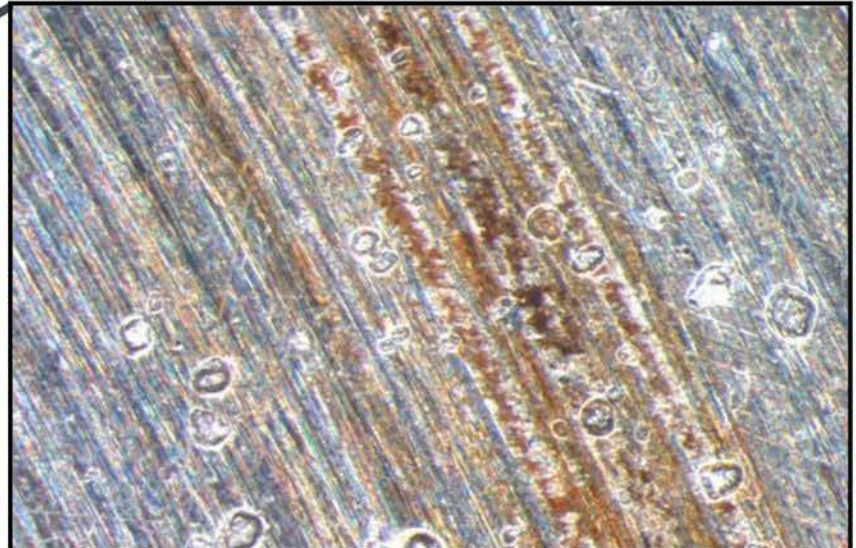
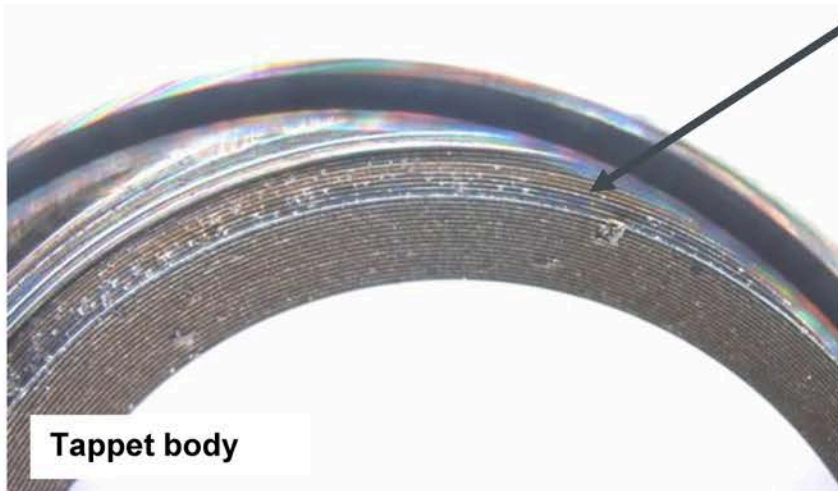
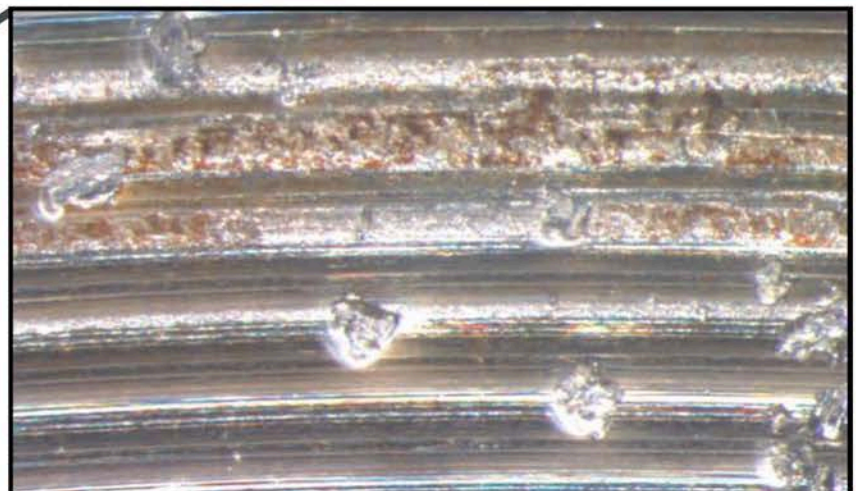
Vehicle: Q7 AU716 90229 MY10

mileage: 89,543 mls (144,075 km)

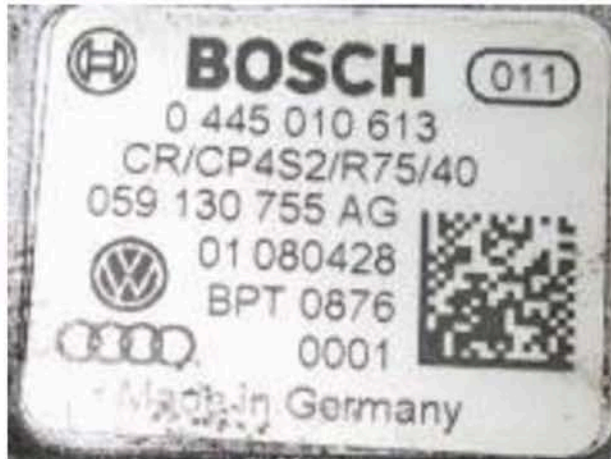
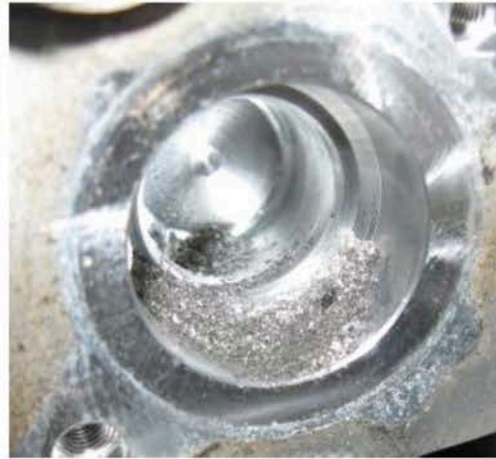
Analysis: Drivetrain damage

- Chips in high-pressure fuel pump and MU (metering unit).
 - Minor traces of corrosion on tappet body and roller support
- Visual check of fuel in fuel filter shows no deposits

Vehicle: Q7 AU716 90390 MY10

mileage: 88,426 mls (141,925 km)

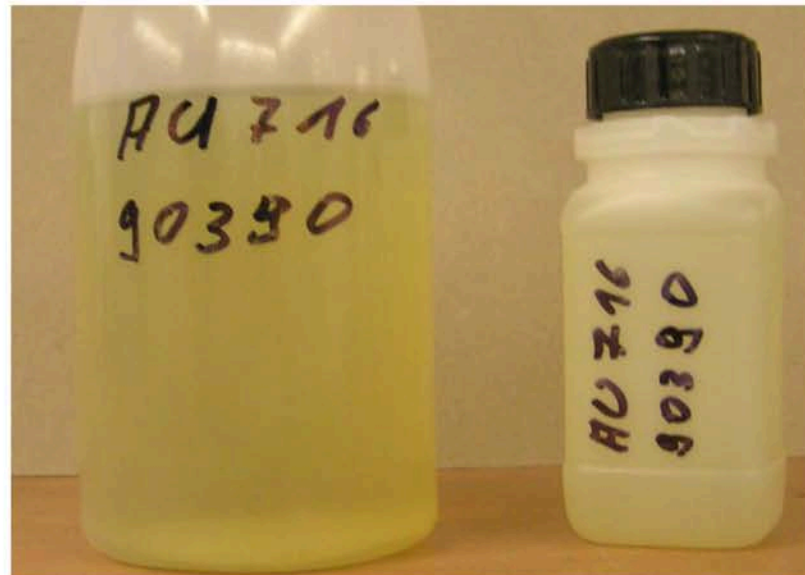
Fuel samples:

- Fuel filter
