Dismantlement and assessment of an R4 CR Bosch HP fuel pump 03L 130 755

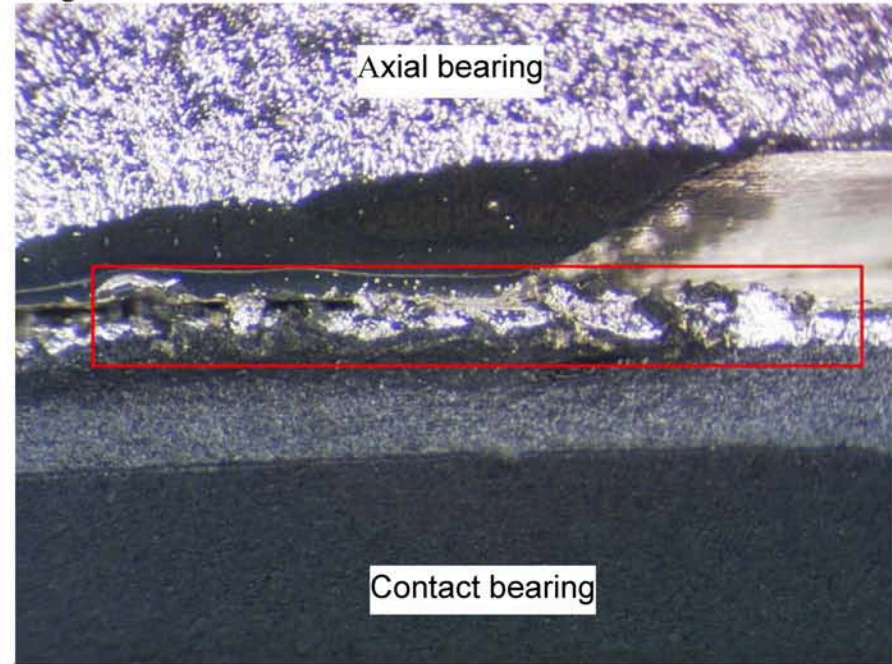
Fig. 6:

Pump no. 1 Space between compensating disk, contact bearing flange
