Dismantlement and assessment of an R4 CR Bosch HP fuel pump 03L 130 755

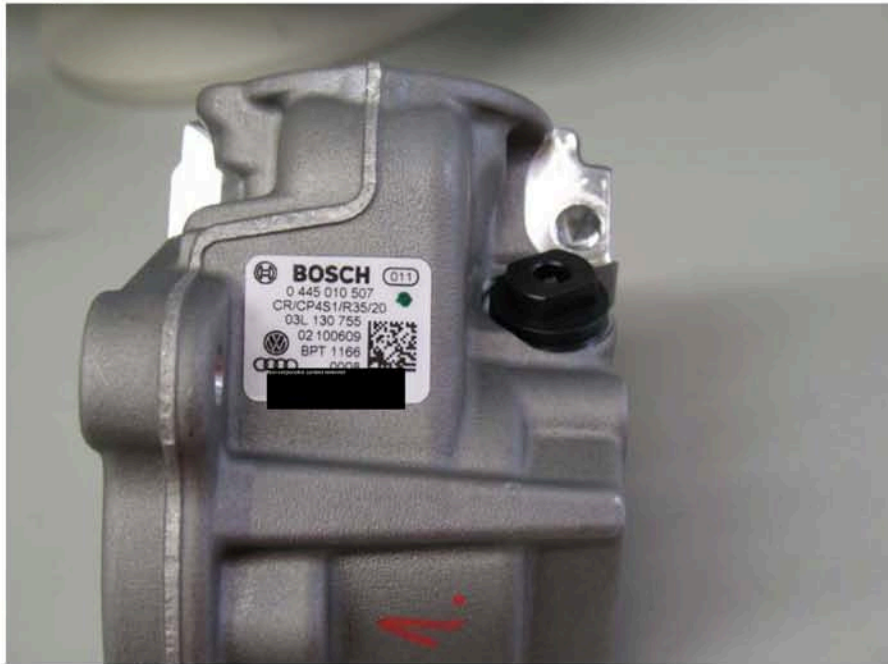
Fig. 1:

Pump no. 1 Data plate

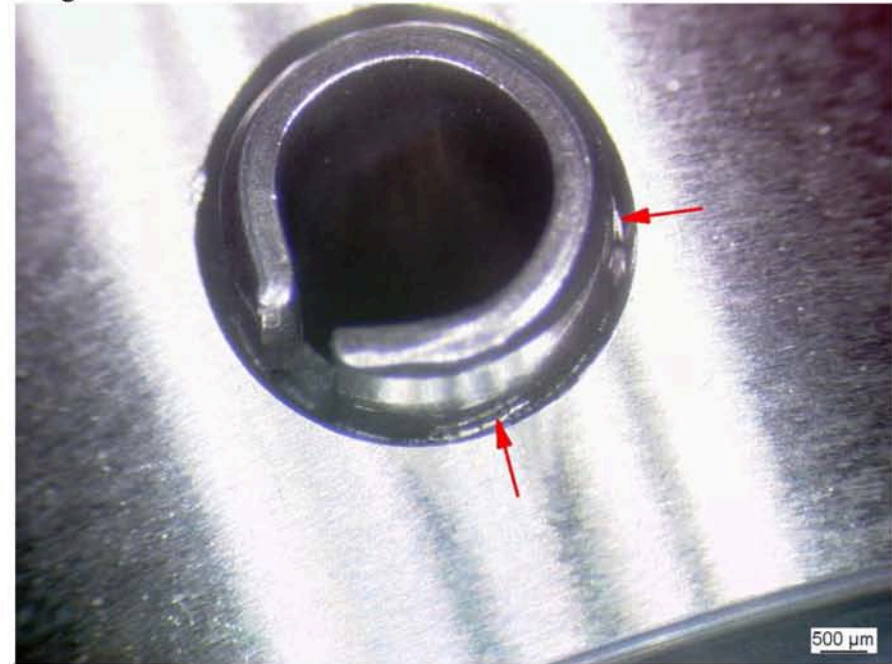
Fig. 2:

Pump no. 1 Extrusion from the pressing process No particles in thread

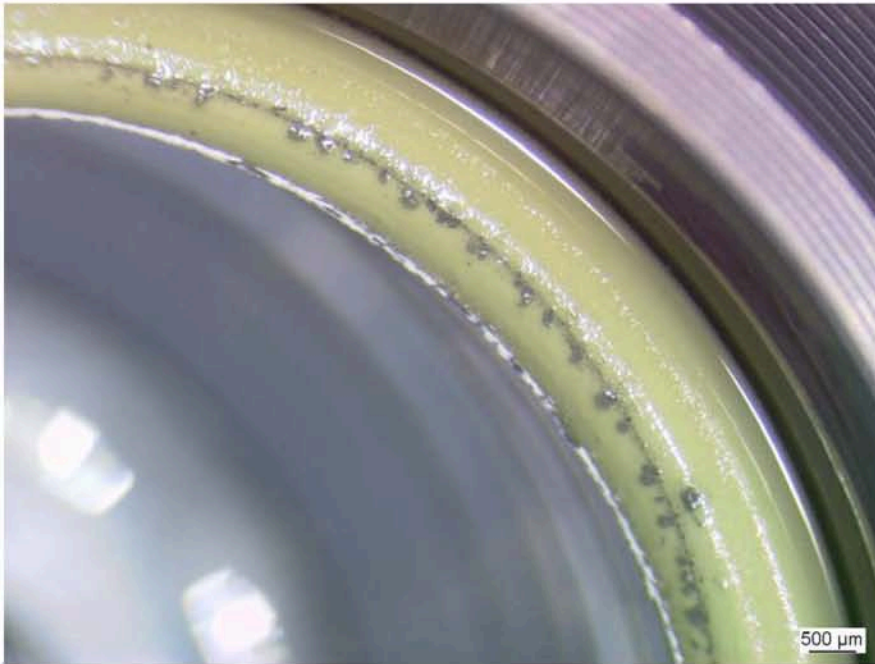
**Fig. 3:**

Pump no. 1 O-ring CH abrasion from the locking ring coating, non-critical

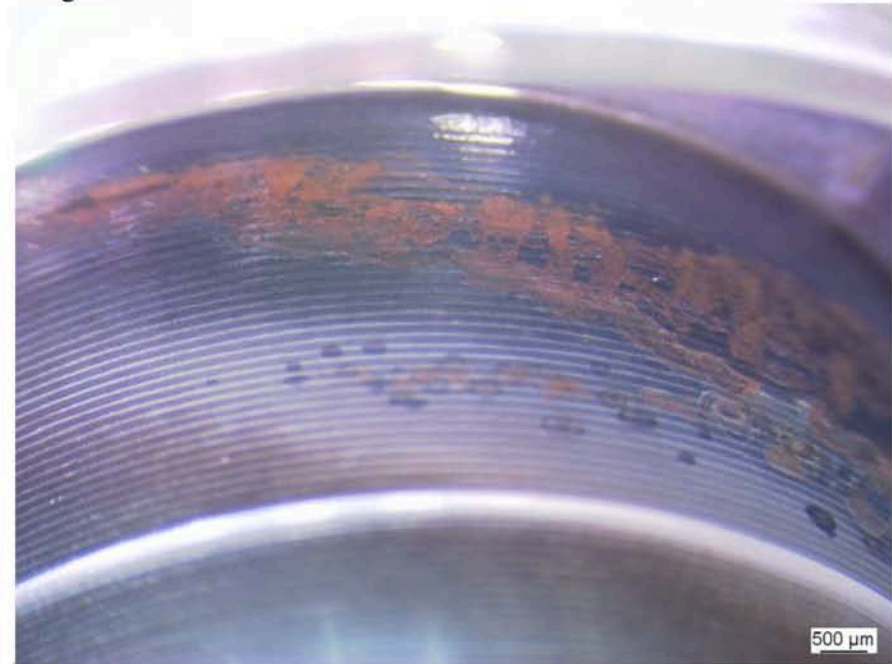
**Fig. 4:**

Pump no. 1 External mantle, piston bore. Rust

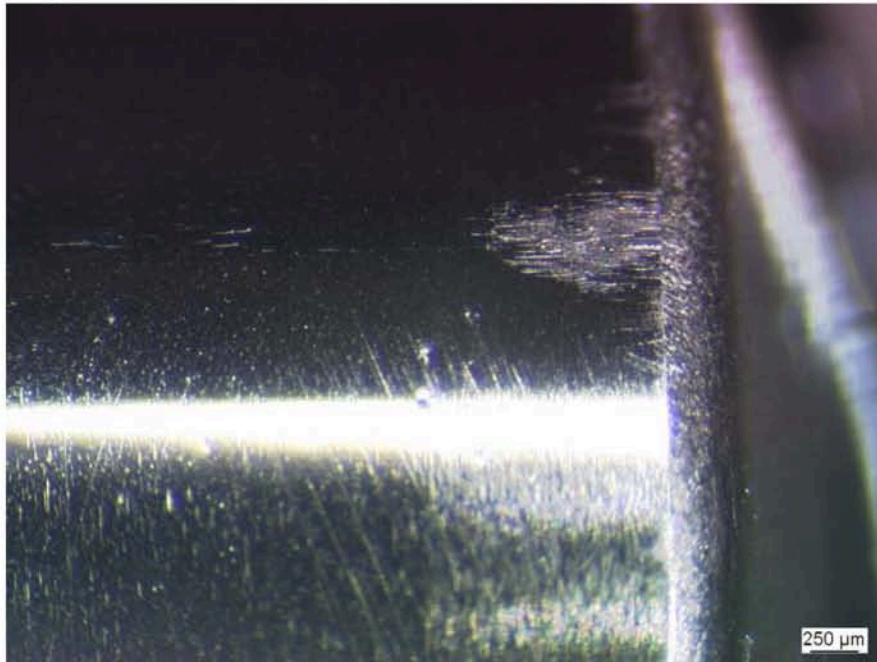
**Fig. 5:**

Pump no. 1 Roller, minor cracks on edge

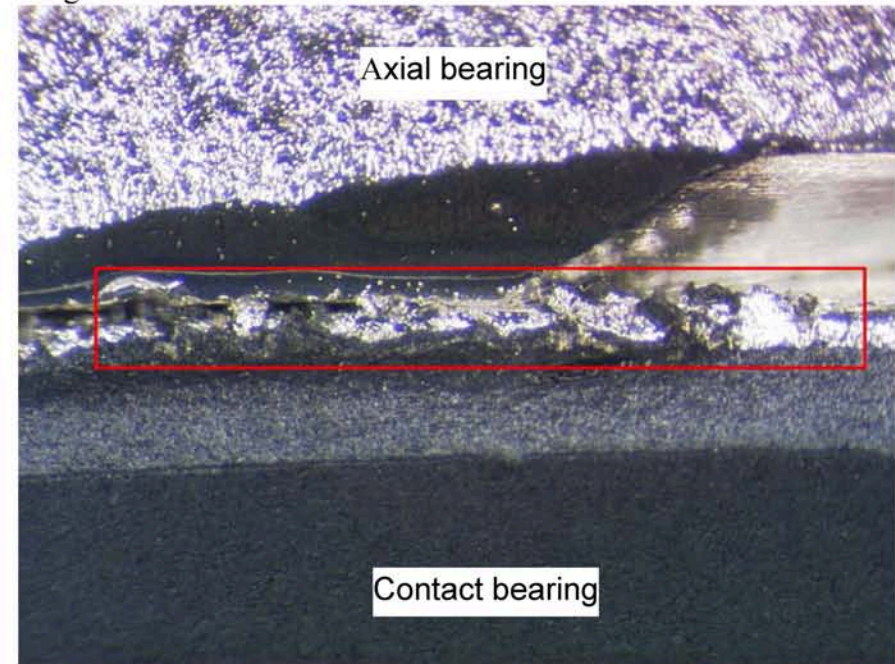
**Fig. 6:**

Pump no. 1 Space between compensating disk, contact bearing flange

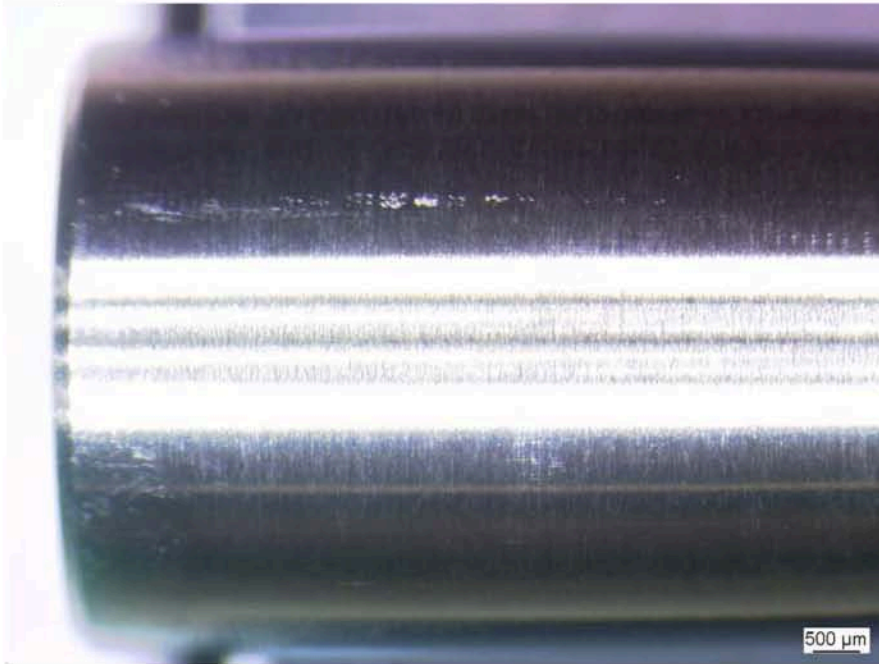
**Fig. 7:**

Pump no. 1 Very slight traces on piston

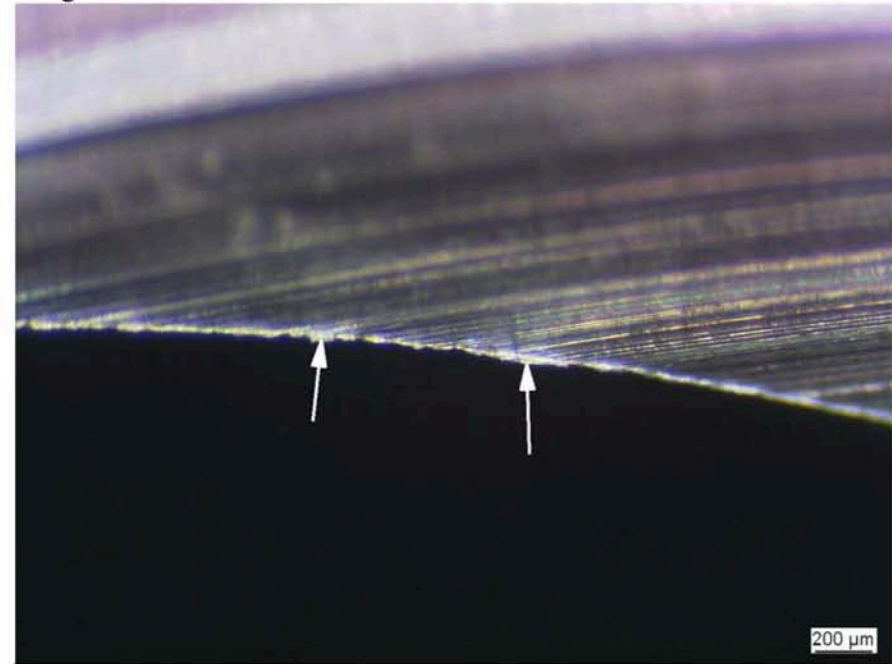
**Fig. 8:**

Pump no. 1 Tappet bore bottom edge, very small burr (sharp edge)

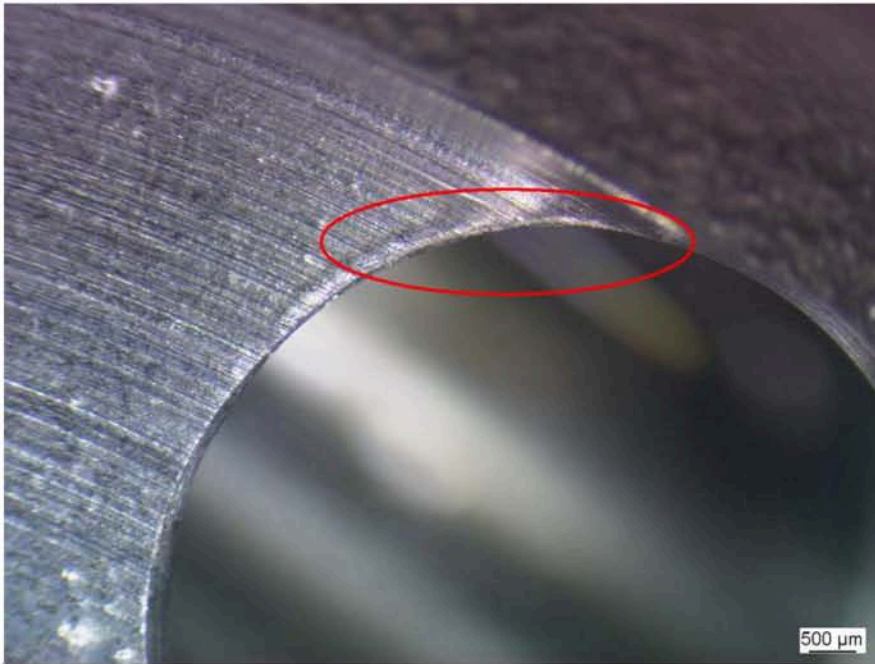
**Fig. 9:**

Pump no. 1 Cross bore inlet edge to interior, burr (sharp edge)

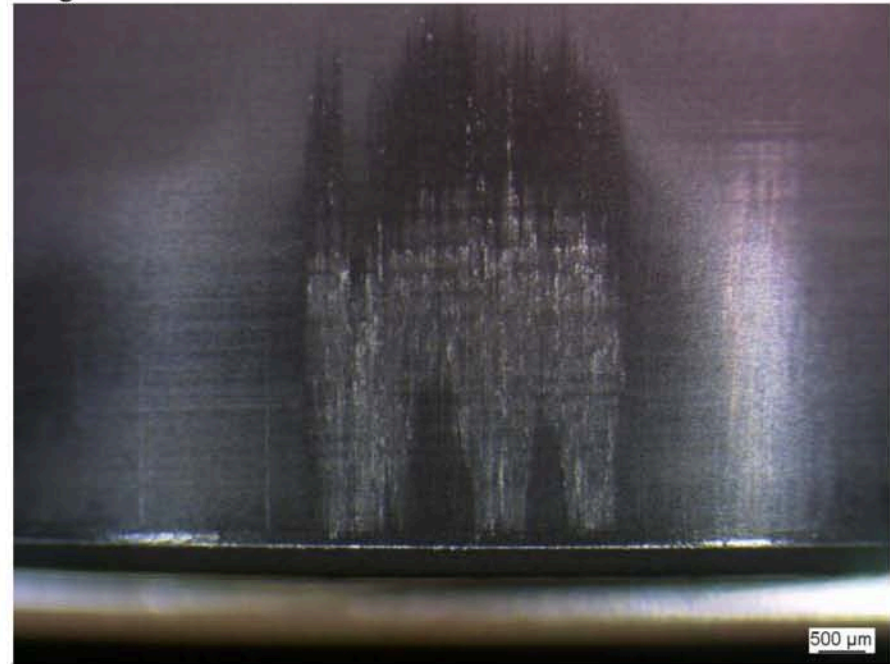
**Fig. 10:**

Pump no. 1 Tappet body run marks
