**From:** Non-responsive content removed**To:****CC:****Date:** 6/22/2009, 6:04:03 PM**Subject:** RE: CP4.1 assessment (R4 CR high pressure fuel pump from Bosch)

The following is a short summary of our telephone conversation on the unusual features of the disassembly audit of 06.19.2009

**Dismantlement and assessment of an R4 CR Bosch HP fuel pump 03L 130 755**

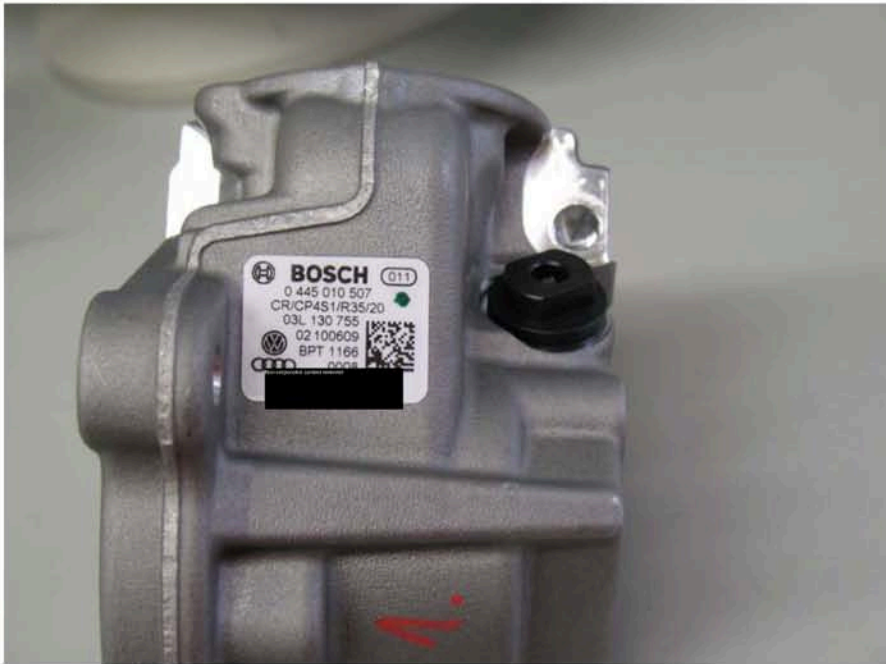
**Fig. 1:**

Fig. 1 ID plate - purely for information about pump data

Pump no. 1 Data plate

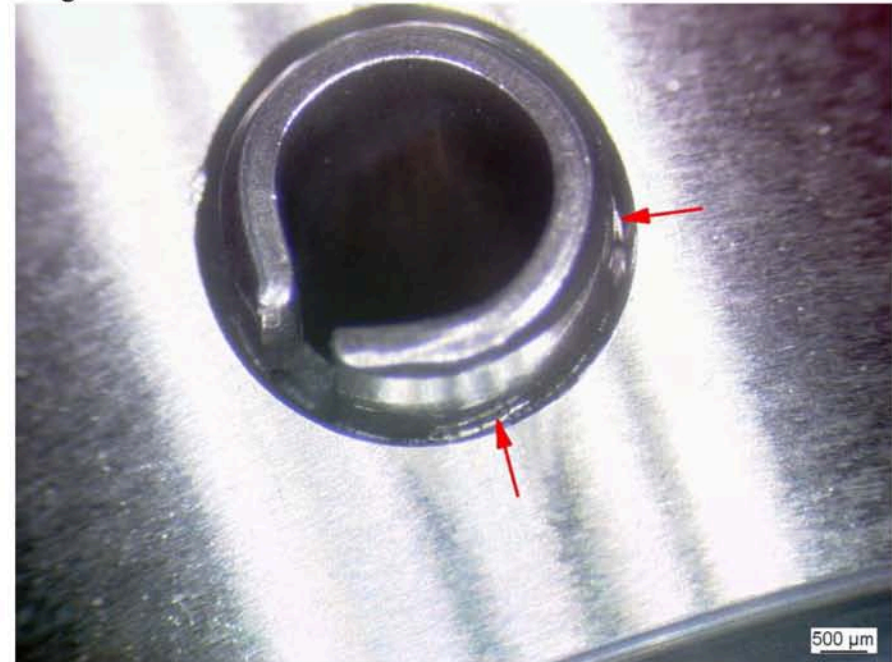
**Fig. 2:**

Fig.2 Shavings / burr pressed tight between tension pin and camshaft: Shavings occur when the tension pin is pressed into the camshaft. The shavings come from the tension pin. Bosch is aware of the matter and is currently working on it; the pressing geometry - chamfer on the camshaft - will be improved for this purpose. Loose shavings and shavings that protrude laterally, preventing the hub wheel from being pressed on, are not permitted, fixed shavings in the base material are permitted according to the visual inspection catalog and are not critical

Pump no. 1 Extrusion from the pressing process No particles in thread

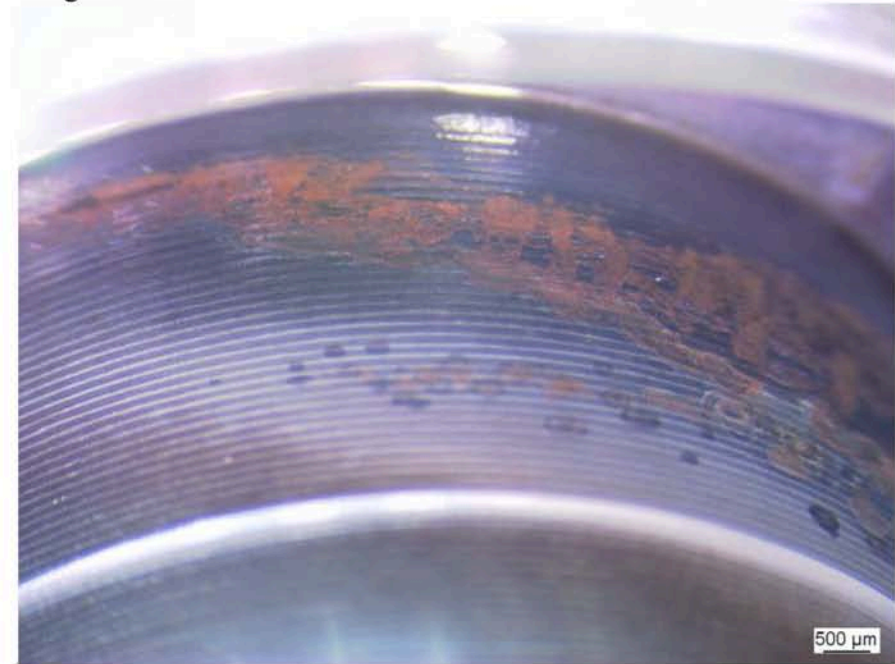
**Fig. 4:**

Fig. 4: Brown discoloration on the base of the outer surface of the cylinder head (transition with the cylinder head support surface - piston guide diameter, outer edge) - not functionally critical, however rust should generally be avoided. Topic under consideration

Pump no. 1 External mantle, piston bore. Rust

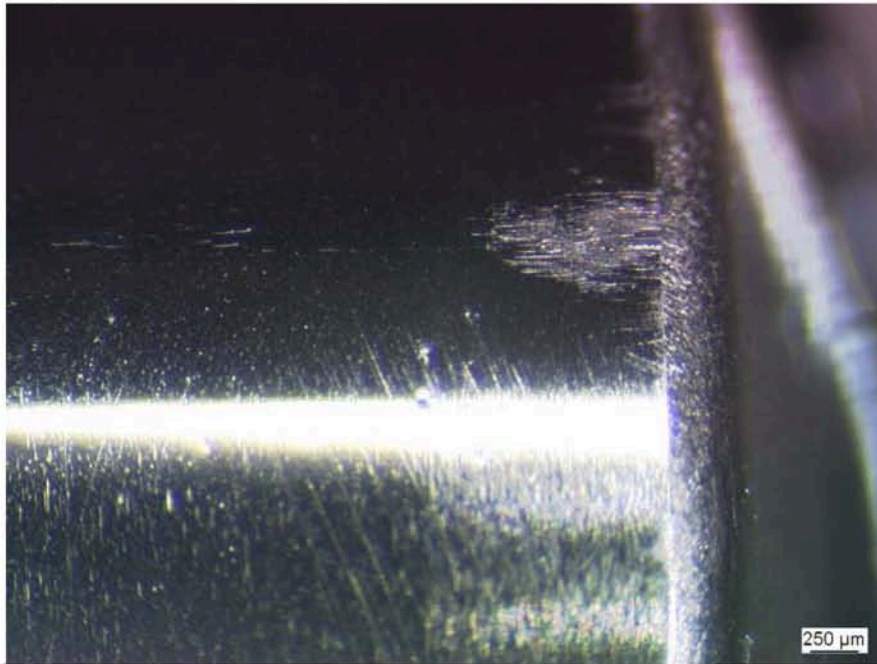
**Fig. 5:**

Fig. 5: Minor scratches on the roller in axial direction approx. 350 µm - familiar pattern, may be caused when the roller is manually inserted into the roller support. The roller can easily drop off in this area - not functionally critical

Pump no. 1 Roller, minor cracks on edge

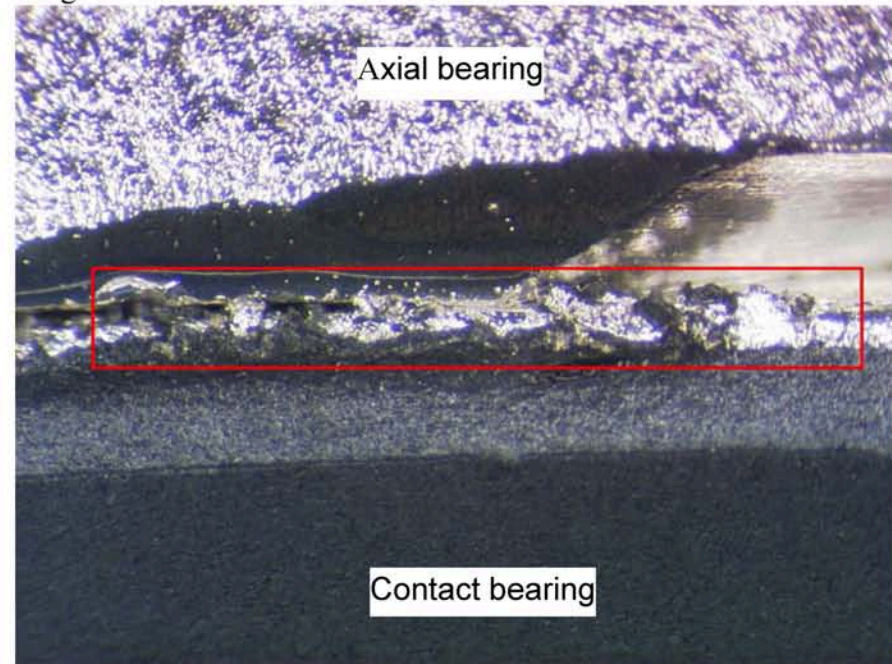
**Fig. 6:**

Fig. 6: Intermediate space / faces of the spacer ring or bushing of the flange bearing - surface structure shown is current state of production - non-critical. Loose burr/shavings not permitted. Area is cleaned in the housing's high-pressure washing system.

Pump no. 1 Space between compensating disk, contact bearing flange

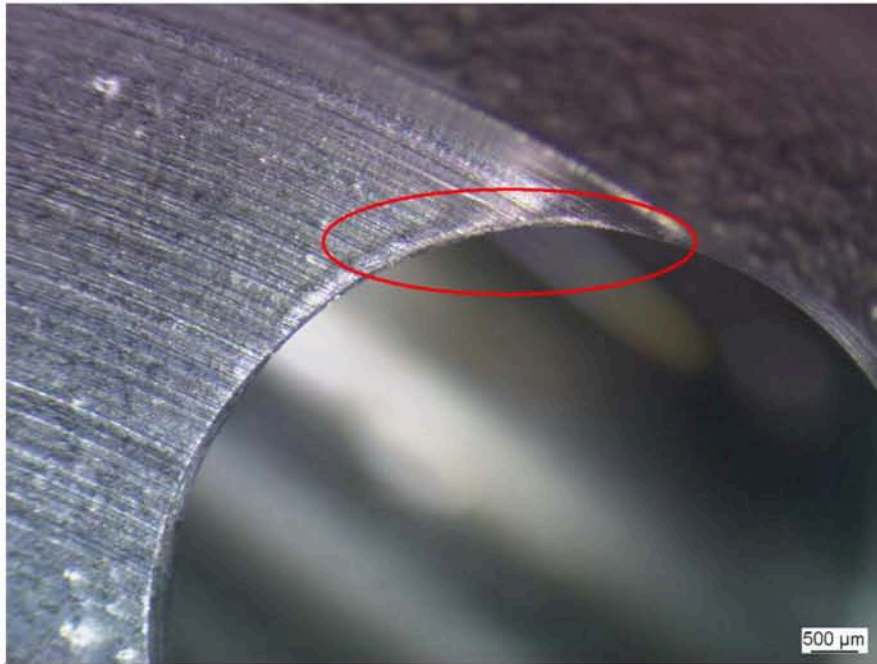
**Fig. 9:**

Fig. 9: Edge geometry on housing well - intake in pump interior 09:00 (inlet connector 12:00) - loose burrs not permitted - photo shows sharp edge, topic will be examined.

Pump no. 1 Cross bore inlet edge to interior, burr (sharp edge)

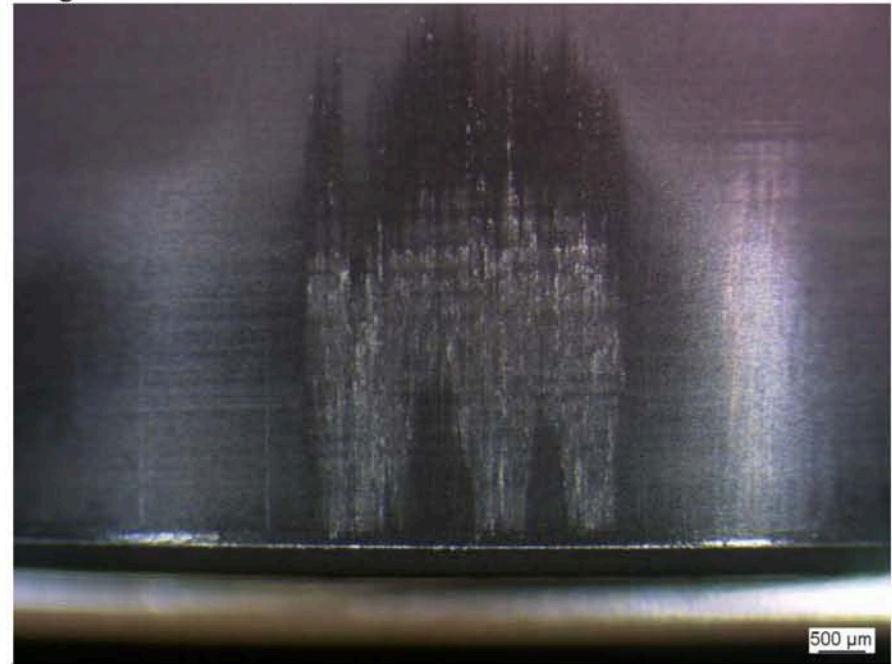
**Fig. 10:**

Fig. 10: Run-in marks on the mantle surface of the tappet body - normal run-in pattern, non-critical

Pump no. 1 Tappet body run marks
