**Drivetrain damage - high-pressure diesel fuel pump CP4.2**

# Drivetrain damage - high-pressure diesel fuel pump CP4.2

**"Power loss" of high-pressure fuel pump, Touareg V6 TDI**

**R4-CR Drivetrain damage to HDP CP4.1**

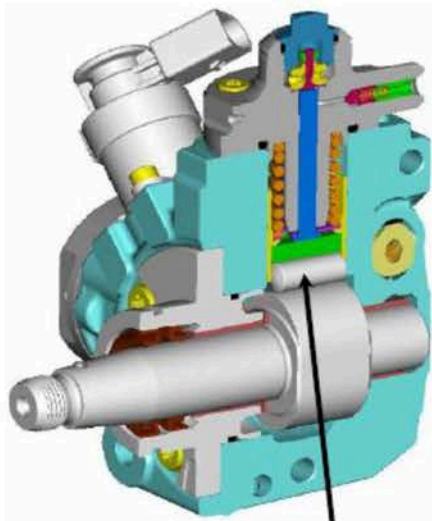
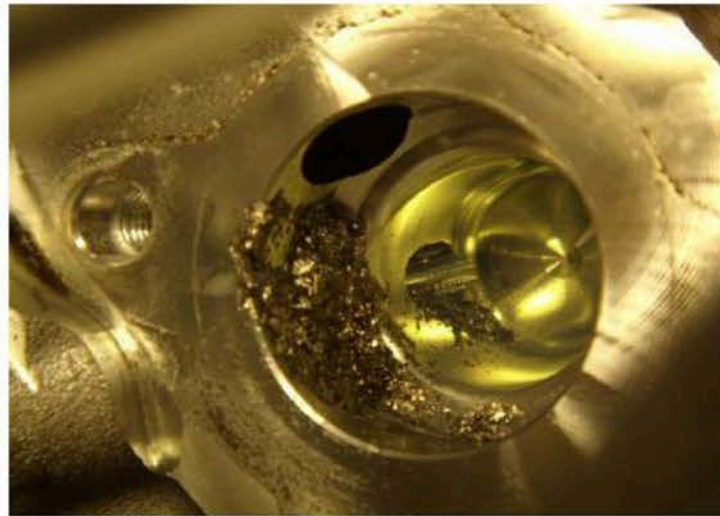
CP4.2 high-pressure fuel pump

Right roller tappet

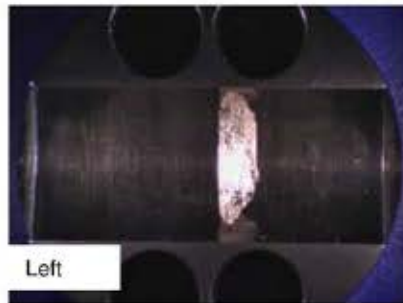
0445 010 611; DoM: 100121 BPT 1190; Chg-Index 05; 059 130 755 AH

Failed pump field [REDACTED]; delivery date unknown

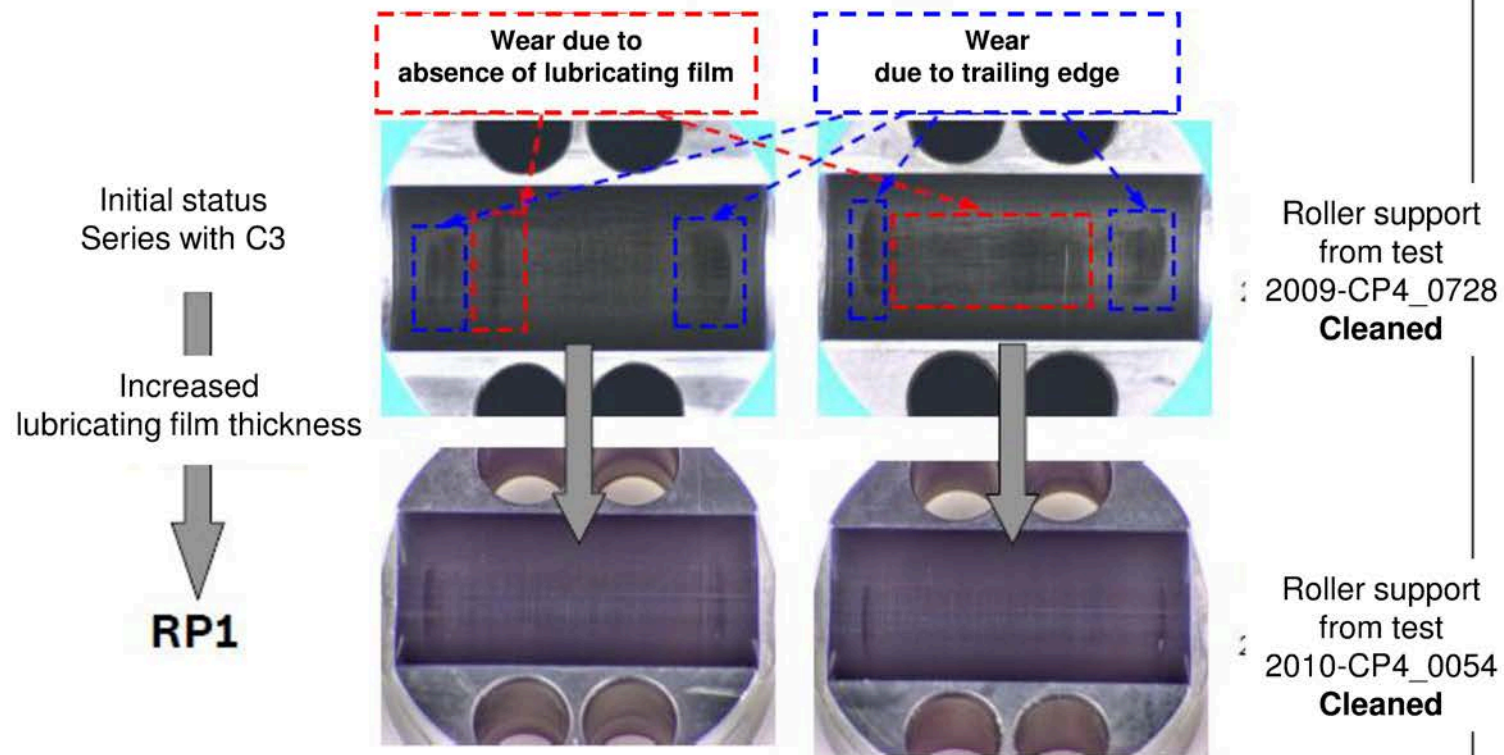
### Anti wear package RP1

Proof of effectiveness through overload test (150 h with low viscosity)

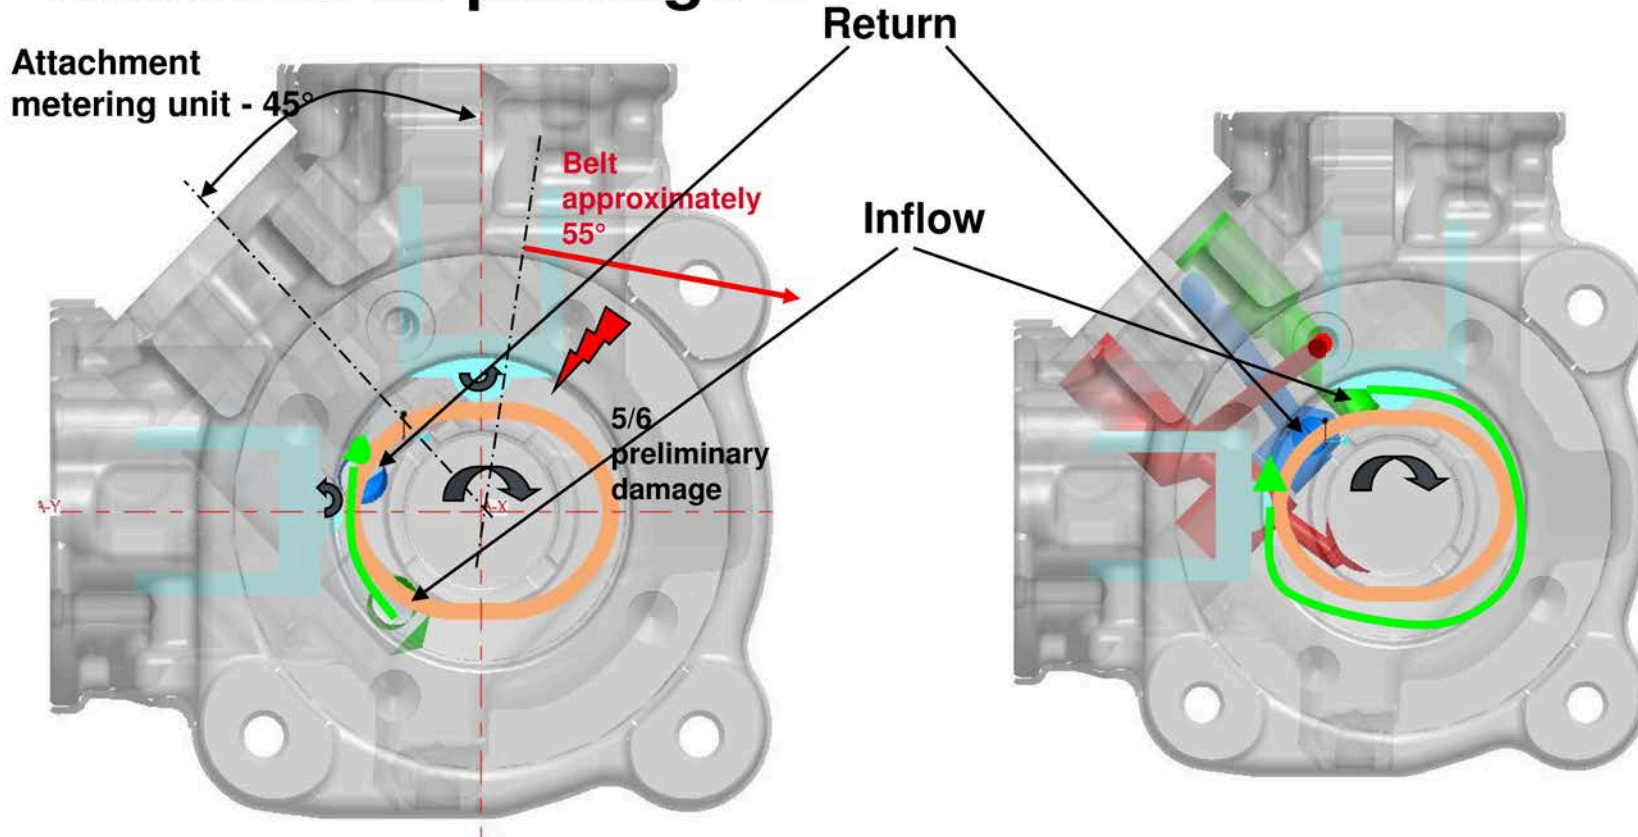
## Robustness package 2

Fuel goes directly to the return line

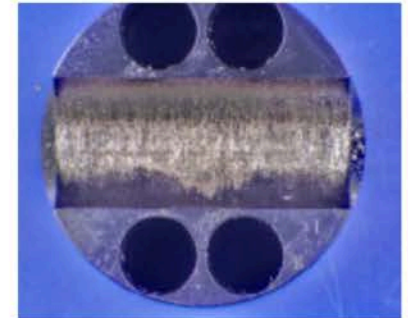
- Inadmissible high mixed friction between the roller and the roller shoe has caused local contact when in operation.
- The C coating of the roller shoe is shattered (wear and the C coating is worn), the friction value increases between the roller and the roller shoe.
- Stiff roller
- Reinforcement factors: Fuel with lower viscosity, raised areas on the roller (melt points) and in the roller shoe (metal splashes), surface of roller/roller shoe
