Rattling pump – 03L 130 755 – 2.0l 4V longitudinal CR TDI

Subject: Regarding brand acceptance run: Breakdowns Q verification run 2.0l TDI BIN5 in Audi A3 - AU 353 08050

CP4 Diesel high-pressure fuel pump in CR injection systems from 1800 bar (EU5)

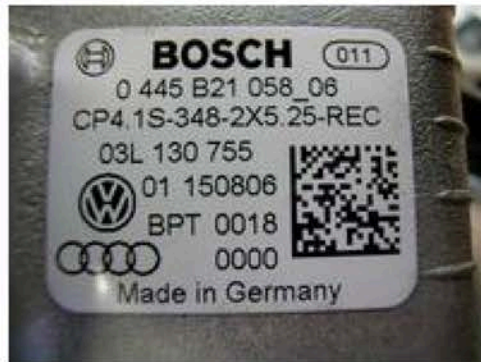
Labeling of 1st pump:

- 1st failure – [redacted] power test bench: WK 38 (problem number in VDS-Win: 4466942). After commissioning and engine start, the pump was immediately noisy (running time of pump approx. 2 minutes).

First statement from [redacted] typical sliding wear on roller assembly, possibly lack of lubrication, dirt etc. Pump sent to [redacted] to Mr. [redacted] analysis results to follow.

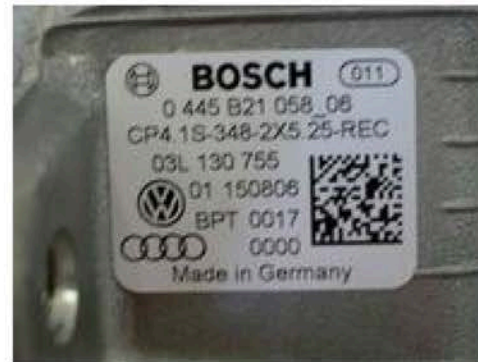
Labeling of 2nd pump:

- 2nd failure – [redacted] power test bench: WK 39 (problem number in VDS-Win: 4466957). After commissioning and engine start, the pump was immediately noisy. Fault symptoms similar to the 1st pump (running time minimal).

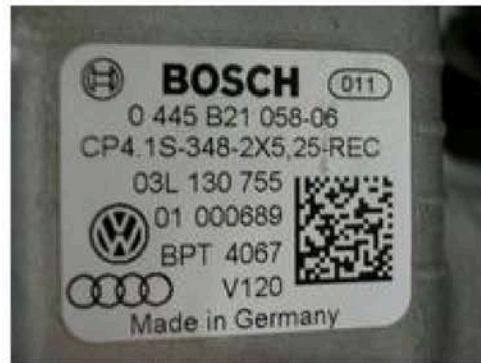
Labeling of 3rd pump:

- 3rd and 4th failures: WK 41 (problem number in VDS-Win: 4467636). After commissioning and engine start by HT, the pump became noisy during the HT test on an engine (3rd failure). Engine was then checked in the [REDACTED]. The noise was established and pump changed. After 30 minutes running time, the engine became loud again and the noise again originated from the HPP (4th failure).

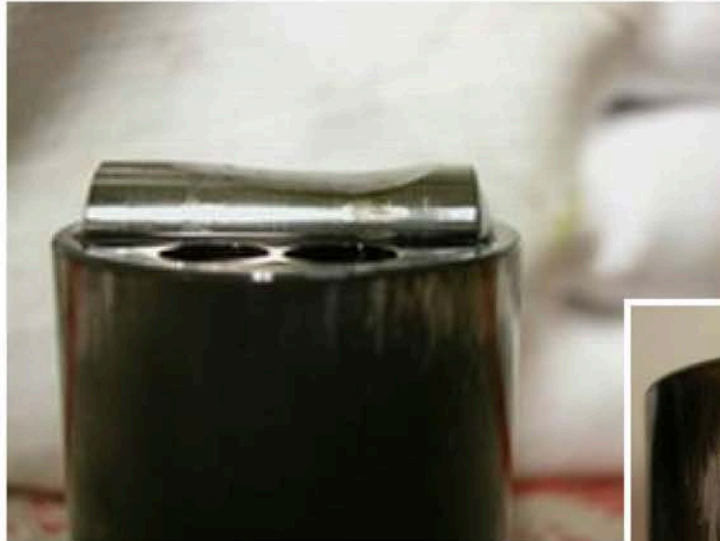
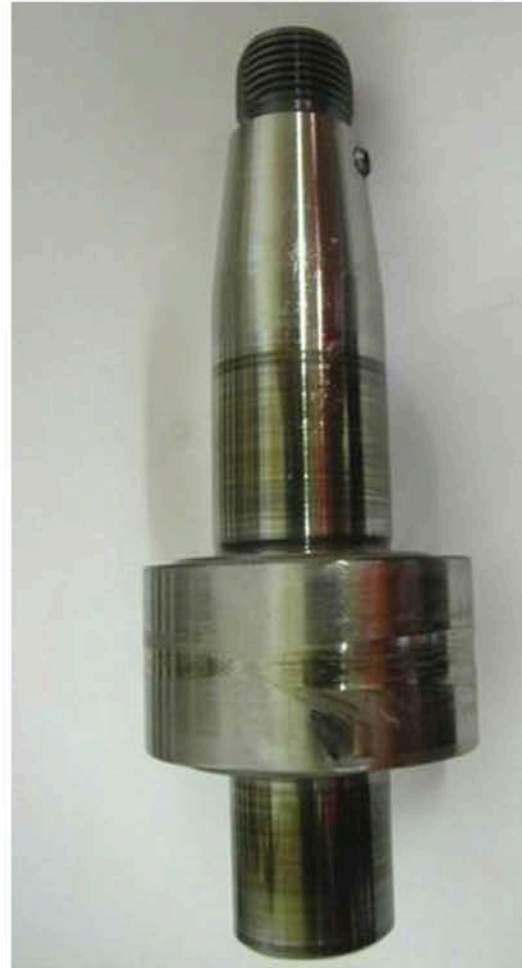
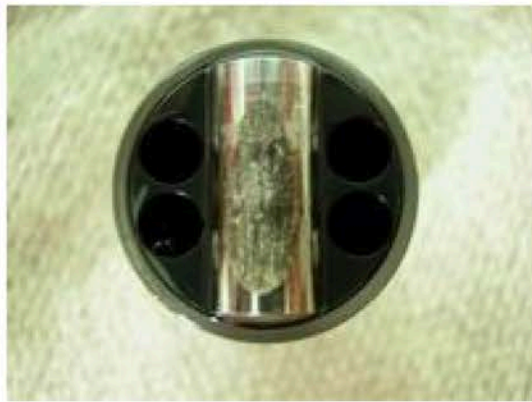
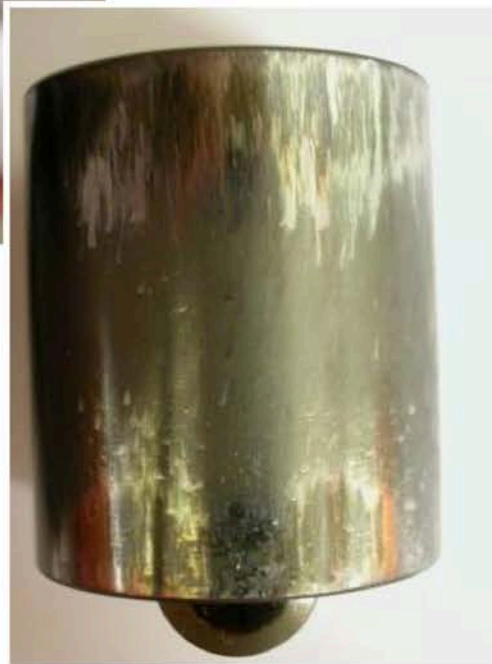
Drivetrain damage: Wear on cams, on the roller, on the slide shoe, on the spring washer:

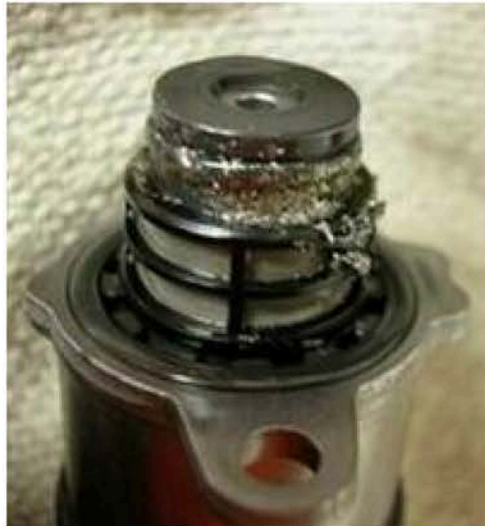
Large chips in the area of the MU:

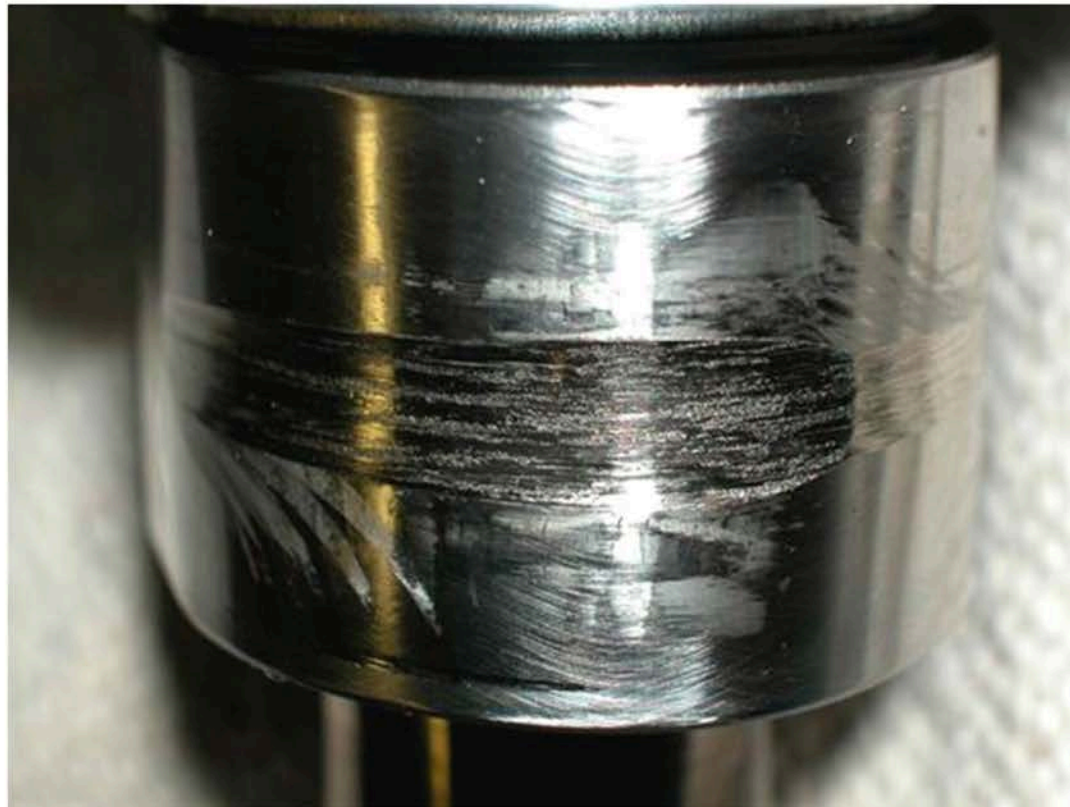
You can see from the wear on the cams that the roller has turned in a clockwise direction several times:

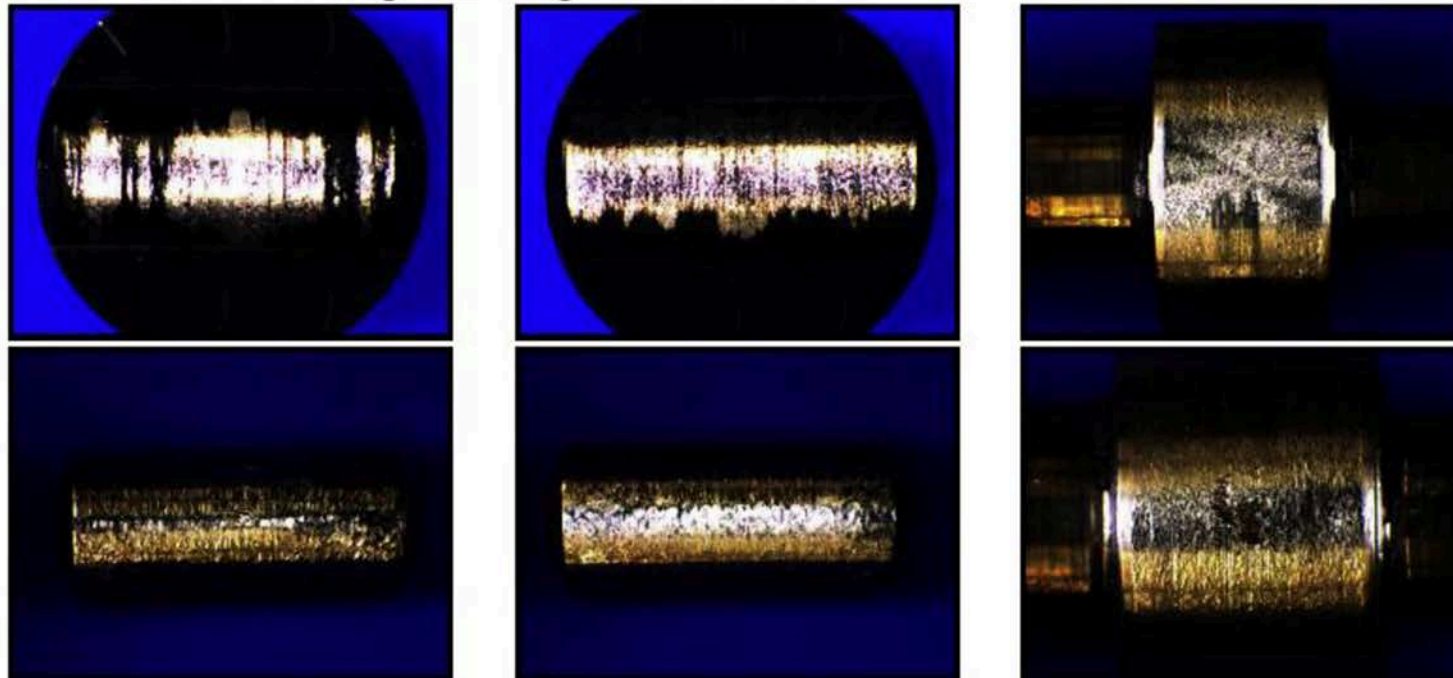
Failure of the high-pressure with drivetrain damage confirmed (see 3-4):

- Circumferential abrasive wear on cam track and roller
- Large areas of C coating in roller support worn
- Slight signs of corrosion

“Cause no longer apparent, indicators of periods of use with water in fuel”

- Standard pump 0445010613
- Date of manufacture 04/2008 (i.e. before the introduction of the straightedge test and further quality improvement measures with respect to metal splashes / fusing on the roller or roller support)
- Drivetrain damage category I
- Circumferential abrasive wear and fatigue breakouts on cam track and roller
- Large areas of C coating in roller support worn

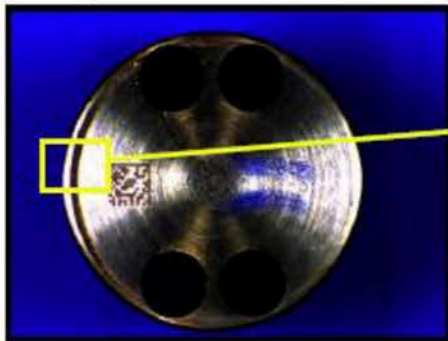
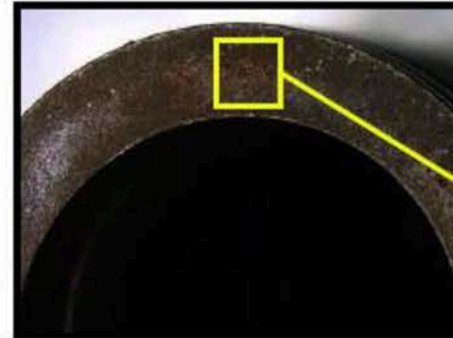
- Little evidence of periods of use with free water in fuel (corrosion)
- The advanced state of the damage means that there is no longer any possibility of identifying anything unusual about the manufacture of the roller support or roller

- The cause of the damage is no longer ascertainable
- Indications of periods of use with free water in fuel. Evidence is too weak to enable definite conclusions to be drawn in relation to the cause of the damage.

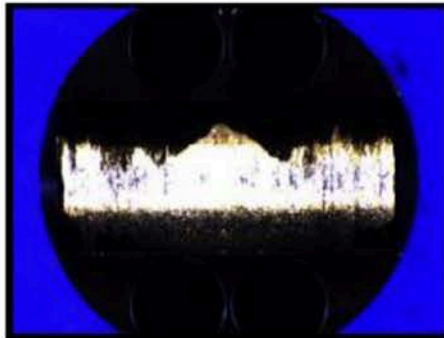
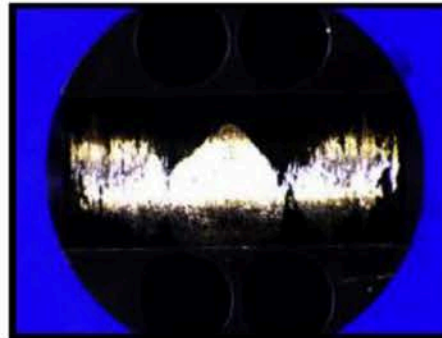
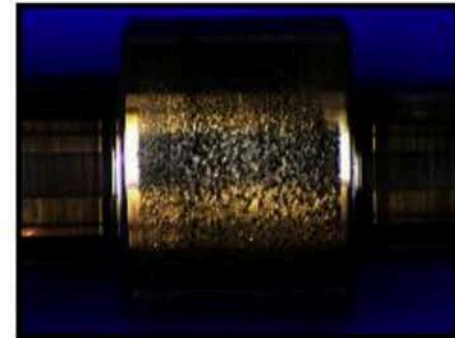
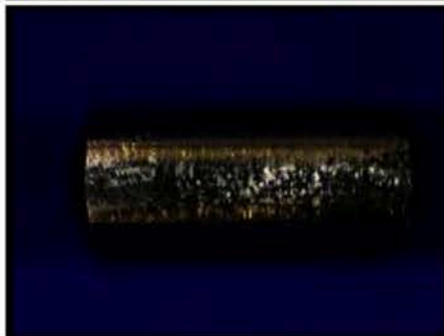
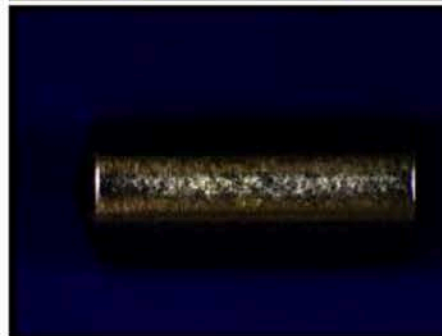
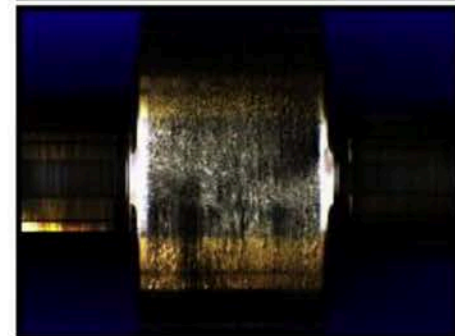
Failure of the high-pressure with drivetrain damage confirmed (see 6-7):

- Circumferential abrasive wear on cam track and roller
- Large areas of C coating in roller support worn

- Sample pump 0445B20169_20
- Date of manufacture 02/2009
- Drivetrain damage category I
- Circumferential abrasive wear on cam track and roller
- Large areas of C coating in roller support worn

Blocking of additional anti-wear measures until the precise reason for the failure has been identified. Diagnostic meeting Audi / Bosch

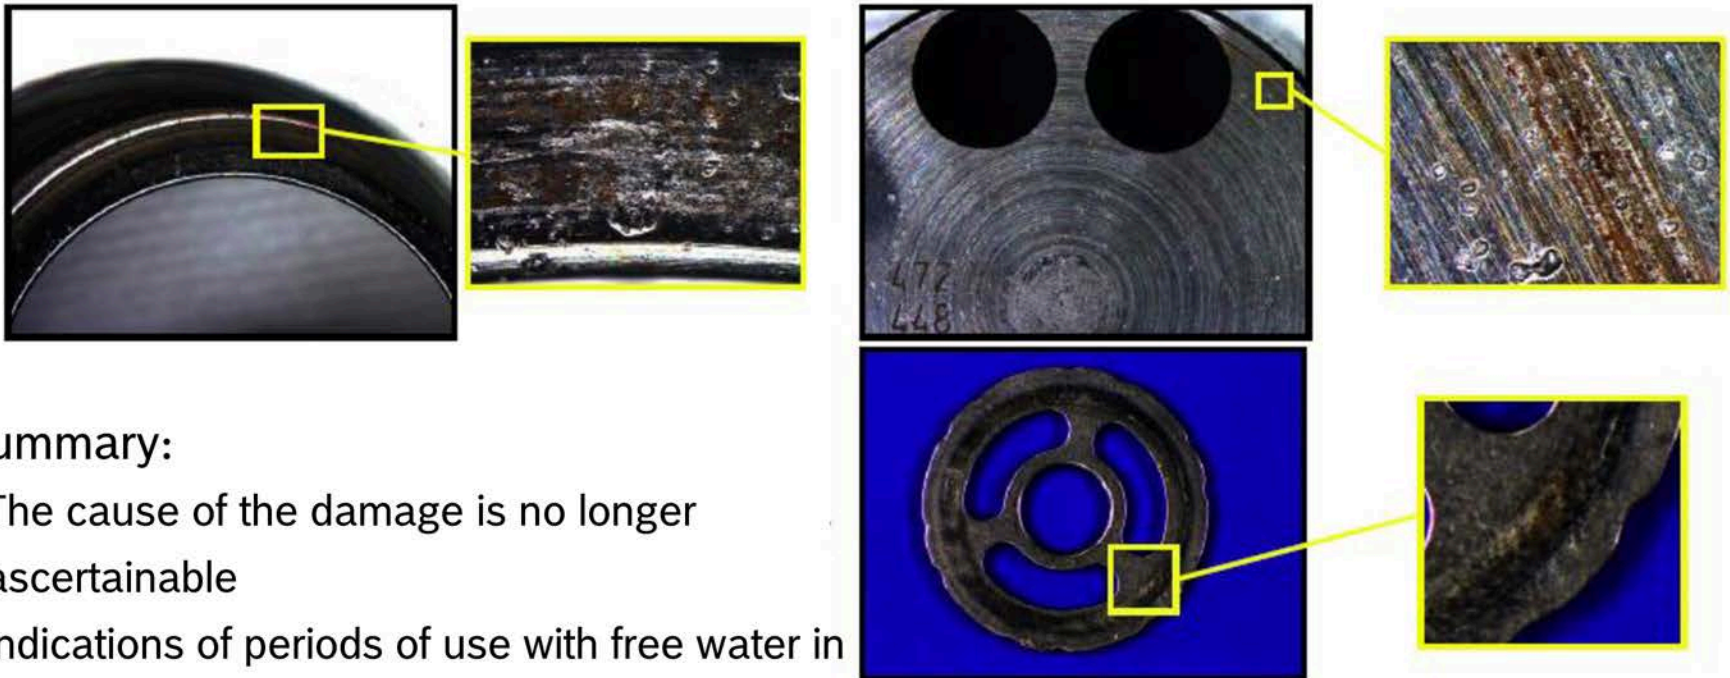
- Little evidence of periods of use with free water in fuel (corrosion)
- The advanced state of the damage means that there is no longer any possibility of identifying anything unusual about the manufacture of the roller support or roller

- The cause of the damage is no longer ascertainable
- Indications of periods of use with free water in fuel. Evidence is too weak to enable definite conclusions to be drawn in relation to the cause of the damage.

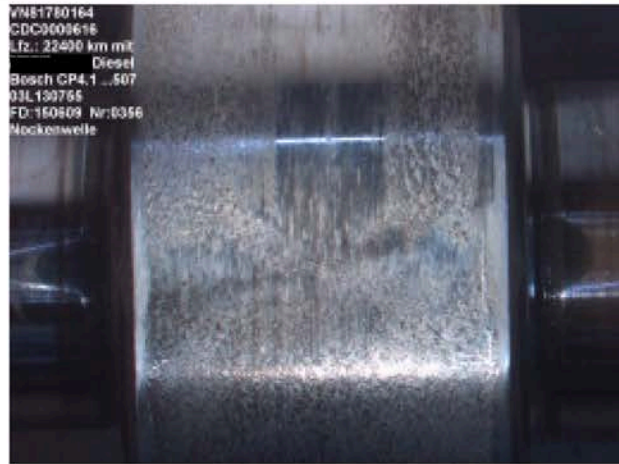
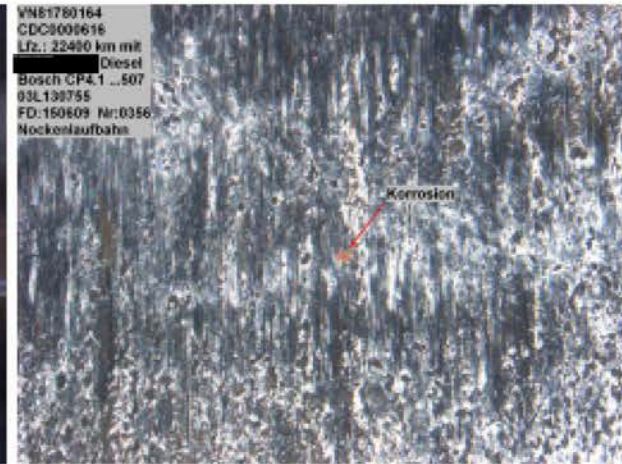
Camshaft

- High-pressure pump wear on the Bosch CP 4.1 (see photographs)
- Wear on the camshaft, roller and roller support due to insufficient lubrication capacity of the fuel
- Traces of corrosion on the camshaft and HP pistons

The cause for the high-pressure fuel pump failure is the poor lubrication capability (HFRR = 659 μm) of the validation fuel.

Determined by validation information, anti-wear packages 0 and 1 must be applied to Bosch CP4.x high-pressure fuel pumps in [REDACTED] including [REDACTED]

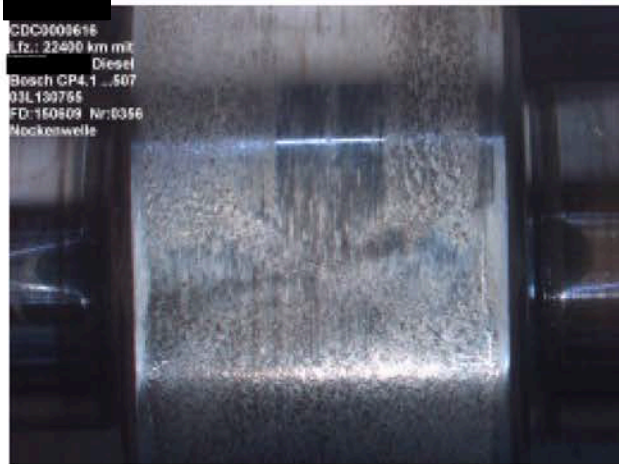
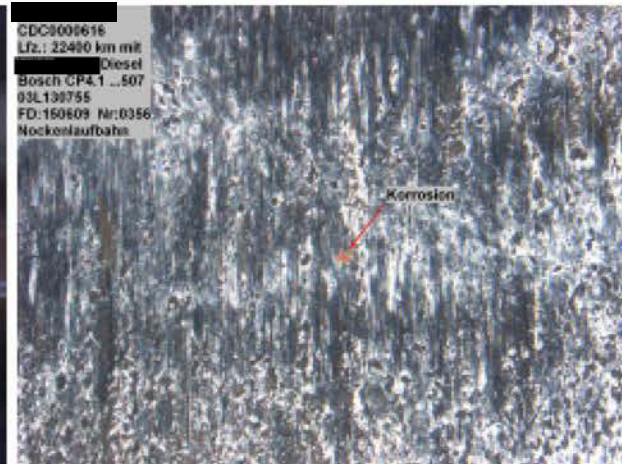
Camshaft

- High-pressure pump wear on the Bosch CP 4.1 (see photographs)
- Wear on the camshaft, roller and roller support due to insufficient lubrication capacity of the fuel
- Traces of corrosion on the camshaft and HP pistons

Determined by validation information, anti-wear packages 0 and 1 must be applied to Bosch CP4.x high-pressure fuel pumps in all EU4 markets, including [REDACTED]

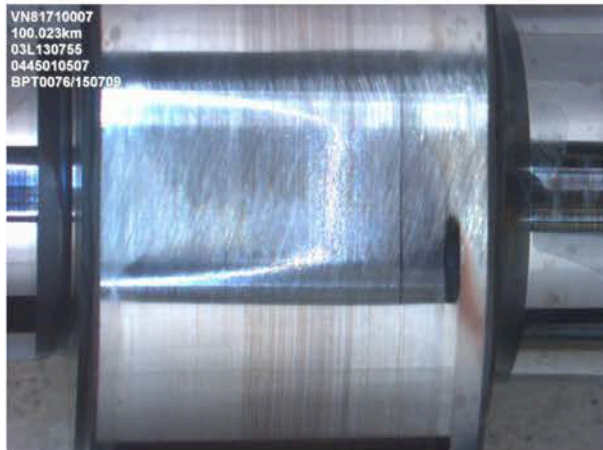
Camshaft

- one-sided smoothing on the camshaft running surface
- Traces of corrosion and deposits on the roller and HP pistons

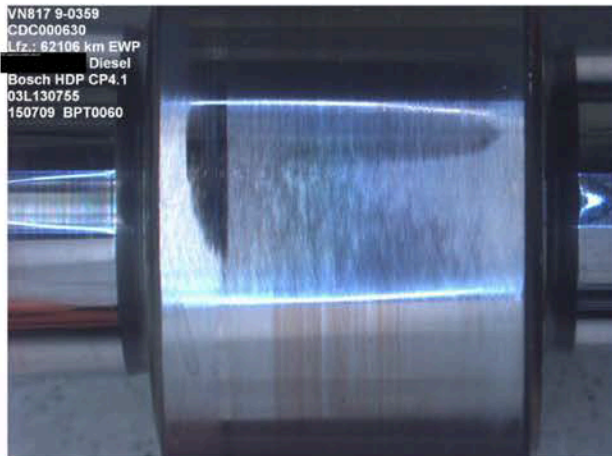
Camshaft

- one-sided smoothing on the camshaft running surface
- Traces of corrosion and deposits on the roller and HP pistons

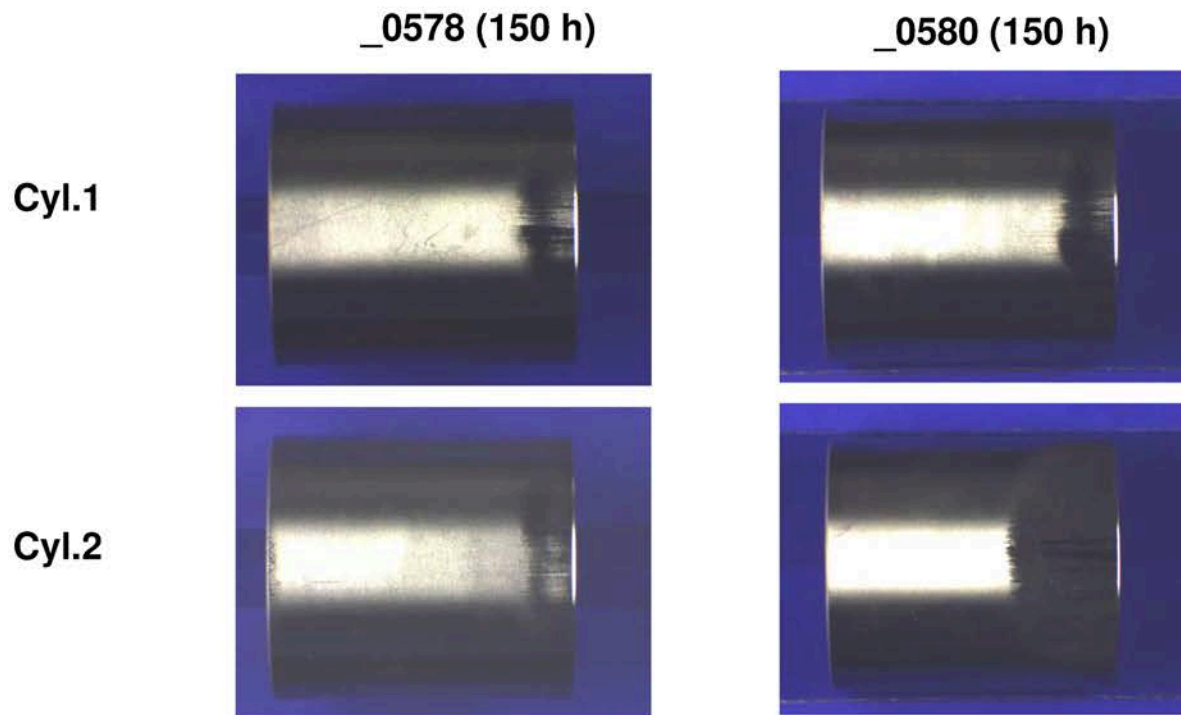
Aluminum oxide build-up (black) as an indication of increased temperatures

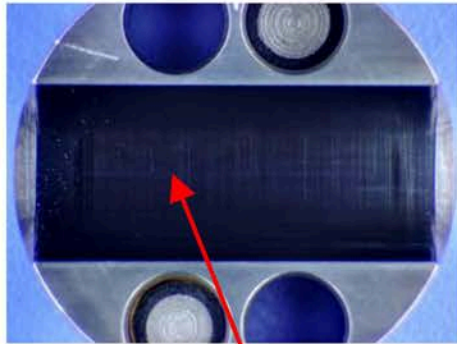
No deposits

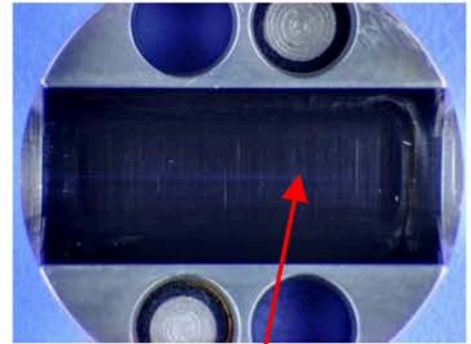
No deposits
