From: Non-responsive content removed
To: [Redacted]
CC: [Redacted]
Date: 8/25/2011 11:52:00 AM
Subject: ANS: HP from endurance run for diagnosis
Attachments: [VW361MECM01-0S 19808 mls 18.06.2011mit Motor aus.txt](#)
[Tankkarte VW361MECM01-0S.PDF](#)

Here is the story of the HPP from MNS (Q verification run, failure at 31,874 km)

Serious problem in [REDACTED] verification run

Component damage in CR development

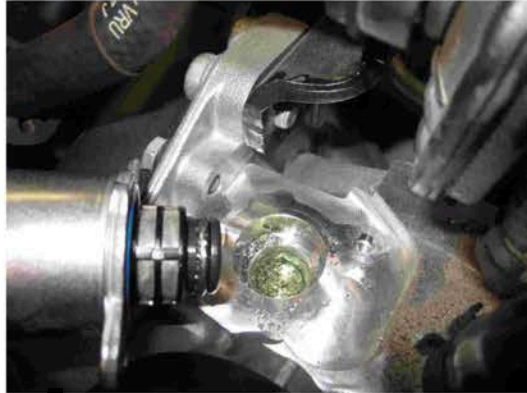
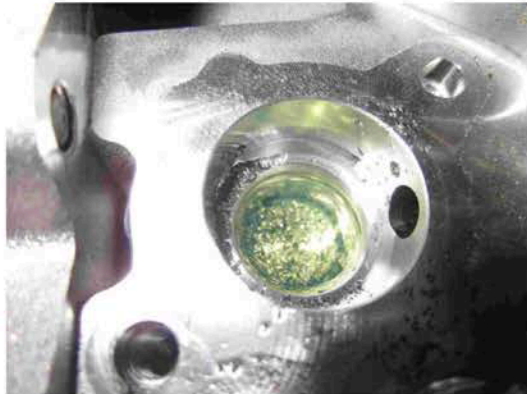
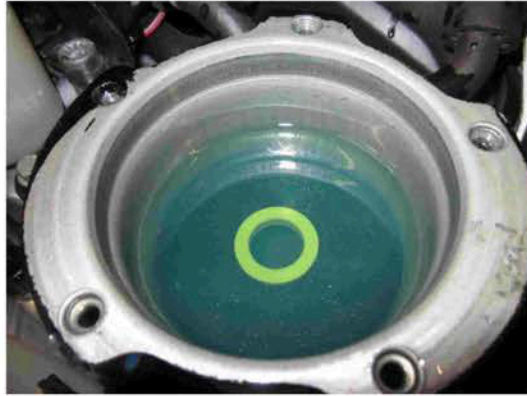
The HPP was analyzed in an initial approach, and several shavings were found (see photos).
HPP part data:
805 010 511 0, Bosch 1000, 1027, 02/53R/1S4PC/RC, A557 031 L30, 01 21 80 80, 1540TPB.

Hello [Redacted]
I heard from Bosch that the pump has had a preliminary analysis and a turned tappet was localized as the cause of the breakdown. The cause of the turned tappet should be determined till the end of the week.
Regards,
[Redacted]

Problem: Breakdown in verification run after shutting off engine.
Restart not possible. Defect in engine control unit, fuel/rail/
system pressure too low.
Deposits of metal shavings found in the fuel tank, fuel filter, fuel supply
unit of the tank, and high-pressure fuel pump.

- Cross-check performed on other vehicles, no striking features
- Preliminary diagnosis of the HPP showed a disturbance in the roller/
roller support area, "turned tappet", caused by insufficient lubricity,
soiling, or incorrect fuel.
- HPP forwarded to Bosch for further examination
- Fuel sample under investigation

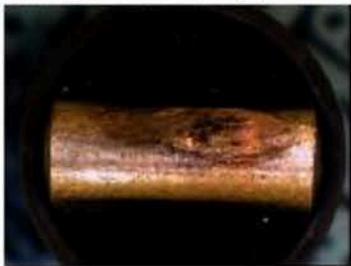
Right roller tappet

Analysis: 1st failure: Preliminary damage due to sluggish roller

Anti-wear measures implemented by 04/07/2008.

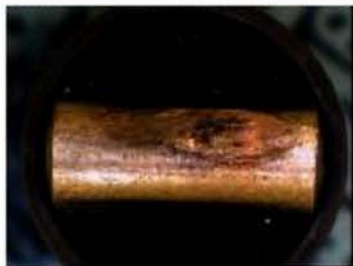
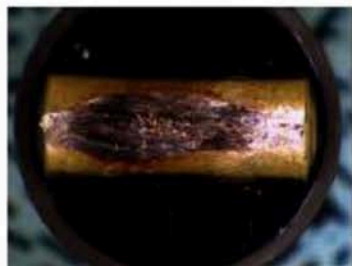
Analysis: 1st + 2nd failure: Preliminary damage due to sluggish roller

Statement from Bosch: Failures are not U.S.-specific, series is also affected

Anti-wear measures implemented by 04/07/2008.

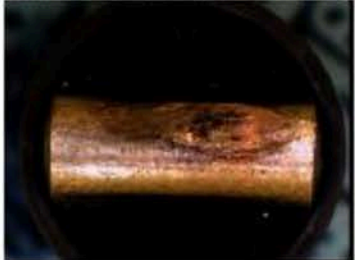
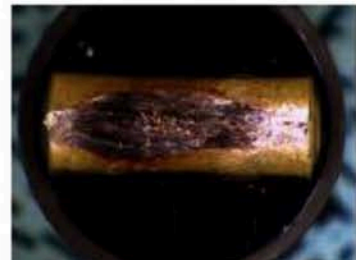
Analysis: 1st + 2nd failures: Preliminary damage due to sluggish roller

Cause of drivetrain damage is a "sluggish roller".
