Subject: Re: SK31600010

Particle analysis - CP4.1-18 (interim report for strainer contamination)

EA189 2.0l CR Field Complaints**-High-Pressure Fuel Pump – U.S. Field Failures**

Problem: Drivetrain damage HPP

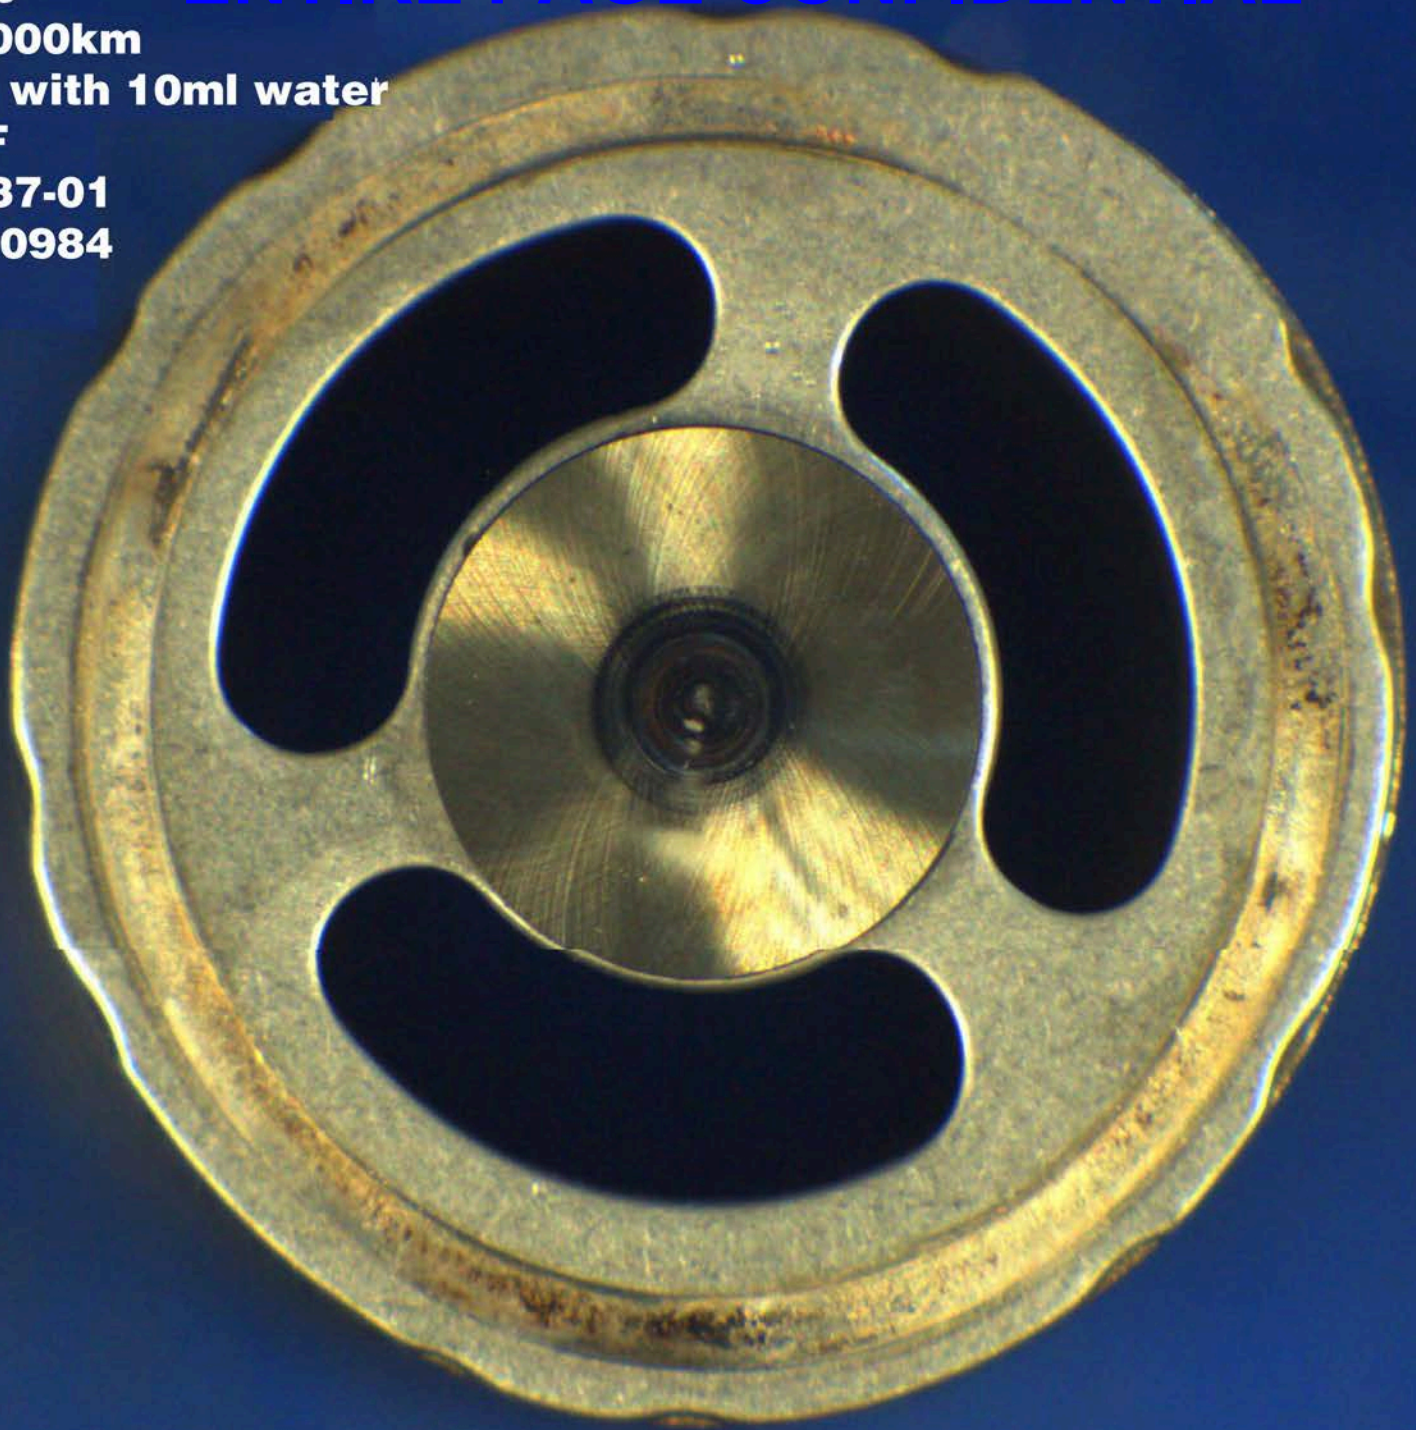
HPP - Assessment

Component	Assessment		Remark
	OK	Not OK	
Housing			
Drive shaft		X	circumferential scoring marks
Roller support	X		
Roller		X	significant running marks
Tappet hole		X	heavy running marks
HP piston	X		
Spring washer / anti-friction paint coating	X		no anti-friction coating, significant wear
Shaft seal / seal-tightness	X		
Corrosion	X		no corrosion
Bearing	X		
LP ports	X		
HP ports	X		
MU / MU hole	X		
Pressure valve / intake valve	X		
Overflow valve	X		
Dirt / chips	X		no shavings
Hydraulic function			
Delivery rate			
Injection pressure			
Drive power			
Seal-tightness under load			
Electrical function			
Plug contacts			
MU			
Remarks:

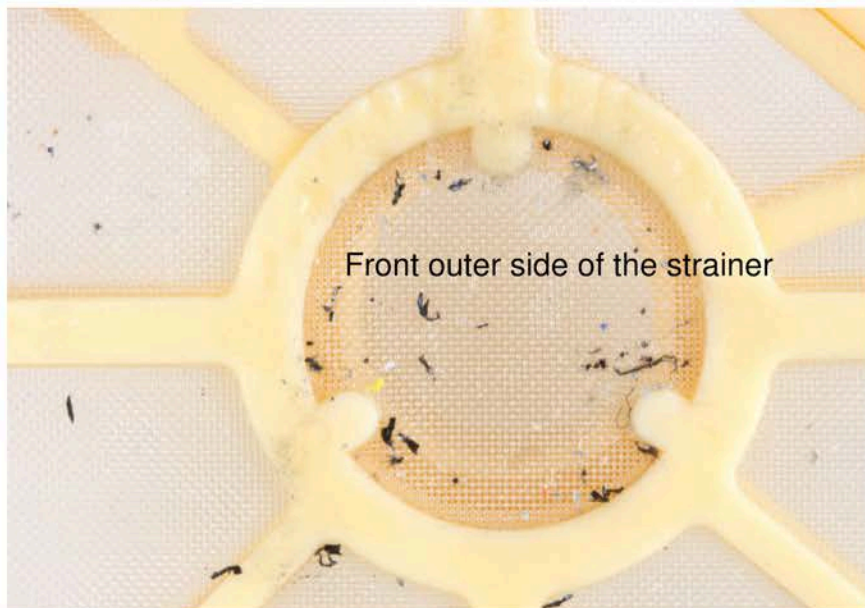
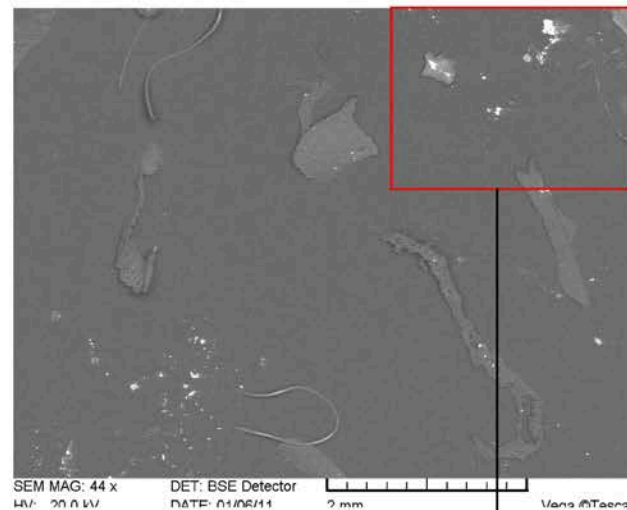
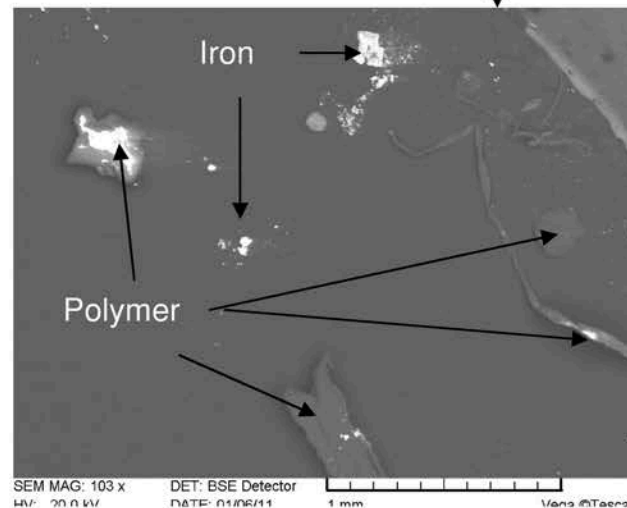
Analysis of the chips from the strainer of vehicle VW411 1-0080

Particles made of iron up to maximum 100 µm in size as well as particles and chips made of polymer on the front outer side of the strainer

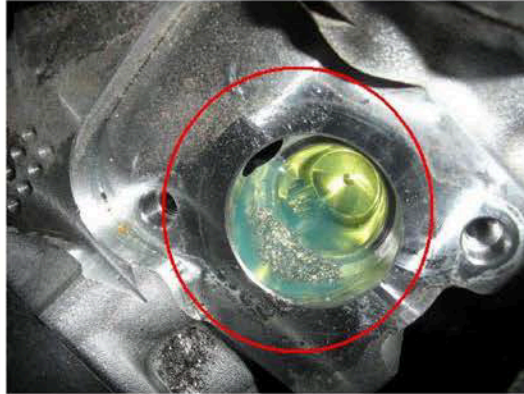
[redacted] 24,853 km, 10/10/2008

Yes, it is typical drivetrain damage.

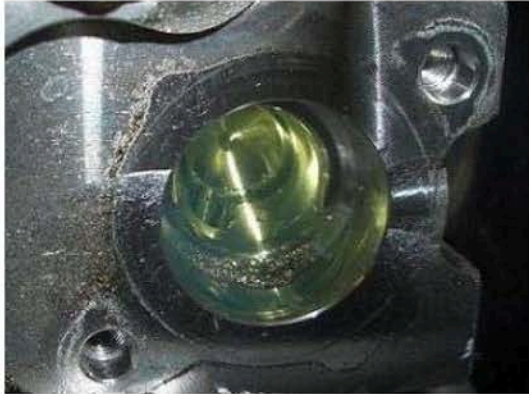
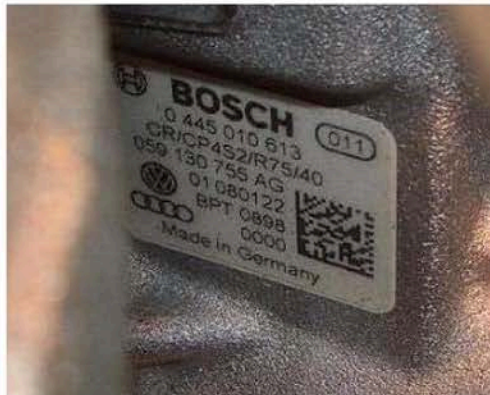
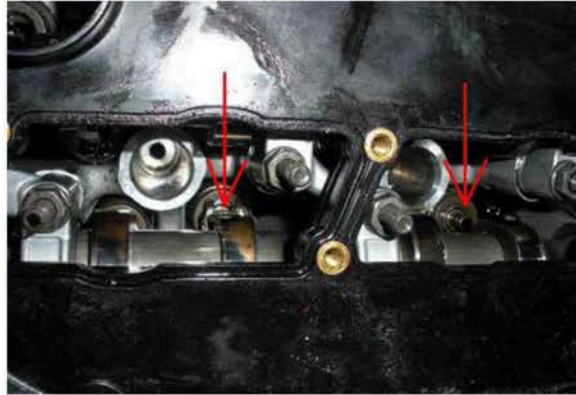
7L69D025, 45,700 km, 10/31/2008

- Drivetrain damage confirmed
- Adhesive wear across the entire cam track
- One RS had only medium C coating damage, tappets were finally turned by 90° (primary damage)
- Second RS completely worn, roller worn across entire circumference

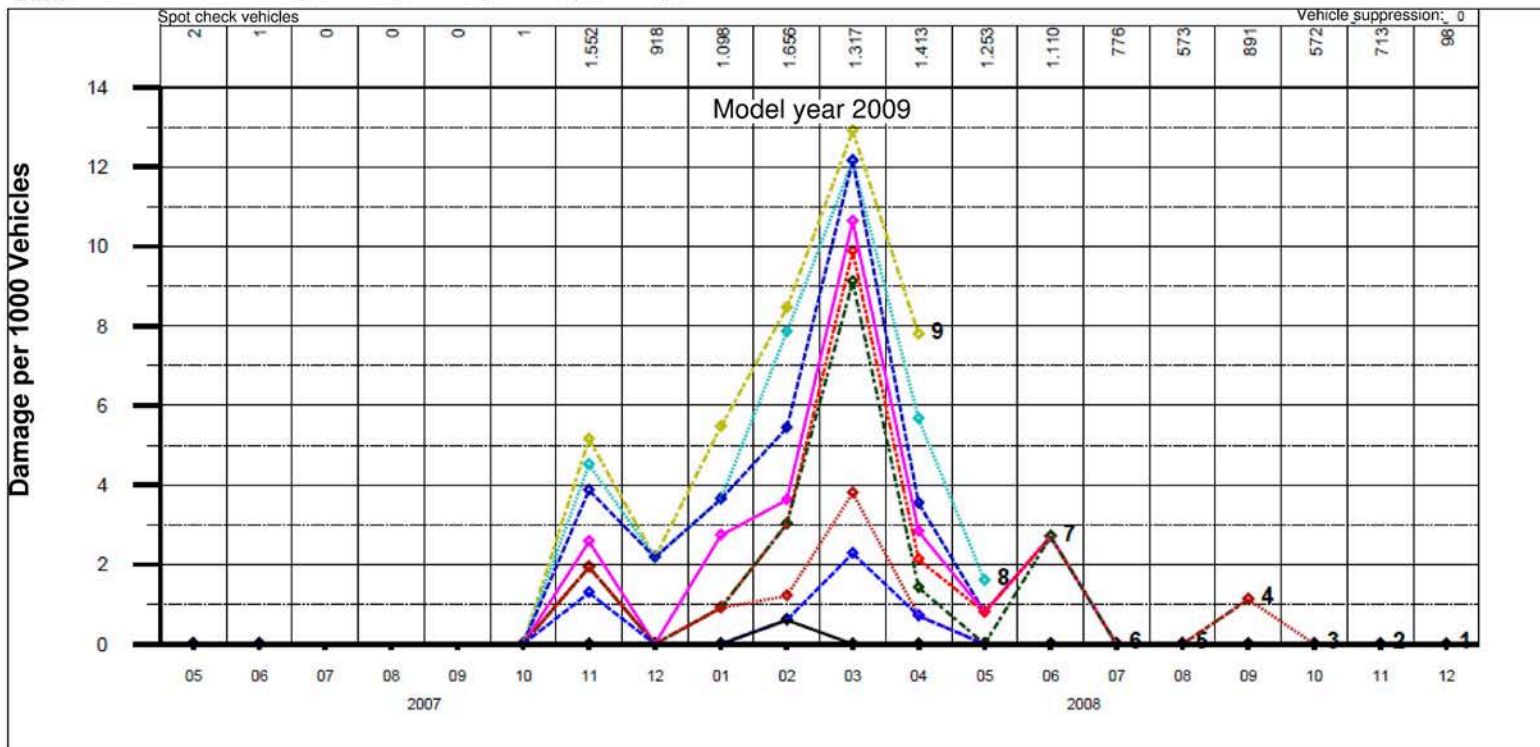
CP4 Q7 Europa Grafik

Note: Large drop in failure numbers due to measures at Bosch.
Lack of robustness with fuels outside the standard still present.

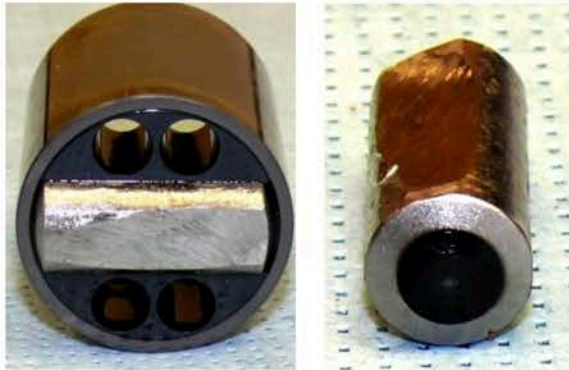
Causes: Increased friction between roller and roller support results in damage to cam, roller and roller support, as well as in turned tappets.

Measures: 100% straightedge test to detect irregularities

on the roller

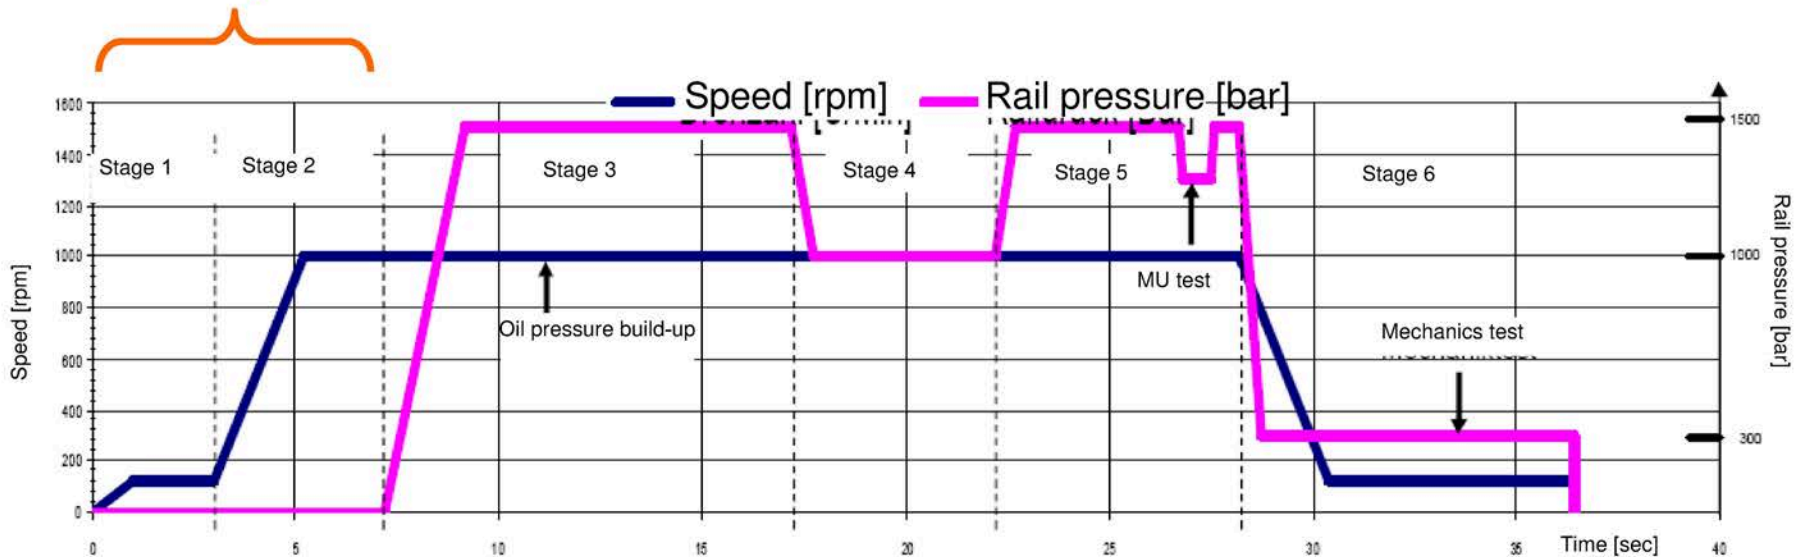
No striking features

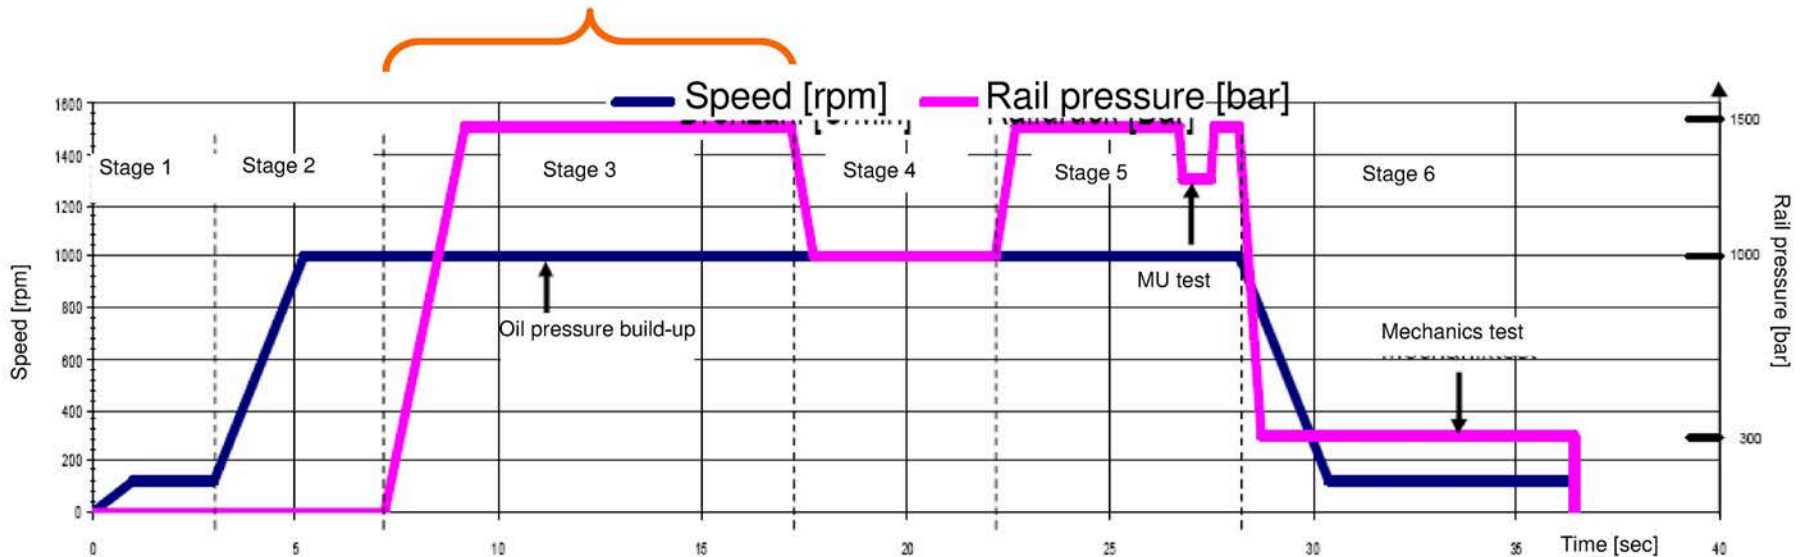
Rail pressure build-up and kept stable, but the torque curve has run up since approx. the second third to a level that is greater than the reference curves

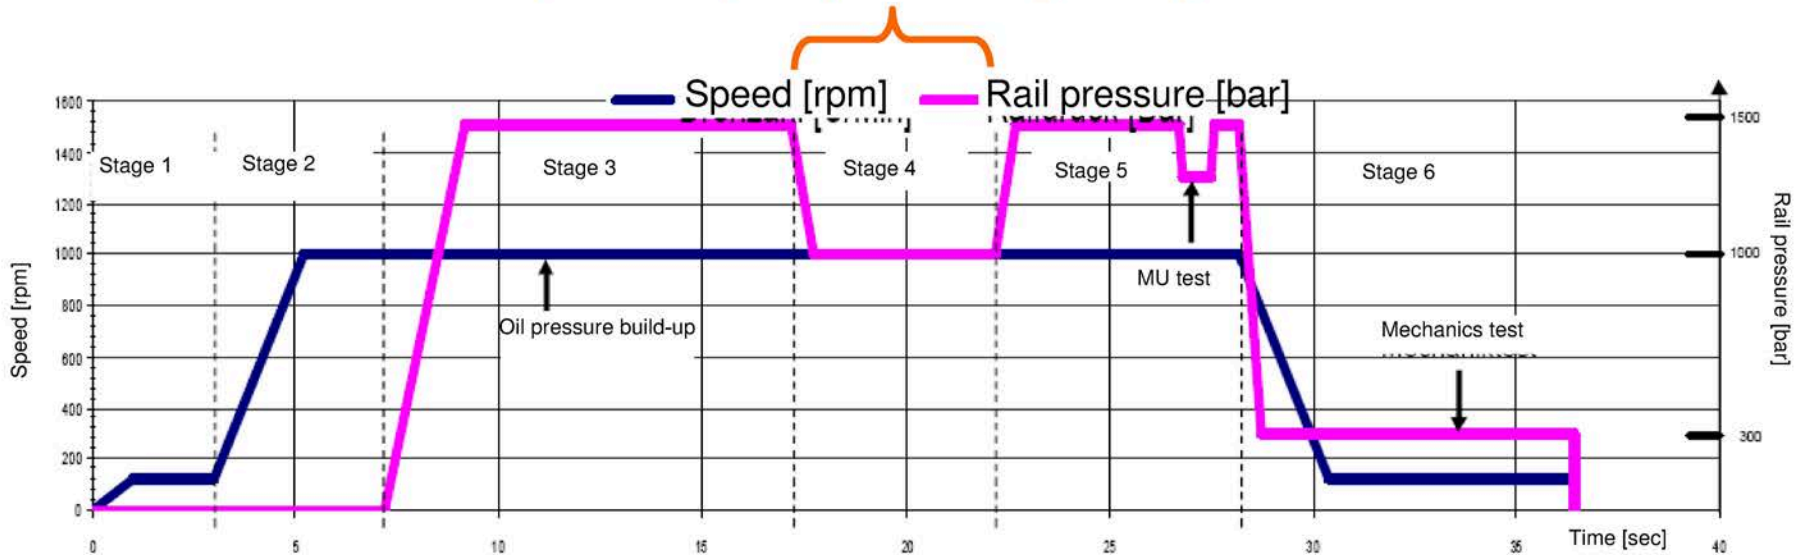
Within a few minutes, considerable rail pressure fluctuations occurred, breakaway torque remaining too high

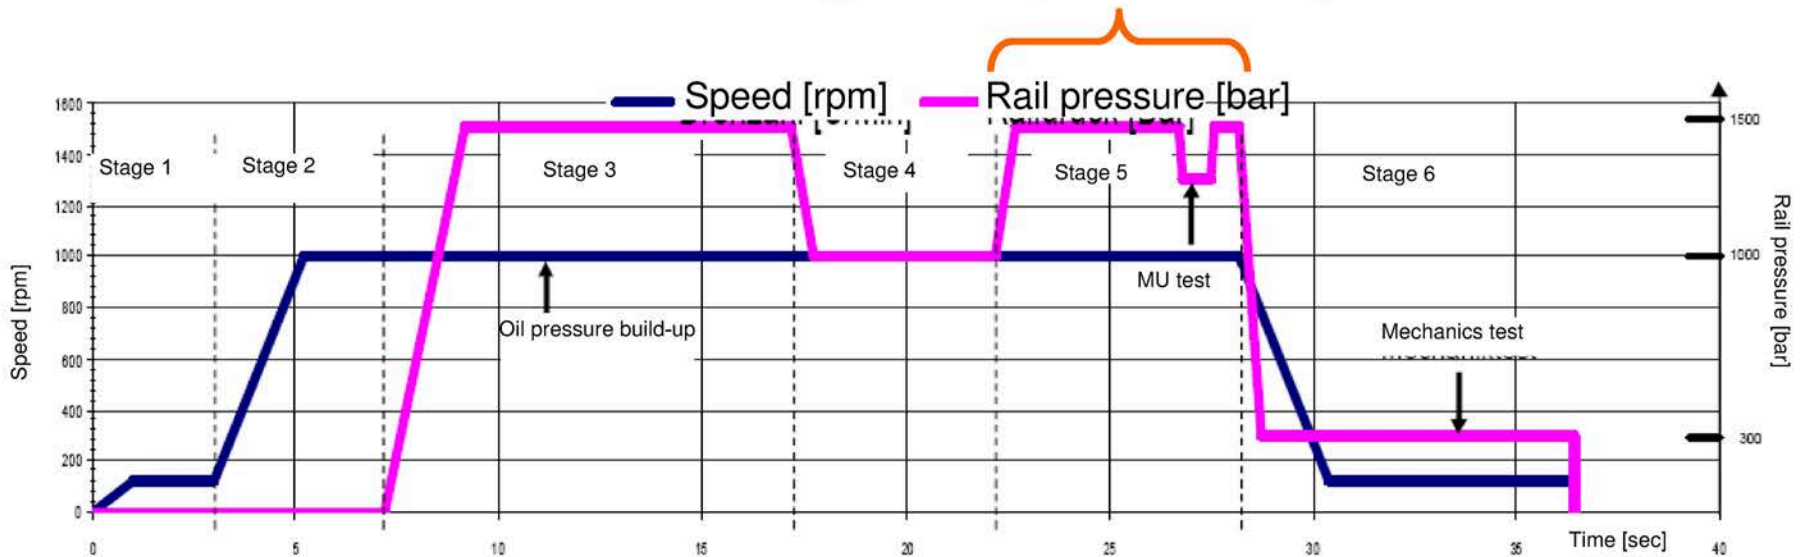
Rail pressure in the further phases of the testing were always unstable, engine not OK
