Status problems/measures CP 4
crack in oil seal

Status problems/measures CP 4.1 (4 cylinder) crack in oil seal: **Summary**

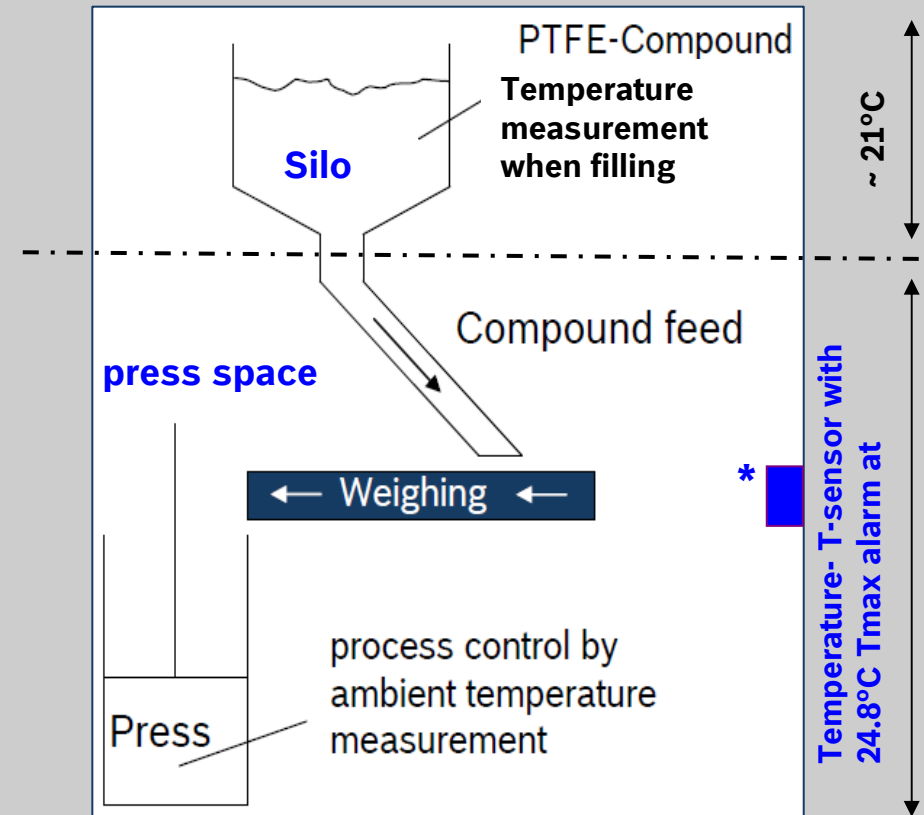
Crack in oil seal: Cause/temperature in the press space

- The room temperature in the press space is set using a an air-conditioning system.
- The PTFE compound in the silo is held at a stable 21°C.
- A temperature sensor* on a wall supplies the control signal.
- The temperature distribution in the press space is not constant.
- A ΔT up to just under +2°C was measured between the sensor and the area above the press (by Bosch room climate experts).
- The press is switched off if the room temperature exceeds 24.8°C as measured on the temperature sensor.

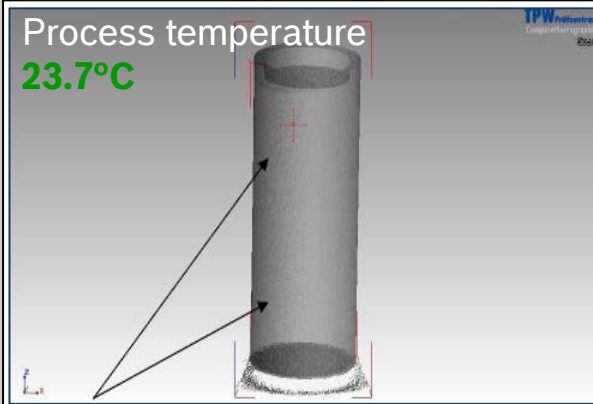
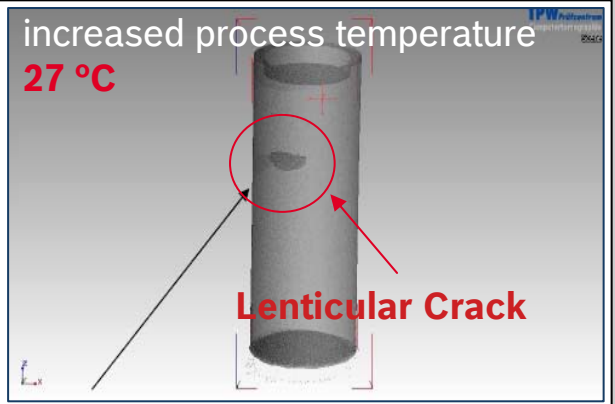
Non-escaped air expands during the sinterizing process and can cause the matrix structure to burst => lenticular cracks
