EA11003EN-01122[0]

From: Non-responsive content removed
To: [Redacted]
CC: [Redacted]
Date: 8/25/2011 11:52:00 AM
Subject: ANS: HP from endurance run for diagnosis
Attachments: [VW361MECM015-0S_19808_mls_18.06.2011mit_Motor_aus.txt](#)
[Tankkarte VW361MECM015-0S.PDF](#)

Audi - CP4 drivetrain damage

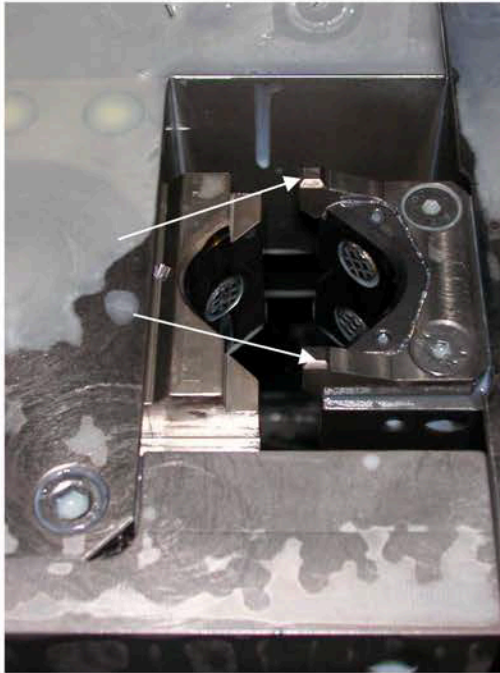
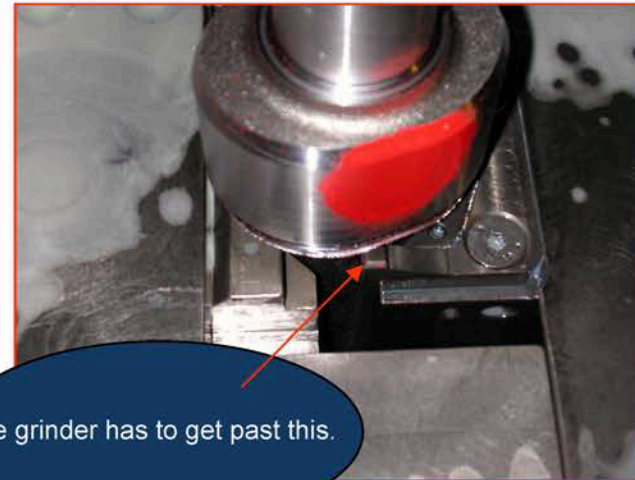
CP4 Audi TM 07/02/2008: PIN turned

PIN turned by 81.82° clockwise relative to cam TDC

If the turned cam were ground, the contact point would be ground away.

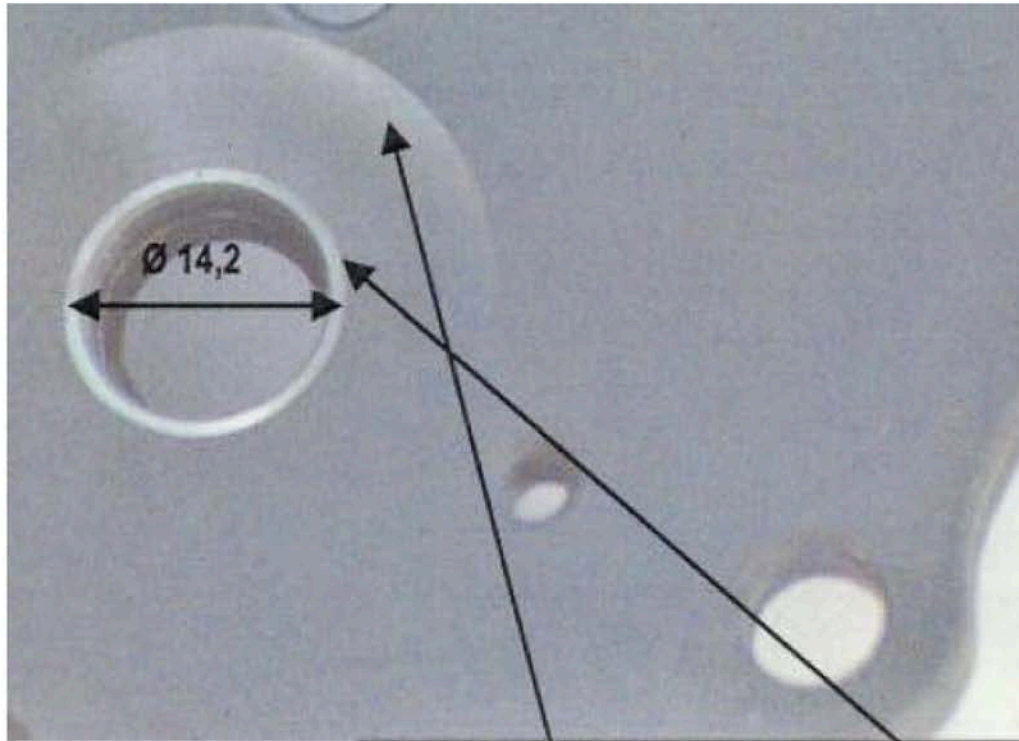
Cap wear

cover wear at prim. gear 14 μm , wear at coupling 55 μm

- Increase anodized layer thickness Done, [redacted]
Statement: not effective, because thicker layer results in rougher surface & therefore to greater initial wear
- Assessment of effectiveness of smaller GP balance choke (if Audi agrees to increase in min. inlet pressure) [redacted]
- Assessment (dates, costs) Ni cap vs. CP40 09/24/2008, [redacted]
- Investigation with cap made of housing material (simulation CP40)

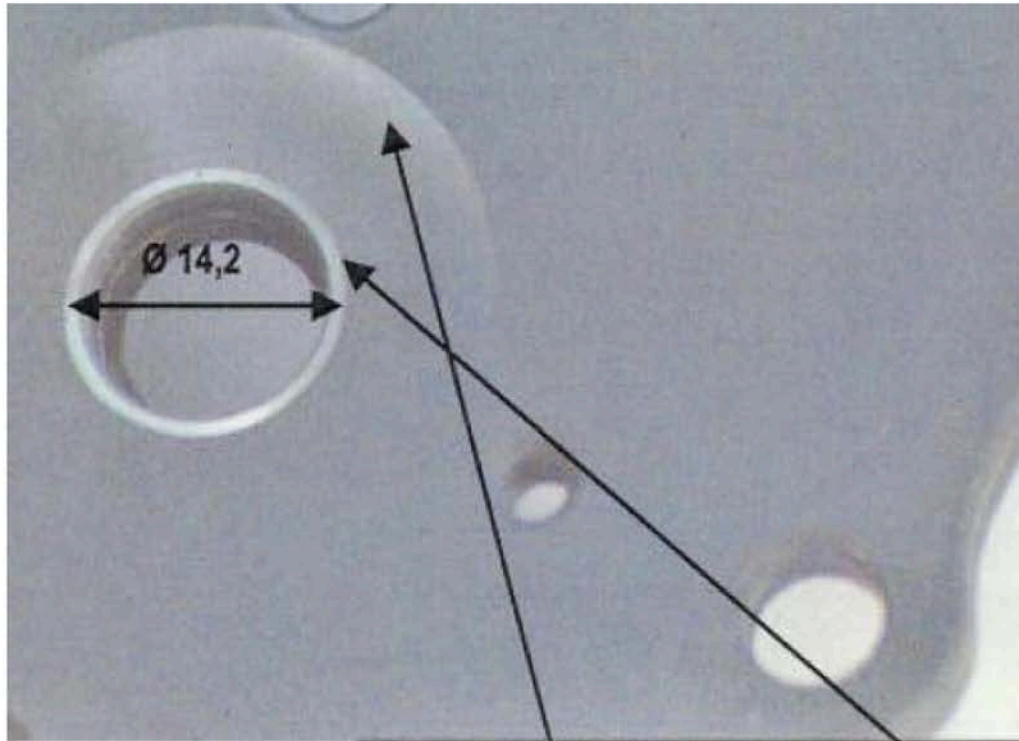
Cap wear

cover wear at prim. gear 14 μm , wear at coupling 55 μm

- Increase anodized layer thickness Done, [Non-responsive content removed]
Statement: not effective, because thicker layer results in rougher surface & therefore to greater initial wear
- Assessment of effectiveness of smaller GP balance choke (if Audi agrees to increase in min. inlet pressure) [Non-responsive content removed]
- Assessment (dates, costs) Ni cap vs. CP40 09/24/2008, [Non-responsive content removed]
- Investigation with cap made of housing material (simulation CP40)

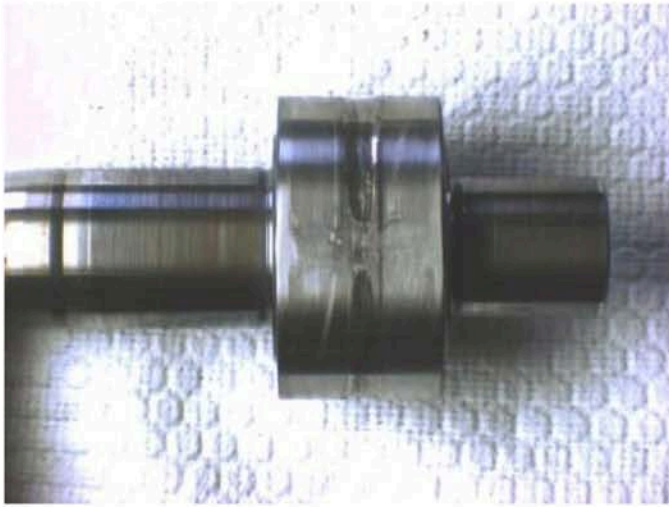
Camshaft

- Drivetrain damage: Deep wear track in middle of cam track due to perpendicular roller as consequence of sluggish roller, corresponding deep wear track on the roller. Wear track in the middle of the running surface on the roller support. Numerous chips present in the MU strainer, OV strainer, CH intake valve compartment, in the OV and MU bores, as well as in the bearings and on the shaft seal.
- MU fastening screw missing upon delivery -> Probably removed by customer

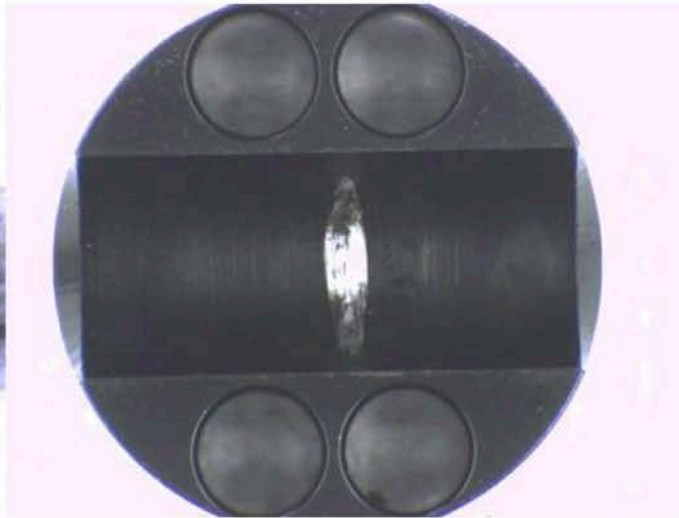
Roller support running surface

- An analysis of the roller support running surface did not show any indications of C layer detachment (adhesion class 1 -> very good) or contamination from previous processes (see set of slides 232_My). The C layer abrasion in the middle is the consequence of the destroyed roller surface (passage of broken-off roller material). No metal spatters or elevations were found.

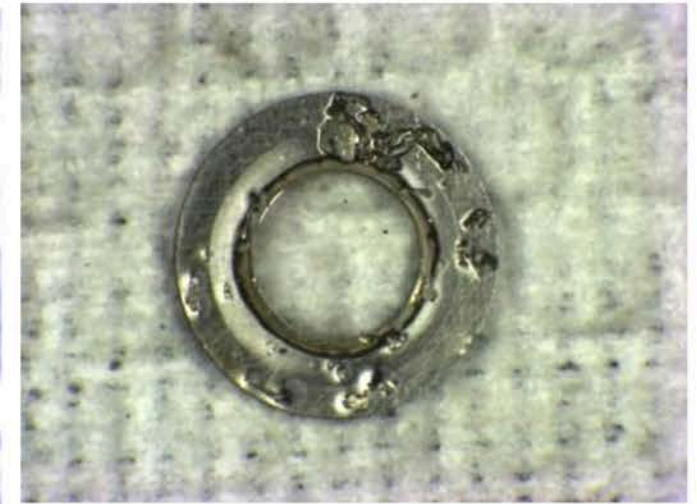
Intake valve gasket

- Tappet bore and piston base show greater cavitation erosion than usual
- The shaft seal shows greater wear optically; wear measurement to follow | RB
- Flange bushing shows smearing and heavy smoothing, which could be a result of the drivetrain damage.

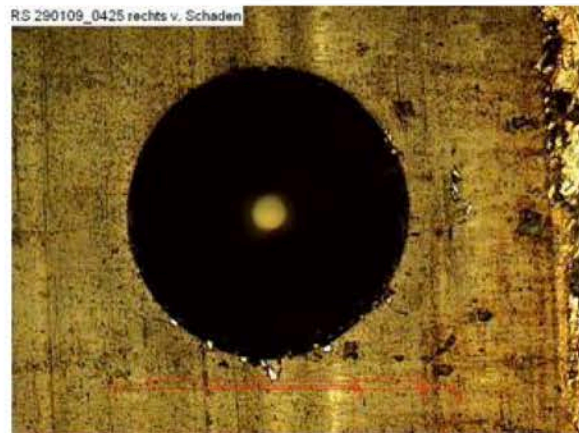
Right of damage

→ Summary: Layer adhesion in damage area inconspicuous. Cause of damage could not be clarified.

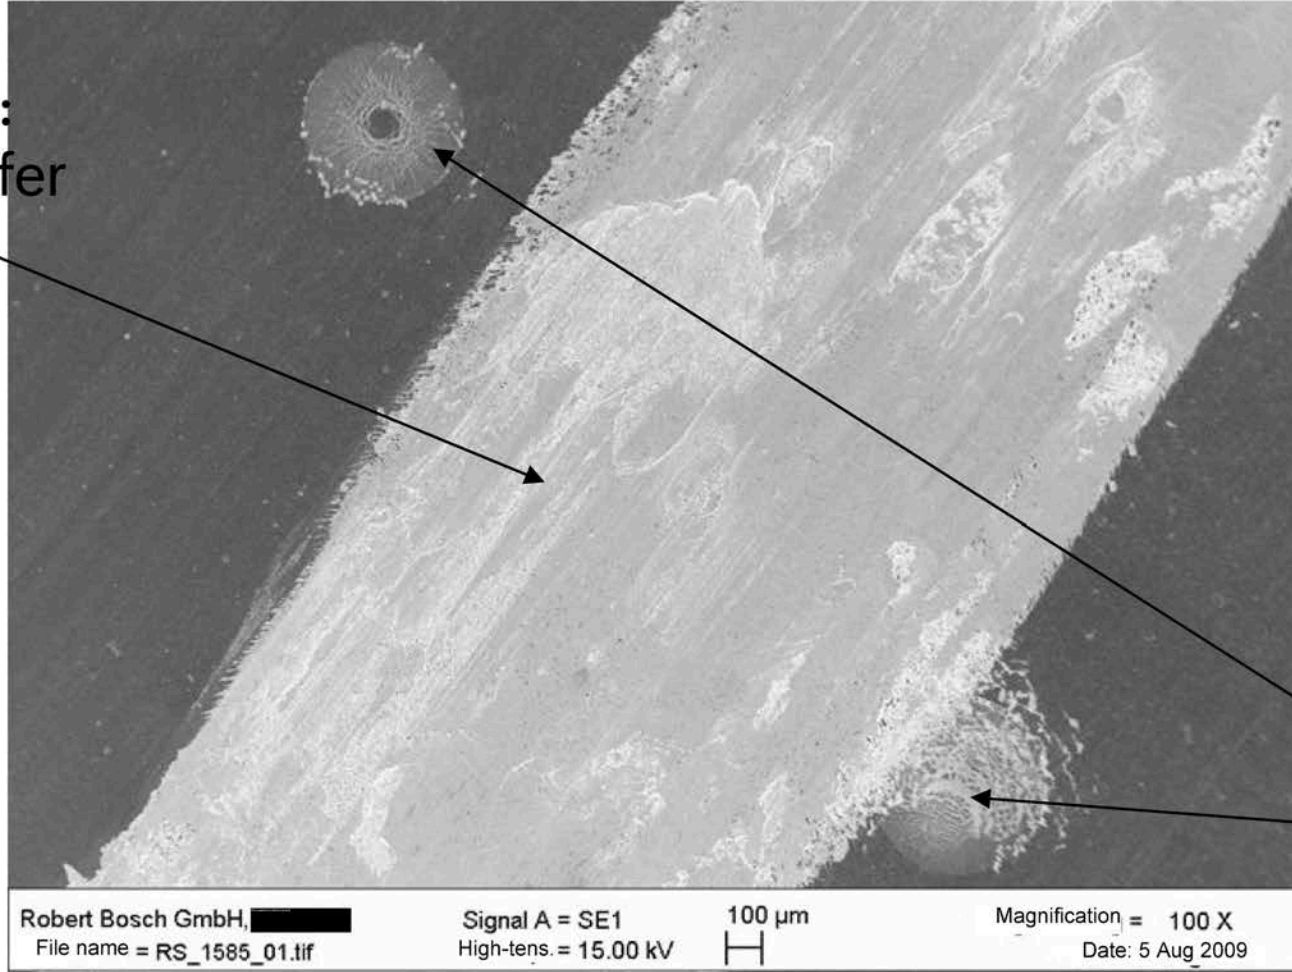
RS: 6007 1585

- Main damage point shows
 - areas with material transfer (with/without breakage),
 - areas with C layer detachment from basic material (as a consequence of thermal/mechanical overload) on which no mechanical contact (consequence: seizing) with opposing body has taken place.
- No area of C layer detachment (subsequent damage) shows indications of contamination.
- Damage in roller support does not have any indications of defective C layer quality or contamination from previous processes as cause

Main damage:
material transfer

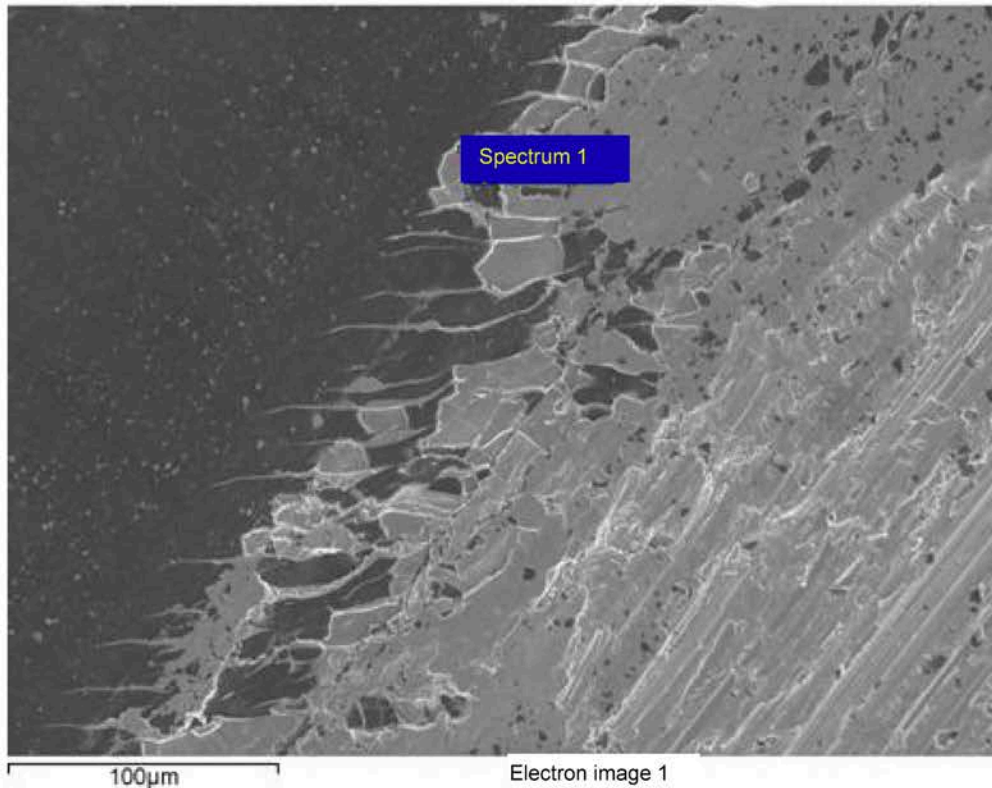
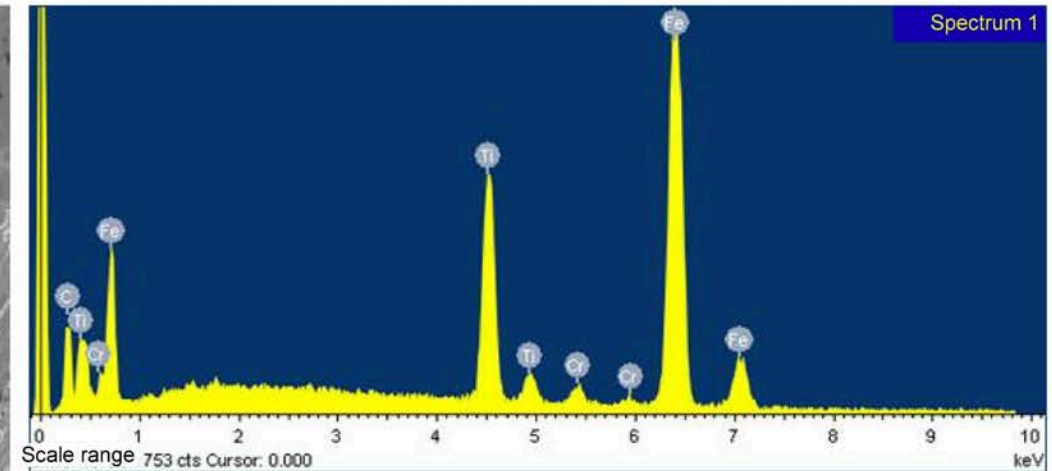
RS: 6007 1585

No contamination found in detached,
non-seized areas

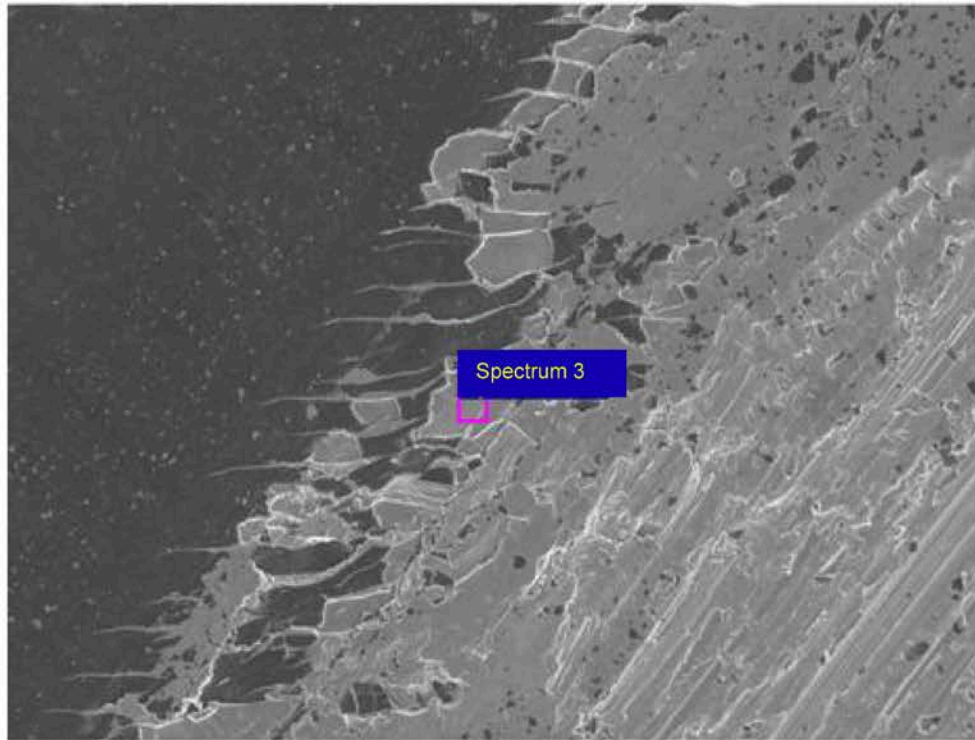
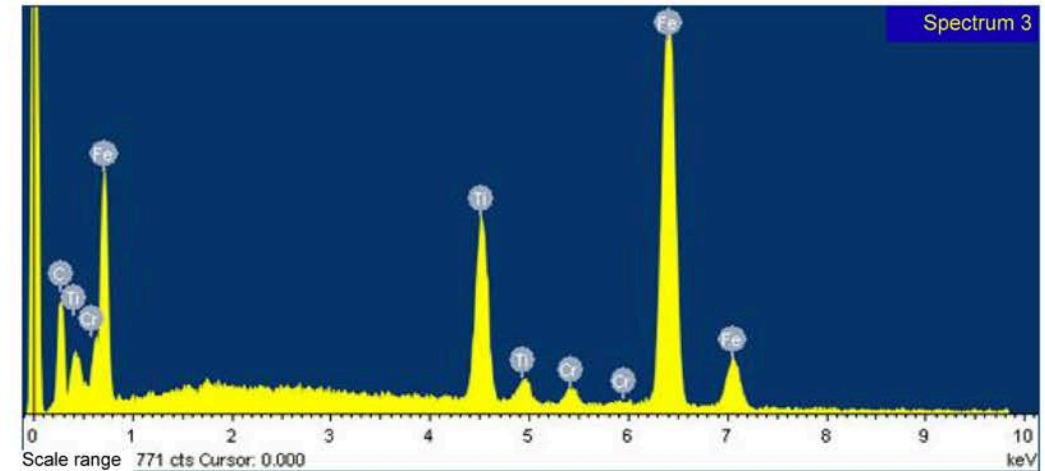
RS: 6007 1585

No contamination found in detached,
non-seized areas

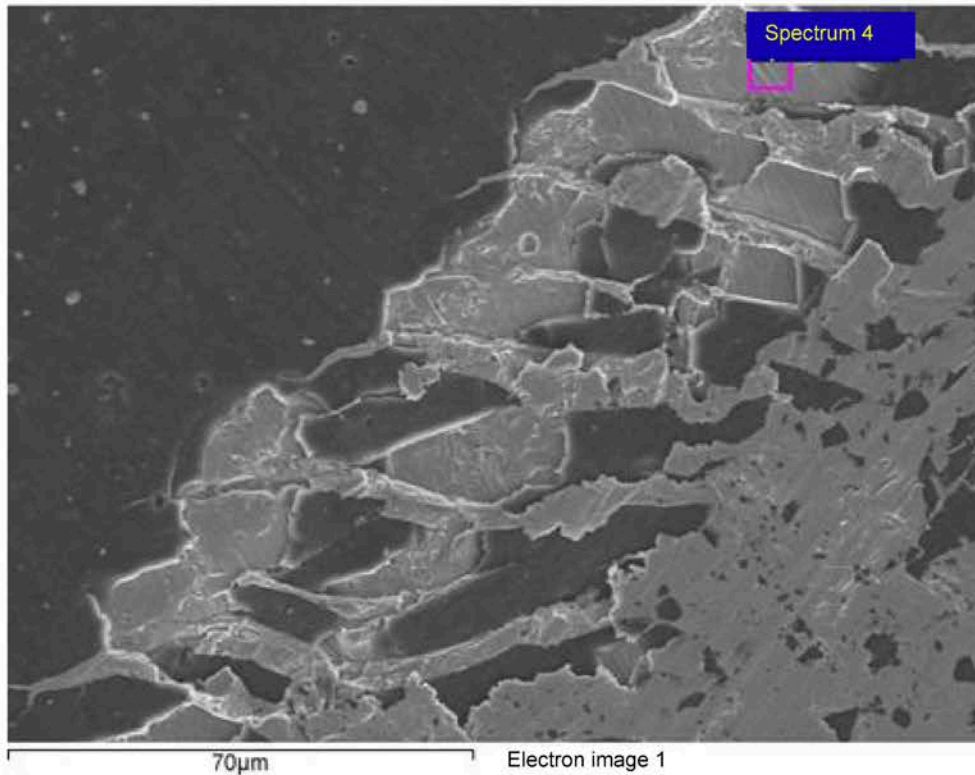
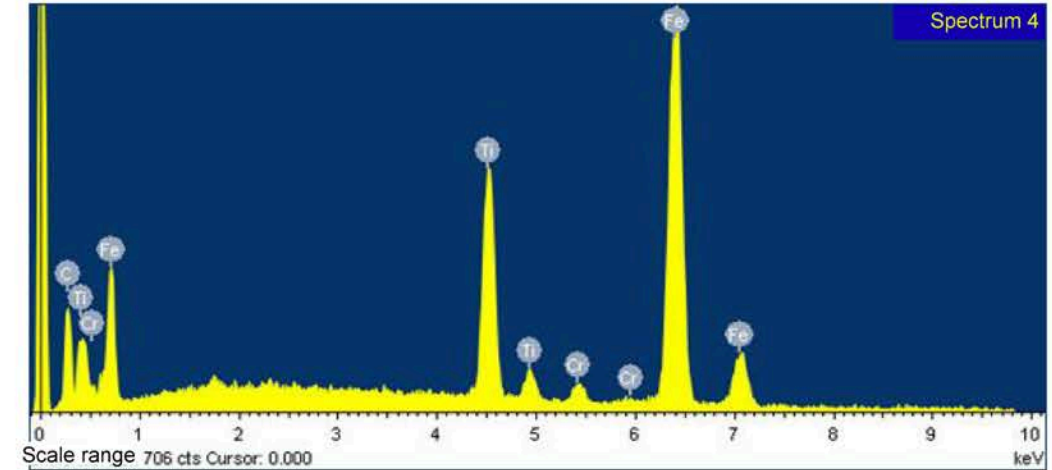
RS: 6007 1585

No contamination found in detached,
non-seized areas

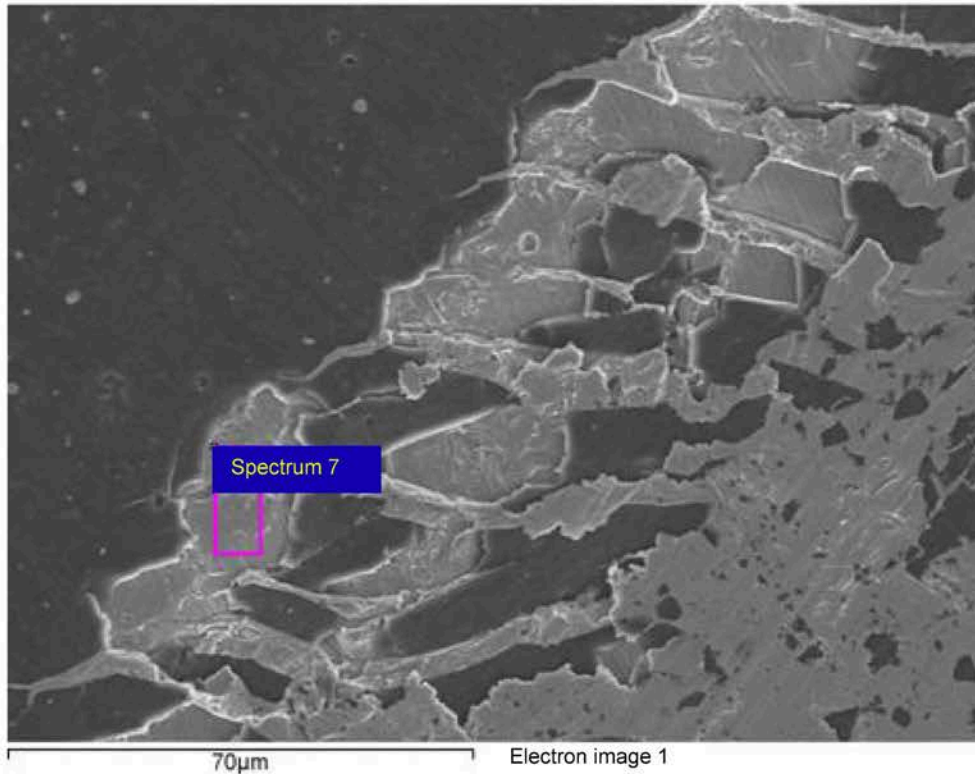
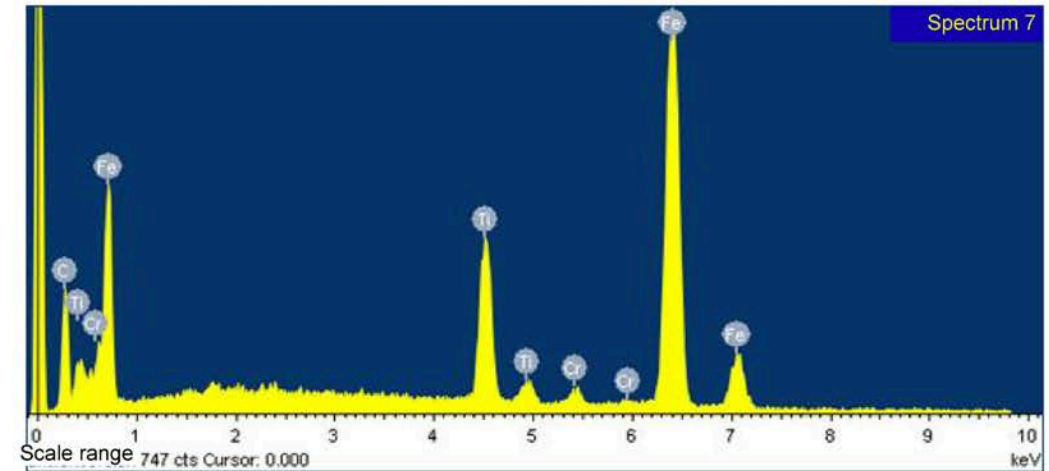
RS: 6007 1585

No contamination found in detached,
non-seized areas

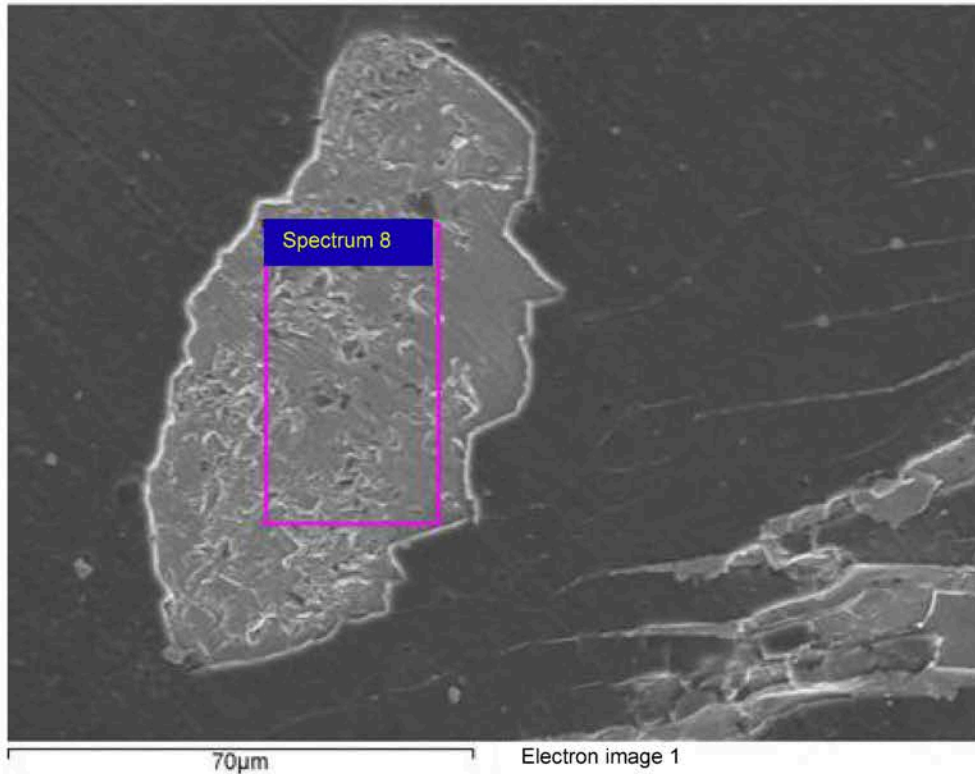
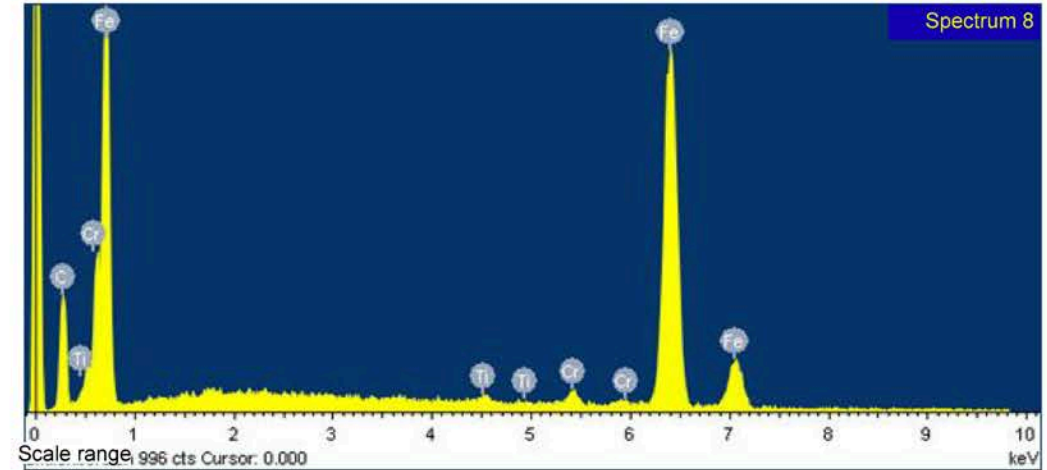
RS: 6007 1585

No contamination found in detached,
non-seized areas

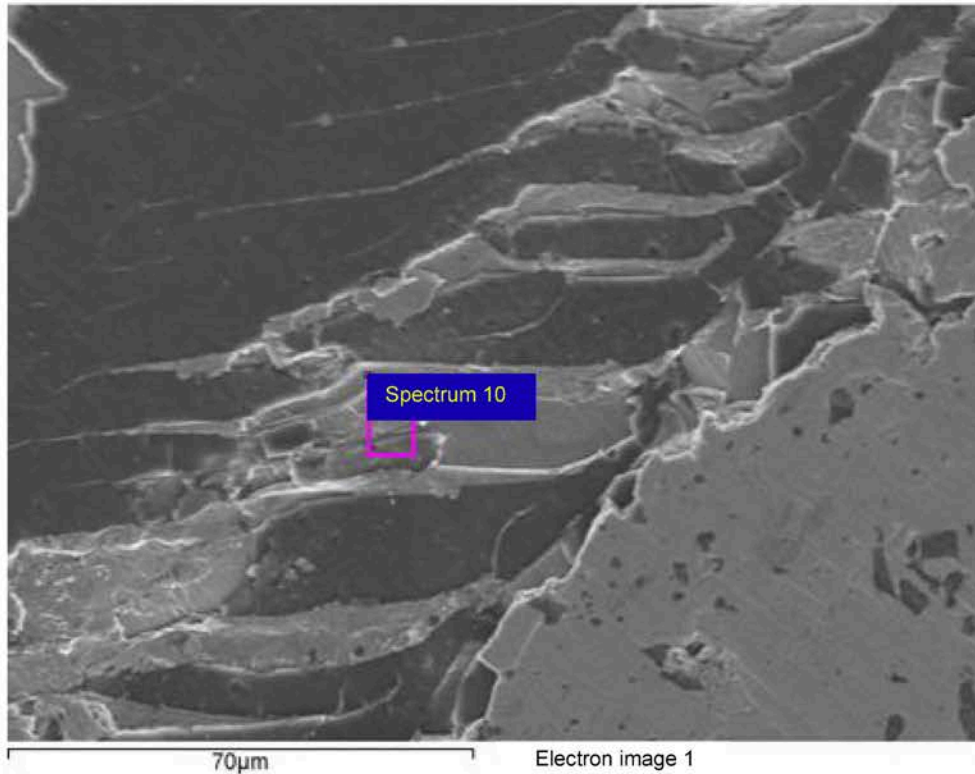
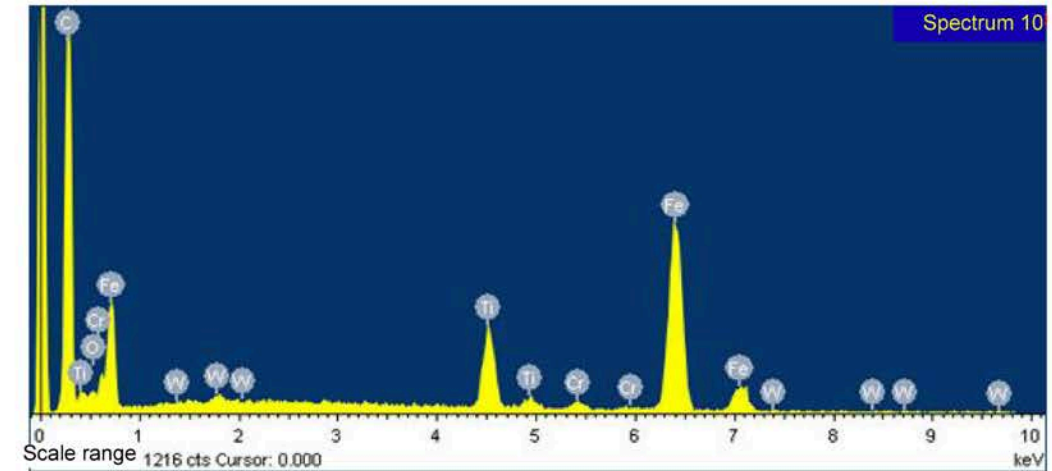
RS: 6007 1585

No contamination found in detached,
non-seized areas.

Transfer tracks on roller (W) found.
