Subject: ANS: Pump complaint from Q Verification USA - Pump no 290109-0425

Subject: HPP failures

Subject: Re: Serious problem with vehicle 1K2AM006 (2,0l 103kW DQ250 6-F PPS), high-pressure fuel pump faulty

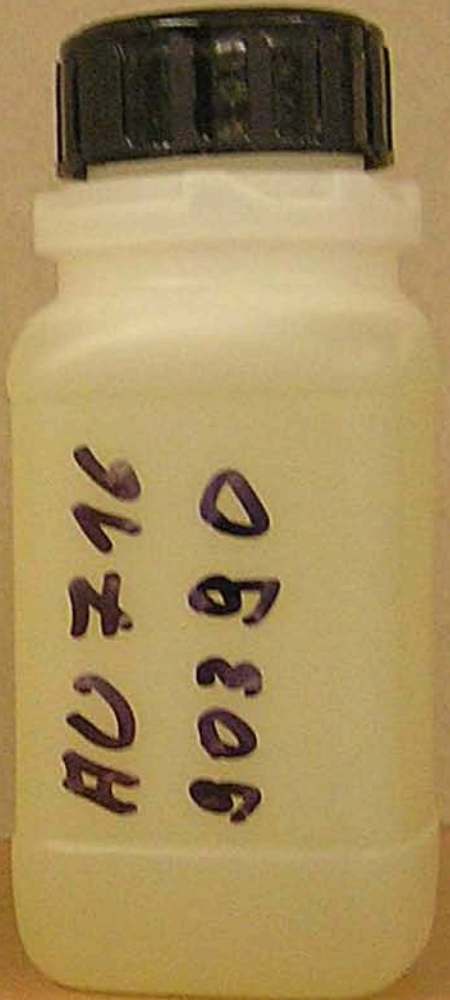
Part Fuel filter
 Vehicle no.
 Removal date 09.16.09
 Removal km km
 Installation km km
 Mileage 27,285 km total.
 Removal Reason:
 faulty high-pressure fuel pump

Teil Kraftstofffilter
 Fzg.-Nr. 10716 90390
 Ausb. Datum 16.09.09
 Ausb. km 144325 km
 Einb. km 144638 km
 Lfstr. 27285 km ges.
 Ausb.Grund
 defekte Hochdruckpumpe

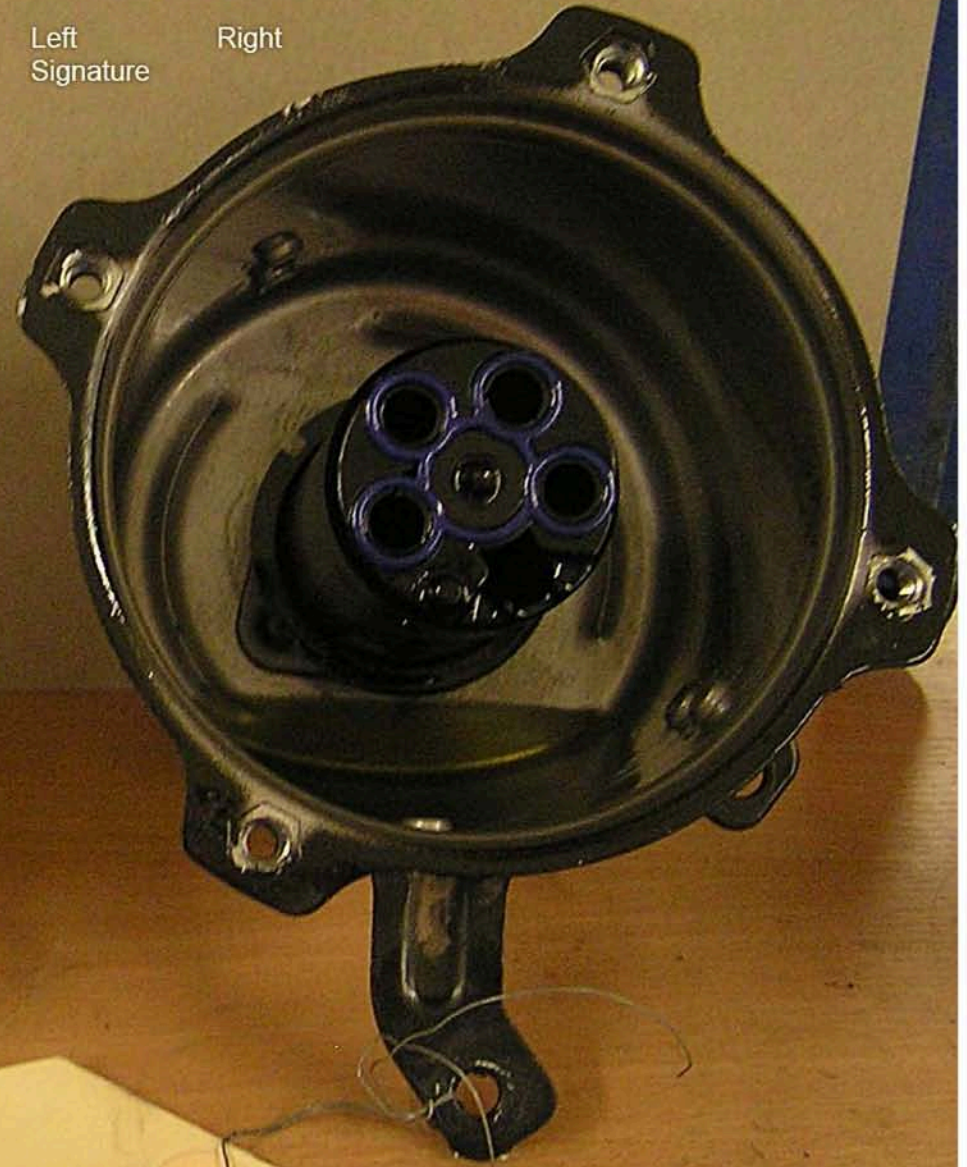
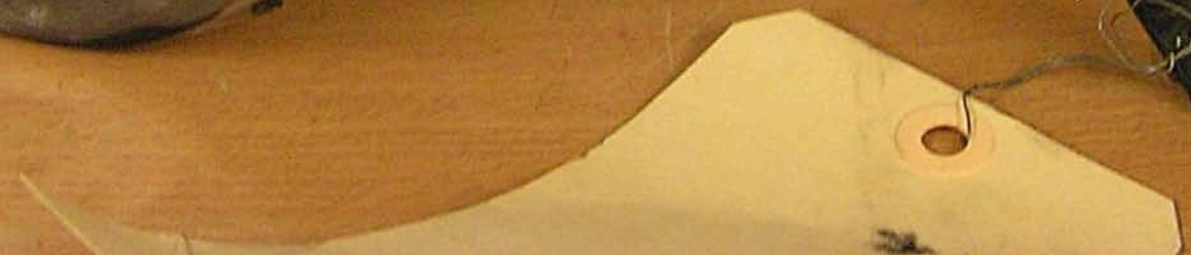
Part Fuel filter
 Vehicle no.
 Removal date
 Removal km km
 Installation km km
 Mileage km total
 Removal Reason HPP defects

Teil Kraftstofffilter
 & Kraftstoffpumpe
 Fzg.-Nr. A4716 9-2219
 Ausb.-Datum 01.02.1997
 Ausb. km 144.076 km
 Einb. km 116.892 km
 Lfstr. 22 274 km ges. -
 Ausb.Grund HDP d. E 44
 VDKw- 5014.694

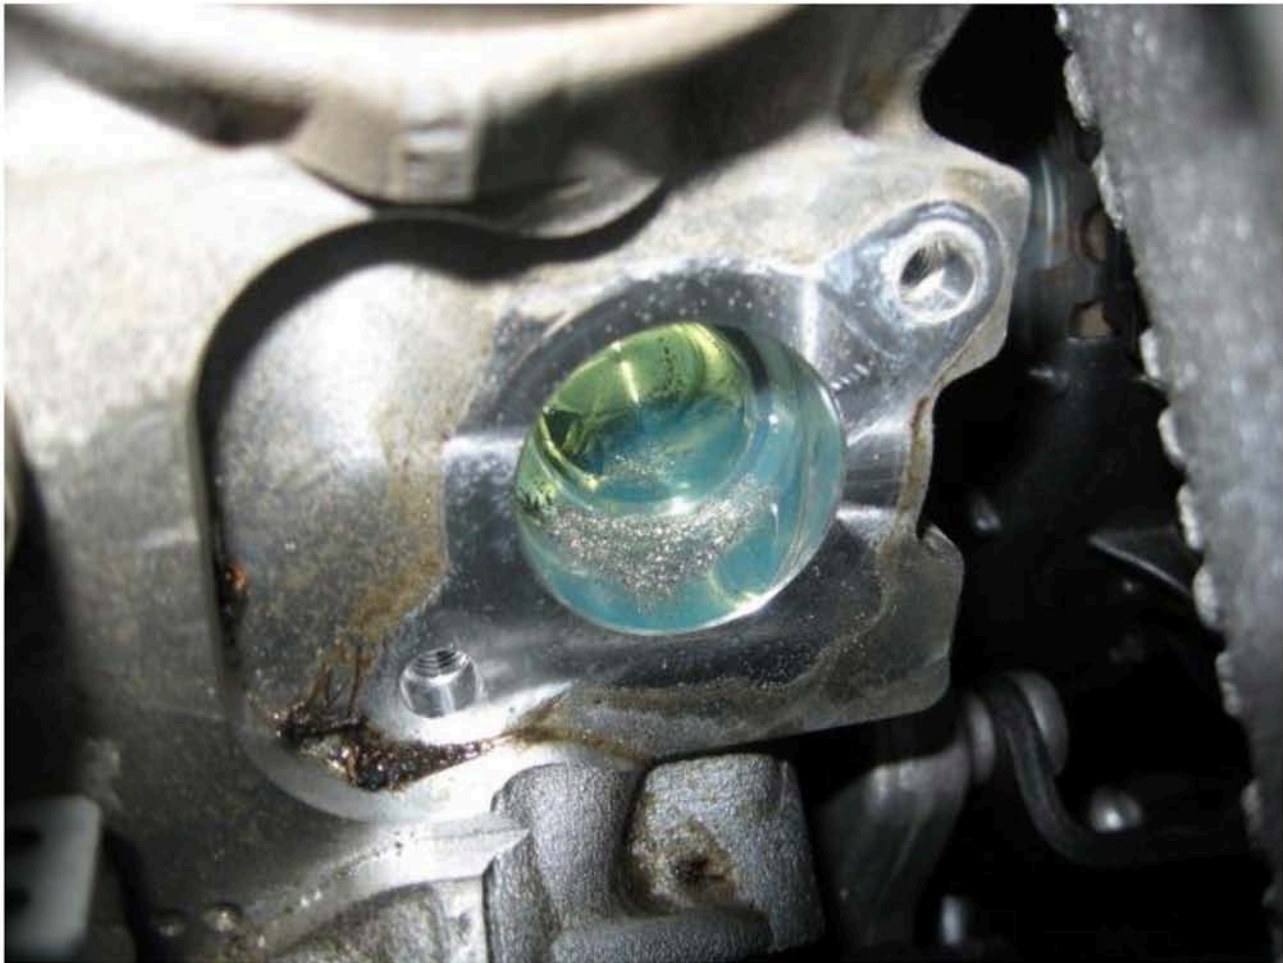
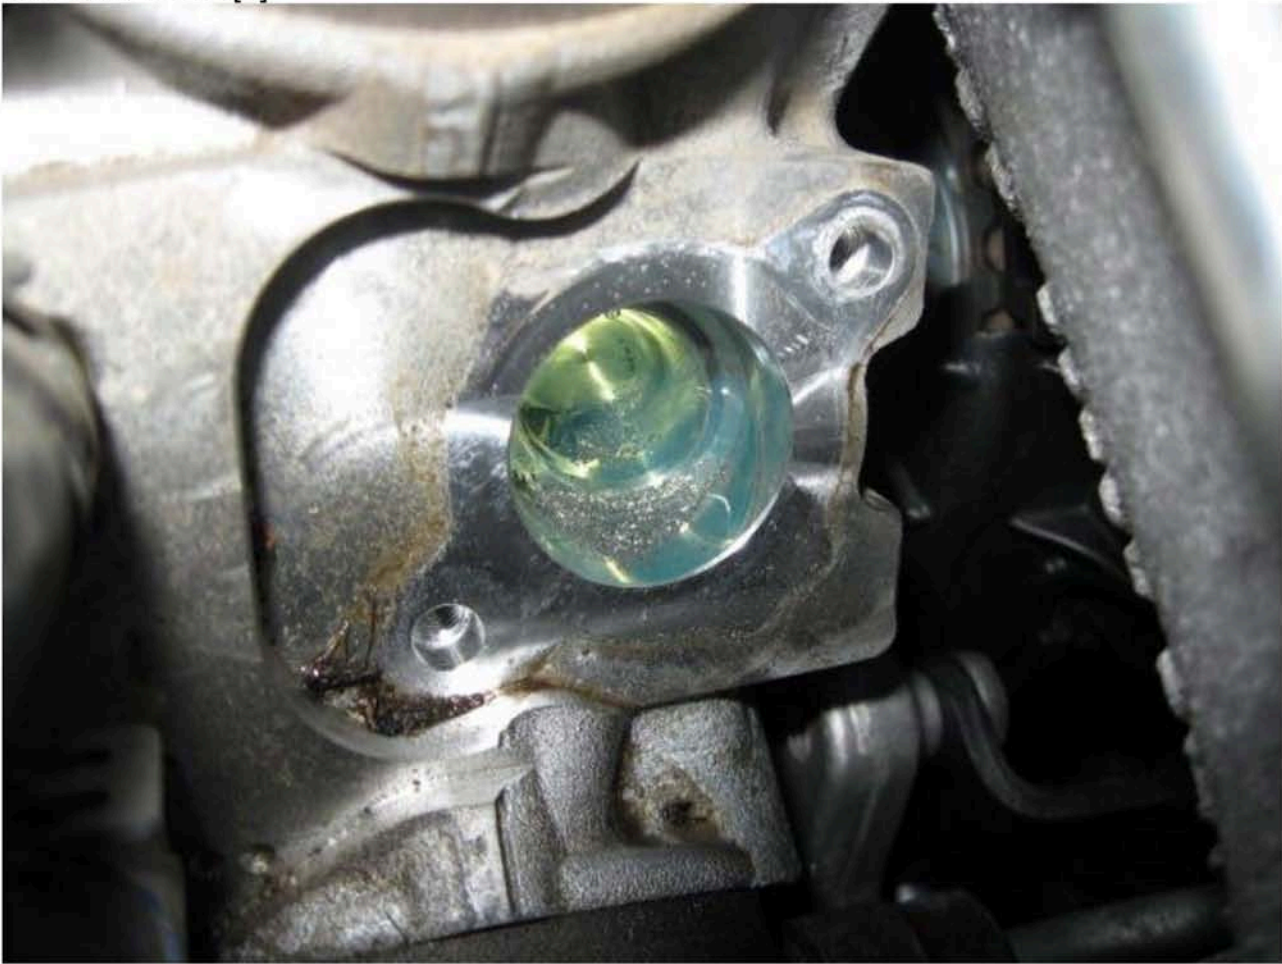
This is a Gen1 high-pressure fuel pump Gen1 with anti-wear package 1 (part no. 059 130 755 BC Indiv. No. 00043 4225) which we installed at tachometer reading 59,916 km.

The vehicle is to be repaired again because it has approximately another 80,000 km ahead of it. We shall supply a Gen1 RP2 pump.

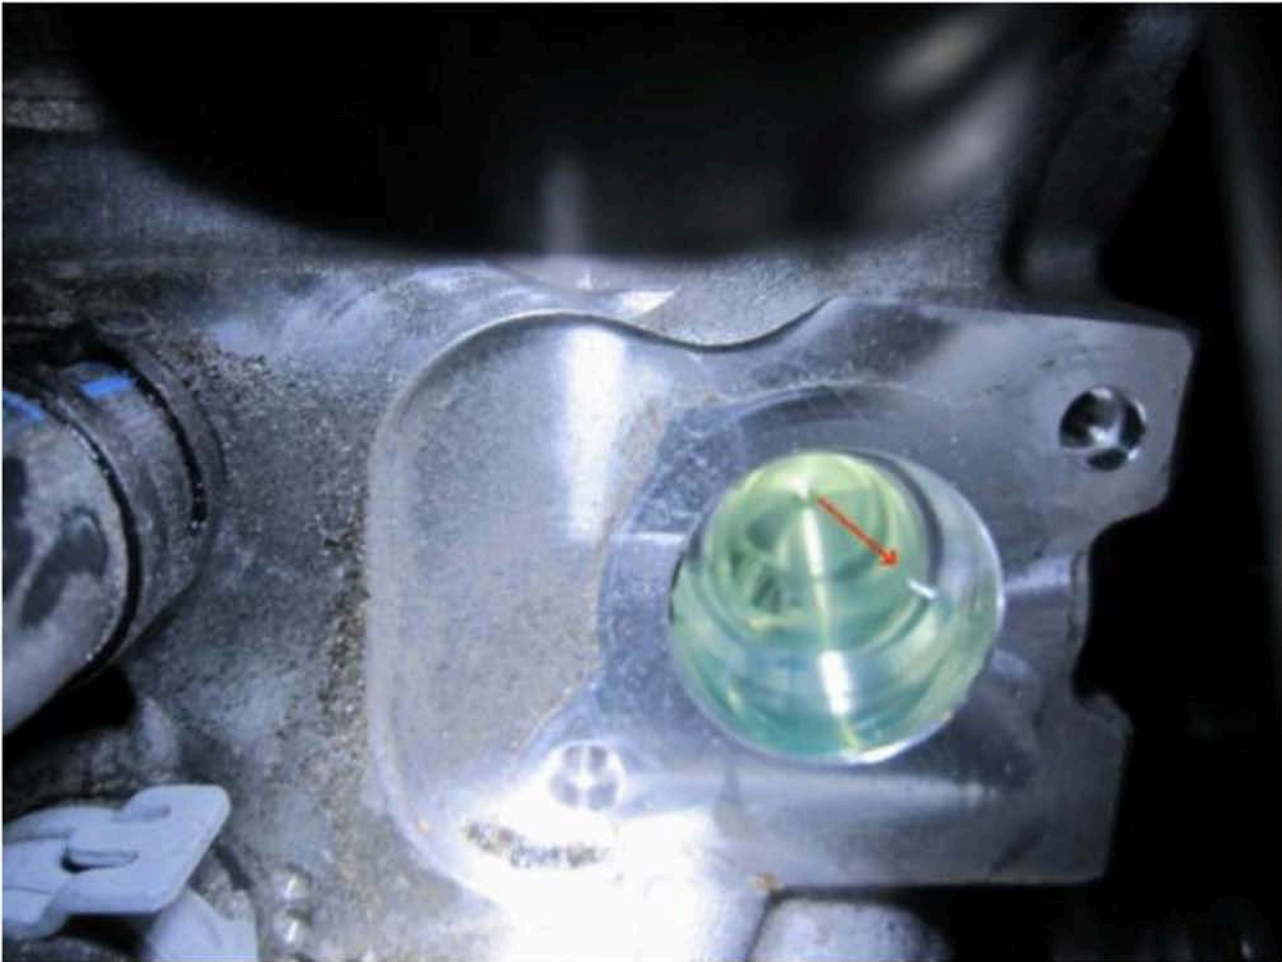
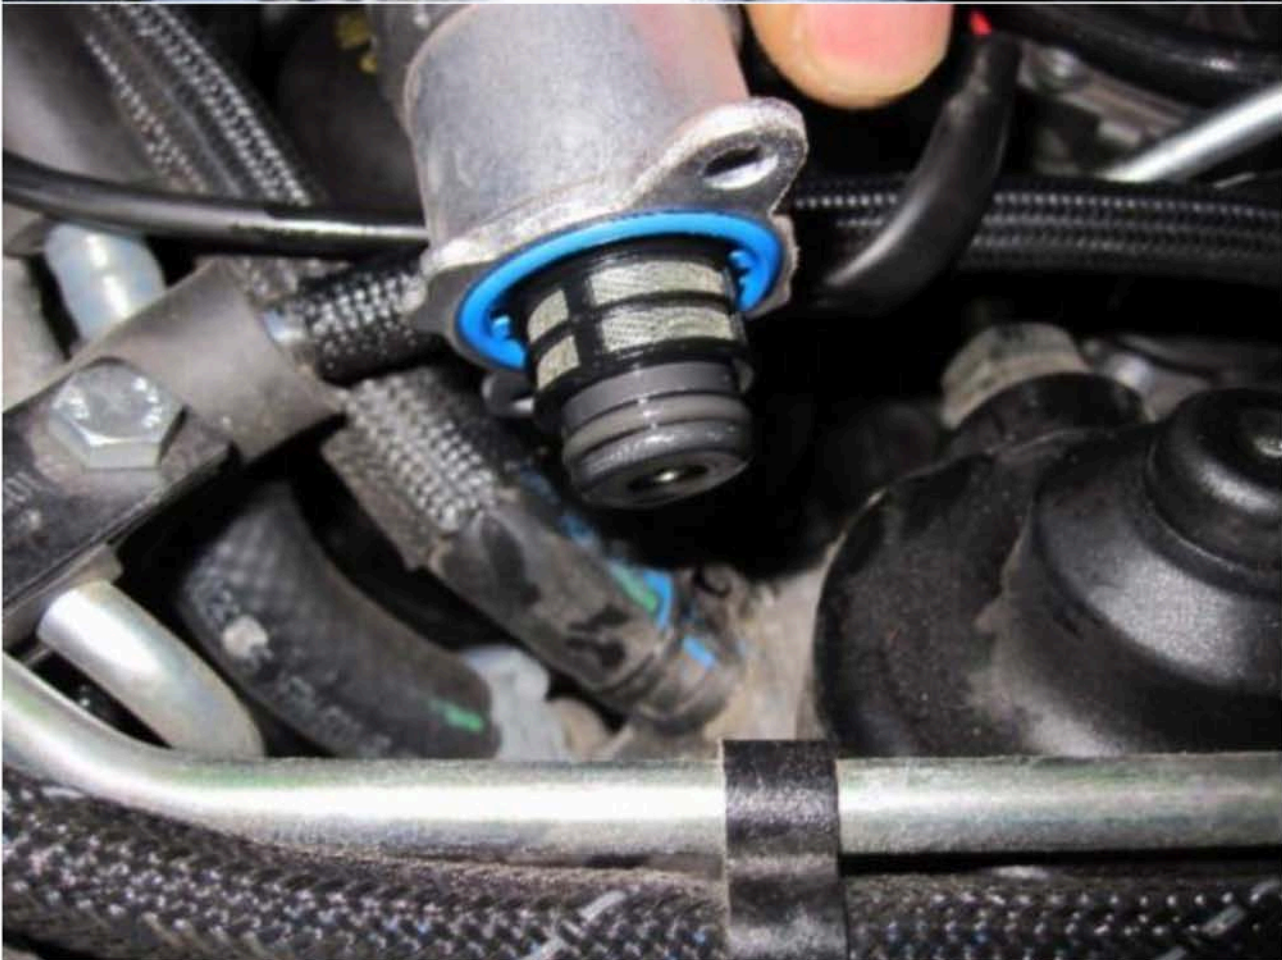
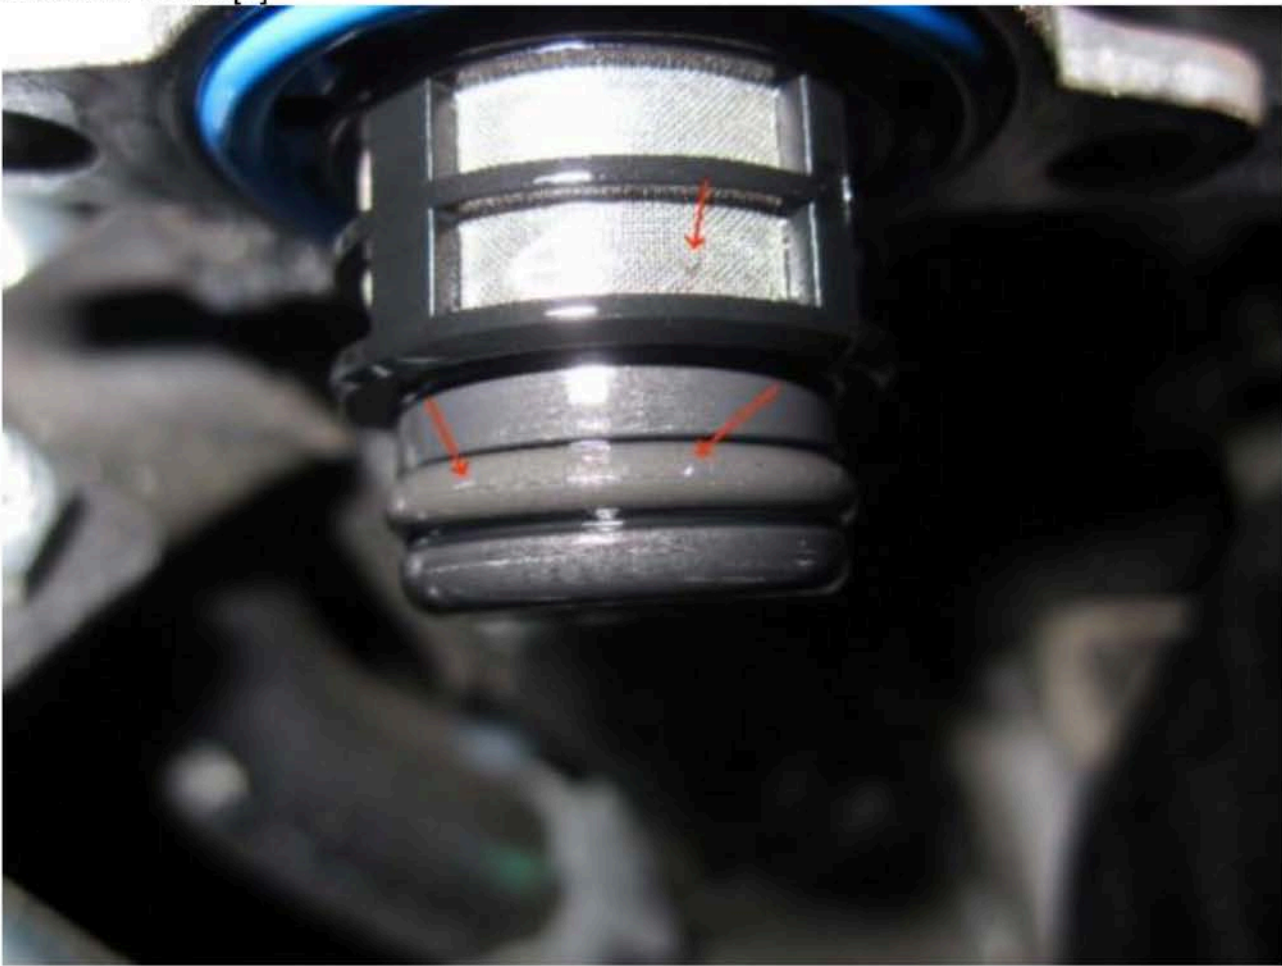
We have found chips in the high-pressure pump of the VW526__BD108-PPS. The vehicle has been laid up.
