EA11003EN-01202[0]

Inspection report 43 Non-responsive content removed pumps in the field

CP4 Task Force Audi – Field Diagnosis Non-responsive content removed

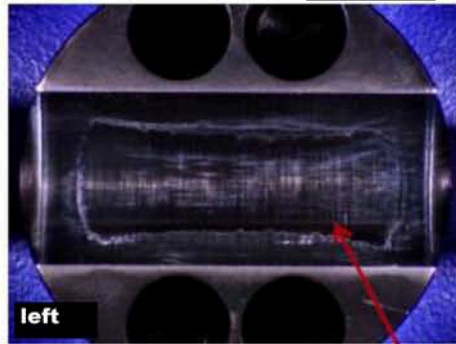
Discoloration R3

Linings R5

Flat spot R6

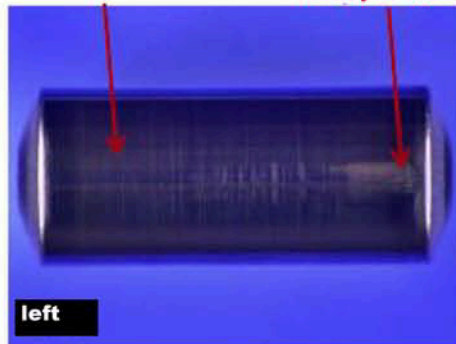
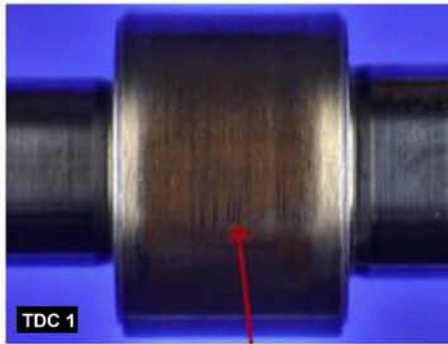
Material transfer

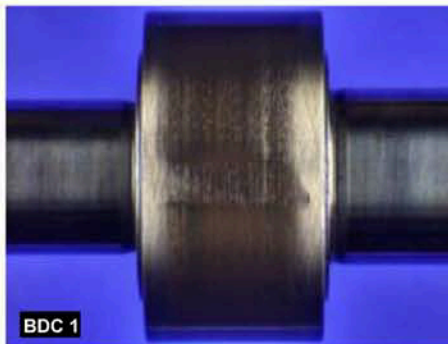
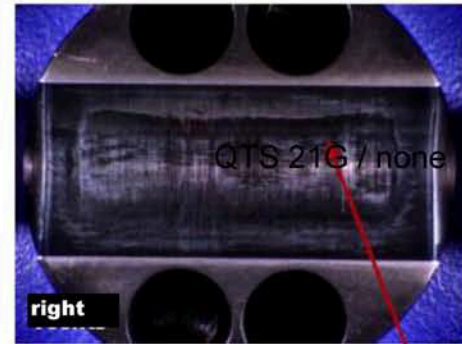
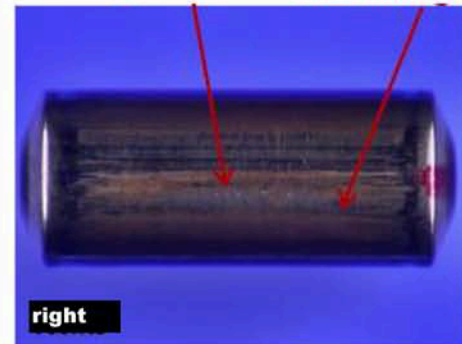
Linings R7

Discoloration R7

Braking flat R8

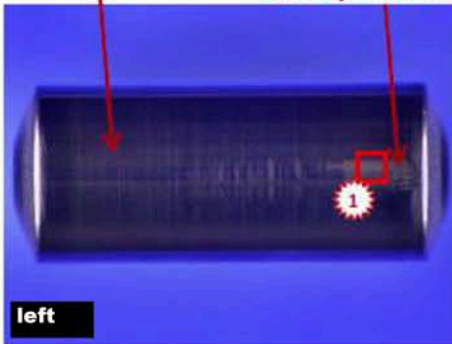
left

Discoloration R3

Flat spot R6

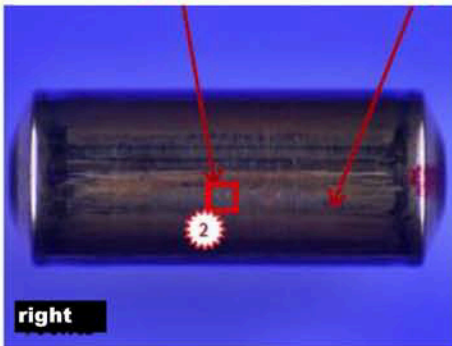
right

Braking flat R8

Discoloration R7

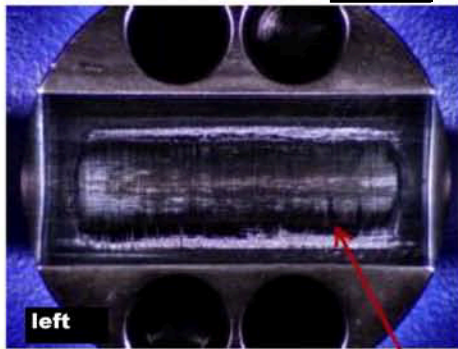
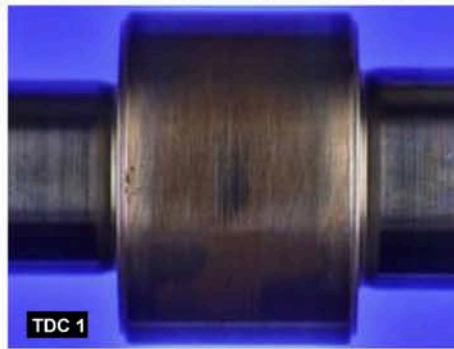
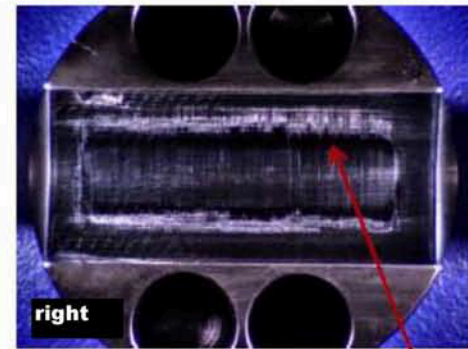
TDC 1

Linings R7

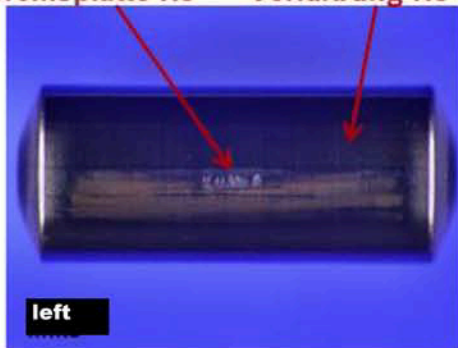
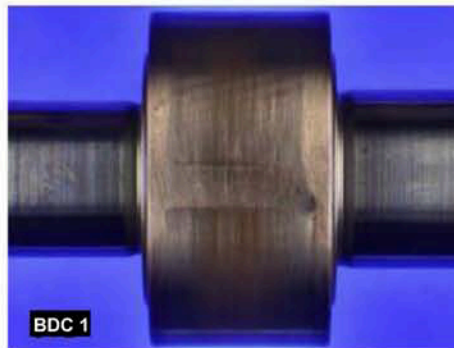
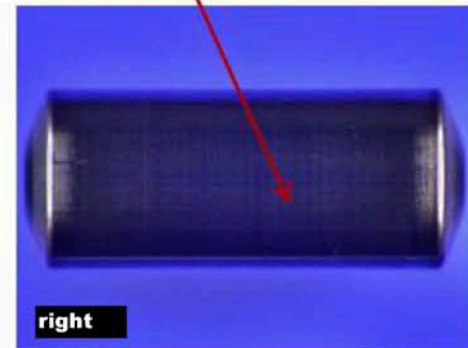
BDC 1

Discoloration R3
