# Audi - Bosch reliability program

## CP4 diesel high-pressure fuel pump in CR injection systems from 1800 bar (EU5)

Field failures V6 diesel high-pressure fuel pump CP4.2 - Non-responsive content removed

**Trouble ticket – Failure of high-pressure fuel pump in EC ER**

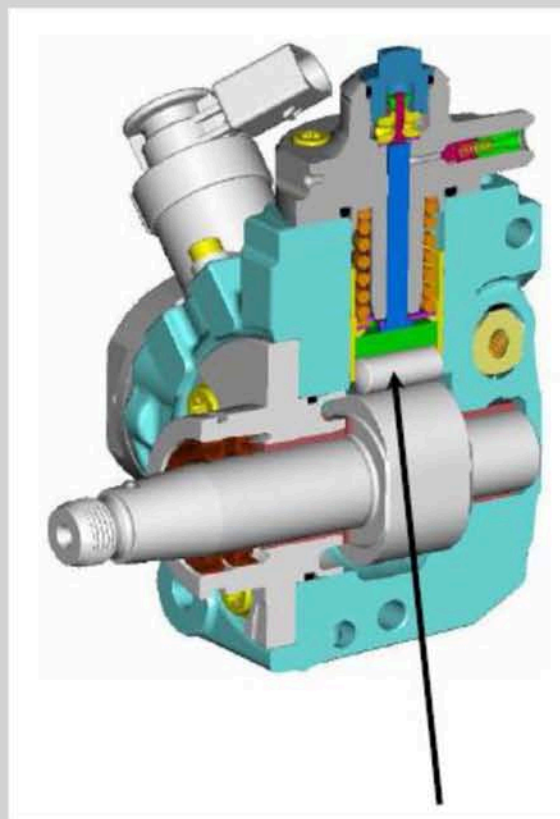
left roller tappet

The “sensitive heart” of the pump is the drivetrain with:

If these conditions are not met, **drivetrain damage** will occur with:

- **sluggishness** of the roller in the roller support due to manufacturing variances (largely eliminated).
- **critical fuel qualities** in various markets worldwide, although the fuel properties that result in damage have not been analytically proven to date:

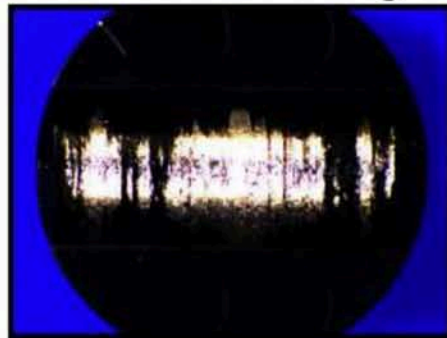
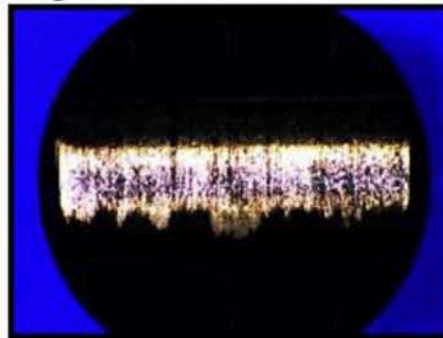
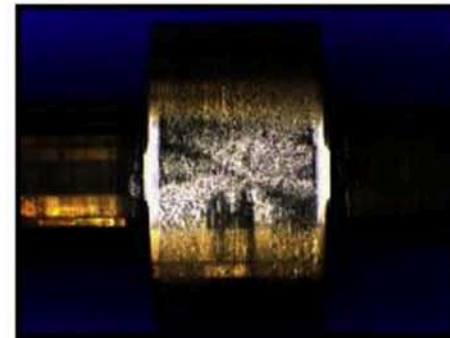
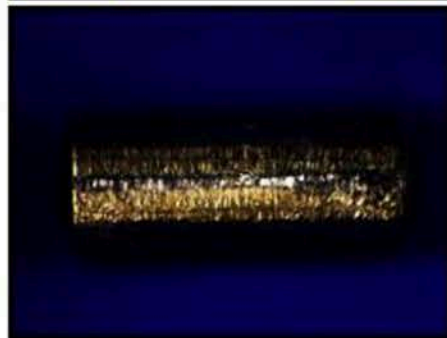
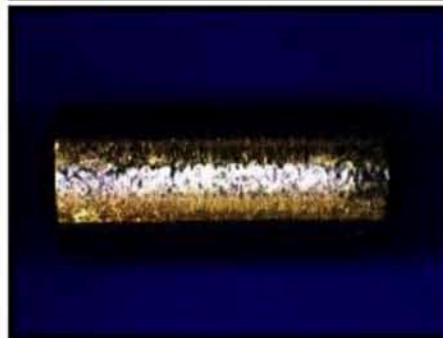
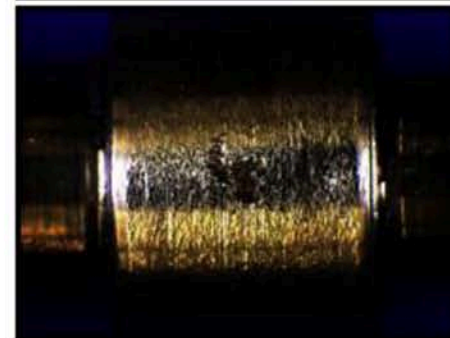
- Circumferential abrasive wear on cam track and roller
- Large areas of C coating in roller support worn
- Slight signs of corrosion

“Cause no longer apparent, indicators of periods of use with water in fuel”

- Standard pump 0445010613
- Date of manufacture 04/2008 (i.e. before the introduction of the straightedge test and further quality improvement measures with respect to metal splashes / fusing on the roller or roller support)
- Drivetrain damage category I
- Circumferential abrasive wear and fatigue on cam track and roller
- Large areas of C coating in roller support worn

**Further action:**

Diagnostic meeting Audi / Bosch

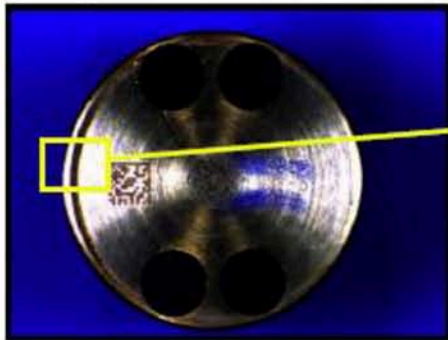
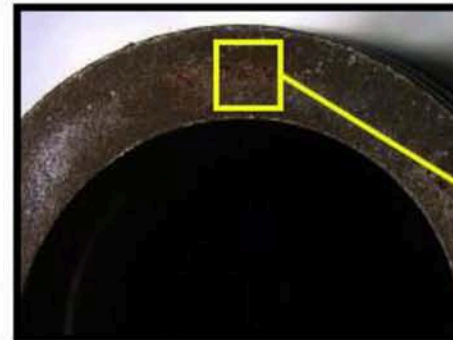
- Little evidence of periods of use with water in fuel (corrosion)
- The advanced state of the damage means that there is no longer any possibility of identifying anything unusual about the manufacture of the roller support or roller

- The cause of the damage is no longer ascertainable
- Indications of periods of use with water in fuel. Evidence is too weak to enable definite conclusions to be drawn in relation to the cause of the damage.

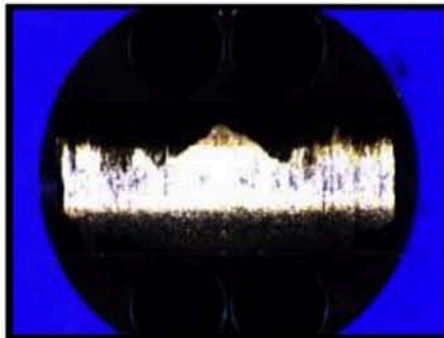
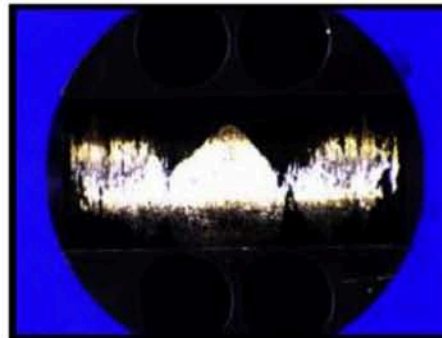
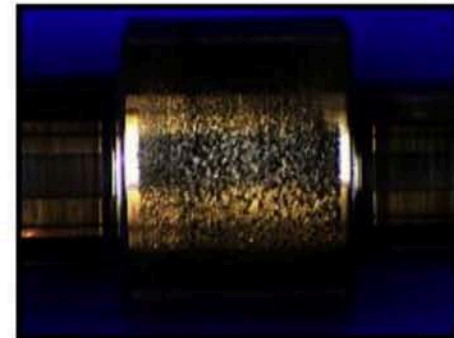
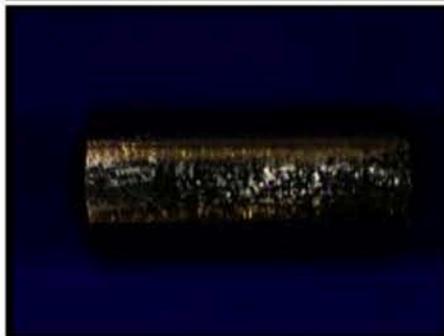
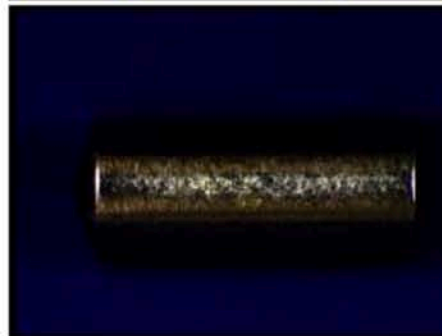
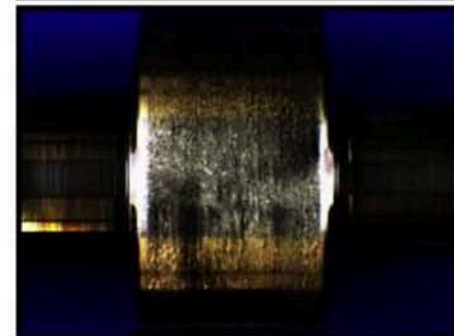
- Sample pump 0445B20169\_20
- Date of manufacture 02/2009
- Drivetrain damage category I
- Circumferential abrasive wear on cam track and roller
- Large areas of C coating in roller support worn

- Roller support with C3 layer
- Roller crests with C3 layer
- Omission of ball peening of camshaft
- Omission of anti-friction coating on spring plate
- Roller support round (instead of partly round)
- Omission of MnPh on tappet body

Blocking of additional anti-wear measures until the precise reason for the failure has been identified. Diagnostic meeting Audi / Bosch

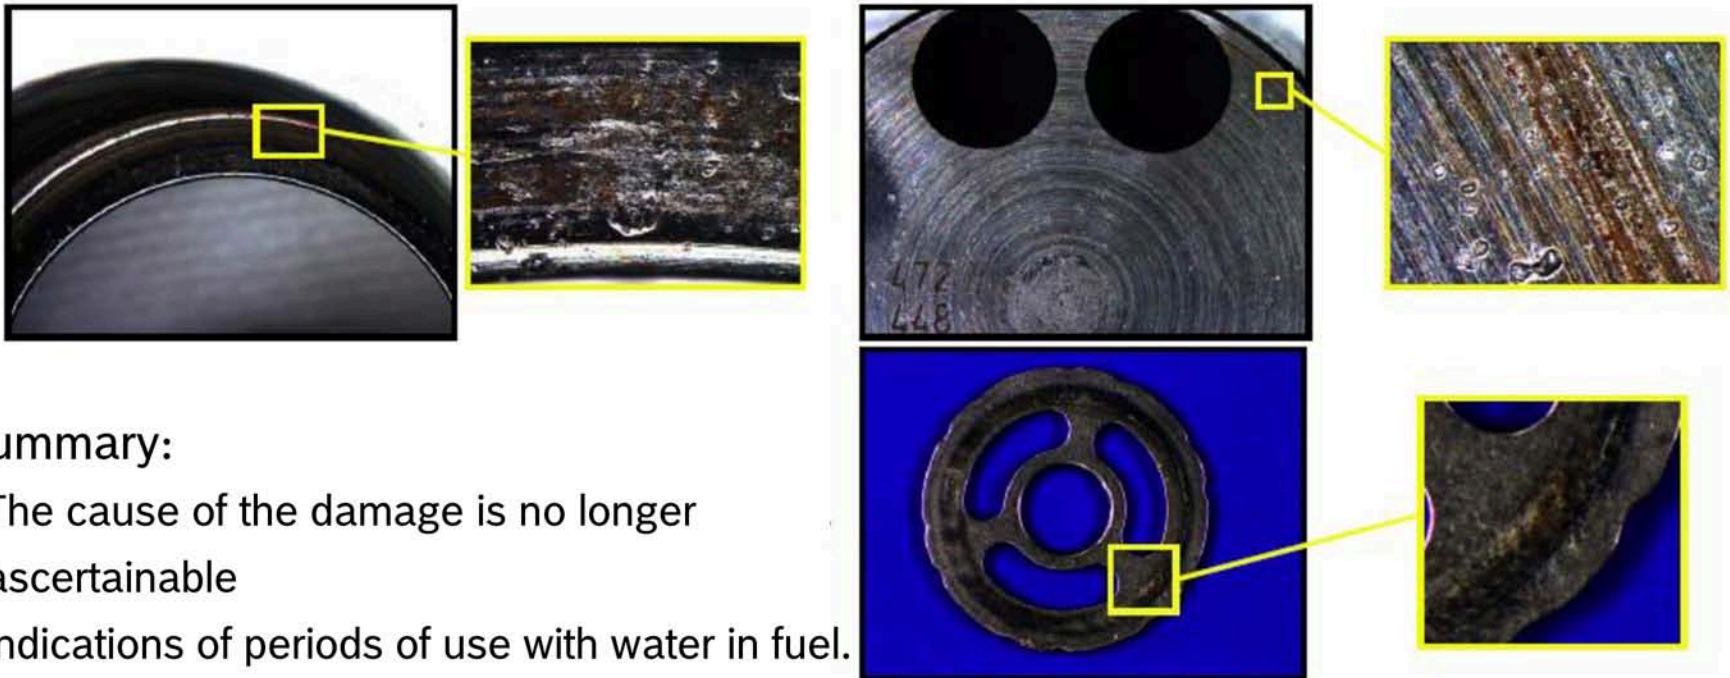
- Little evidence of periods of use with water in fuel (corrosion)
- The advanced state of the damage means that there is no longer any possibility of identifying anything unusual about the manufacture of the roller support or roller

- The cause of the damage is no longer ascertainable
- Indications of periods of use with water in fuel.

Evidence is too weak to enable definite conclusions to be drawn in relation to the cause of the damage.

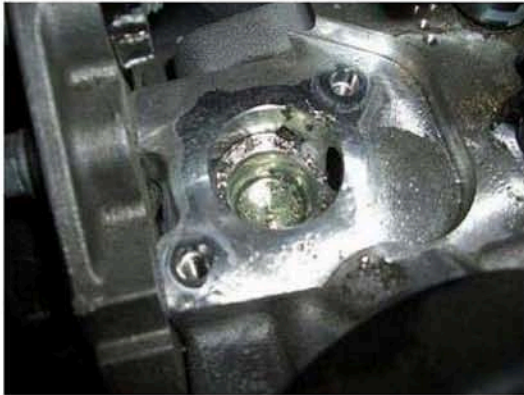
1K2AM006 HPP\_2

1K2AM006, 82,640 km, 10.20.2009

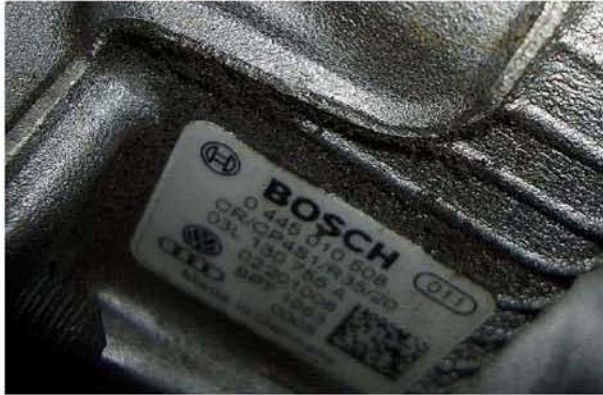
1K2AM006 HPP\_3

1K2AM006, 82,640 km, 10.20.2009

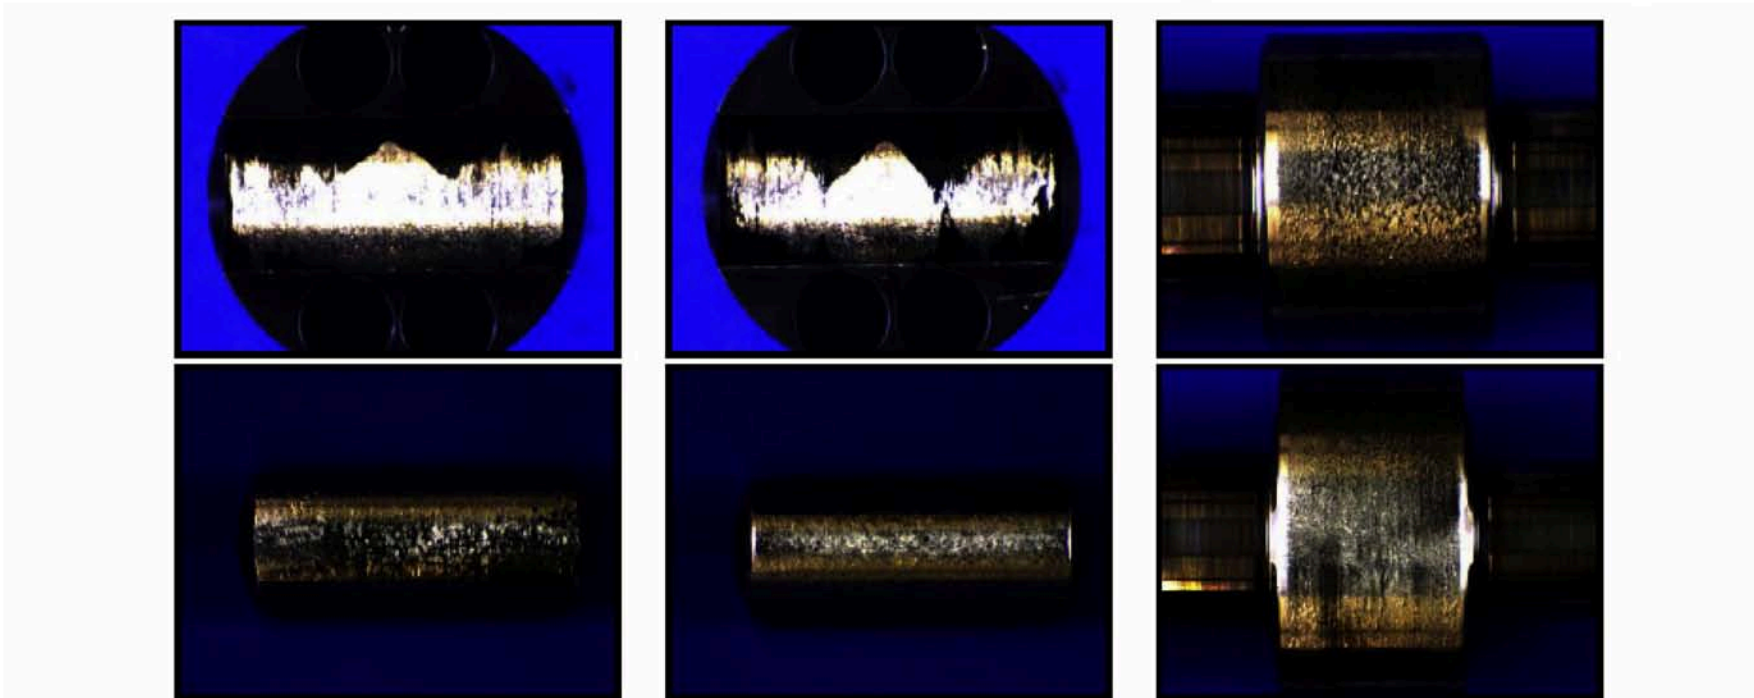
- Sample pump 0445B20169\_20
- Date of manufacture 02/2009
- Drivetrain damage category I
- Circumferential abrasive wear on cam track and roller
- Large areas of C coating in roller support worn

- Roller support with C3 layer
- Roller crests with C3 layer
- Omission of ball peening of camshaft
- Omission of anti-friction coating on spring plate
- Roller support round (instead of partly round)
- Omission of MnPh on tappet body

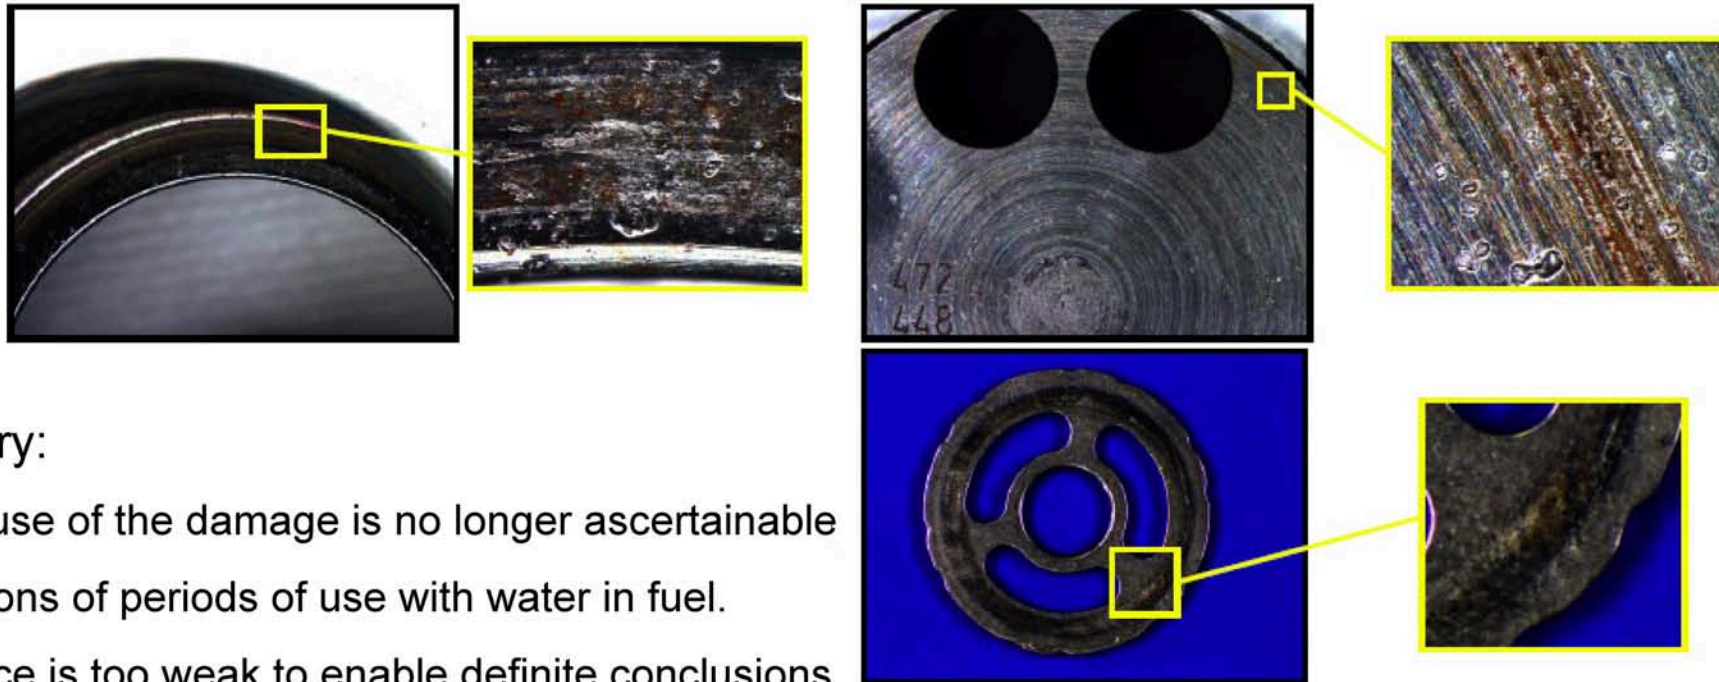
- Little evidence of periods of use with water in fuel (corrosion)
- The advanced state of the damage means that there is no longer any possibility of identifying anything unusual about the manufacture of the roller support or roller

- The cause of the damage is no longer ascertainable
- Indications of periods of use with water in fuel.

Evidence is too weak to enable definite conclusions to be drawn in relation to the cause of the damage.

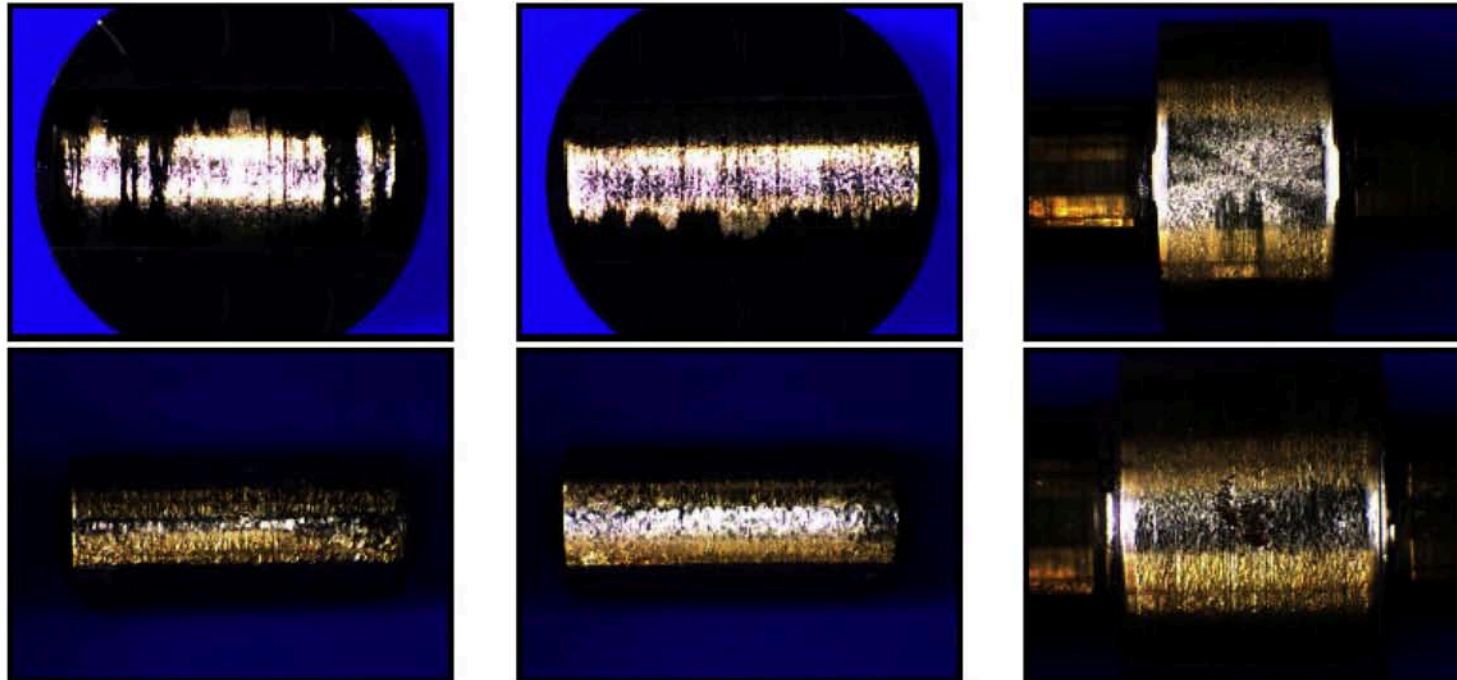
- Standard pump 0445010613
- Date of manufacture 04/2008 (i.e. before the introduction of the straightedge test and further quality improvement measures with regard to metal splashes / fusing on roller or roller support)
- Drivetrain damage category I
- Circumferential abrasive wear and fatigue on cam track and roller
- Large areas of C coating in roller support worn

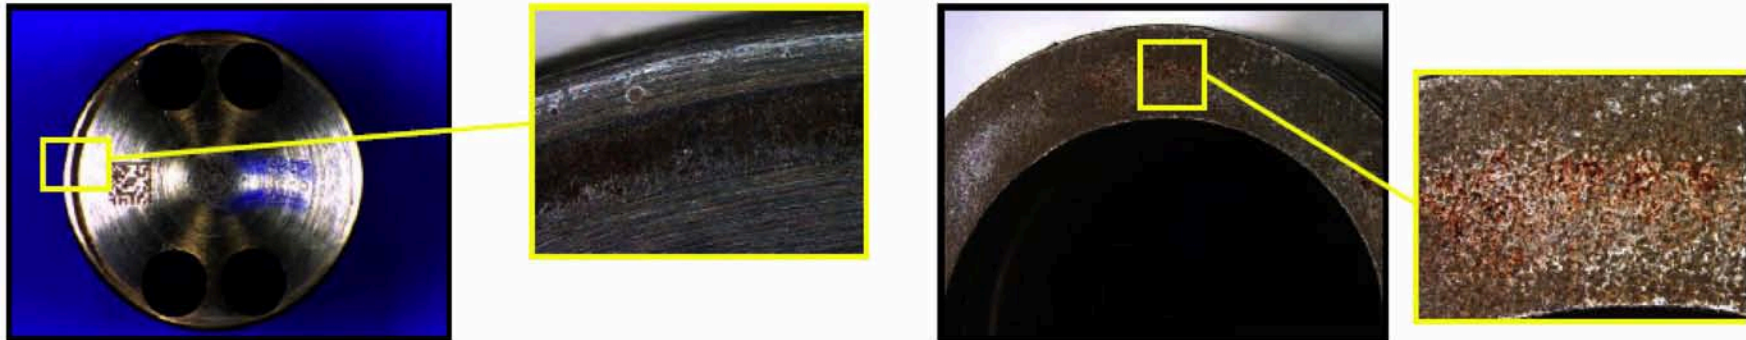
- Little evidence of periods of use with water in fuel (corrosion)
- The advanced state of the damage means that there is no longer any possibility of identifying anything unusual about the manufacture of the roller support or roller

- The cause of the damage is no longer ascertainable
- Indications of periods of use with water in fuel.

Evidence is too weak to enable definite conclusions to be drawn in relation to the cause of the damage.

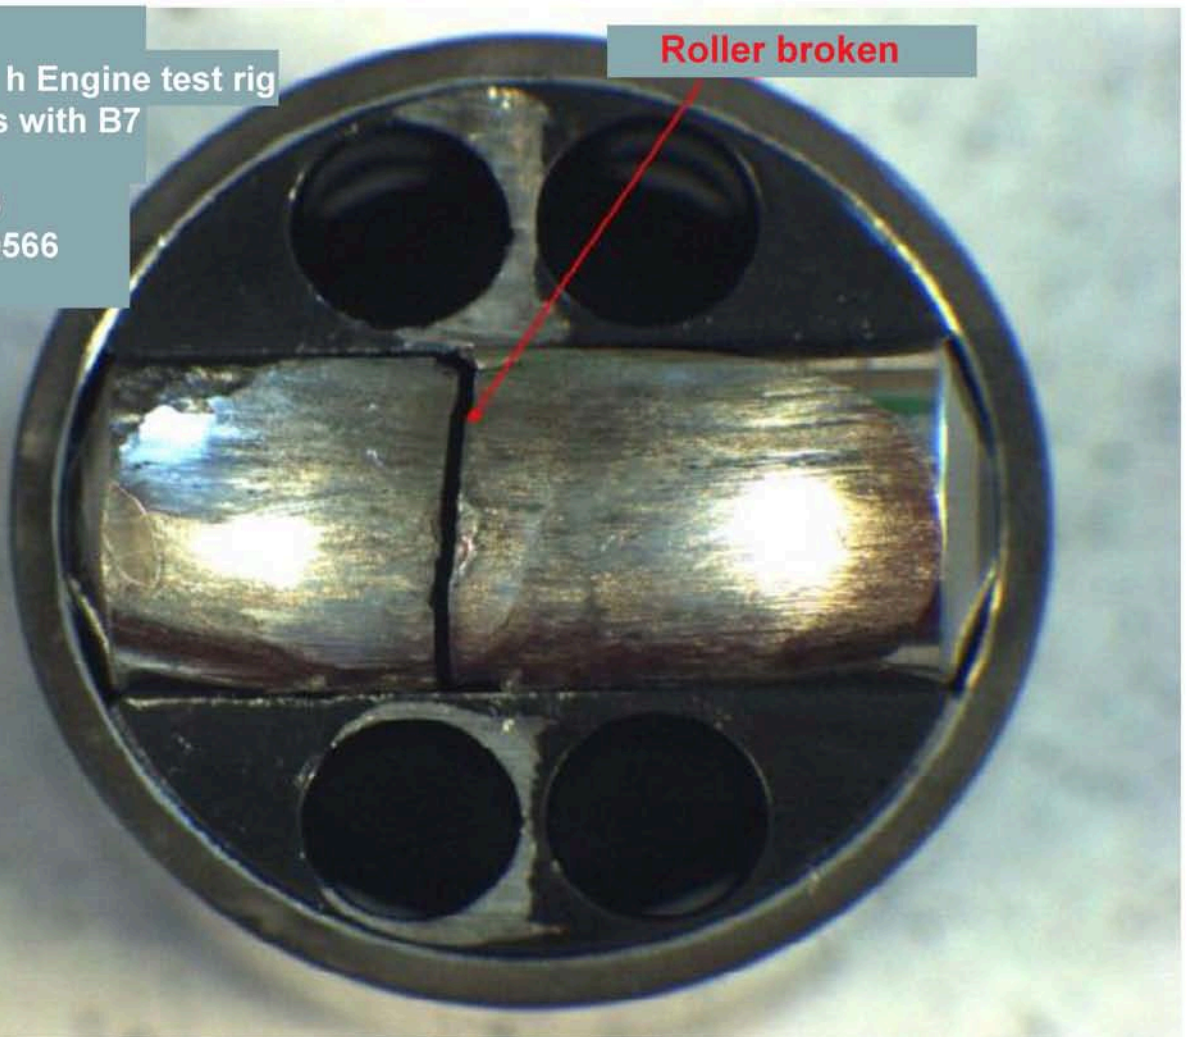
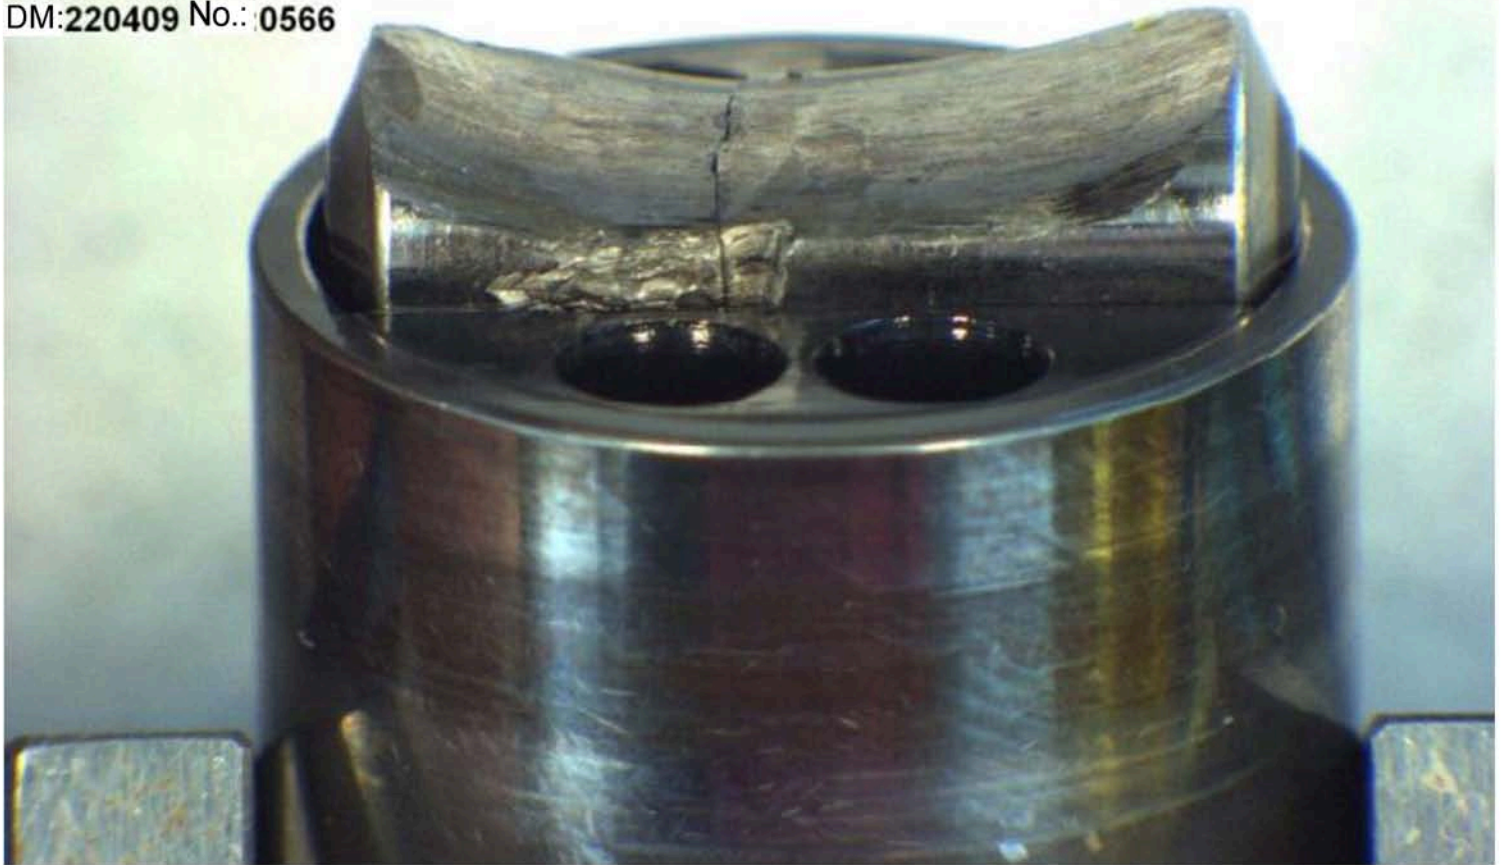
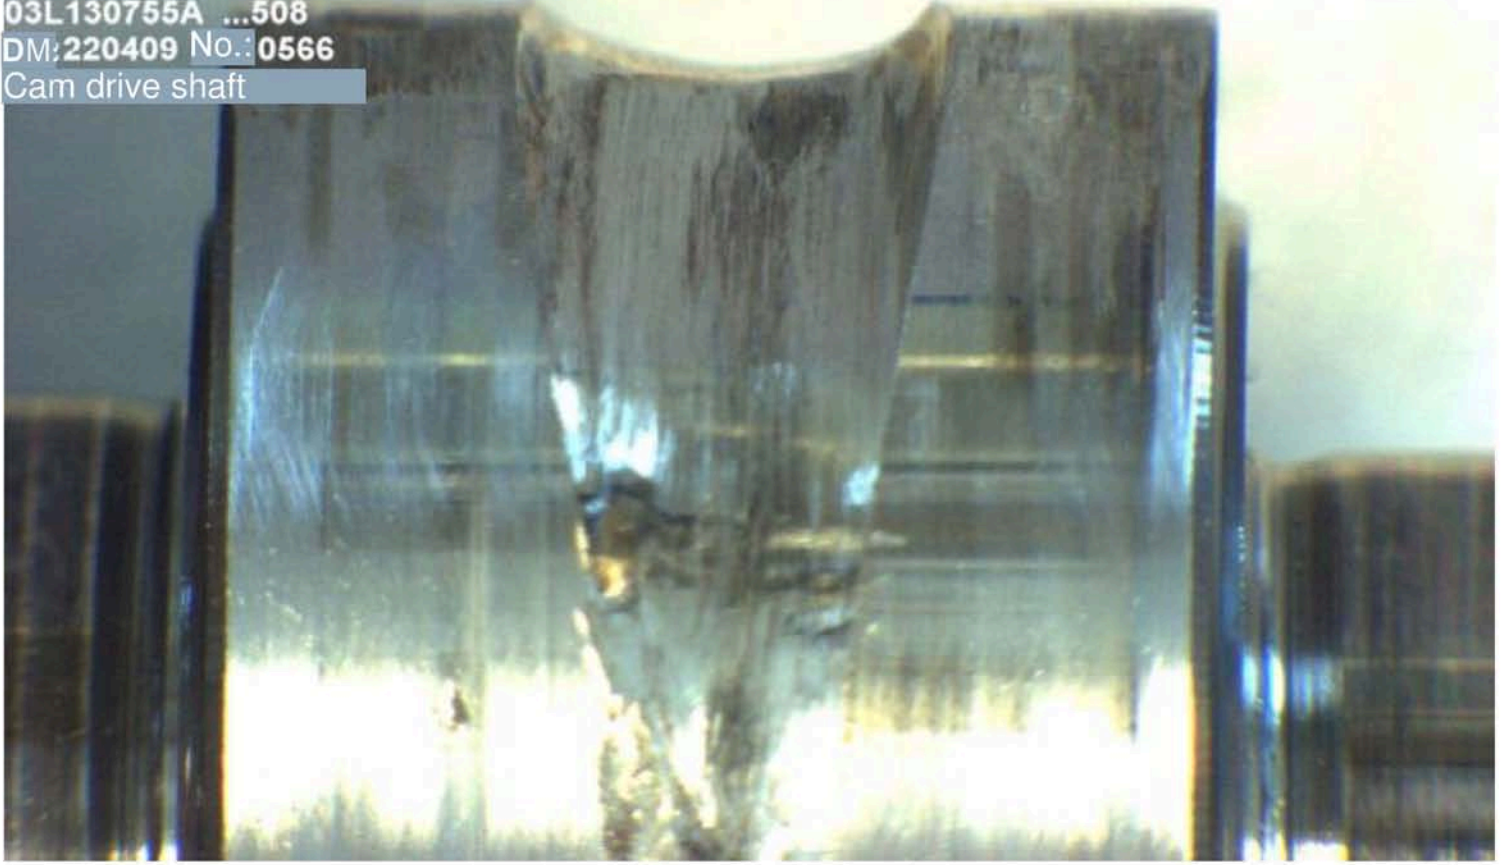
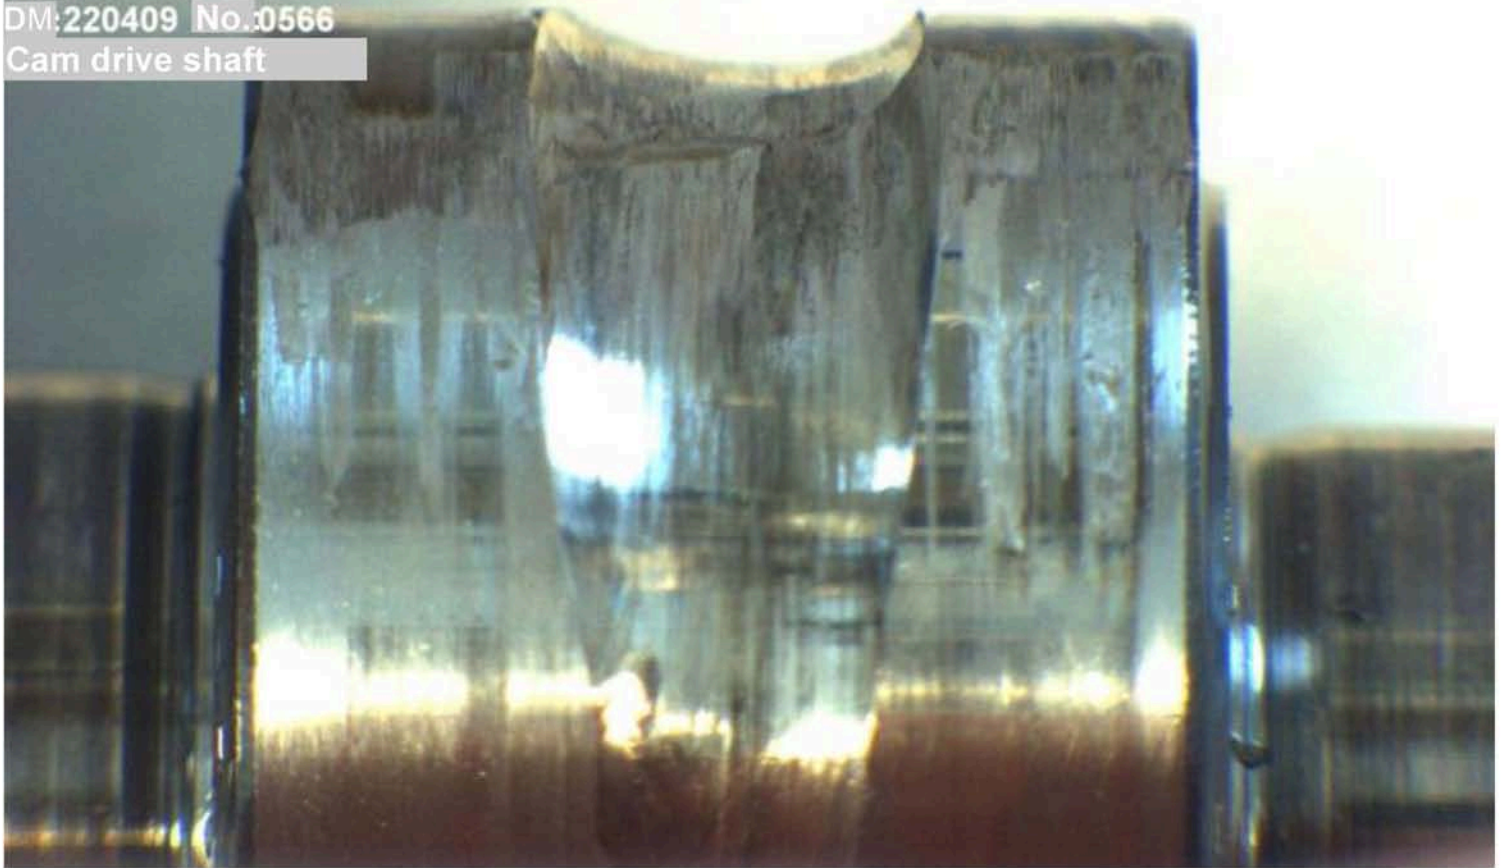
Hello [Redacted]  
I have received a CP 4.1 US07 HPP from [Redacted]  
The engine failed during testing - no building up of pressure and particles in the MU. When dismantled, there were signs of serious drivetrain damage with a broken roller.

CJA0000598  
Running time: 567 h Engine test rig  
of which 230 hours with B7  
Bosch HPP CP4.1  
03L130755A ...508  
DM:220409 No.:0566

Manufacturer	Bosch	Date,	2/24/2010
Series	CP4.1	Handled by	
VW - Part number	03L130755A	Project	
Manufacturer - Part no. Serial no. / DM	0445010508 BPT 0566 /220409	Engine no.	CJA0000598
Drawing no./prototype.		Output:	
Change index,	0006	Fuel	
Plant	011	Fuel vehicle / test rig	Engine test rig H72a
		Running time / Operating mode	567 h VCT
Complaints / comments	Run for 230 hours with B7 - Remaining time with gas stations diesel drivetrain damage - turned tappet

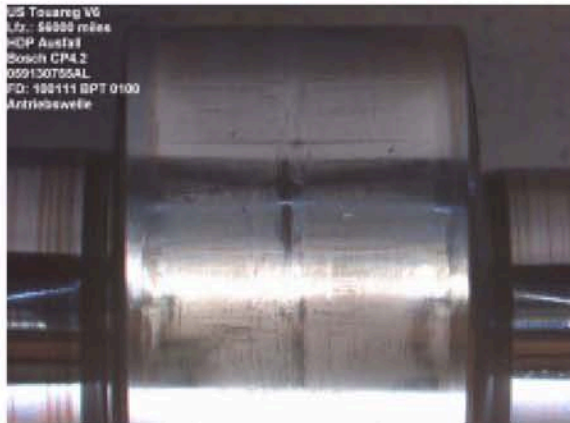
Roller cylinder 1

- High-pressure fuel pump wear in Bosch CP 4.2 (see photos)
- Wear on camshaft, rollers and roller supports
- Flattening and abrasive wear on camshaft
- Material chips and braking flats on both rollers
