**Subject:** Documents for Q offensive

**From:** Non-responsive content removed  
**To:** [REDACTED]  
**CC:**  
**Date:** 2/6/2009 4:33:00 PM  
**Subject:** CP4 robustness  
**Attachments:** [Bemerkung zur Robustheit CP4.doc](#)

**CC:**  
**Date:** 18/02/2008 14:24:23  
**Subject:** Minutes and attachments for CP4 technical discussion on 13/02/2008 in [redacted]  
**Attachments:** [882801 Protokoll CP4 Fachgespräch am 13.02.08 bei \[redacted\].pdf](#)  
[Übersicht DL-Ppen für Audi.pdf](#)  
[CP4 Audi\\_080213.pdf](#)

**From:** Non-responsive content removed  
**To:** [REDACTED]  
**CC:** [REDACTED]  
**Date:** 12/3/2010 3:58:22 PM  
**Topic:** RE: RP1 Failure USA \_BC / QTS 3833800  
**Attachments:** [4A970 Zwischenbericht.pdf](#)

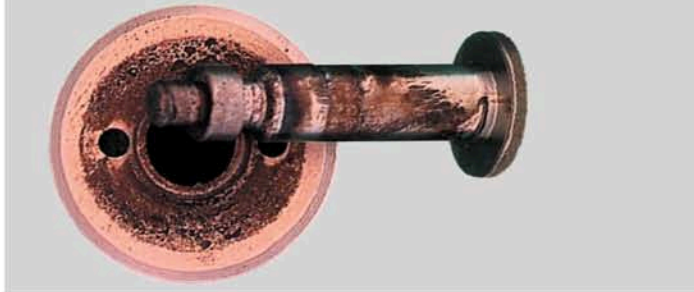
- Is essential to maintain the water separator in order to avoid water entering the system
  - Ensure via feedback in the in the estate
- Examples of corrosion on the injectors

Parts of common rail injector

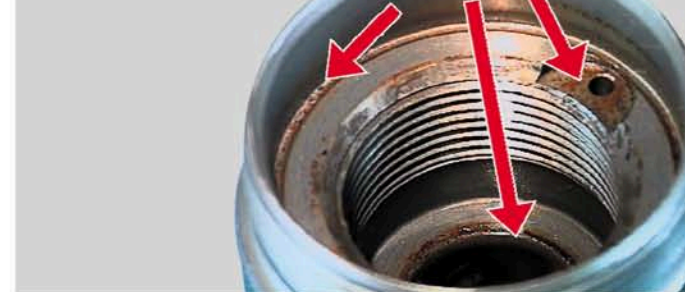
Injector body

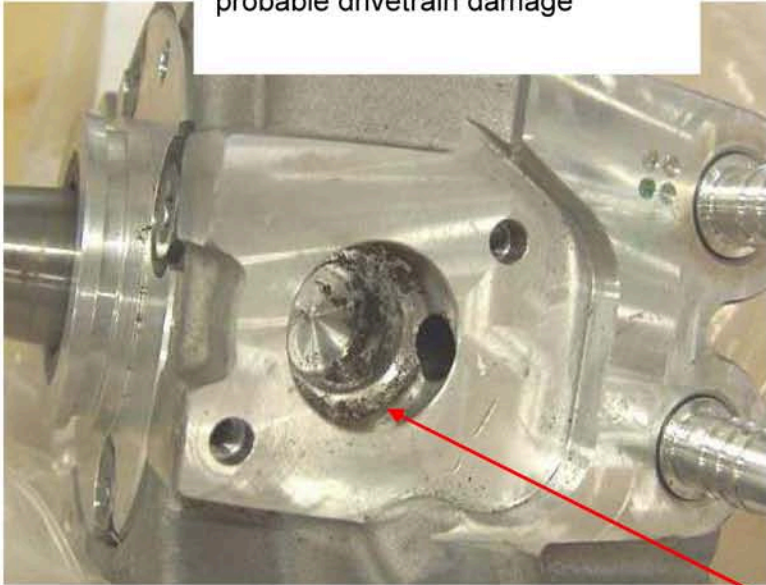
P pump no. 2

probable drivetrain damage

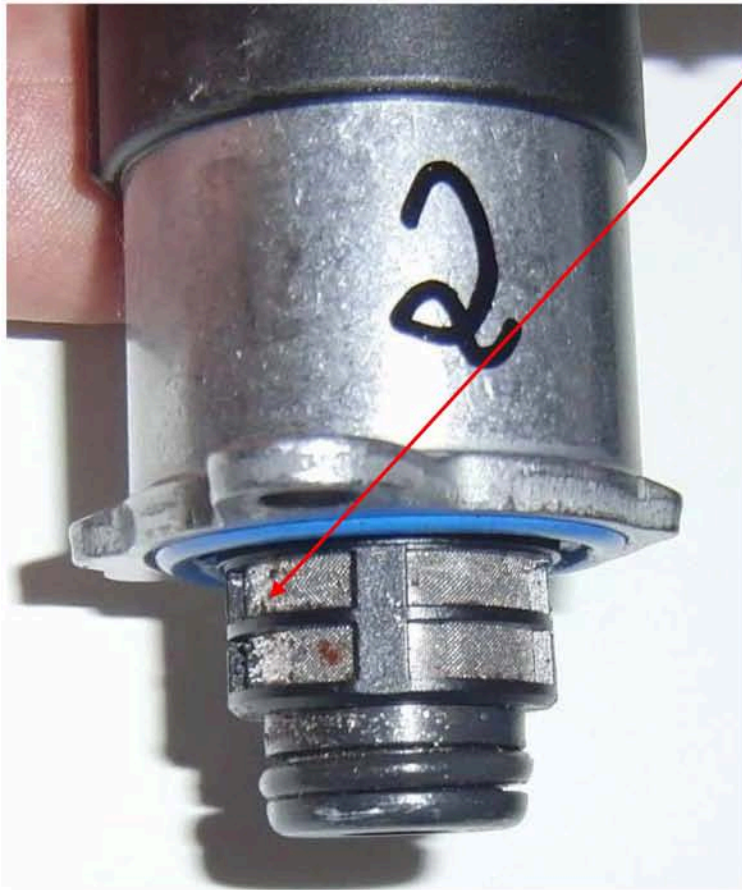
HP pump no. 2

Chips deposits metering unit strainer and in the pump chamber below metering unit

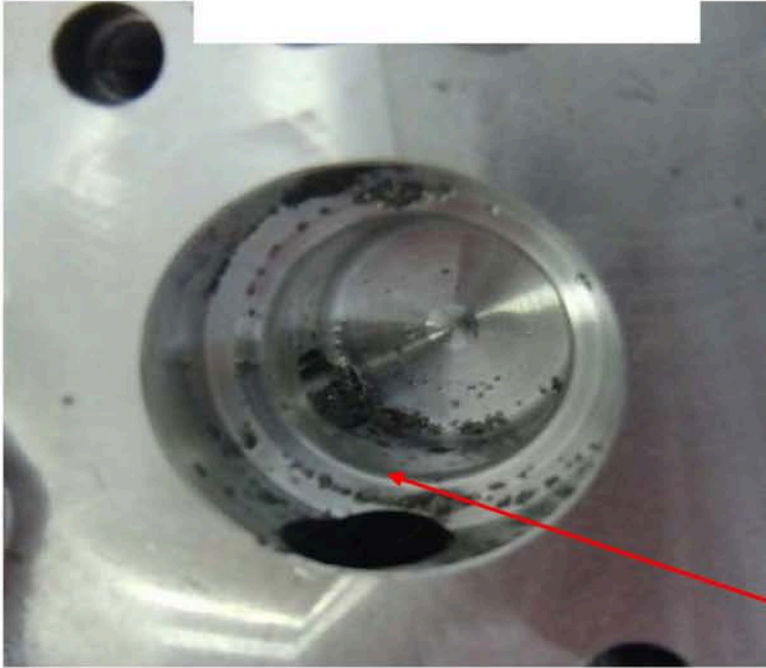
P pump no. 24

probable drivetrain damage

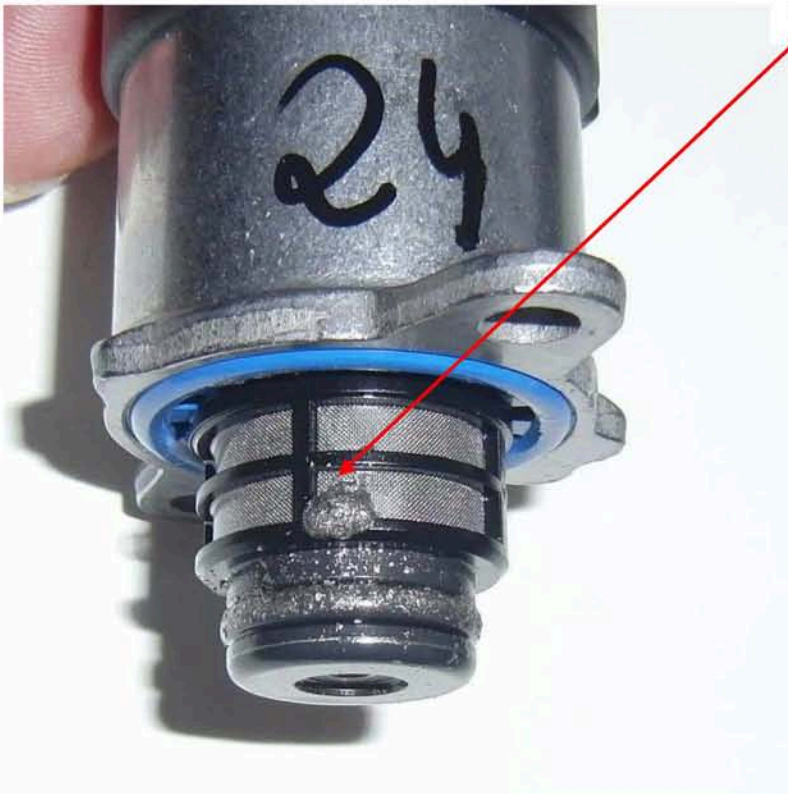
HP pump no. 24

Chips deposits metering unit strainer and in the pump chamber below metering unit

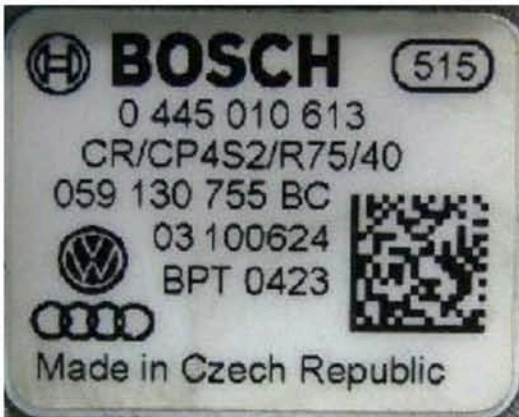
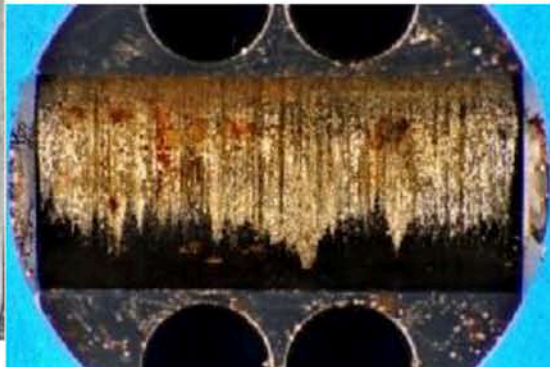
Drivetrain damage, deposits on all parts

**Summary:**  
Deposits were found on all pump parts.  
Drivetrain damage occur only when the pumps are operated outside of the technical customer document (fuel type, air, starting conditions, temperature).  
We must reject the complaint for this reason.
