**From:** Non-responsive content removed  
**To:** [REDACTED]  
**CC:** [REDACTED]  
**Date:** 10/18/2010, 5:20:19 PM  
**Subject:** Re: Analysis results [REDACTED] pumps"

>Bosch presented additional analysis results today of the 5 pumps that were removed from the blocked vehicles in [REDACTED]. Deposits were discovered on all the pumps.

**Subject:** First findings, 2nd USA Failure pump

# Analysis report

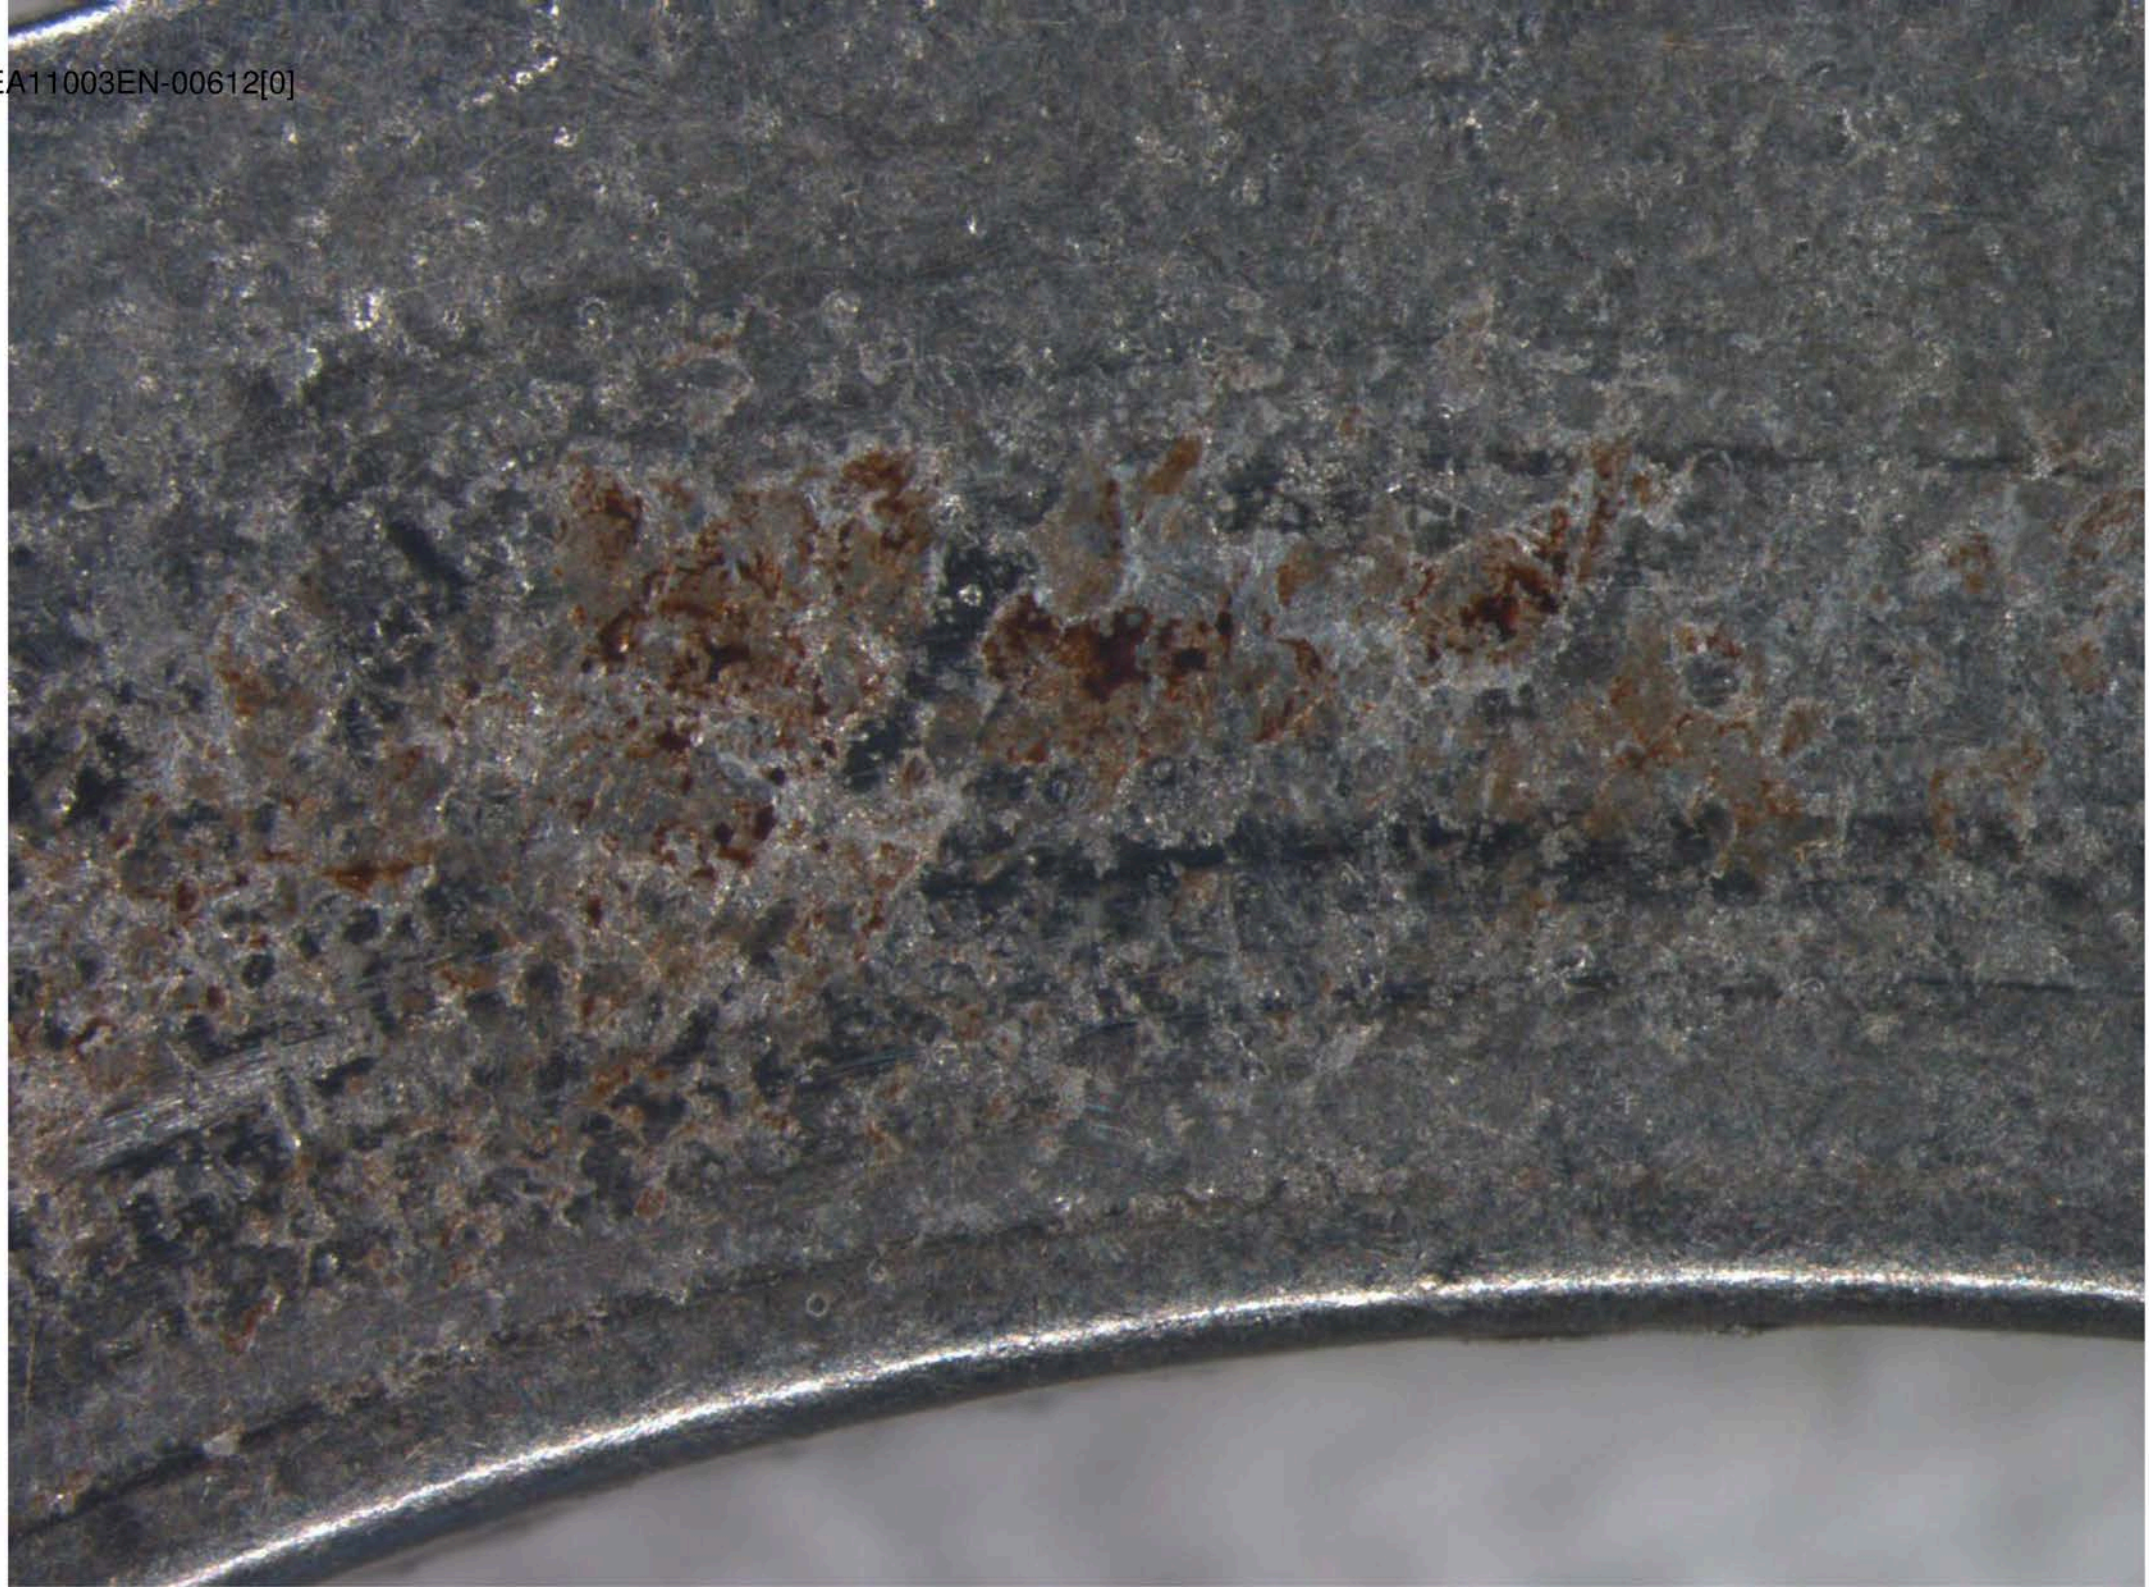
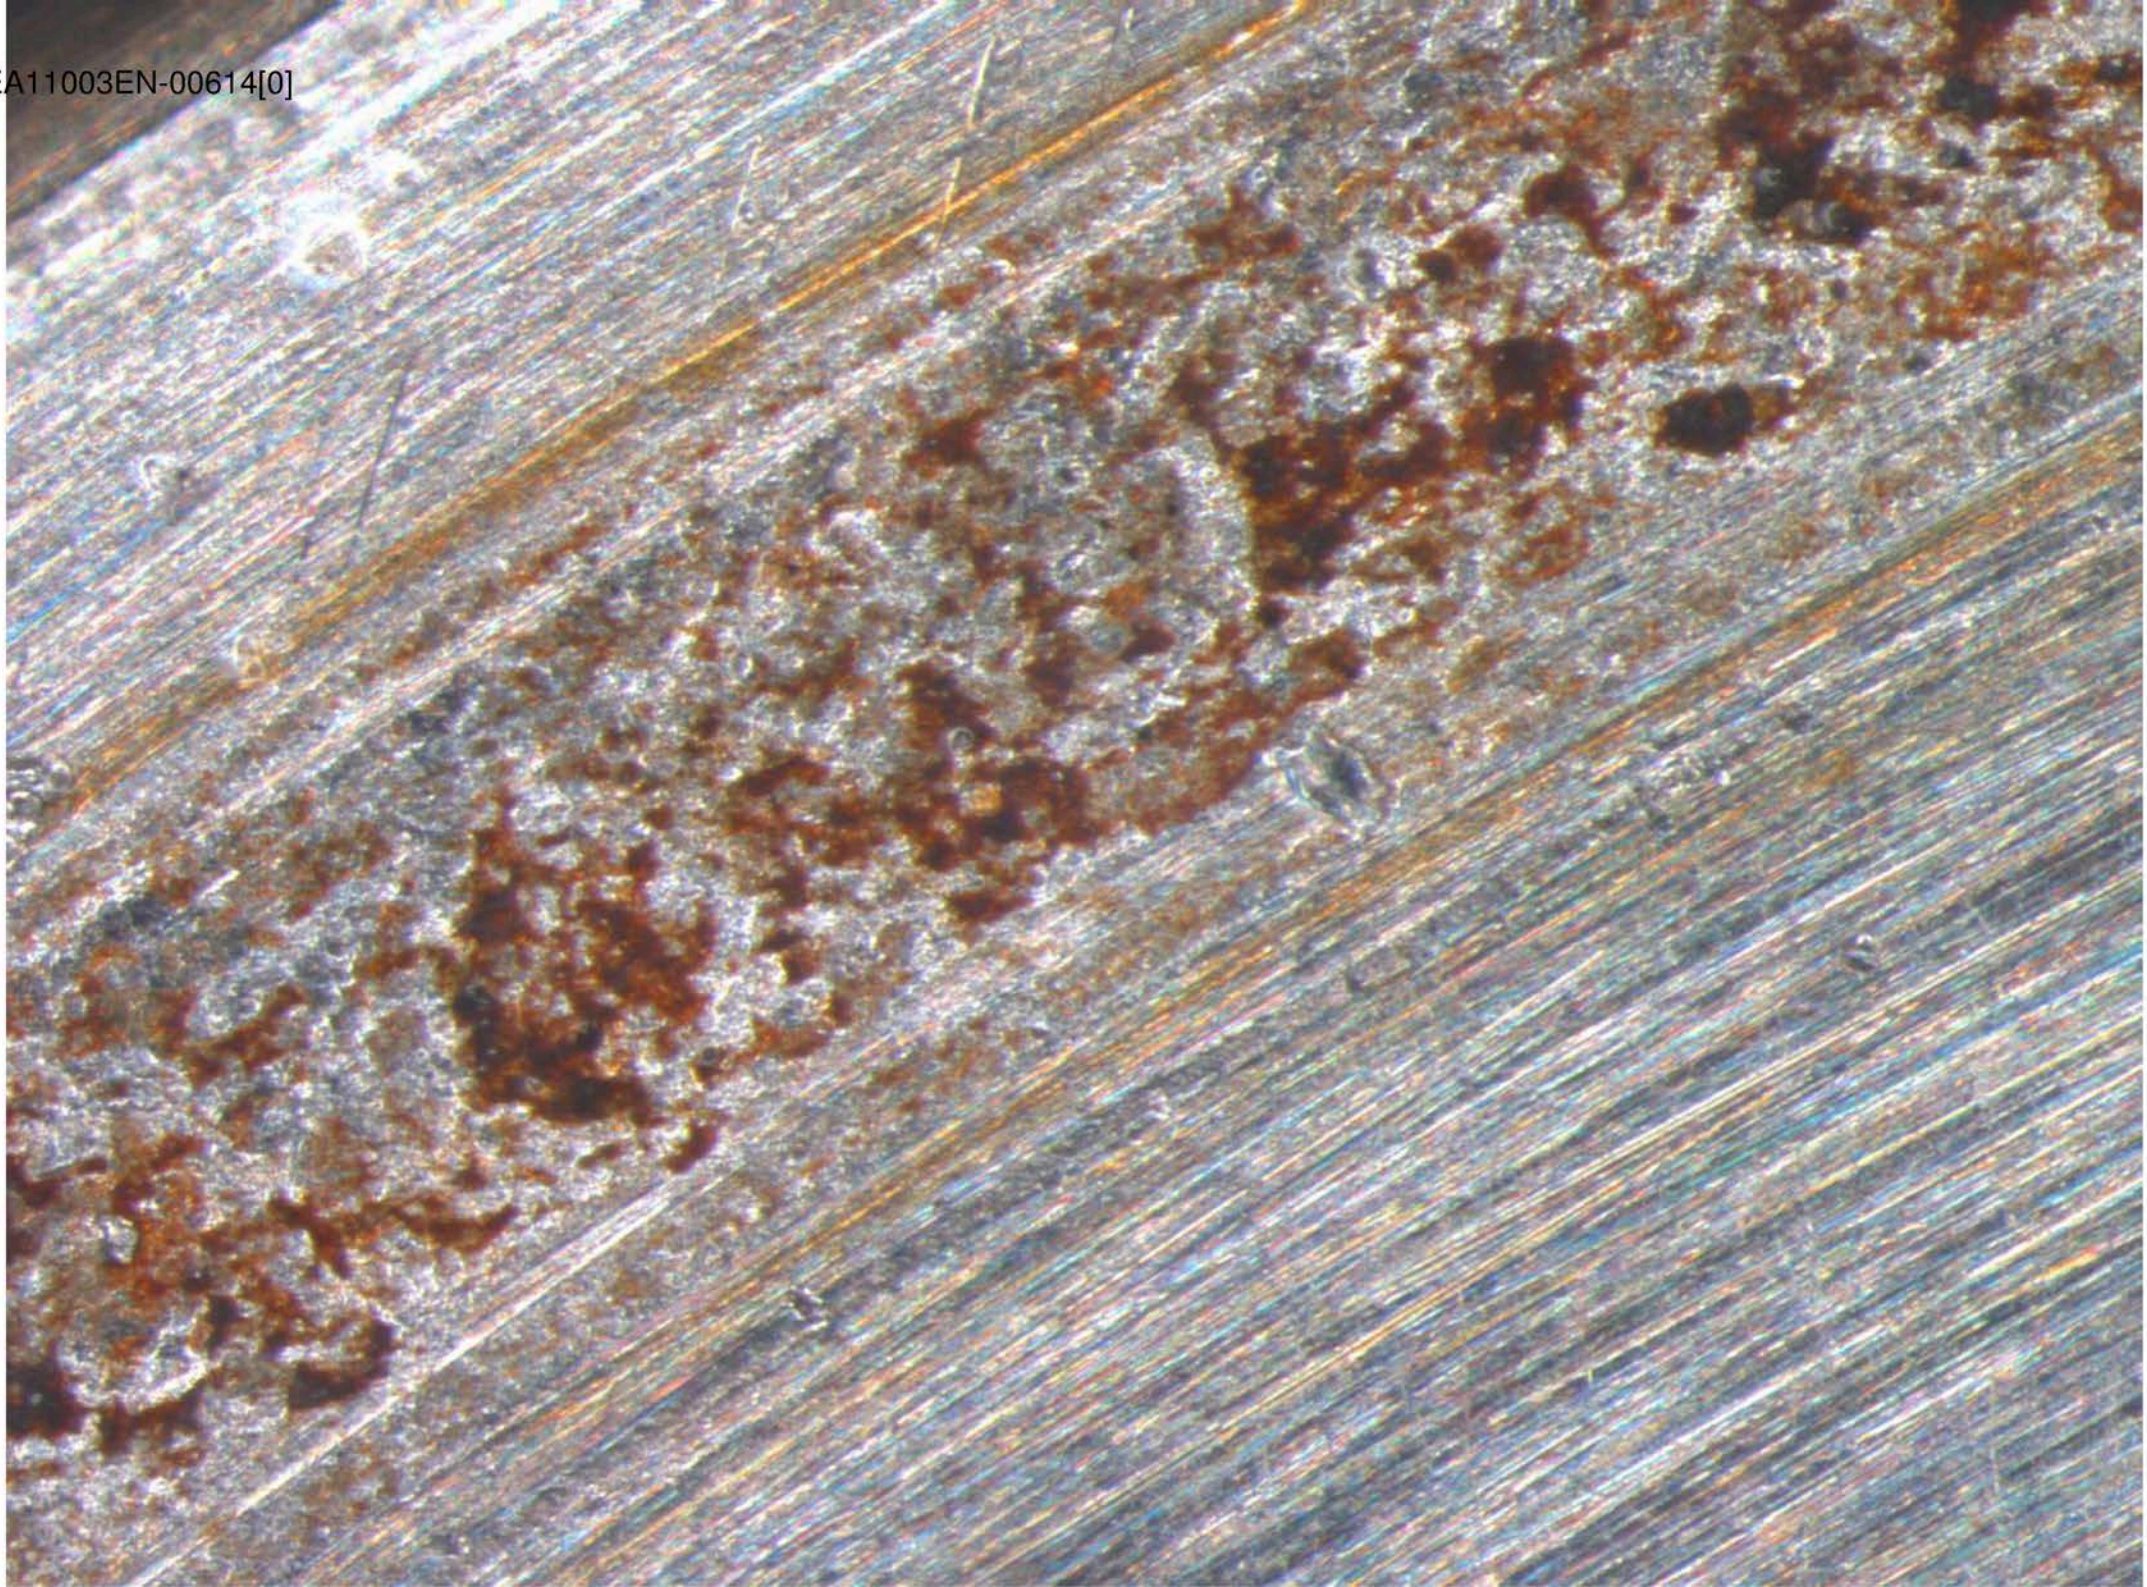
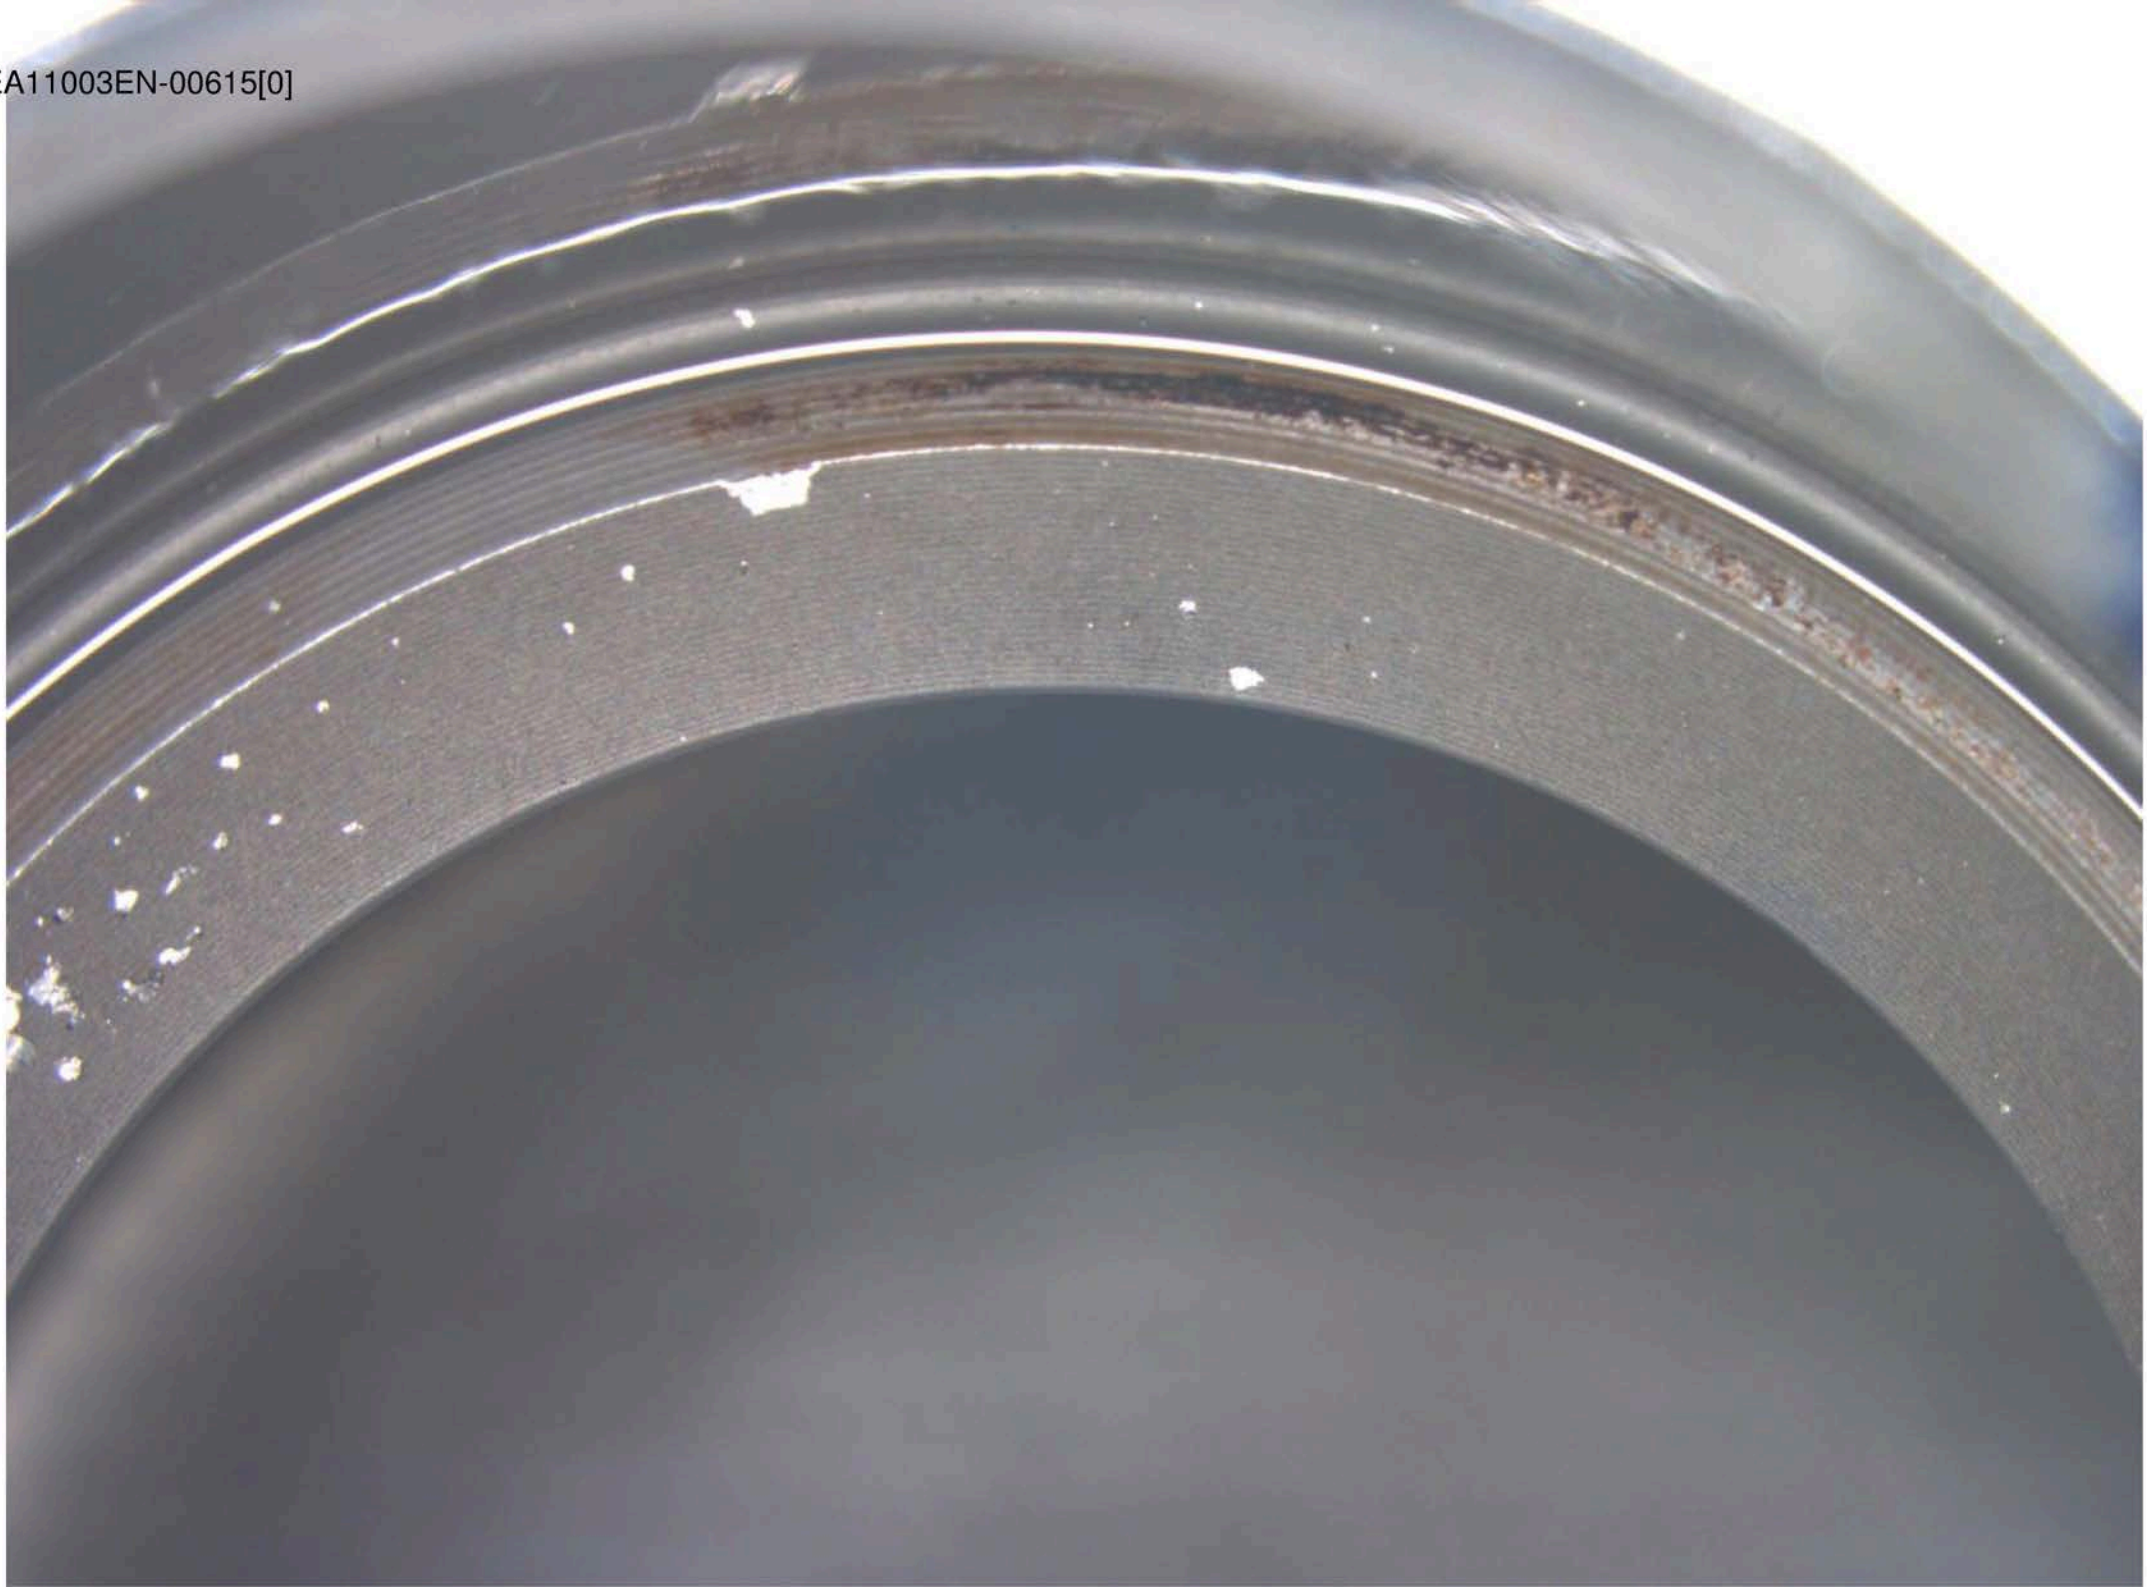
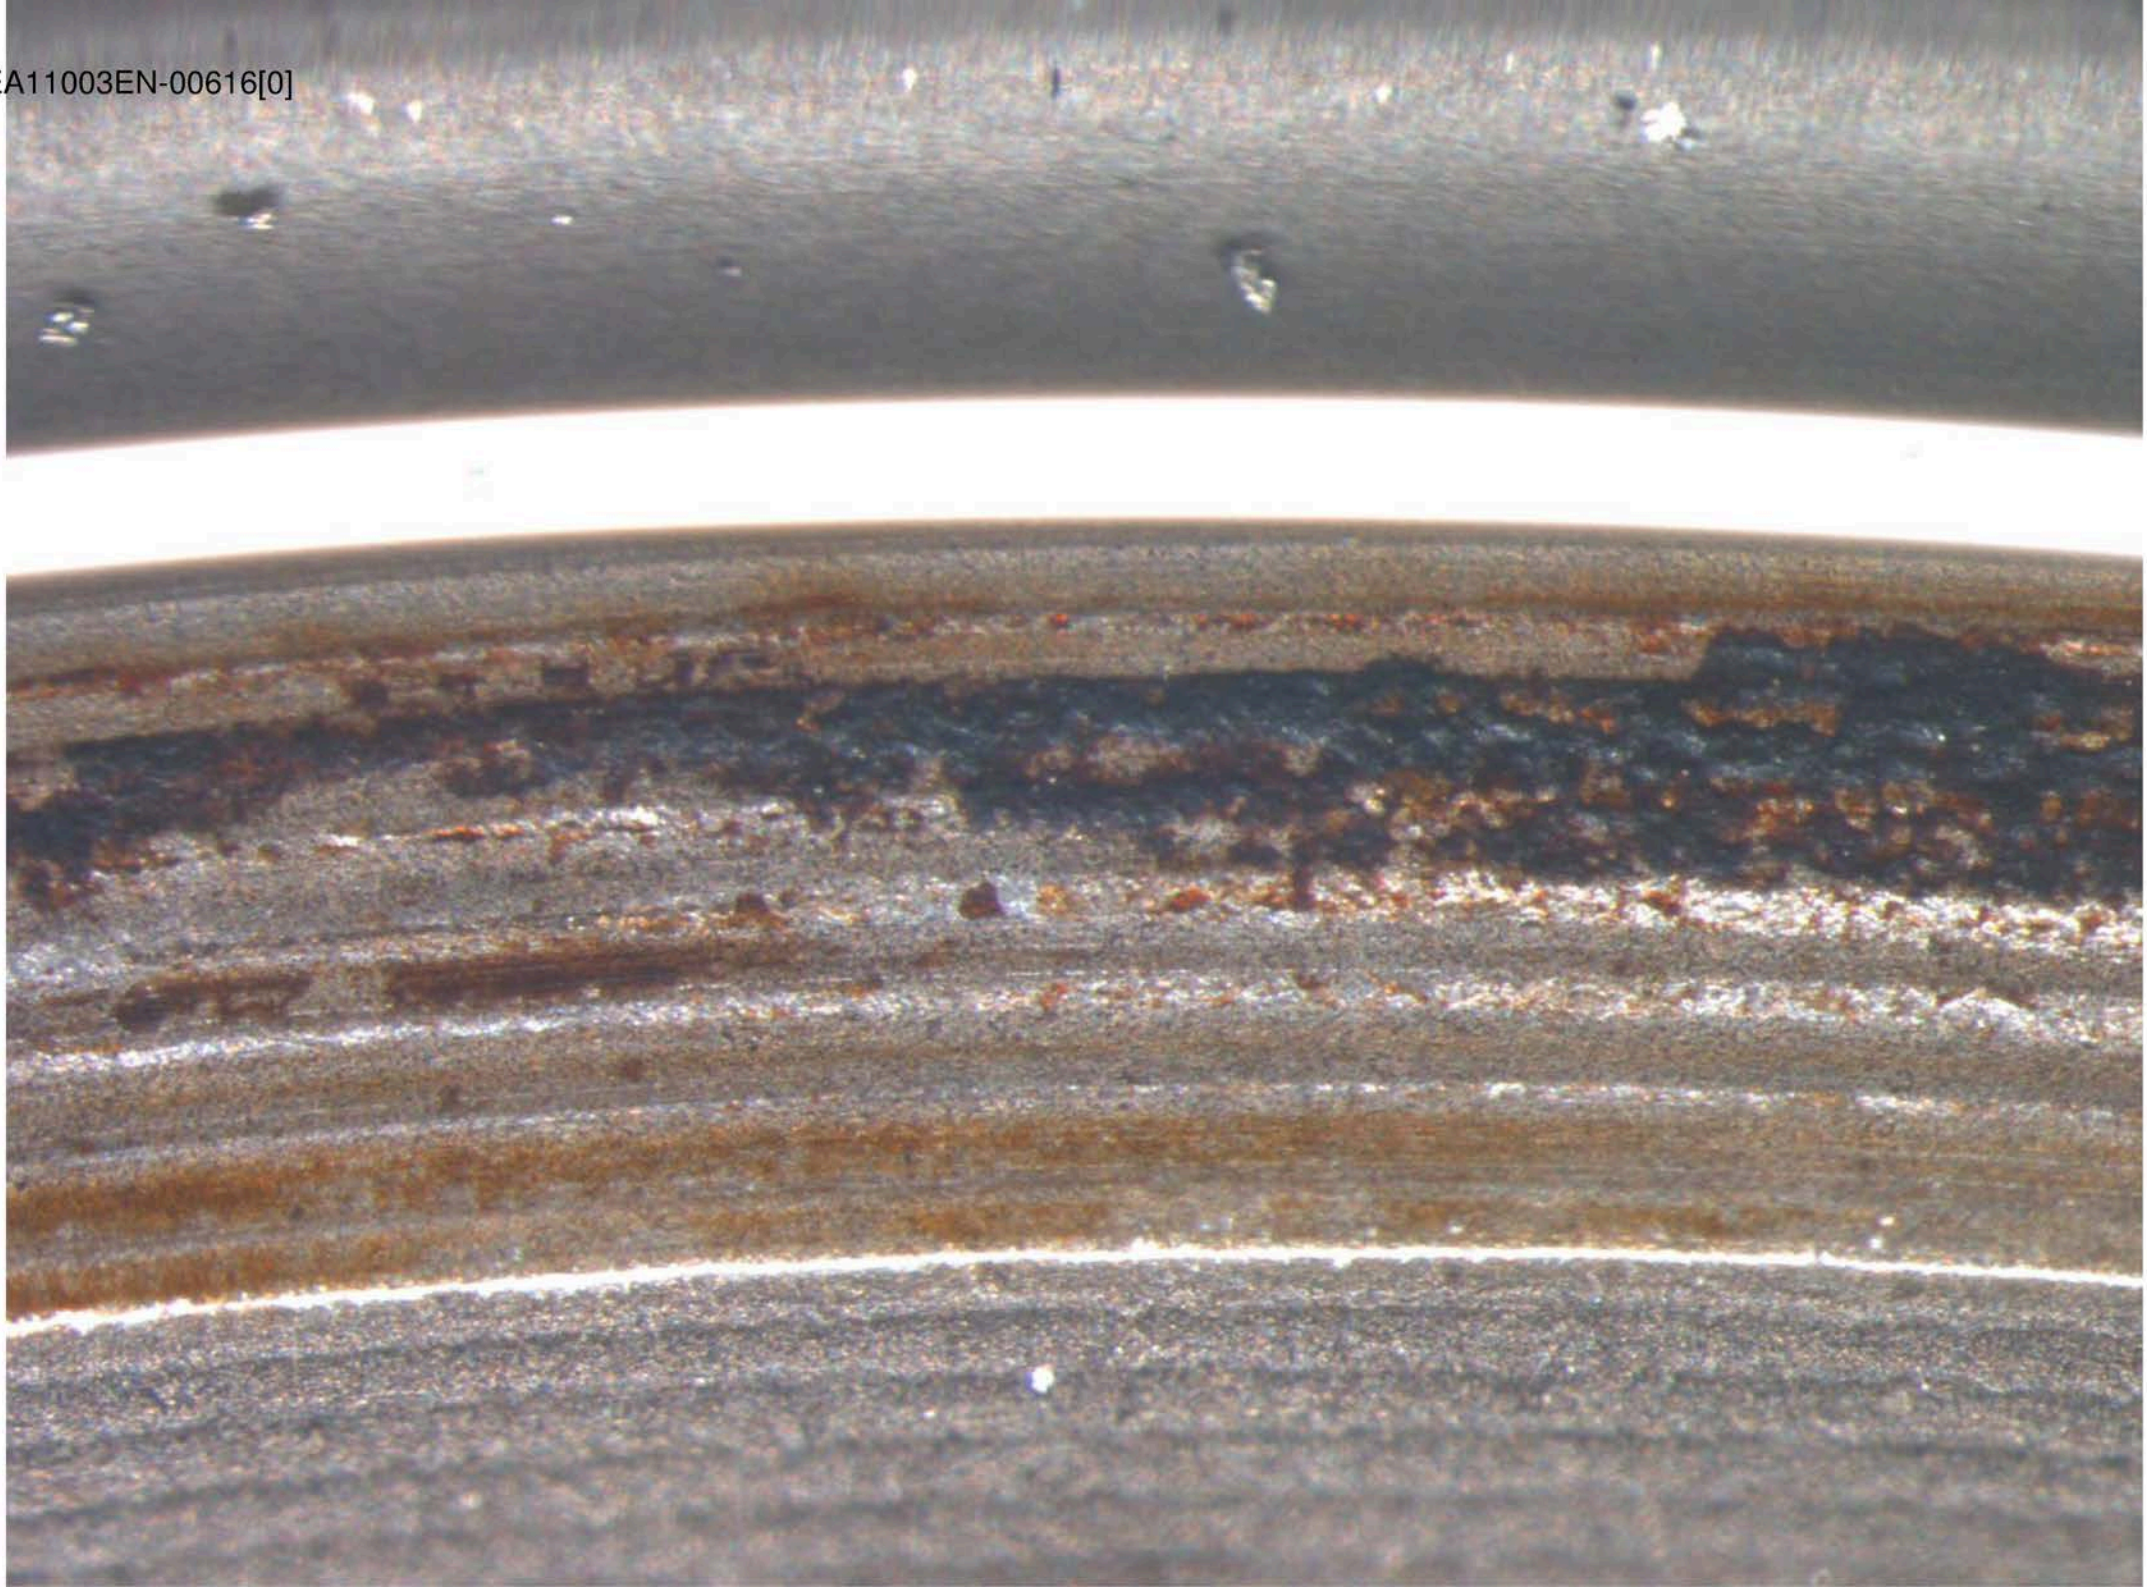
Here are images of the second pump, again with minimal signs of corrosion (indication of free water).

The 2nd return feed pump from the Audi USA tests (0445010613 #080428-0876 with 141925km) has Category I drivetrain damage and also indications of water in fuel at RS, tappet body, tappet spring and spring plate. VVT-No. 2009-CP4\_0500
